# **A Case History of Highwater Shore Erosion and Bank Stabilization via Tree Roots**

**Bret N. Lingwall<sup>1</sup>**

## **ABSTRACT**

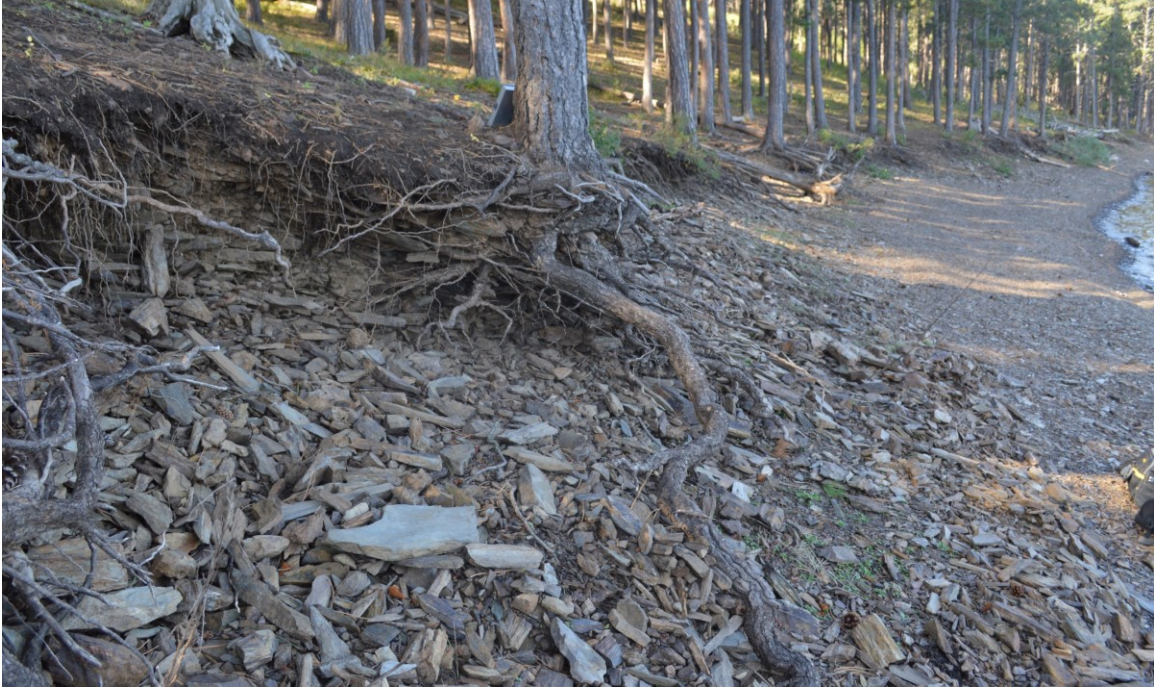
**Figure 3. Bank as pictured after the 2019 erosion event. Note the talus of rock fragments from the high-water erosion event earlier that year. Talus from the 2015 high-water erosion event is to the right and has weathered into smaller fragments and gravels.**

Figures 3 and 4 show that the new bank that formed in the 2019 erosion event formed along the root structures of the large coniferous *P. ponderosa* trees that grown plentifully on the hillside. These trees have provided surface erosion protection to the slope for millennia, and in this new erosion paradigm have stabilized the slope and arrested the high-water erosion event of the bank. The woody roots of the trees are of particular interest. Although the “first order” (i.e. very small rootlets) rootlets certainly play a large role in surface erosion mitigation, for the purposes of this deep-seated bank erosion during high-water events, the woody roots appear to be performing most of the stabilization while the rootlets do not.

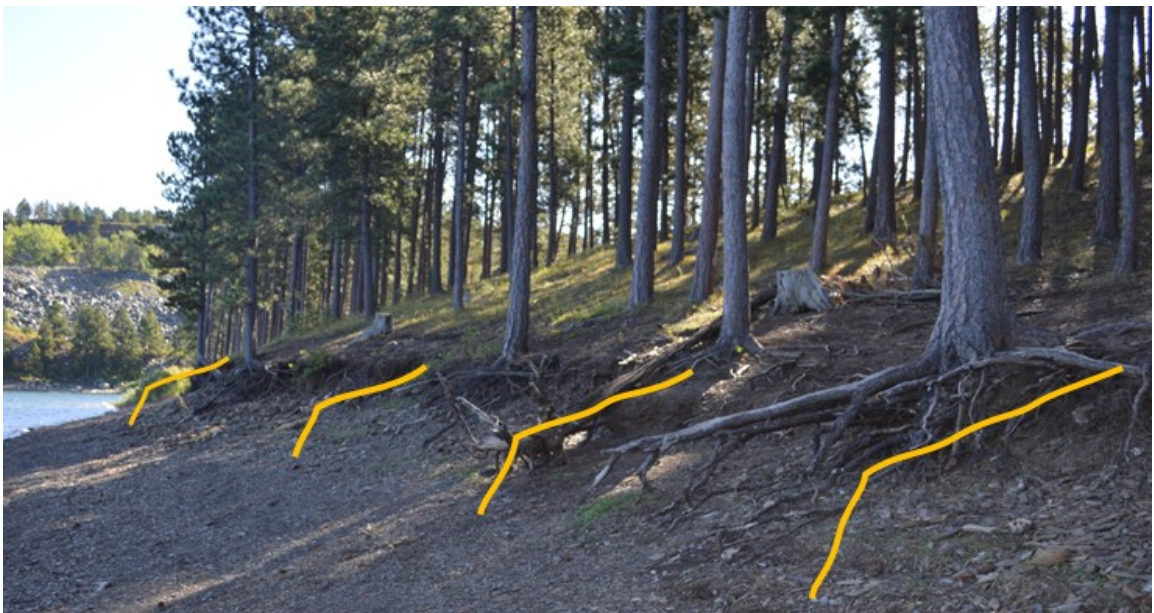
**Figure 4. View of the erosion area to the east after then 2019 erosion event. The yellow lines show the approximate slope and bank after the 2015 erosion event.**

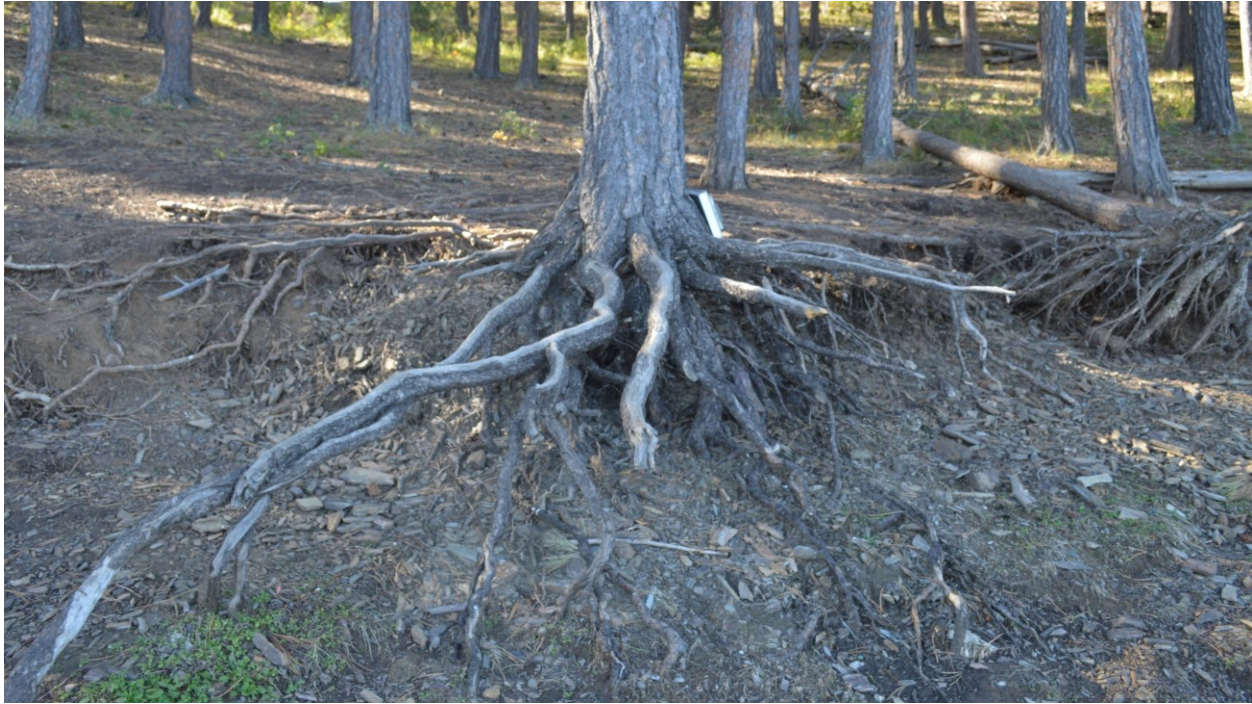
The three individual specimens mapped in detail are typical of that seen in Figure 9. In these specimens, the taproot is not dominant. The woody roots spread out far from the bole (see the turquoise roots in Figure 6). The trees have many sinker roots (see the red roots in Figure 6). The root structures often interlock with those of adjacent or nearby trees. Exposed woody roots can be seen along the new bank, where the bank has stabilized at approximately the midline of the trees, meaning about half of the woody roots of the trees have been exposed in the erosion event. This does not bode well for the long-term survivability of the trees, and it is anticipated that, consistent with previous high-water events, that these specimens will die off over the next decade. Their roots will rot away, and when a new high-water event occurs, another erosion event will occur. However, the focus of this paper is on the role that the existing woody root structures play in bank stabilization in the subject high-water events. Table 1 lists the 5 specimens mapped in detail and shows the relative spread of the woody roots compared to the diameter of the foliage crown and the bole.

**Figure 9. Root structure that stabilized the bank (newer exposures from the 2019 event to the left and right of the bole). The bleached roots at the front middle of the image were exposed in the 2015 high-water erosion event. Note large root spread and frequent sinkers.**

All trees mapped leaned into or towards the slope, rather than away from the slope, indicating that there was no general slope instability underlying the vegetated root mat. All 5 trees had maximum heights exceeding 16 meters, and all specimens are estimated to be at least 50-years old or older. Common amongst all tree woody root structures that performed well in stabilization were: 1) large spread of the woody roots in the upper 1-m of the ground, 2) less reliance on a single large taproot, 3) a higher concentration of sinkers, and 4) high degree of interlock with the woody roots spreading out from adjacent specimens.

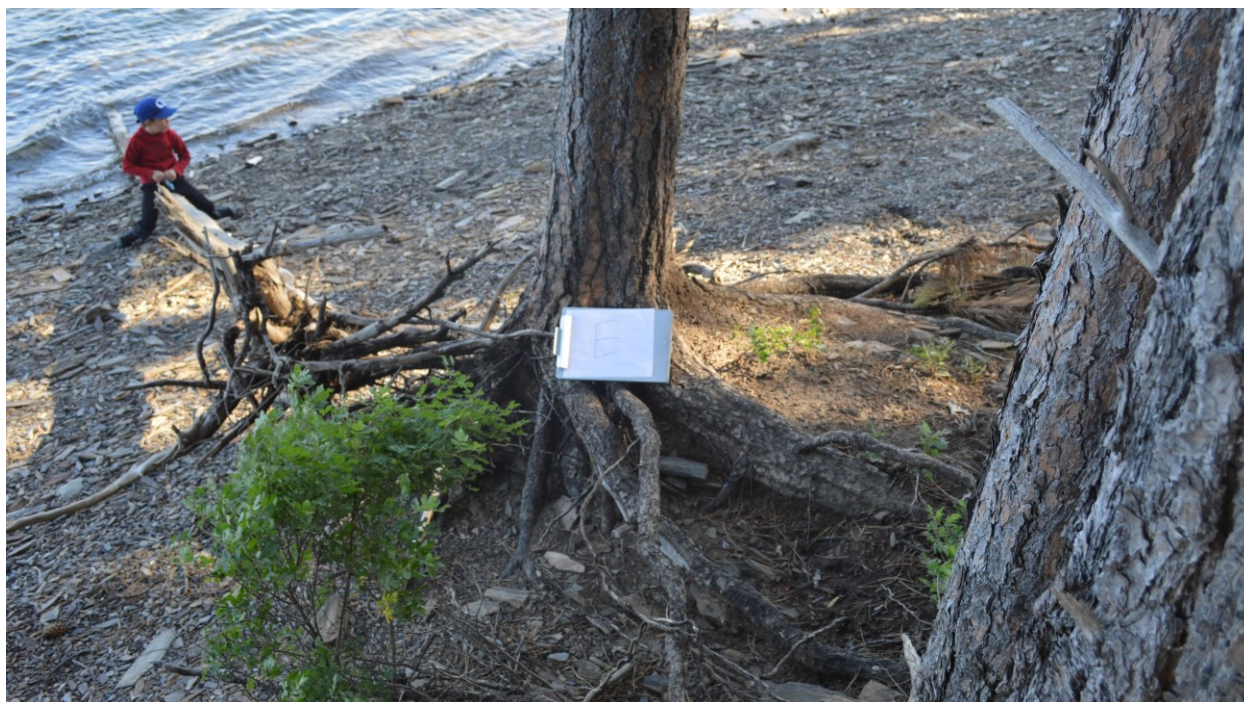
Figure 10 shows an example of the two specimens mapped in detail that performed poorly at bank stabilization. These two specimens had erosion mass losses of at least 80% around the taproot. Common to the poor performing specimens were 1) a single, large, dominant taproot, 2) few (if any) sinkers, 3) less spread of the woody roots relative to the foliage crown, and 4) less interlock with the spreading roots of neighboring specimens. Figure 10's specimen was only saved from toppling due to the interlock of roots on its upslope side.

**Figure 10. Specimen "E", typical of root structures that did not stabilize the bank. Note that erosion occurred on 80% of the base of the tree. This specimen had a deep taproot but had very few of the spreading woody roots or sinkers. Interlock only in the area not eroded.**

| Tree | Crown Diam (m) | Bole Diam (cm) | Max Height (m) | Lean (deg, + is upslope) | Woody Root Spread (m) | Root Interlock? | Predominant Tap Root? | Sinkers? | Did the Roots Stabilize? |
|---|---|---|---|---|---|---|---|---|---|
| E | 3.7 | 46 | 18.3 | 15 | 4.3 | Y | Y | N | No, Only in the root interlock area |
