# **Liquefaction-Induced Ground and Building Interactions in İskenderun from the 2023 Kahramanmaraş Earthquake Sequence**

Significant and widespread liquefaction occurred in İskenderun during the 2023  $M_w$  7.8 Kahramanmaraş earthquake. Liquefaction effects on buildings were observed in several areas of İskenderun, predominantly in areas of reclaimed land and near historic shorelines. Liquefaction-induced building settlements were particularly concentrated in the Çay District, which is almost entirely reclaimed land. Liquefaction-induced ground and building settlements were either marginal or not apparent in areas away from the historical shorelines. Building settlement and ground deformation were documented at 26 buildings in İskenderun through lidar scans and laser-level hand measurements. Liquefaction-induced building settlements ranged from 0 to 740 mm. Building-ground interactions were evident from hogging ground deformations, including cases where buildings deformed nearby ground and damaged nearby buildings, and sagging buildings. Historic land development affected the spatial extent of observed liquefaction-induced building damage. Representative liquefaction-induced bui

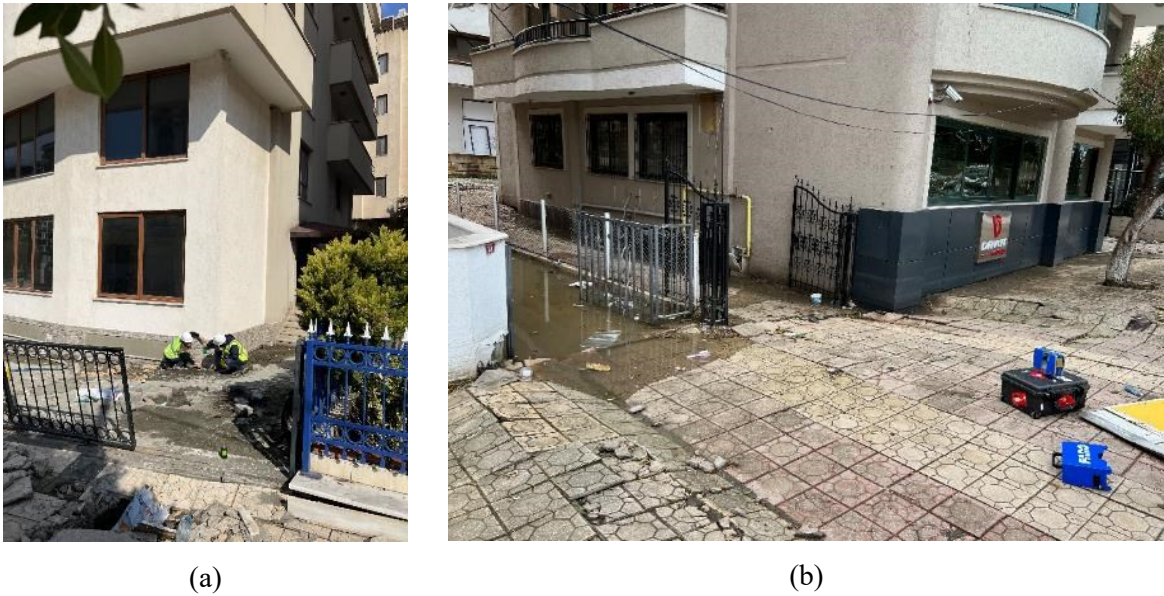
**Figure 6.** Examples of building settlement survey methods: (a) hand survey at Building E on Bahçeli Sahil Evler Street with a laser level where the laser level is placed on a reference ground level that was judged to have not settled (36.5901N 36.1778E; 28 MAR 2023), and (b) lidar scans at Building K on Atatürk Boulevard (36.5907N 36.1781E; 29 MAR 2023).

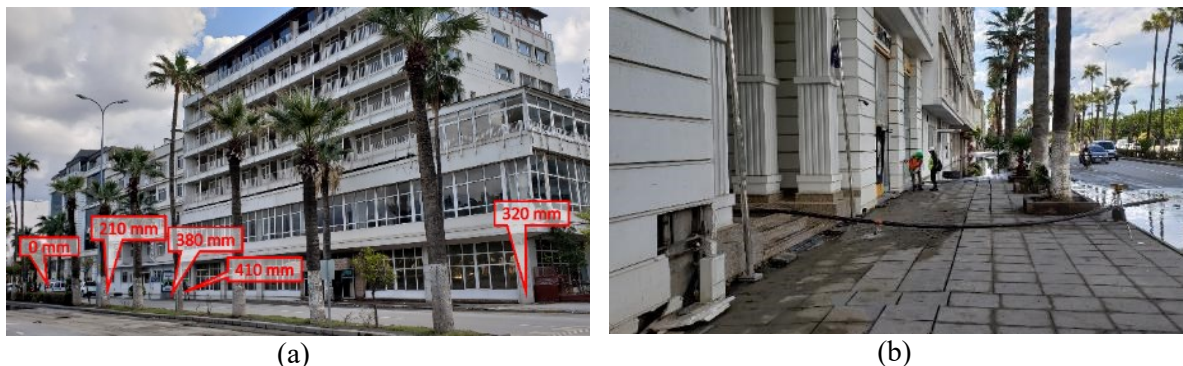
Settlement was observed across a block of adjacent buildings along Atatürk Boulevard in the Yenişehir neighborhood (shown in Figure 8), providing an example of settlement for closely spaced buildings along the historic shoreline. The eastmost building is Building Q (36.5917N 36.1699E). Negligible settlement was observed at the east corner of Building Q (32.45 m wide) and 210 mm at its west corner. The middle building, Building R (36.5918N 36.1696E; 25.33 m wide), settled 210 mm at its east corner and 380 mm at its west corner. The westernmost building, Building S (36.5919N 36.1693E; 40.55 m wide), settled 410 mm at its east corner and 320 mm at its west corner. The presence of standing water in Figure 8b follows the pattern of observed settlement; standing water is present at Buildings R and S where larger settlements were measured compared to Building Q.

**Figure 8.** (a) Photo of adjacent buildings Q, R, and S with settlement measurements (36.5924N 36.1690E; 1 APR 2023), (b) same group of buildings with Building Q in the foreground and including standing flood water on front sidewalk in front of buildings R and S (36.5916N 36.1700E; 1 APR 2023).

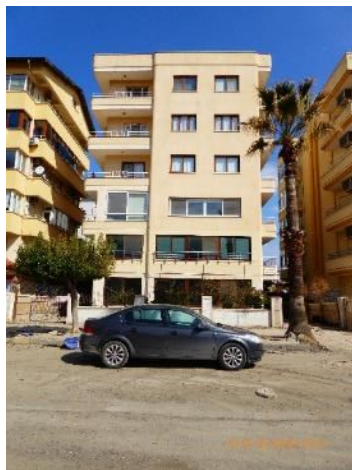
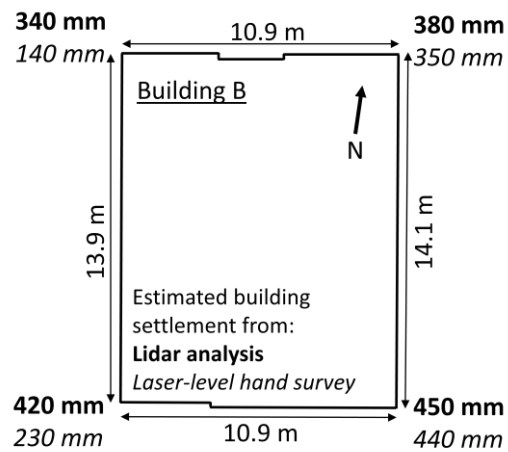
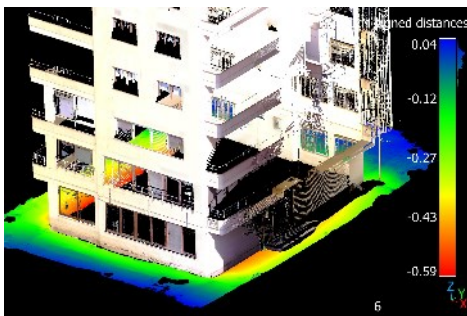
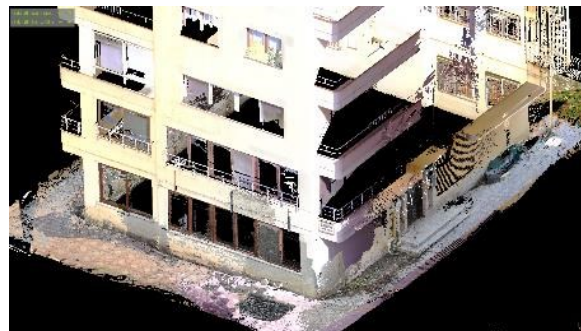
Building B on Bahçeli Sahil Evler Street (36.5902N 36.1772E) was surveyed with laser level hand survey, lidar scans, and photogrammetry that was subsequently combined with lidar data. The street view of the building is shown in Figure 9a. Building B is a six-story residential RCF-IW structure. There was no apparent basement, however, there was a sub-ground level room for the electrical panel. A summary of the building settlement estimates by hand survey and lidar scan data is provided in Figure 9b. The average building settlement by lidar scan analysis is 400 mm. There are discrepancies between the hand survey and lidar analysis estimates of settlement at the west side of this building. This likely reflects difficulties in finding a reliable datum (i.e., a point at which the ground elevation was not affected by earthquake deformations) and referencing each corner of the building to this point. The lidar scan estimates are considered more reliable than the hand survey estimates because of the detail captured by lidar scans and the ability to re-analyze the point cloud.

**Figure 9.** Building B on Bahçeli Sahil Evler Street in the Çay District: (a) street view of the building (36.5900N 36.1772E; 28 MAR 2023); (b) summary of survey measurements from various methods; (c) lidar scan of the building with contours of ground settlement (in m); (d) combined photogrammetry and lidar data also showing ground deformation around the structure.

Lidar scans were performed at the four corners of Building B. A reference ground plane that slopes  $1^\circ$  from north (rear of the property) to south (front of the property) was fit to the ground elevation data; this plane represents the assumed pre-earthquake ground elevation. The ground contours in Figure 9c represent the difference between the scanned ground elevation and the reference plane (i.e., contours of ground settlement due to the earthquake event). The ground deformation shows settlement around the building extends over 2 m around the building footprint. As evident in Figure 9c, there were data shadows in the lidar scans, particularly around the base of the building. At the building's northeast corner, the ground adjacent to the building was largely shadowed, not allowing the ground elevation to be analyzed in this area. Combining the lidar data with photogrammetry can fill in these data shadows. Photogrammetry was performed by stitching many high-resolution photos obtained from the scanner into a 3D model. The result of combining the lidar and 3D photogrammetry is shown in Figure 9d, showing that photogrammetry was able to compensate for several of the areas shadowed in the lidar data, including the ground near the east side of the building.

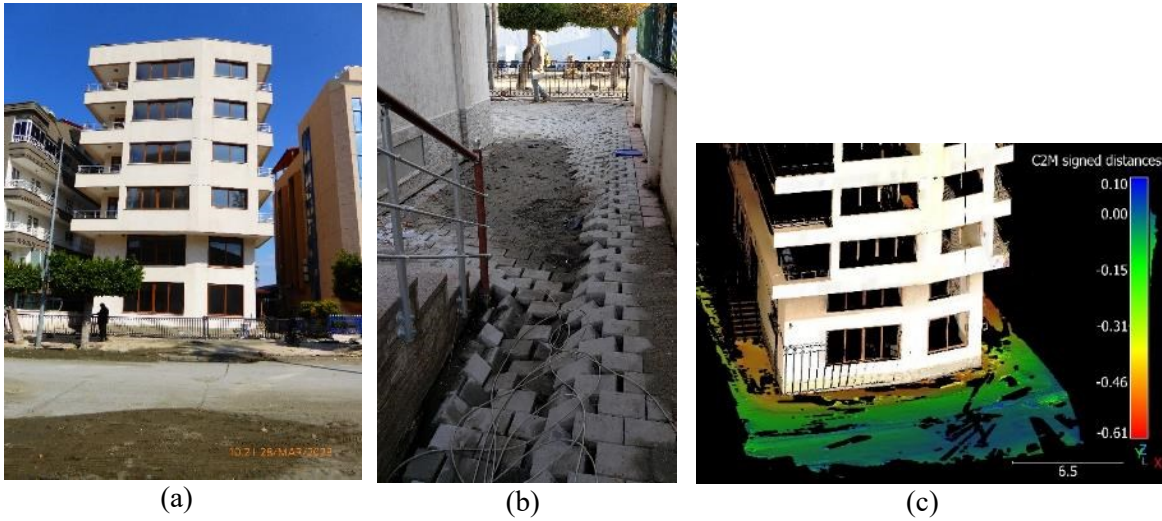
Building E on Bahçeli Sahil Evler Street (36.5902N 36.1777E) provided an example of the influence of the building foundation type on building-ground interactions. Building E is a five-story residential RCF-IW structure; the building's street view is shown in Figure 10a. The building owner reported that the structure has a 2.8 m deep basement with a 40 cm thick reinforced concrete mat foundation that extends out 1.5 m around the footprint of the building. The average building settlement was estimated to be 740 mm from combined laser-level hand surveys and lidar scan data. Figure 10b shows the effect of the building foundation on ground deformations, where a depression that coincided with the foundation mat was observed around the building. The settlement at this building was the largest of the buildings surveyed in the Çay District. The foundation type appeared to be unique among the buildings surveyed in the Çay District: few buildings had full basements without pile foundations, and there were no other similar ground deformation patterns that could be attributed to a foundation mat that extended a similar distance around the building footprint. The large liquefaction-induced settlements at Building E likely indicate poor ground conditions.

**Figure 10.** Building E on Bahçeli Sahil Evler Street in the Çay District: (a) street view of the building (36.5899N 36.1779E; 28 MAR 2023), (b) west side of the building showing the effect of the building foundation on ground deformation and settlement (36.5903N 36.1776E; 27 MAR 2023), and (c) lidar scan of ground settlement (in m) and the building.

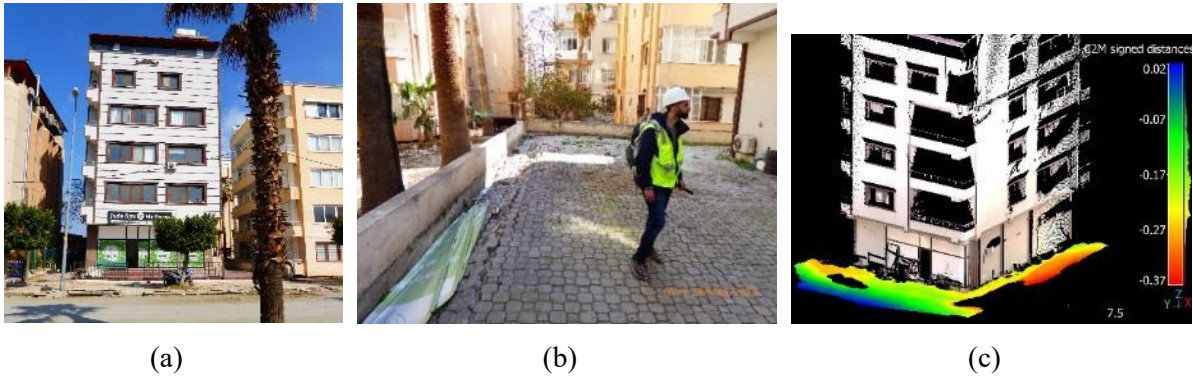
Buildings on pile foundations generally performed well, with little liquefaction-induced settlement observed. In addition to the three high-rise buildings with no noticeable settlement described in the previous section, Building F on Bahçeli Sahil Evler Street (36.5903N 36.1781E; shown in Figure 11a) settled less than the other buildings without deep foundations surveyed in the Çay District. The building owner reported that the foundation has a full basement with concrete piles. A settlement of 240 mm was estimated at Building F from a laser-level hand survey and from a lidar scan at the northwest corner. Building settlement also deformed the ground around the building; Figure 11b shows the rear courtyard (north side of the building), where there is an apparent slope in the ground from the partition wall towards the building. The ground pavers around the partition wall in Figure 11b show additional ground settlement, which may be attributed to poor fill compaction close to the wall, ground extension from nearby lateral spreading, ground extension from building settlement-induced ground deformations, or some combination of these factors. The contoured lidar ground data at the rear courtyard in Figure 11c further show these building settlement-induced ground deformations, where lidar data indicate ground settlement extends over 2 m from the building. The ground to the west of Building F and on the right of Figure 11c had a depression that did not appear to be related to liquefaction settlement, and was likely due to erosion during flooding or poor fill compaction around the basement.

**Figure 11.** Building F on Bahçeli Sahil Evler Street in the Çay District: (a) street view of the building (36.5900N 36.1782E; 28 MAR 2023), (b) north side of the building showing the ground deformation and settlement (36.5903N 36.1780E; 28 MAR 2023), and (c) lidar scan data showing ground deformation patterns around the structure.

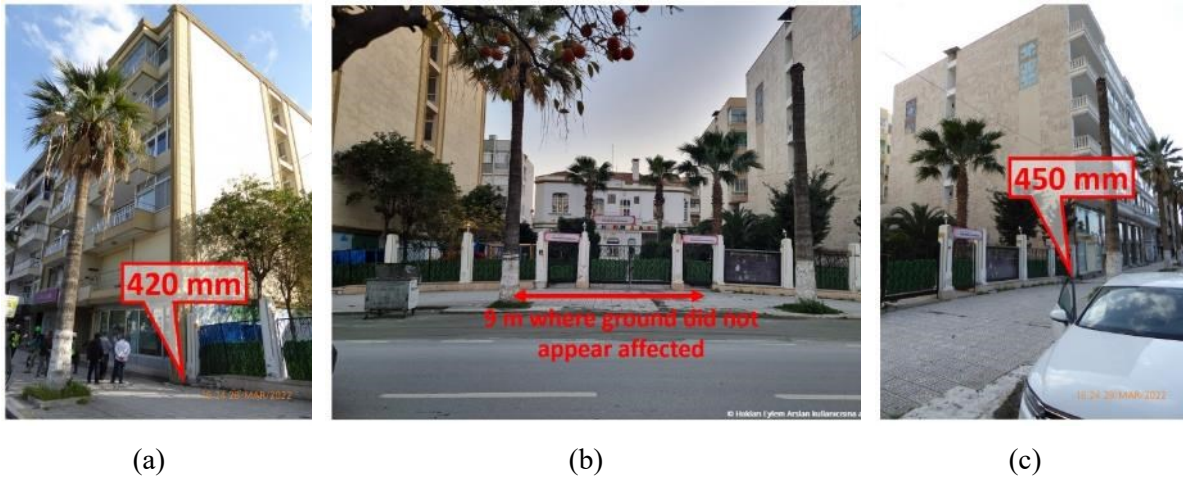
Hogging ground deformation was observed at Building U (36.5930N 36.1657E) on Atatürk Boulevard in the Yenişehir district. The hogging ground deformation developed between two six-story RCF-IW structures: Building T (36.5930N 36.1661E; east of Building U in Figure 13a) and Building V (36.5932N 36.1655E; west of Building U in Figure 13c). Building U sits between these buildings in the background of Figure 13b. Building T settled an average of 450 mm, and Building V settled an average of 500 mm; at the building corners along Atatürk Boulevard and closest to Building U, Building T settled 420 mm, and Building V settled 450 mm. There was no discernible building settlement at Building U. All settlements at this site were performed with hand laser-level measurements. Building U was built before 1946, although the construction date is not known at this time. Building T was measured to be 16.8 m in width (i.e., parallel to Atatürk Boulevard), estimated to be 22.5 m in length (i.e., orthogonal to Atatürk Boulevard) by Google Earth, and 18.7 m in height. Building V was measured to be

**Figure 13.** Buildings T, U, and V on Atatürk Boulevard in İskenderun. (a) Building to the east of Building U (Building T) where liquefaction-induced settlement caused hogging deformation to the nearby ground (36.5928N 36.1661E; 28 MAR 2023), (b) Building U, which appeared unaffected by liquefaction (36.5935N 36.1660E; 16 FEB 2023). (c) Building to the west of Building U (Building V) where liquefaction-induced settlement also caused hogging deformation to the nearby ground (36.5928N 36.1661E; 28 MAR 2023). The photo in Figure 12b is credited to Eylem Arslan and retrieved from SiteEye.

The settlement of Buildings T and V appeared to drag down the surrounding ground in the same pattern as shown in Figure 12. There was a diminishing amount of depressed ground surface extending out from the buildings until it was no longer noticeable. Because there were contributions from both buildings on either side of Building U, the hogging ground deformation pattern in Figure 12 is horizontally mirrored. The central horizontal segment between the convex ground deformations, and where there was no apparent ground settlement, was about 9 m long. This central area appears to be free-field conditions, which is also supported by observations of negligible settlement and damage at Building U. Therefore, the zone of influence over which the hogging deformations extended is about 9.9 m from both Buildings T and V. Given the observations of widespread liquefaction, it is likely that the entire area also settled. However, this interpretation assumes that the area around these buildings is equally affected by this widespread settlement, which does not significantly affect these localized building-ground interactions.

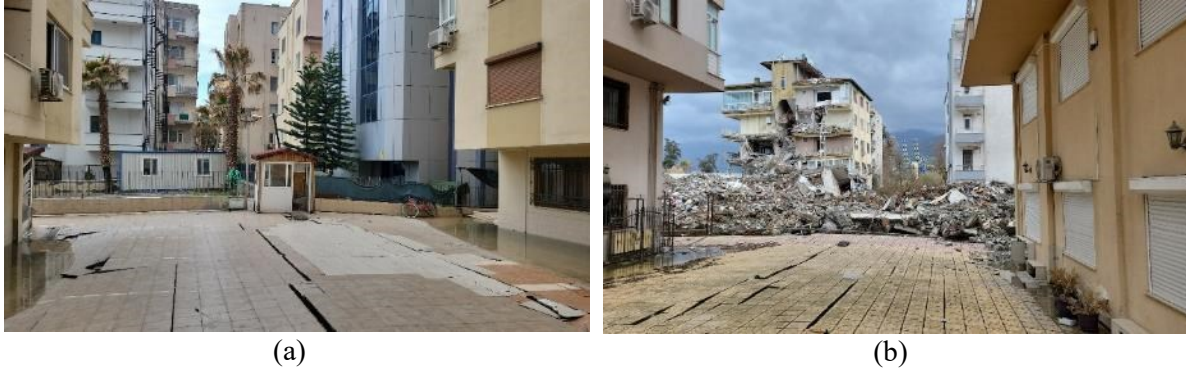
Hogging ground deformation was also observed in the courtyard between two sets of two similar buildings in the Çay District. Figure 14 shows the courtyard between the buildings with the hogging ground settlement pattern between the buildings; the convex warped ground is also apparent through the spreading of the ground tiles and floodwater present only around the base of the buildings (photographs were taken on March 29, 2023 when there was significant flooding in the Çay District and İskenderun).

**Figure 14.** Building-ground interactions between four buildings in the Çay district resulting in hogging ground deformation (a) facing west with Building G on the left and Building J on the right; (b) facing east with Building I on the left and Building H on the right. Both photos were taken from the same location (36.5906N 36.1790E; 29 MAR 2023).

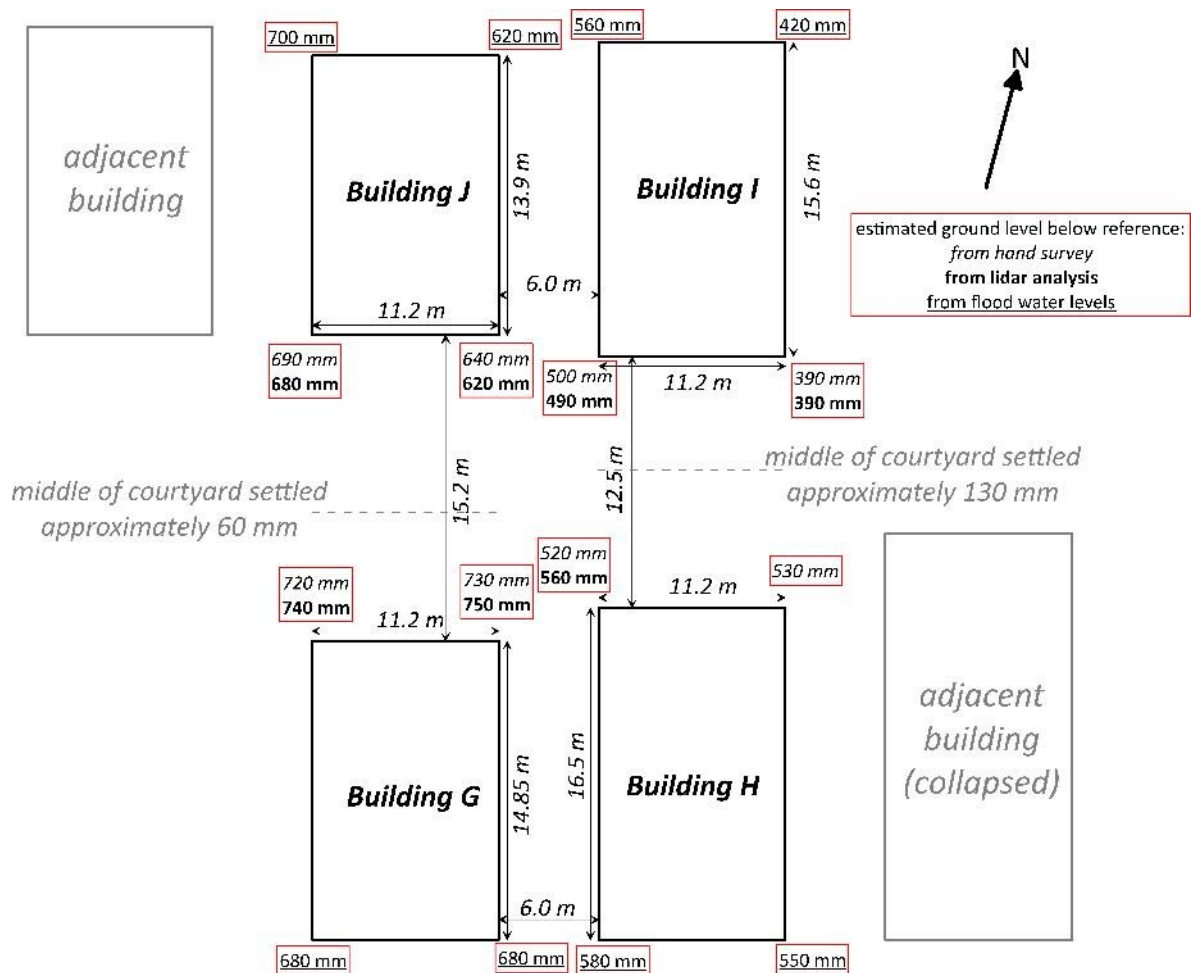
The plan view of the set of four buildings, including dimensions and estimated settlements, is shown in Figure 15. The two west structures, Building J (36.5907N 36.4789E) located on Atatürk Boulevard, and Building G (36.5905N 36.1790E) located on Bahçeli Sahil Evler Street, appear to have similar design, age, and construction. These two structures were built prior to September 2007, according to Google Earth imagery. Similarly, the two east structures, Building I (36.5908N 36.1791E) located on Atatürk Boulevard, and Building H (36.5906N 36.1792E) located on Bahçeli Sahil Evler Street, also appear to have similar design, age, and construction. These two structures were built between September 2007 and 2010 based on Google Earth images. All the structures appear to be RCF-IW structures, six stories high with a half-seventh story. There were no apparent basements for the buildings; however, there were sub-ground level utility rooms on the east side of Buildings I and H and on the west side of Buildings J and G.

**Figure 15.** Four-building layout with dimensions and settlement measurements.

Settlement at the corners of the buildings was estimated from a combination of hand laser-level measurements, lidar scan data, and flood water depth during the March 29, 2023 flood event. The flood water was used to estimate settlements by measuring flood water depth from the building base and then referencing that depth to a location where settlement could be measured by hand survey or lidar. The flood water approach assumed consistent water surface elevation during measurements and was only used at locations that could not be surveyed otherwise. Settlement estimates were generally consistent between lidar and laser-level approaches, with differences being less than 40 mm or 10%. Average settlements were significant at all buildings, with 560 mm, 710 mm, 660 mm, and 470 mm estimated for Buildings H, G, J, and I, respectively. The settlements of Buildings H and I were similar, as were the settlements of Buildings G and J; however, the settlements of the pairs of buildings differed. It is unknown if the difference in the pair of building settlements is due to differing

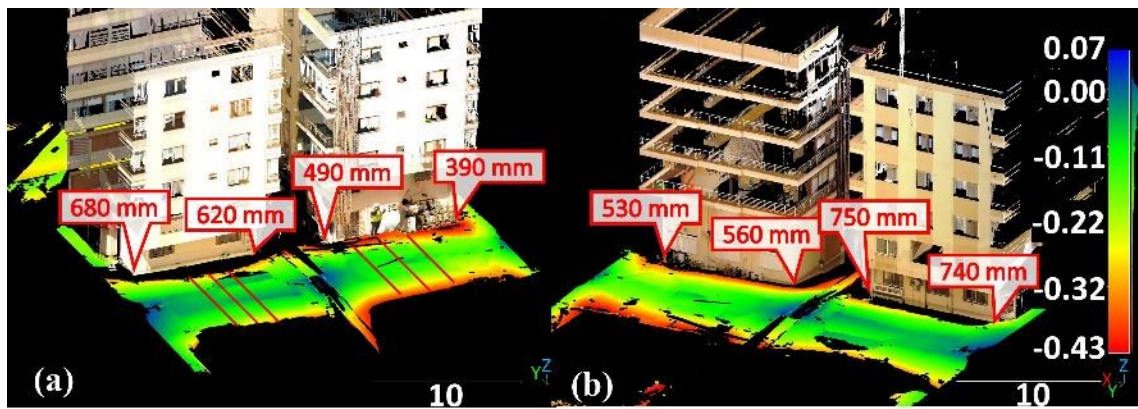
Lidar scans performed on March 29 and April 1, 2023 captured ground settlement between the four buildings, which displayed a hogging ground deformation pattern from all four buildings. Figure 16 provides contours of vertical distance from a horizontal reference plane. The original ground elevation is estimated from the elevations at the sides of the courtyard, not directly between the buildings because the lidar data show the sides of the courtyard are at a higher elevation than the areas between the buildings. The settlement contours indicate the least ground settlement occurred in the middle of the courtyard between the buildings, and ground settlement increased towards the buildings. Six profiles of ground surface deformation in the courtyard between the four buildings were extracted from the lidar data and plotted in Figure 17; the locations of these profiles are shown by the red lines in Figure 16a. The ground settlement of these six profiles between the buildings is relative to the interpreted initial ground elevation. The ground deformations show distinct warping of the ground from individual buildings, consistent with the interpreted pattern in Figure 12. The average building settlements measured on the courtyard side of the buildings are plotted as the triangle symbols for Buildings H and I and the circle symbols for Buildings G and J in Figure 17. As plotted in Figure 17, the building settlement measurements fall into a similar pattern as the ground deformation between the buildings, with some variation due to measurement variability and other potential settlement mechanisms (e.g., punching shear failure, global seaward lateral spreading); however, the supporting evidence suggests the ground deformation patterns of the ground adjacent to the buildings relate strongly to building settlements.

**Figure 16.** Four-building group: (a) lidar scan data facing the north buildings with Building J on the left and Building I on the right. The red lines represent locations of ground deformation profiles in Figure 17; (b) lidar scan data facing south buildings with Building H on the left and Building G on the right. Called out numbers are the building settlements from lidar or hand survey (if lidar not available). Color scale represents the ground distance from the initial reference plan (in m). Note that data shadows prevent lidar data from extending to the base of the buildings in most cases.

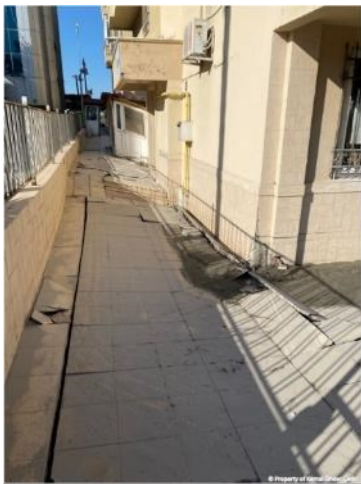
**Figure 19.** Ground deformation to the west of Building G (36.5904N 36.1790E; 15 FEB 2023).

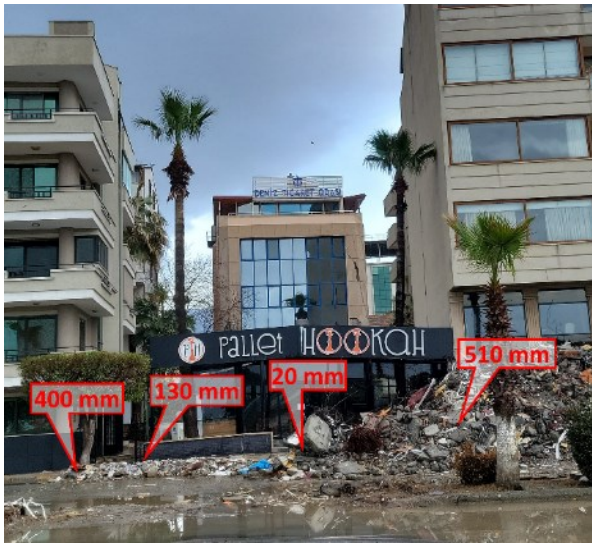
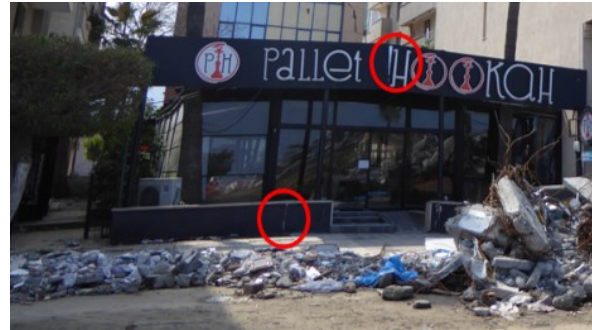
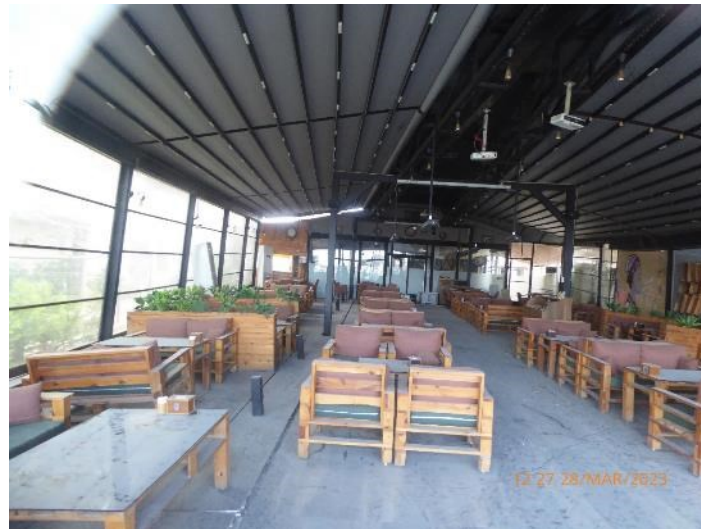
The hogging ground deformation induced by the settlement of Buildings K and M distorted the restaurant structure. Settlement was surveyed at Building L in reference to a point on the sidewalk in front of the building. These settlements, summarized in Figure 20a, measured 200 mm at the center of the structure, 130 mm at the east corner of the front retaining wall and 510 mm at the west corner of the front retaining wall. To the west of Building L, Building M settled 510 mm at its front. To the east of Building L, Building K settled 400 mm at its corner closest to Building L. Damage at Building L is highlighted in Figure 20b and included extension cracks in the façade and to the concrete floor slab, which are consistent with the observed hogging ground deformation pattern. Measurements of cracking in the interior floor were not taken as it was unsafe to do so.

**Figure 20.** (a) Group of three buildings on Atatürk Boulevard with the restaurant Building L in the middle (36.5909N 36.1777E; 29 MAR 2023), (b) damage to the exterior at Building L associated with hogging ground deformation (36.5906N 36.1778E; 28 MAR 2023), (c) damage to the concrete slab at Building L associated with hogging ground deformation (36.5907N 36.1779E; 28 MAR 2023).

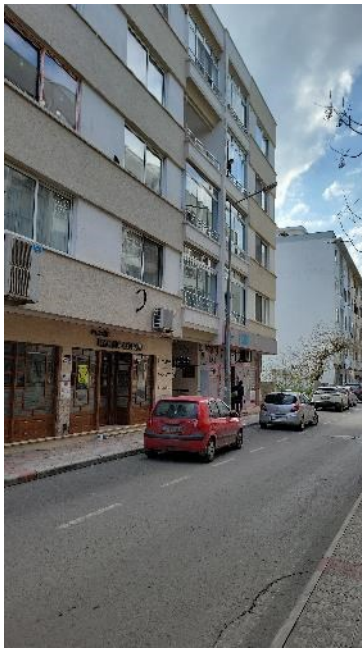
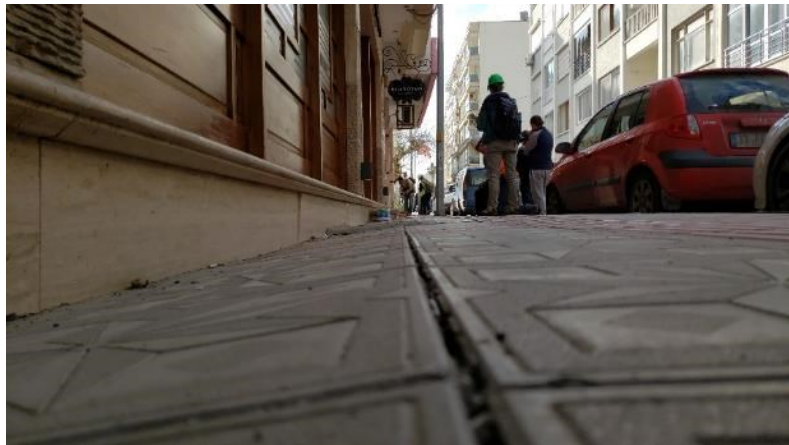
In contrast to hogging ground deformation, sagging ground deformation is defined by a concave ground curvature. Sagging across a building results in larger settlement beneath the middle of a building relative to the ends of the building. Minor sagging was observed over the footprint of Building W (36.5925N 36.1660E) on Mareşal Fevzi Çakmak Street, which had an average of 60 mm of settlement. The five-story RCF-IW structure is 26.55 m wide and located one block south of Atatürk Boulevard. The middle of the structure had about 10 mm more settlement than both corners. The street view of Building W is pictured in Figure 21a; the building settlement relative to the sidewalk in front of the building is pictured in Figure 21b. Sagging building-ground interactions were also observed across Buildings S, R and Q, as presented previously in Figure 8. Although sagging was not measured for any of these buildings individually, the overall settlement pattern showed larger settlements for the buildings and building corners closest to the center of the city block than for the building corners at the edges of the city block.

**Figure 21.** Building W on Mareşal Fevzi Çakmak Street: (a) street view of the structure (36.5926N 36.1661E; 28 MAR 2023), and (b) ground and building settlement near the front entrance (36.5926N 36.1661E; 28 MAR 2023).
