SEISMIC PERFORMANCE OF A STICK-BUILT CURTAIN WALL SYSTEM IN A FULL-SCALE BUILDING SHAKE TABLE TEST

S.L. Wynn¹, K.L. Ryan¹, W. Roser¹, Y. Ji¹, T.C. Hutchinson² & R. Madeley³

This paper evaluates the seismic performance of the two-story non-structural curtain wall system. The 60-minute fire-rated curtain wall system features stiff, fire-resistant steel mullions along with 27 mm thick multilayer-laminated glazing. This C-shaped curtain wall system was supported on a steel ledger protruding from the edge of a concrete slab at the base and was attached to the structure at each floor slab. The subassembly has been designed to rack along with the movement of the floor diaphragms, while the glass lites are intended to rotate within the glazing pocket to accommodate movement within the framing. The cantilevered slab supporting the curtain wall caused vertical acceleration amplitudes up to 3 times higher than the input ground motions, which may have caused damage to the door latch mechanism. The results also showed that out-of-plane motions can lead to higher component acceleration amplitudes compared to the in-plane component amplification. After the 88 ground motions, including four MCE_

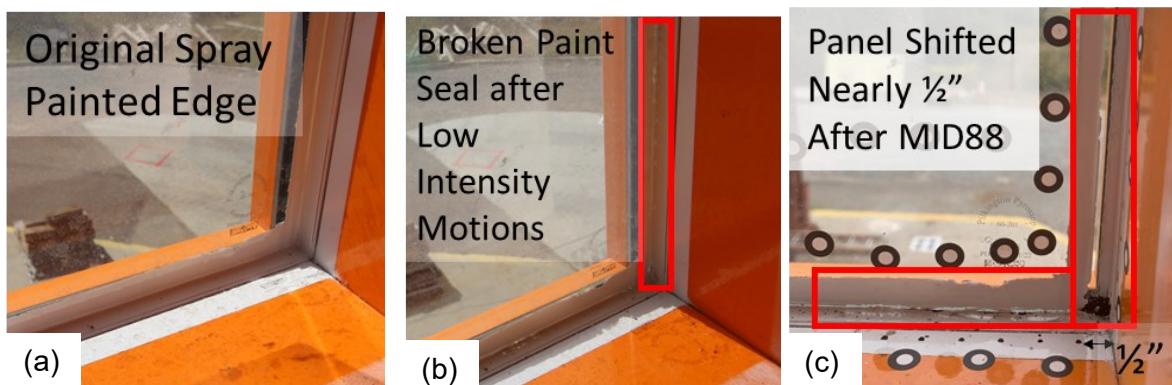
- Prior to testing, the corners of the glass lites were spray-painted to indicate movement of the glass within the glazing pocket during testing as shown in Figure 8(a). Figure 8(b) shows that initially, following lower intensity motions (<225-year return period), movement was apparent during shaking as the paint exhibited some separation but had returned to its initial position. At higher intensities (>475-year return period), it was apparent that the glass lites had begun to shift slightly. After MID88, a significant shift in the glass panel at the top west corner on Level 2 was observed; the tape around the glass became exposed as illustrated in Figure 8(c). In the subsequent ground motions, other glass lites shifted more noticeably from their original positions.

Figure 8: Spray painted edge of the top west panel on 2nd story (a) before testing, (b) after low intensity motions, and (c) after MID88 – MCE_R Loma Prieta XYZ

- The curtain wall system experienced only minor damage that would not affect a building's serviceability. The most notable damage observed was a cumulative shifting of the top west panel such that one corner was at risk of dislodging from the glazing pocket. However, the panel was contained in the glazing pocket around the other edges, so there was no imminent risk of the entire panel dislodging. Other damage observations include failure of the door latch mechanism and failure of the weatherproof and fire-resistant seal at the head of the system. This damage may have compromised the fire-resistance and weathertightness of certain locations on the curtain wall, and some repairs may be necessary in an actual structure. It is important to note that this damage occurred after many strong motions, much more than an actual building would experience.

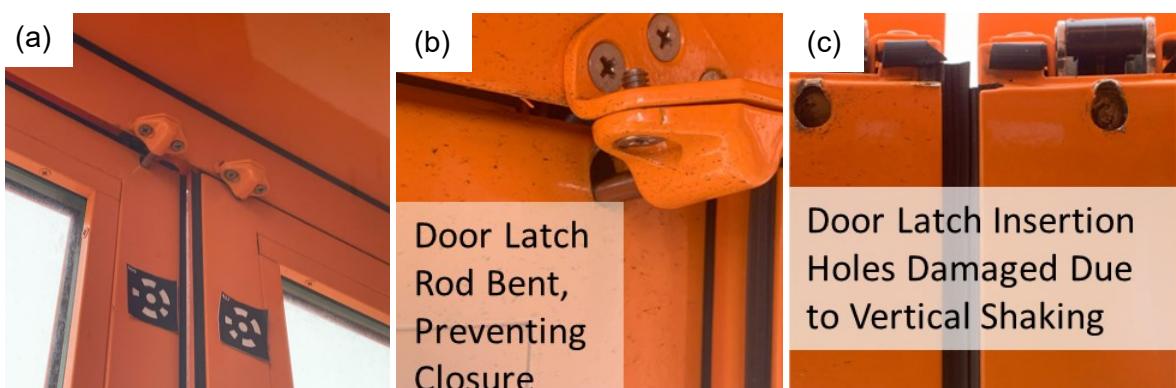
- During testing, the curtain wall doors were visibly opening and closing. By the end of the test program, after MID100, one of the doors would not close properly because the door latch rod was permanently bent as shown in Figure 9(a) and (b). Figure 9(c) illustrates the widened door latch insertion holes, which may have been caused by vertical shaking. The damage to the door latch mechanism compromises the fire-resistance of the door system within the curtain wall, as door closure is essential to preventing fire-spread.

Figure 9: (a) Door latch mechanism preventing closure and (b) close up of damaged door latch, with (c) apparent damage to the door latch mechanisms' openings at end of testing
