## SHAKE TABLE TEST OF A BALLOON-FRAMED, COLD-FORMED STEEL FAÇADE WITH DRIFT CLIPS

W. Roser<sup>1</sup>, K.L. Ryan<sup>1</sup>, Y. Ji<sup>1</sup>, S.L. Wynn<sup>1</sup>, T.C. Hutchinson<sup>2</sup>, C. Melcher<sup>3</sup> & R. Belvin<sup>4</sup>

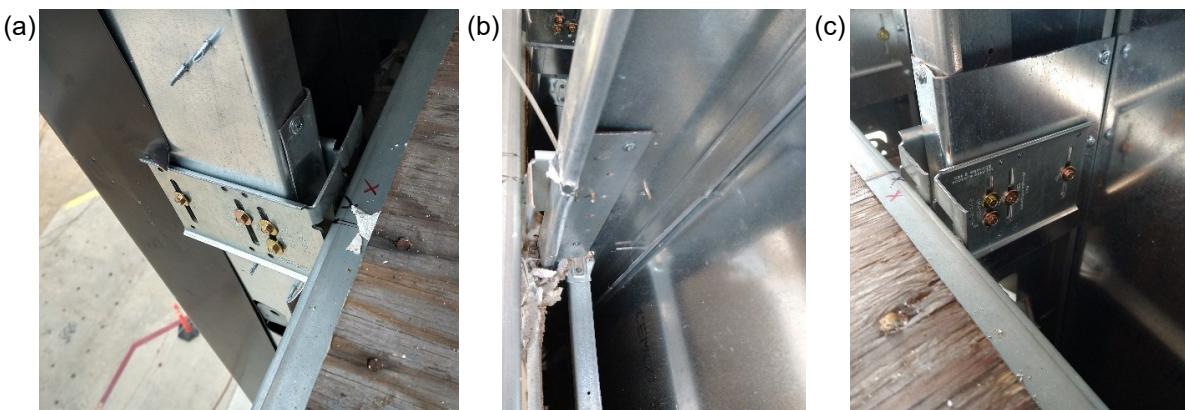
After damage was observed (MID37), clips were reinstalled at locations where screw pull-out had occurred or initiated. Most connections on the fourth floor were reinforced in several ways to increase resistance to screw pull-out and increase system redundancy. Two screws were installed in the slot closest to the U-strut (Fig. 6a). Where possible, a 12-gage backing strap was added to increase pull-out strength (Fig. 6b), and a second clip was installed on the open side of the stud using a track section attached to the stud flanges (Fig. 6c).

Figure 6: Clips were reinforced by (a) using additional screws, (b) adding backing material, and (c) adding a second clip to studs using a short track

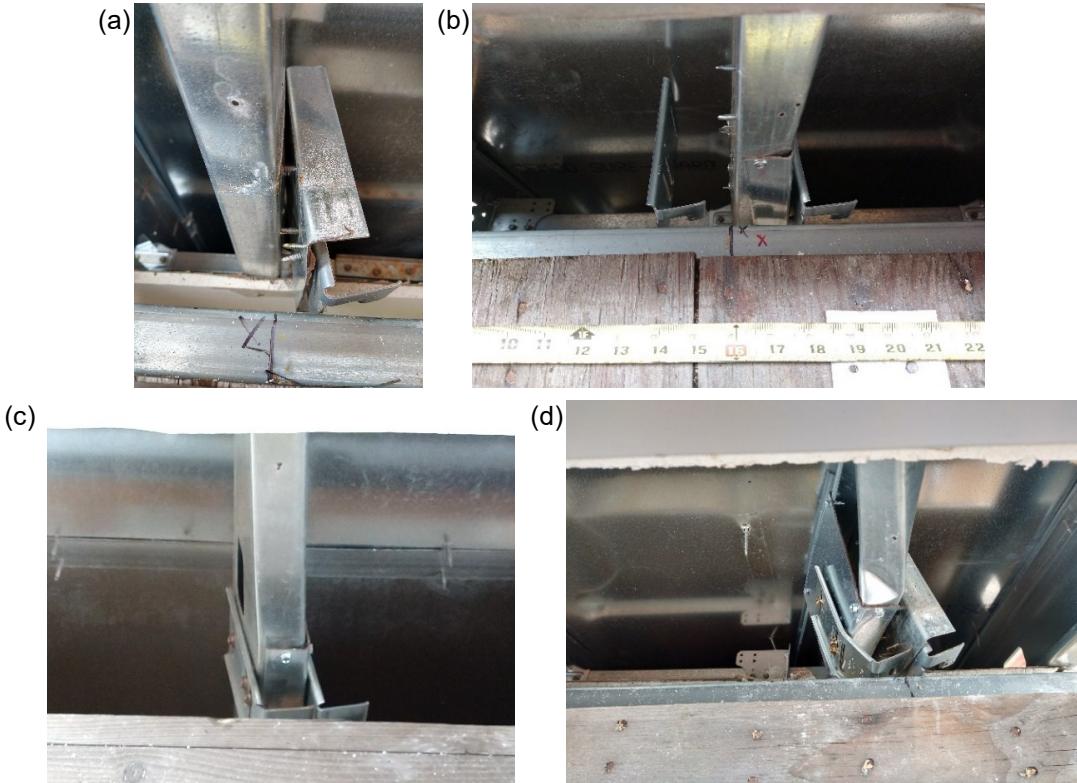
After the repair, damage continued to concentrate at the same clip locations, but the modes of failure became more varied, including screw pull-out, screw tear out, stud bending, and stud buckling (Fig. 7). All of these failure modes can be attributed to binding action. Screw pull-out was the most common mode of damage and signs of incipient pull-out were observed soon after the repair. Unlike before the repair, screw pull-out did not

occur during single tests but instead progressed slowly over multiple tests (Fig. 7a). Many of the reinforced clips on the fourth floor and almost all of the original clips on the second and third floors survived the testing program without damage, and after reinforcement the clip system exhibited sufficient redundancy and resiliency to survive many large shakes and prevent damage from propagating to the wall itself.

Figure 7: Damage modes included (a) incipient and (b) full pull-out, (c) stud bending, and (d) stud buckling

In general, signs of damage to clips appeared within a few large shakes. Stud bending and buckling did not occur until the MCE<sub>R</sub> ground motions (MID88). Studs, unlike clips, cannot be repaired without deconstructing the entire subassembly, so designing clips to pull-out before they cause stud damage could be advantageous. Clips that showed no signs of stress after a few earthquakes remained undamaged for the remainder of the testing program, suggesting that resolving binding issues would eliminate most of the damage observed during the testing program.

- Future projects may prevent pull-out by using thicker or higher yield strength studs, multiple clips per stud, or more screws per clip to increase pull-out resistance while also strengthening the system against other failure modes.

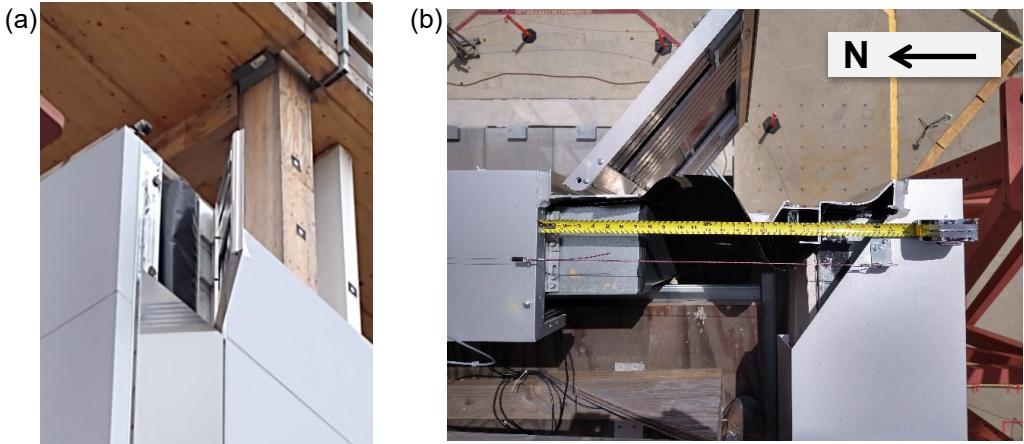
No damage occurred at the intersection between the two wall segments. The expansion joint cover was able to open and close as the subassembly slipped relative to the building in both directions, and the joint cover returned to its nominal position after shaking concluded. Figure 8 shows how the expansion joint opens. The joint could close up to 260 mm (10.25") before contact between the two wall segments occurs; of this, 86 mm (3.40") was the maximum observed movement (gap closure/compression). It should be noted that the maximum slip, 128 mm (5.03"), was in the E-W direction, which shows that a greater portion of the joint capacity might have been used if the building had been oriented differently relative to the ground excitation. The movement capacity in the direction perpendicular to the joint cover (lateral) was designed to be equivalent or greater than the in-plane movement (tension/compression). Overall, the high capacity relative to demand occurred because the joint was designed for larger drifts than those actually experienced during the test program. Nevertheless, the lack of damage to the walls demonstrates that placing an expansion joint between perpendicular wall segments is an effective solution for mitigating corner damage.

Figure 8: Corner expansion joint corner after opening viewed from (a) outside and (b) above
