# Deep Trouble! Common Problems for Ocean Observatories

Ocean Observing Infrastructure and Sensing – Technical Lessons Learned and Best Practices; Moss Landing, California, 23–25 September 2016

By [Bruce M. Howe](#) and Eric McRae © 22 May 2017

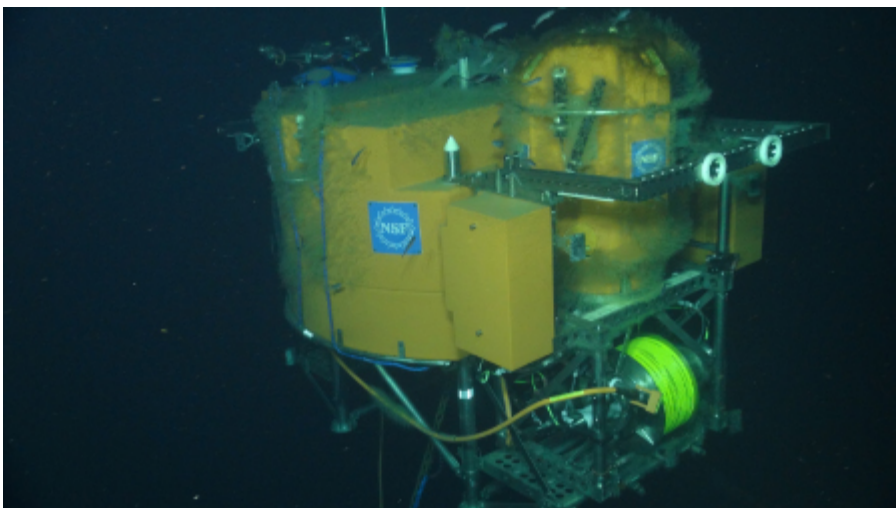
Biofouling during long-term deployments, such as the algae growing on the Regional Cabled Array 200 Meter Mooring and Shallow Profiler located at the Juan de Fuca Ridge's Axial Seamount, could prevent sensors from reading data. At the time the picture was taken, the mooring had been deployed for 2 years, and the profiler (above the yellow winch drum) had been operating continuously for 1 year. Such biofouling is just

one of the issues facing cabled ocean observatories.

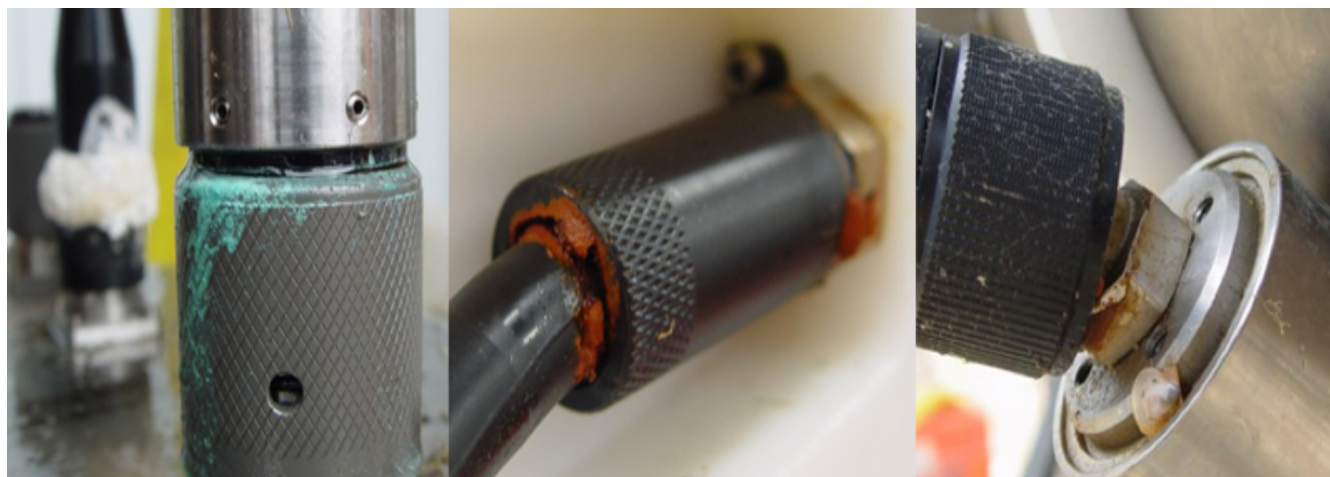
One attendee described accumulated corrosion on connectors after a yearlong deployment (Figure 1), which may indicate that performance has been compromised. Another common failure discussed at the meeting was seawater intrusion into “atmospheric” housings. These housings enclose their contents in dry gas environments at or near normal surface-level pressures. Seawater leaking into an electronics housing creates a dangerous situation beyond the simple destruction of the electronics. Electrolysis can produce hydrogen and oxygen at seafloor pressures, and a compromised housing can spontaneously explode when brought to the surface or weeks later during postrecovery inspection.

Fig. 1. Connectors suffering damage following a yearlong deployment. (left) Pressure-balanced oil-filled electrical connector that leaked oil and opened a conduction path to seawater. Green is probably copper corrosion. Also note heavy corrosion on the connector in the background due to the stainless-steel snap ring used in the assembly of a titanium connector shell.

(middle) Instrument connector showing unknown red deposits. (right) Camera connector that delaminated, exposing power pins to seawater. Credit: Eric McRae, Applied Physics Laboratory, University of Washington

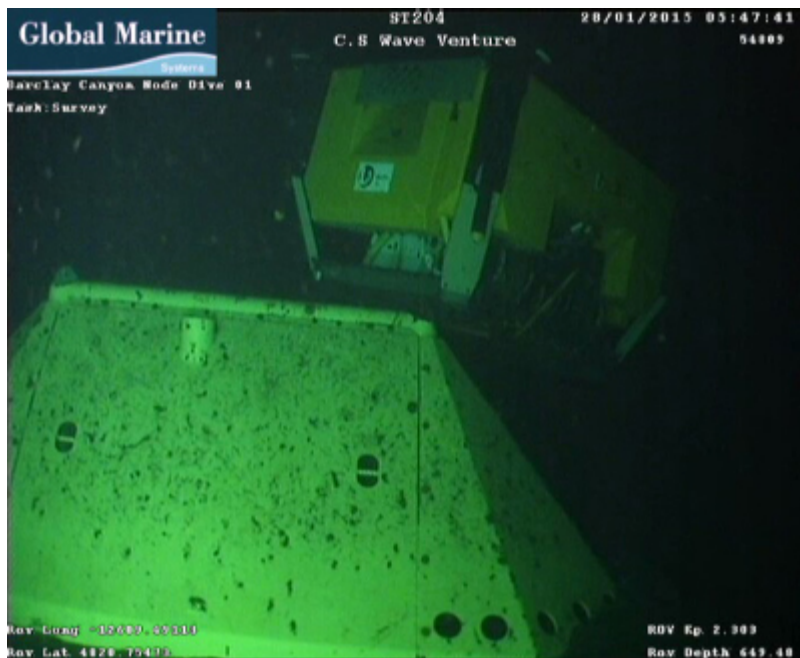
Human interference, both purposeful and accidental, is an ongoing problem, attendees noted. Observatories using surface buoys regularly find their equipment vandalized, stolen, or damaged by human activity. Subsea equipment is subject to damage by fishing operations. In Figure 2, a node in the Northeast Pacific Time-Series Undersea Networked Experiments cabled system ([NEPTUNE \(http://www.neptunecanada.ca/\)](http://www.neptunecanada.ca/)) is askew, likely due to a trawl net catching the lower edge of what was billed to be a trawl-resistant frame. This incident revealed two failures. The first was nontechnical: The trawler was in a marked no-operations area. The other was a design fault where no latches were installed to keep the node in the frame.

Fig. 2. A Northeast Pacific Time-Series Undersea Networked Experiments cabled system (NEPTUNE) trawl-resistant frame with its node ejected. A trawl net had caught on the lower edge of the trawl-resistant frame. That tilted the entire assembly, and the node fell out of the frame. Credit: Ocean Networks Canada and Global Marine Systems
