GEOTECHNICAL ASPECTS OF THE 2016 KAIKŌURA EARTHQUAKE ON THE SOUTH ISLAND OF NEW ZEALAND

(Submitted March 2017; Reviewed April 2017; Accepted May 2017)

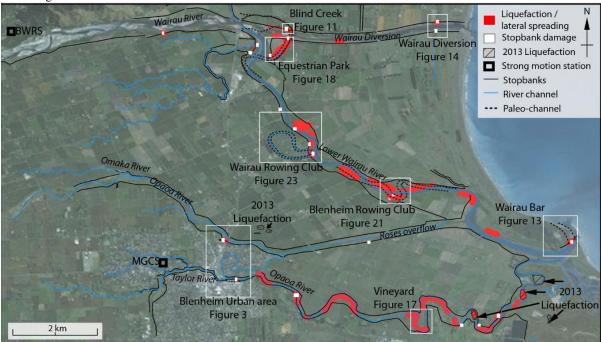
Liquefaction and lateral spreading was observed within the area during historic earthquakes. For example, liquefaction and lateral spreading was documented on the Wairau Plains as well as the Awatere and Clarence Valleys to the south during the Mw7.5 1848 Marlborough earthquake and the Mw8.2 1855 Wairarapa earthquake [7, 18, 19], while van Dissen et al [10] reported liquefaction and lateral spreading around the Opaoa River and Wairau Lagoon (shown in Figure 2) during the Mw6.6 2013 Lake Grassmere earthquake.

Figure 2: Overview of liquefaction damage in Blenheim and the Wairau Plains resulting from the 2016 M_w7.8 Kaikōura earthquake and 2013 M_w6.6 Lake Grassmere earthquake (Approx. coord. of centre of image: -41.495°, 173.980°).

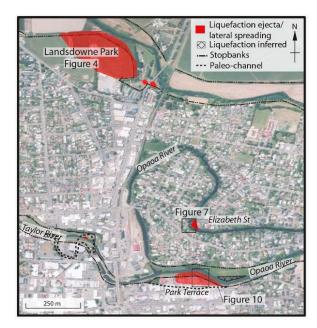
Figure 3: Overview of liquefaction related damage within the Blenheim urban area (Approx. coord. of centre of image: -41.507°, 173.962°).

Localised liquefaction and associated lateral spreading occurred during the Kaikoura earthquake proximal to the Opaoa River within Blenheim as outlined in Figure 3. Liquefaction and lateral spreading related damage was confined to the inner-banks of meander bends of the rivers or was associated paleo-channels; no damage was observed on the outer-banks of the meander bends. Localised liquefaction also occurred adjacent to the Taylor River within central Blenheim, in an area that was formerly within the river channel prior to modification and straightening in 1969 which subsequently reduced flow levels (Figure 3 [20]).

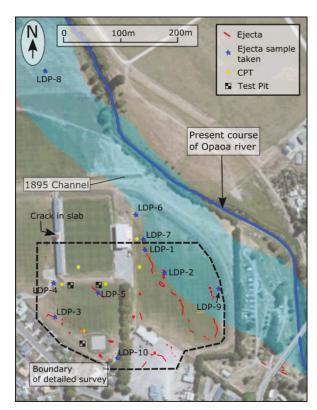
A detailed survey of ejecta was conducted in the southern half of Lansdowne Park; the location of ejecta features are shown in red in Figure 4. Sand boils were typically 1-2 m in diameter and in many cases formed lineaments of aligned sand boils (Figure 5). The ejecta material was largely bluish-grey in colour, but there were some features which were light brown in colour. No liquefaction ejecta was observed adjacent to the main stadium buildings; a single crack in the concrete foundation slab was the only observable damage (Figure 5b).

Figure 4: Ejecta deposits mapped within Lansdowne Park shown by red areas, and their relationship to the position of the 1895 channel of the Opaoa (Opawa) River (Approx. coord. of centre of image: -41.498°, 173.958°).

Historical maps from 1895 [22] indicate that the Opaoa River formerly flowed across the northeast part of Lansdowne Park (1895 river channel is shown in blue in Figure 4). It is apparent that, with the exception of LDP-4, the samples of ejecta classified as medium sands fall along the edge of this river channel. The other liquefaction features either fall within the old river channels, or in the flood plain to the west of the 1895 river channel. It should be noted that additional liquefaction features were discovered outside the boundary of the detailed survey. However, the distribution of features was not mapped in detail with only the location of ejecta samples indicated. Additional liquefaction ejecta features were discovered within paleo-channels in the former flood plain to the west of the park, while lateral spreading and grey sand ejecta were observed to the east. These features also align with the 1895 river channel. The occurrence of liquefaction and lateral spreading in paleo channels is common and was observed in the 2011 Christchurch earthquake, where paleo channels running through the city caused localised damage and manifestations of liquefaction [17].

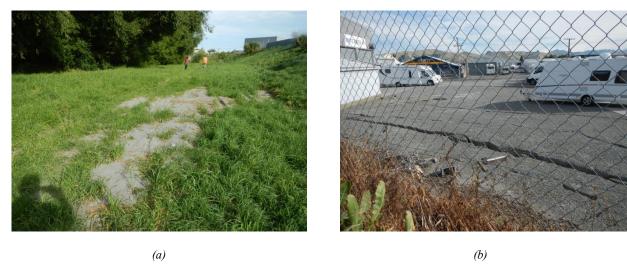
Figure 9: a) Example of liquefaction ejecta proximal to the river bank at the base of the stop bank (-41.5121°, 173.9651°, taken facing SE); b) Example of damage to properties on Park Terrace as a result of lateral spreading (-41.5122°, 173.9649°, taken facing S).

Cracking continued into the properties on Park Terrace that border the stopbank (Figure 9b). Permanent ground deformation, differential settlement of structures, separation between foundation slabs and the surrounding ground, and damage to the stopbanks were observed at these properties and a summary of the location of the cracks are shown in Figure 10. The total crack widths were 1-1.5 m: 0.3 m in floodplain and 0.7 - 1.2 m in the fill. Historic photographs indicate that the position of the stopbank in 1959 lay approximately 20m north of Park Terrace. The affected properties shown in Figure 10 were constructed on an area of fill that raised the elevation of the zone between the historic stopbanks and present-day stopbanks, with the southerly extent of cracking just north of the position of the historic stop bank.

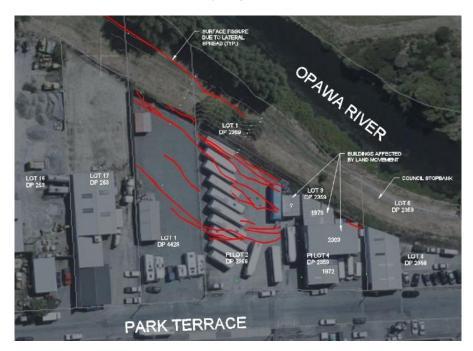
Figure 10: Summary of liquefaction manifestations at the Park Terrace site (Approx. coord. of centre of image: -41.5123°, 173.9650°).

Moderate volumes of liquefaction ejecta and lateral spreading was observed at the inner-meander bend of the Opaoa River north of Park Terrace, just downstream from the confluence of the Opaoa and Taylor Rivers (location shown in Figure 3). At this location, the river bank is surrounded by a relatively flat floodplain with stopbanks present ~20 m inland. The land behind the stopbanks is at the same elevation as the top of the present day stopbanks and is relatively flat.

Ejecta material was confined to the floodplain, and lateral spread-induced cracks orientated sub-parallel to the river bank were evident. Cracks ranged in width from 1 to 30 cm and were associated with 1 to 5 cm of vertical settlement. Crack widths decreased with increasing distance from the apex of the inner meander bend and became discontinuous along the river bank further upstream. The total lateral spreading displacements in this area were typically less than 50 cm. Fine-medium grey sand ejecta up to 10 cm thick and infilling the lateral spreading cracks were observed (Figure 9a). A hand auger performed adjacent to the river (on the floodplain) indicated that the soil profile at this site includes a silty sand

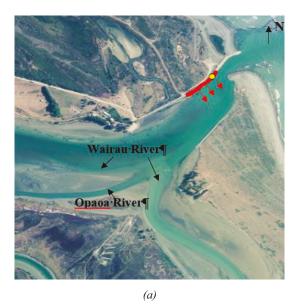
Lateral spreading and slumping were observed along a 100 m long section of the northern stopbank at the mouth of the Lower Wairau River (Wairau Bar; indicated in Figure 2). The damaged section corresponds to the position of the former river channel that existed prior to diversion and stopbank construction (Figure 2 and Figure 13). Cracks varied in width from 30 to 50 cm and exhibited vertical settlements of 20 to 120 cm (Figure 12b). No liquefaction ejecta was observed along the stopbank or in the mudflats exposed within the river channel. A series of lateral spreading cracks were observed along the inland edge of the stopbank within the paleo-channel and these were surrounded by fine grey sand ejecta.

Figure 13: Aerial photographs showing location of damage stopbank at the mouth of the Wairau River: (a) Current landscape; (b) Landscape in 1948. (Approx. coord. of centre of images: -41.504°, 174.058°) Marlborough District Council (2017).

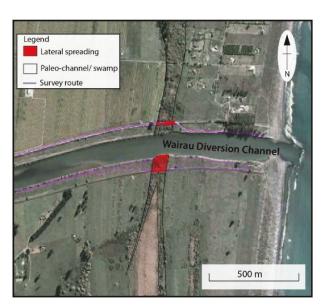
Lateral spreading-induced cracking was also observed along the northern and southern stopbanks of the Wairau Diversion and corresponds with the location of a paleo-stream channel recognizable by a depression in the landscape and by a change in vegetation (Figure 14). Lateral spreading on the northern stopbank was characterised by cracking ranging in width from approximately 30 to 50 cm and exhibiting 10 to 50 cm of vertical settlement (Figure 15). Localised cracking was observed at the base of stopbank proximal to the river. Lateral spreading along the southern stopbank resulted in cracking ranging in width from ~2 to 10 cm with 1-2 cm of vertical settlement. Lateral spreading was also observed along the river bank. No liquefaction ejecta was observed on either stopbank.

Figure 14: Overview of damage to the stopbank along the Wairau Diversion with the location of the paleo-channel and swamp indicated. (Approx. coord. of centre of image:

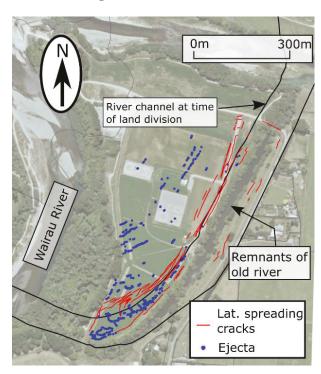
Lateral spreading was accompanied by widespread ejecta across the site (Figure 18) with the volume of ejecta most severe in the southern part of the park where the ground elevation was the lowest (Figure 19). It should be noted that the observations in Figure 18 are only considered complete in the grassy area of the park. As shown, lateral spreading is aligned with the position of the Wairau River at the time when the property boundaries were being drawn. Lateral spreading cracks ranged in width from ~10-70 cm and exhibited vertical displacements up to 70 cm. Total lateral movements towards this old river channel was of the order of 1 – 2m. Soil profiles derived from hand augers in this area of cracking showed silty sand to a depth of approximately 1.5m below which was clean sand that changed from brown to a bluish-grey colour at around 2.8 m depth.

Figure 18: Lateral spreading and ejecta at Marlborough Equestrian Park (Approx. coord. of centre of image: -41.445°, 173.976°).

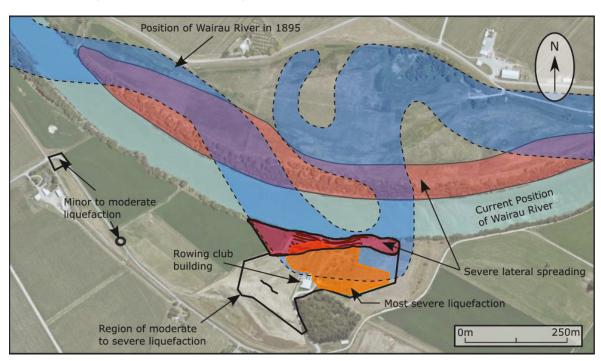
Severe lateral spreading was observed at the Blenheim Rowing Club on the southern bank of the Wairau River, with lateral spreading displacements (estimated from cumulative crack widths) between 2-5 m. Lateral spreading cracks ranging from 0.5-1.5 m in width were observed within 75 m of the river at the site (Figure 21 and Figure 22). Many of these cracks also had a number of associated ejecta features that were 1-2 m in diameter. Only minor evidence of liquefaction was observed around the perimeter of the Blenheim Rowing Club building. Two hand augers in the region of severe lateral spreading indicated that the soil profile consisted of silty sand, transitioning to clean fine sand between 1.5-2.5 m below the ground surface. The clean sand changed colour from brown to bluish-grey between 2.5-4 m depth.

Historic maps and property boundaries show that the river formerly flowed through an S-bend (Cook, 1895) with much of the damage appearing to be confined to the boundaries of the paleo-channel. Particle size distribution characteristics of ejecta samples are summarised in Figure 20. At the main rowing club site, the ejecta was composed of grey medium-fine sands. West of the main site (at the left side of Figure 21), the ejected material was fine sand.

Figure 21: Summary of observations at Blenheim Rowing Club (Approx. coord. of centre of image: -41.489°, 174.007°).

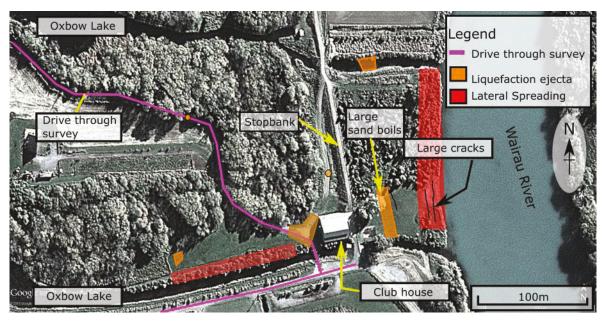
Severe lateral spreading was observed close to the river at the Wairau Rowing Club, located adjacent to the southern bank of the Wairau River (Figure 2). A key feature of this site (Figure 23) is the Grovetown Lagoon, an ox-bow lake cut off from the main channel during a flood in 1861. Drainage channels have been cut through the north and south paleo channels. The grassy area visible to the east and west of the club house in Figure 23 marks the position of the old river channel. A stopbank runs approximately N-S through the site, and the 3-level clubhouse was built so that it extends into the west side of the stopbank and has its second floor level with the crest of the stopbank. East of the clubhouse, the land (above the paleo channel) gently slopes down to the river.

Cracks ranged in width from 1-2 m (also representative of the cumulative lateral displacements at this site), and were associated with up to 50 cm of vertical settlement (Figure 24). A significant volume of ejecta vented into the drainage channels, but this was removed soon after the earthquake to restore the channel. A line of sand boils orientated parallel to the river was additionally observed ~70 m inland from the river in the grassy area between the drainage channels. The sand boils transitioned into an ~10 cm wide lateral spreading crack within the surrounding vegetation. Numerous minor to moderate sand boils were also observed around the rowing club building on the west side of the stopbank. Lateral spreading cracks also formed along the southern drainage channel (i.e. within the paleo channel) proximal to the rowing house (Figure 23). Particle size distribution characteristics of ejecta samples (collected from both sides of the stopbank) are summarised in Figure 20, and were comprised of finer sand than samples from both the Blenheim Rowing Club and the Equestrian Club sites.

Figure 23: Summary of observations at Wairau Rowing Club (Approx. coord. of centre of image: -41.476°, 173.984°).

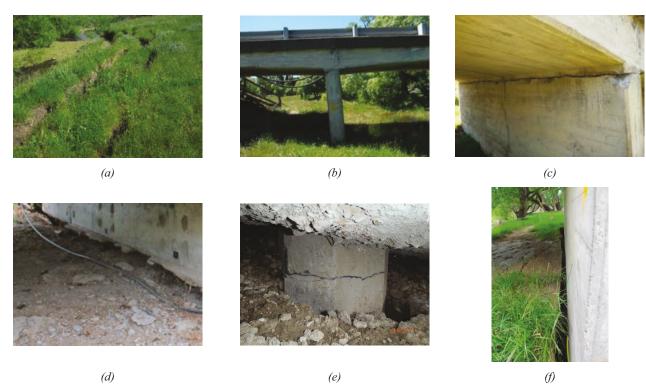
Some liquefaction-induced lateral spreading caused minor damage at the 4-span Needles Creek Bridge, located just north of the town of Ward about 35 km south of Blenheim on SH1. Figure 26 shows some of the damage observations at the Needles Creek Bridge. Moderate liquefaction ejecta was observed under the bridge between several of the piers, and minor ejecta was found in one location on the north bank, 25 m west of the bridge. Between the bridge piers, the ejecta had separated into a sandy portion near the piers (i.e. where it exited from the ground) and clayey silt which had pooled on the raised floodplain of the creek. The free-field ejecta (25m west of the bridge) was very coarse compared with the ejecta beneath the bridge and elsewhere in the region. Free-field lateral spreading 30m west of the bridge (Figure 26 a) resulted in localised movements of up to 50cm, with individual cracks being 15-25 cm wide. A local farmer reported that there was additional lateral spreading located east of the bridge, but this was several hundred meters away and not investigated.

The lateral spreading resulted in some structural damage to several of the bridge piers and in the tops of some visible abutment piles. As shown in Figure 26 b-c, the inward movement of the soil has caused some rotation of the piers. The movement caused single cracks to develop at the top and

bottom of the piers, particularly at the north end of the bridge shown in Figure 26 b-c. Pipes that were attached to the east side of the bridge to carry services failed at joints between sections of pipes.

Figure 26: Damage at Needles Creek Bridge (-41.8217°, 174.137°): (a) Tilting of first pier from north abutment looking east; (b) Cracking across the top of first pier from north abutment caused by tilting, taken facing SE; (c) Subsidence of fill exposing base of north abutment, taken facing NW; (d) Free-field lateral spreading cracks, taken facing W.

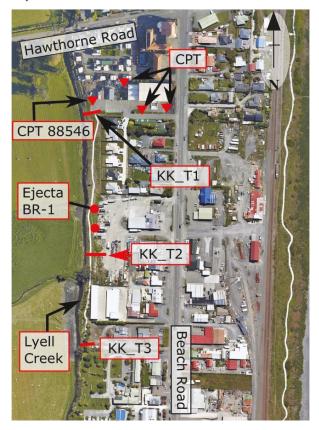
The magnitudes of permanent lateral ground displacements were estimated by summing up measured ground fissures along three lines (transects: KK_T1, KK_T2, and KK_T3, Figure 35) on the east side of Lyell Creek. The transects were carried out between the river channel and the last clearly

identifiable crack along the heading being traversed. The transects were oriented perpendicular to Lyell Creek and parallel to the direction of ground movement, with KK_T1 being close to where CPT 88546 was performed and the site shown in Figure 34. The other two transects were located ~150 m (KK_T2) and 300 m (KK_T3) to the south. Consistent with observations elsewhere along the creek, the cracks at the transect locations extended between 10-20 m from the river. Cumulative measured horizontal ground crack widths were in the range of 0.6–1.2 m, while cumulative vertical displacements were between 0.4-0.8 m.

Figure 35: Location of CPT and Transects along Lyell Creek (Approx. coord. of centre of image: -42.391°, 173.679°.

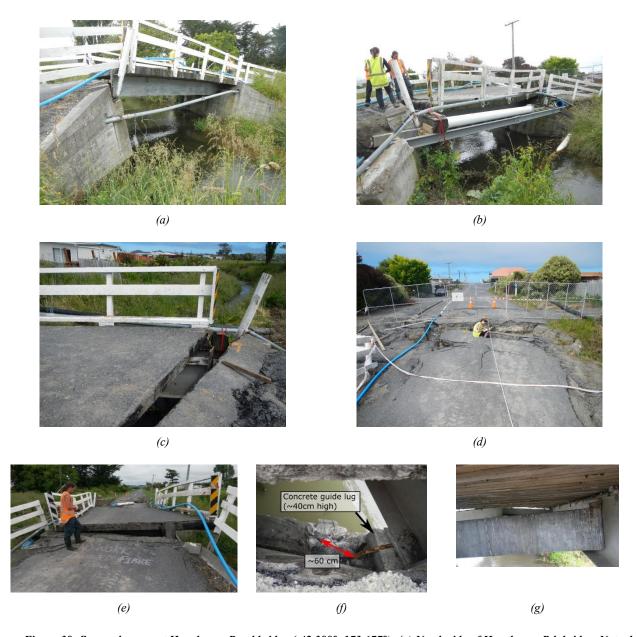
Figure 38: Severe damage at Hawthorne Road bridge (-42.389°, 173.677°): (a) North side of Hawthorne Rd. bridge. Note the abutment rotations and the deck displacements; (b) South side of Hawthorne Rd. Bridge; (c) Gap between deck slab and west abutment (taken facing S); (d) Cracking in the eastern approach to the bridge (taken facing E); (e) Vertical displacement of deck slab (taken facing W); (f) Pull-out of deck beam restraint at the east abutment (taken facing W); and (g) Twisting of the deckbeam (taken facing W).

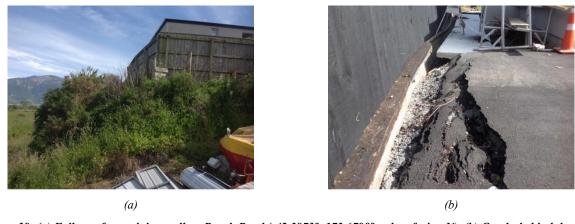
Figure 39: (a) Failure of a retaining wall on Beach Road (-42.3973°, 173.6798°, taken facing N). (b) Cracks behind the retaining wall on Beach Road (-42.3971°, 173.6798°, taken facing N).

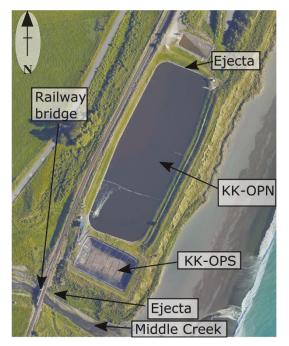
Figure 43: Overview of Oxidation Ponds north of Kaikōura (Approx. coord. of centre of image: -42.366°, 173.688°.

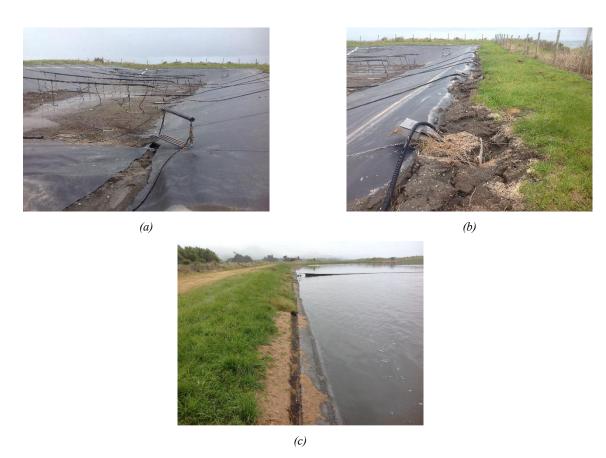
Figure 44: (a) KK-OPS looking from the SW corner. Note: Geoliner in the foreground has ripped (-42.3668°, 173.6865°, taken facing E). (b) Rotation of the aeration-line control posts on the south side of KK-OPS (-42.3669°, 173.6867°, taken facing E). (c) West edge of KK-OPN. Note concrete panel has displaced into pond (-42.3660°, 173.6868°, taken facing N).

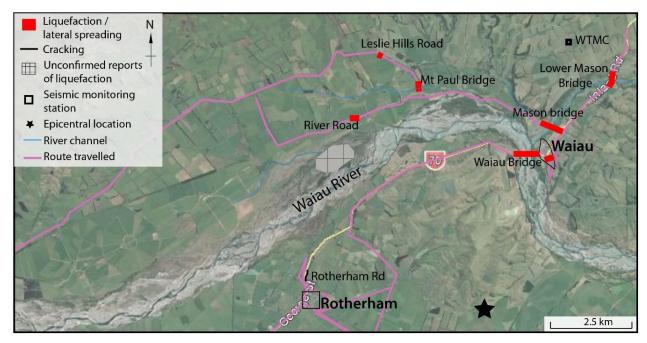
Figure 45: Map of the Waiau area indicating areas with liquefaction manifestation (Approx. coord. of centre of image: -42.658°, 173.005°).

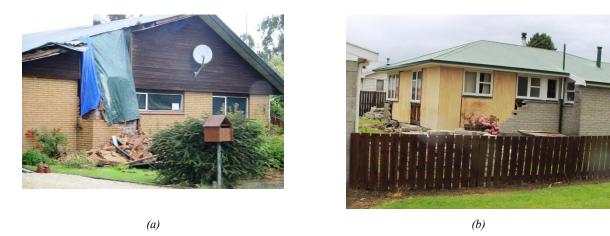
Figure 46: Examples of damage to residential buildings in Waiau township (Approx. coord: -42.66°, 173.04°): (a) fallen chimney; (b) damage to brick façade.

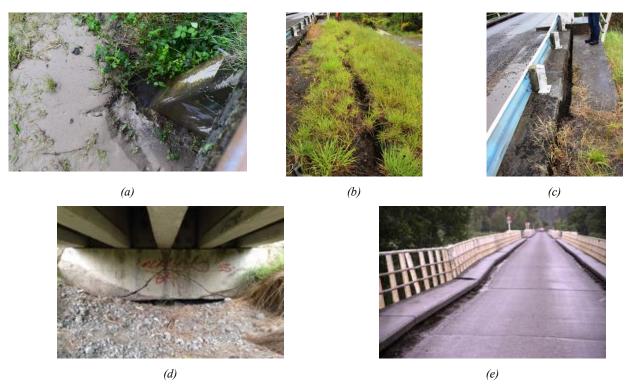
The Waiau River Bridge is a 33-span reinforced concrete bridge located just west of the Waiau township as shown in Figure 45. Moderate amounts of liquefaction ejecta were observed at the toes of the approach embankments and in the river banks ahead of the abutments, as well as being visible around unsubmerged bridge piers (Figure 51a). Some minor lateral spreading cracking was visible on both sides of the

river and in the bridge approaches as shown in Figure 51b. On the west approach, there was ~20 cm of outward spreading and about 40-50 cm of settlement (Figure 51c). As shown in Figure 51d, the western abutment wall rotated (base moving towards the river), opening up some large cracks in the centre of the wall. At the second pier from the west end of the bridge, visible deformation in the bridge deck was observed (Figure 51e), as a result of some (clockwise) twisting in plan, as well as differential settlements in the N-S direction. The approach deformation on the eastern side was more modest, with ~10 cm of outward spreading and 20 cm of settlement. Despite the cracking and apparent movements, the overall impact of liquefaction and lateral spreading was very low, with the bridge remaining open to reduced speed traffic after the earthquake.

Figure 51: Liquefaction-induced damage at Waiau River Bridge (-42.66°, 173.03°): (a) Moderate liquefaction and gap (from inertial loading) around bridge pier; (b) Lateral cracking in southern side of western approach embankment looking E; (c) Settlement at outward movement at western abutment looking E; (d) Cracking and subsidence of fill at river side of western abutment looking W; (e) Differential settlement at second pier from western abutment looking E.

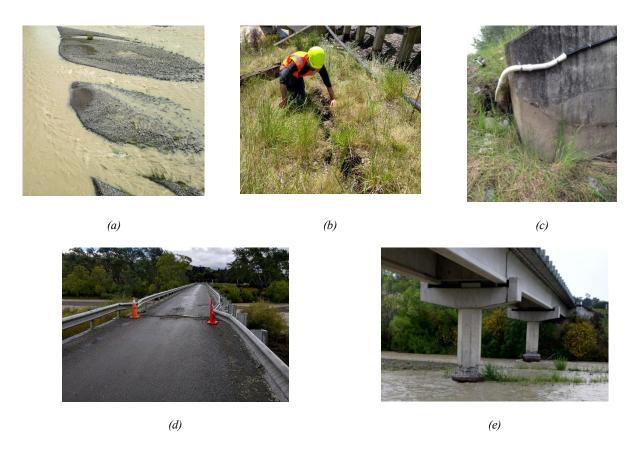
The Lower Mason Bridge is a 165-m long, 8-span reinforced concrete bridge located on the Inland Road about 3 km NE of Waiau township. Evidence of liquefaction was observed on the unsubmerged parts of the gravelly river channel (Figure 52a), as well as just north of the river (i.e. on the floodbank); the ejecta material was gravelly sand (PSD shown in Figure 49). It should be noted that the river occupied the southern portion of its channel at the time of the reconnaissance, so any ejecta at the south end of the bridge was not visible. Reasonably minor lateral spreading cracks were observed in the river banks, and outward spreading and settlement of the approaches occurred. Cracking in the embankments indicate at least 40 cm of outward deformation occurred in the fill material behind the abutment walls as shown in Figure 52b. The marks on the abutment walls were used to estimate the settlement of the embankment. The measurements indicate 50-60 cm of settlement on the river side of both abutments (example from northern abutment is shown in Figure 52c), and at least 30 cm of settlement on the approach side. Despite the settlement and cracking in the approaches, the bridge was not really impacted by the liquefaction and lateral spreading at the site, but rather by the extreme inertial loading which caused reasonably large permanent deformation (visible in the location of the buckled crash barrier in Figure 52d), the unseating of the deck from the rubber bearings at the abutments, and the plastic hinging which is visible in Figure 11e and discussed in further detail in Palermo et al [30].

Figure 52: Liquefaction, deformation and damage at the Lower Mason Road Bridge (Approx. Coordinates: -42.63°, 173.07°): (a) Ejecta within the braided river channel (taken facing W); (b) Large outward spreading (~40 cm) at the west side of the south approach (taken facing N); (c) Settlement of fill materials at west side of north abutment (taken facing N); (d) Lateral displacment of bridge deck relative to the abutment and buckling of crash barrier (taken facing S); (e) Structural damage at the base of the bridge piers.

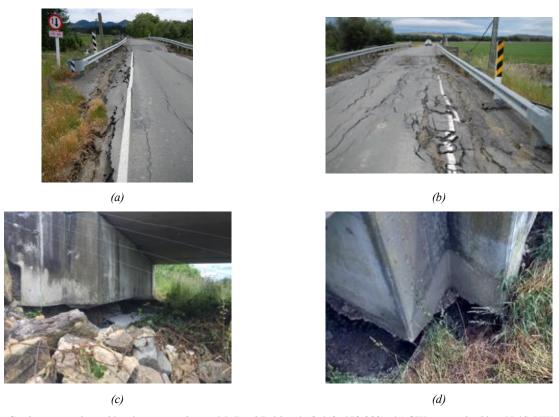
Figure 53: Settlement and cracking in approaches to Mt Paul Bridge (-42.64°, 172.99°): (a) SW corner looking N (d) NW corner looking S. (c) Settlement and spreading of fill on north (stream) side of southern abutment (looking W) exposing severely damaged piles; (d) Settlement and soil gapping on eastern side of north abutment facing N.
