Performance of Manufactured Housing during Hurricanes Irma and Michael

Elaina J. Sutley, Ph.D., A.M.ASCE¹; Karen Vazquez, S.M.ASCE²; Jae H. Kim, S.M.ASCE³; Thang Dao, Ph.D., A.M.ASCE⁴; Blythe Johnston, S.M.ASCE⁵; and Josh Hunt, S.M.ASCE⁶

Author keywords: Mobile home; Manufactured housing; Hurricane Michael; Hurricane Irma; Wind damage.

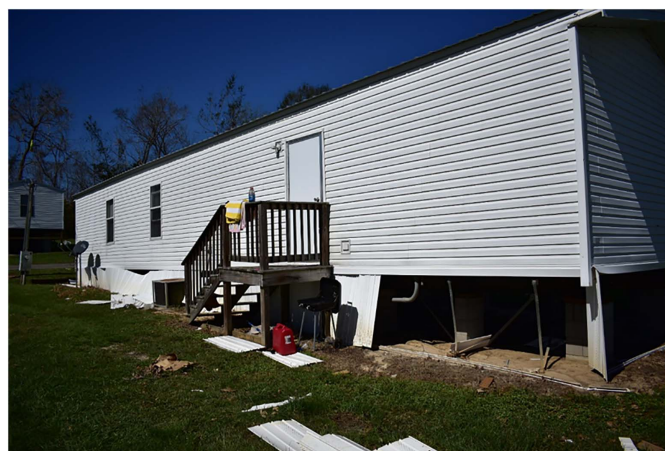
Fig. 3. Damage state 1 classification example. (Image by authors.)

Damage state 1 was classified for 36% of the homes surveyed. Fig. 3 is a post-Michael photo of a manufactured housing unit classified as Damage state 1. The damage visible in Fig. 3 is to the skirting, which is common across all damage state classifications. The siding, door, windows, and attachment all are unharmed.

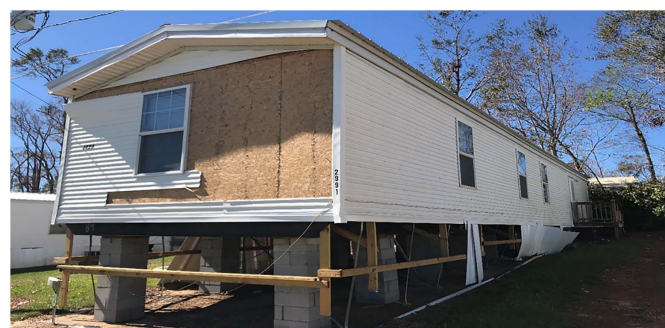
Fig. 4. Damage state 2 classification example. (Image by authors.)

Fig. 4 is an image of a manufactured home classified as Damage state 2. In total, 23% of all surveyed homes were classified as Damage state 2. Noticeably in Fig. 4, there is between 15% and 50% skirting and siding loss. The foundation, windows, and attachment all are unharmed.

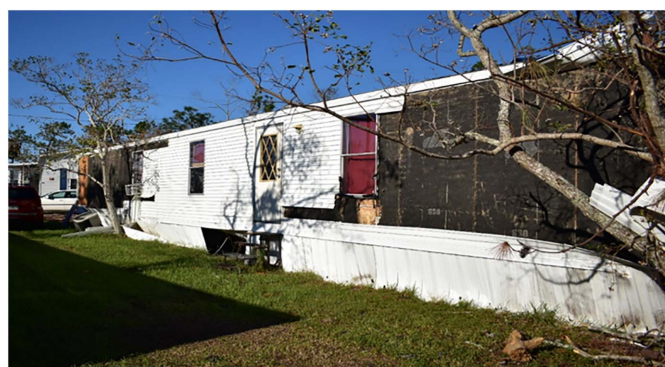
Fig. 5. Damage state 3 classification example. (Image by authors.)

Fig. 5 is a post-Michael image of a home categorized as Damage state 3. In total, 10% of all surveyed homes were classified as Damage state 3. The damage observed in Fig. 5 includes significant wall

cover loss and some skirt loss. The structural integrity of the home appears to remain in good shape.

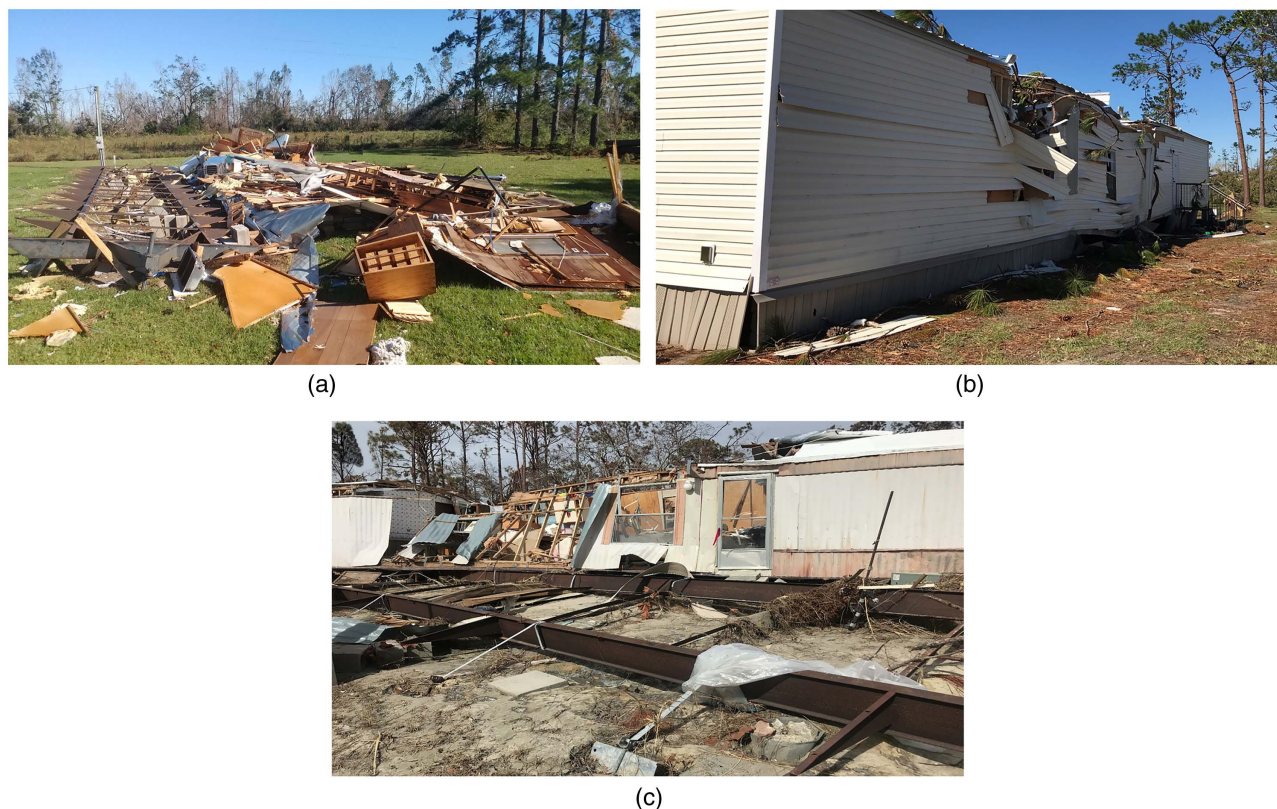
Fig. 6. Damage state 4 classification example: (a) exploded home; (b) tree-destroyed home; and (c) surge-dislocated and partially collapsed home. (Images by authors.)

Fig. 6 provides three examples of manufactured homes classified as Damage state 4, representing 20% of the total sample. These were the three most common catastrophic failures observed. Fig. 6(a) shows an exploded home, which was quite common for older homes due to their poor connections and lack of wood sheathing used in the walls and roofs. Fig. 6(b) shows a home with the middle third collapsed due to tree-fall. Fig. 6(c) shows a home that was picked up and dislocated from its foundation. This latter case was due to the surge and flooding experienced by homes on the coast, which in total represented a small portion of the sample. The majority of damage observed and classified in the sample was caused by wind, including some of the damage shown in Fig. 6(c). In Fig. 6(c), sections of the wall and roof structure have collapsed, exposing the structural system, which again lacks sheathing. Also notable in Fig. 6(c) are the anchor straps which kept the chassis system in place; the trailer itself was not well-attached to the chassis system, and thus was easily picked up and relocated with the surge.

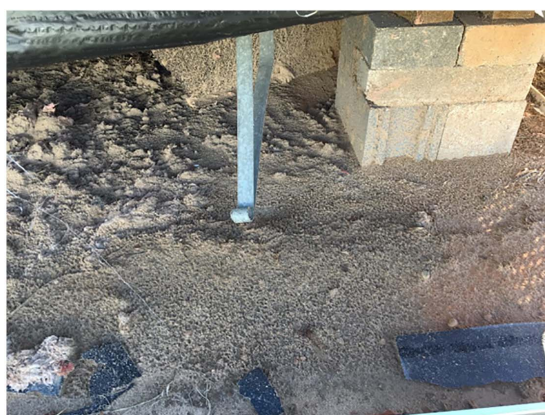
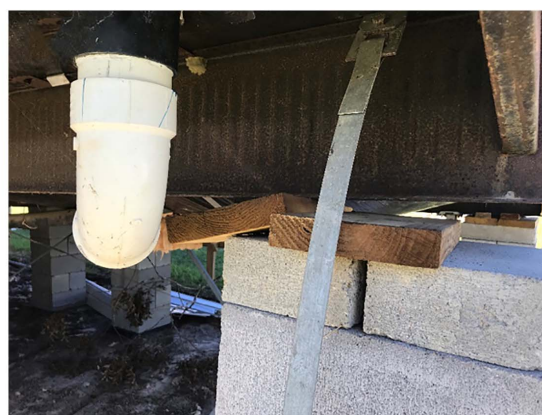
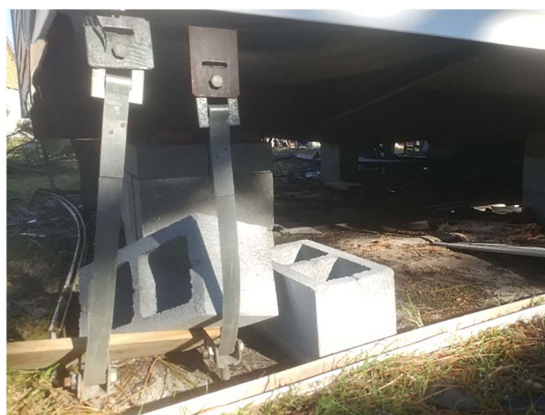
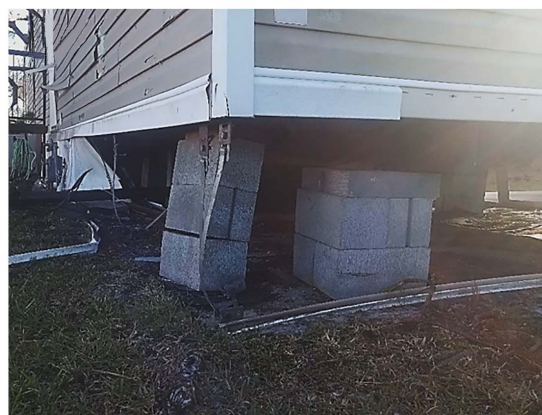
Fig. 9 provides a histogram of the range of elevation heights measured in the field, in which the first bin captures heights up to 305 mm (1 ft) in elevation and the last bin captures heights more than 1,067 mm (42 in.) in elevation. Most homes were elevated between 457 and 914 mm (18 and 36 in.); recent wind tunnel tests showed that buildings raised to these lower heights experience high suction pressure coefficients on their floor underside (based on forthcoming work by the authors). Fig. 10 provides examples of the types of damage observed to the foundation, including anchorage devices becoming detached from the ground or the unit, and wood or concrete blocks being displaced and even collapsing. The images in Fig. 10 are in addition to complete failures related to the foundations of manufactured homes, in which common failure modes included the trailer rolling off of the foundation or experiencing a pancake-like collapse onto the foundation.

Fig. 10. Damage to foundation: (a) anchorage device detached from ground; (b) wood block slipped off concrete block footing; (c) collapsed concrete block footing; and (d) permanently tilted concrete block footing. (Images by authors.)

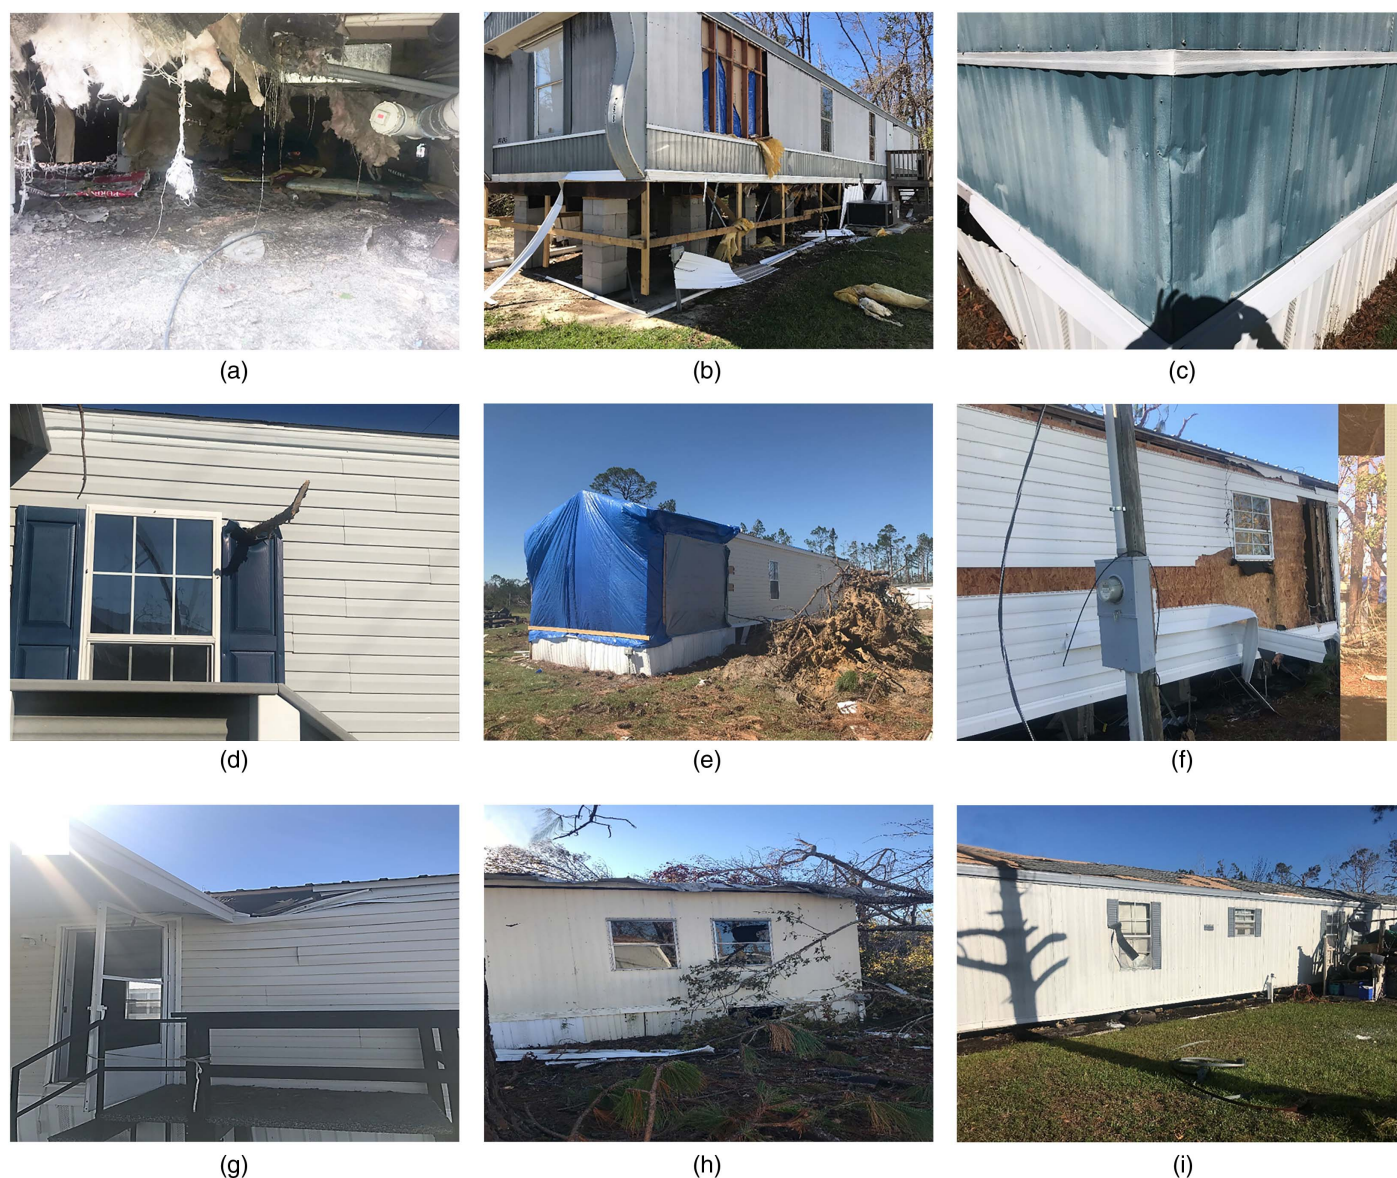
Excluding skirt damage, 99 homes experienced other types of damage to the body of the trailer (e.g., roof, walls, floor, windows, and doors). Fig. 11 provides images of different types and locations of damage to the body of the trailer, including the floor underside, with insulation components ripped out; removed siding; out-of-plane wall siding indentations; damage to the wall structure, exposing the interior; debris missile impacts; tarped portions of the trailer; roof structure loss exposing the interior; tree impact to the roof structure; and shingle loss on the roof. Figs. 11(b and f) show differences in wall structures. Stud spacing without exterior

sheathing, which is common in older homes, can lead to the out-of-plane deformation observed in Fig. 11(c). As before, these damages were in addition to the complete destruction of the trailer for homes that were marked as Damage state 4.

Regarding Fig. 11(e), the reconnaissance team entered the field just 1–2 weeks after Hurricane Michael. In the coastal cities, such as Port St. Joe and Mexico City Beach, this sometimes seemed too soon, because some homeowners were returning to their damaged homes at the same time the reconnaissance team reached the site, although utmost efforts were made to never interfere with emergency response operations. However, further inland, the timing sometimes seemed late, because many structures with apparent roof damage and major wall damage already were covered with tarps, making detailed observations impossible.

Fig. 11. Damage to trailer: (a) floor underside damage; (b) skirting and siding loss; (c) siding indentation; (d) debris missile; (e) tarping covering portions of the roof and wall structure; (f) siding and skirting removed with a full-height hole in the wall structure; (g) hole in the roof; (h) tree fall onto roof; and (i) roof shingle loss. (Images by authors.)

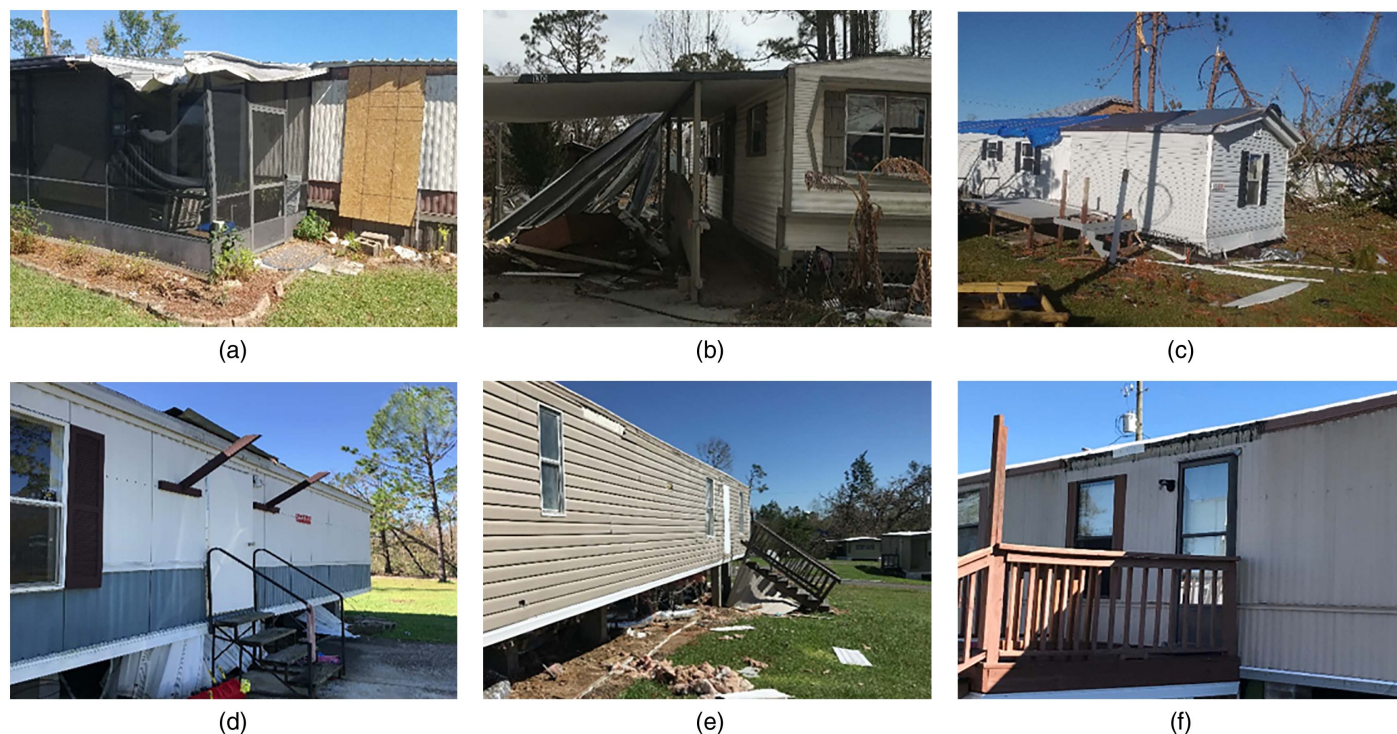
Fig. 12. Damage to attachments: (a) roof crumpling; (b) carport collapse; (c) railing removal; (d) awning loss; (e) stair collapse; and (f) awning loss with removal of trailer roof edging. (Images by authors.)

Attachments also included awnings, carports, screened porches, and elevated decks; as is the case for damage to trailer components, detached attachments can become additional hazards in the form of windborne debris. Of the 144 manufactured homes surveyed that were not completely destroyed, only 19% were recorded as having damage to attachments. Fig. 12 provides images of several types of attachment failures, including damage to porch roofing, carport collapse, damage to stairs and stair railing, and damage to awnings. Figs. 12(d and f) show instances of roof awning loss; the latter also shows that a portion of the trailer's roof edging was ripped off with the awning. This type of failure is particularly important to capture because it can lead to cascading failures of homes by creating new vulnerabilities to the trailer.
