## Experimental Seismic Test of Drywall Partition Walls with Improved Detailing for Damage Reduction

R. Ryan<sup>(1)</sup>, H. Hasani<sup>(2)</sup>

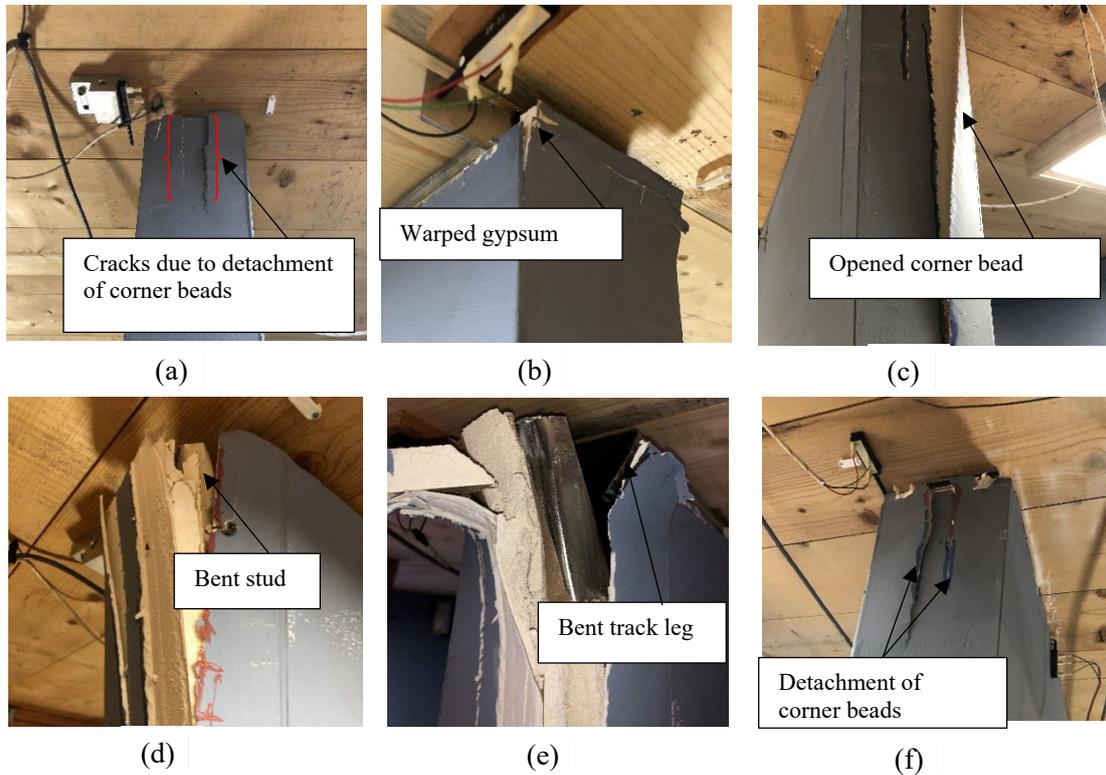
Damage observations for both walls are shown in Fig. 7. Corner beads at the end of both walls started to lightly detach at around 0.46% drift (shown for slip track detailing in Fig. 7(a)). This damage occurs because the entire wall below the top track tends to remain stationary, while the top track tends to move with the top diaphragm (natural behavior of slip-track). Since fire regulations permit only up to half-inch gap at the top of the gypsum [9], while the length of the top track leg is 2 in. for both types of detailing, the top track hits the gypsum at the top of the wall ends.

The detachment of corner beads increased with increasing drift. Light warping of the gypsum was observed at 0.67% drift (Fig. 7(b)), and the corner bead opened significantly at 0.84% in the slip-track connected wall (Fig. 7(c)). Coincident with this observation at 1.26 in. displacement, the resisting force increased significantly. Since the stud leg is 1.25 in., the authors believe that the considerable opening in the corner bead is due to the stud not returning to its nested track in the slip-track connected wall. Bending of the end stud was observed at 2.56% drift in the slip-track detailed wall (Fig. 7(d)). At 3.2% drift, the damaged end stud in the slip-track detailed wall bent the leg of the track (Fig. 7(e)), which was coincident with a considerable increase in the resisting force. While all of this damage progressed in the slip-track detailed wall, the telescoping detailed wall showed only minor damage at the top end of the wall (Fig. 7(f)).

Fig. 7: Phase 1 observations: (a) Light detachment of corner bead at wall ends (0.46% drift, slip track); (b) light warping of drywall (0.67% drift, slip track); (c) significant opening in the corner bead (0.84% drift, slip track); (d) end stud bending (2.56% drift, slip track); (e) track leg bent (3.2% drift, slip track); (f) light detachment of corner bead at wall ends (5% drift, telescoping)

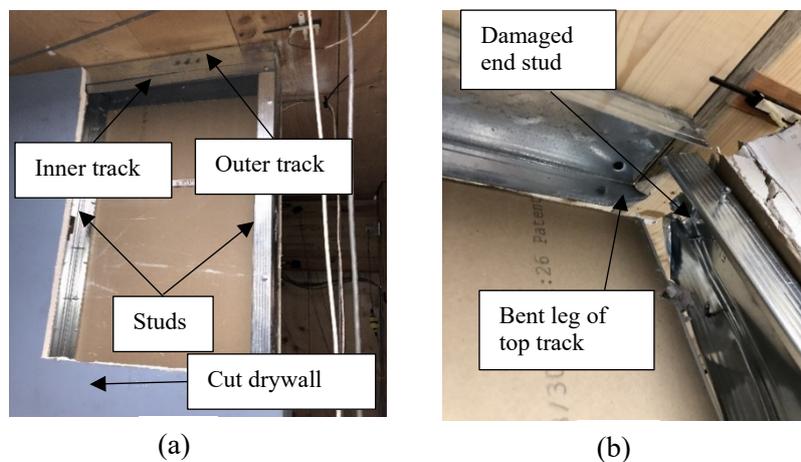
Photos from the post-test inspection of both walls are included in Fig. 8. These inspections suggest that the framing of the wall with telescoping detailing remained damage-free during the test (Fig. 8(a)). However, the stud and track of slip-track detailing suffered damage due to the detachment of end studs from the track (Fig. 8(b)).

Fig. 8: Phase 1 post-test inspection after removal of drywall: (a) damage in the wall with telescoping detailing; (b) damage in the wall with a slip track connection

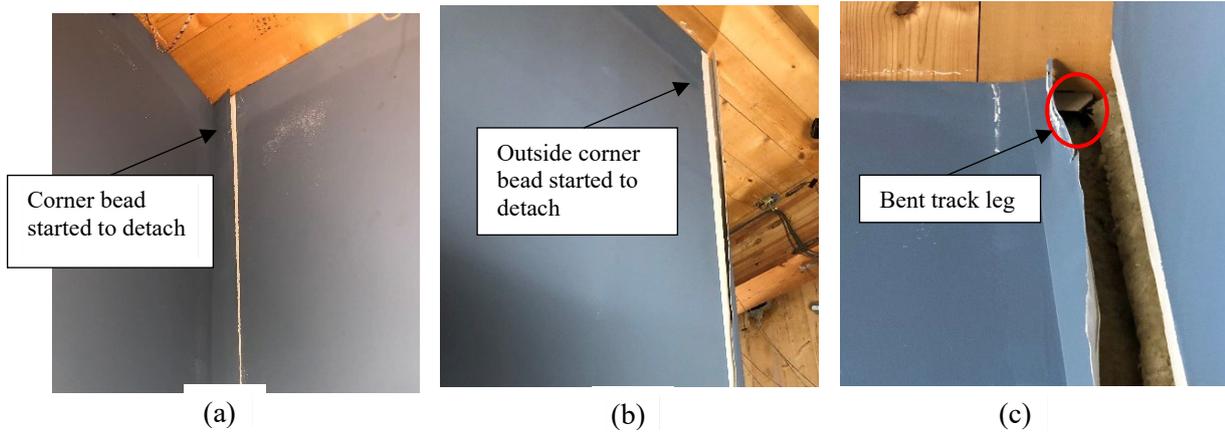
Representative damage is shown in Fig. 9 for the corner gap wall and Fig. 10 for the distributed gap wall. One of the corner beads started to detach at a 0.43% drift (Fig. 9a). At 0.84% drift, all of the corner beads started opening, and the width of the opening increased as the drift was increased (Fig. 9b). At 2.56% drift, the bending of the track leg within the corner gap region was apparent (Fig. 9c). For the distributed gap wall, at 0.84%

Fig. 9: Phase 2 observations in corner gap wall: (a) corner bead opening (0.43% drift), (b) opening of outer corner bead (1.05% drift), (c) bending of the track (2.56% drift)

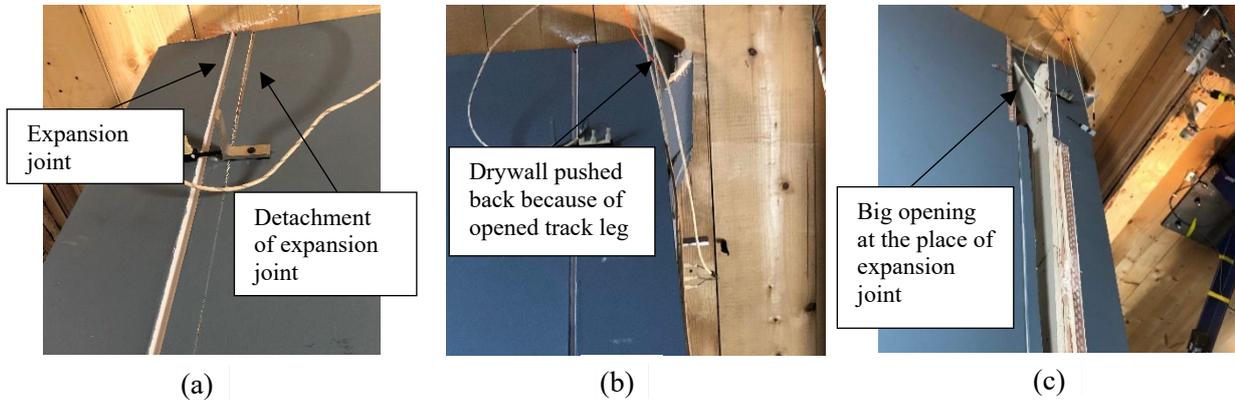
drift, the non-fire rated expansion joint adjacent to the return wall started to detach (Fig. 10a). At 1.05% drift, the leg of the track at the wall intersection began to open and pushed the drywall (Fig. 10b). At 2.56% drift, the distributed gap developed big openings adjacent to the return walls (Fig. 10c).

Fig. 10: Phase 2 observations in distributed gap wall: (a) detachment of expansion joint (0.84% drift), (b) opening of the track leg (1.05% drift), (c) opening in the fire-rated wall intersection (2.56%)

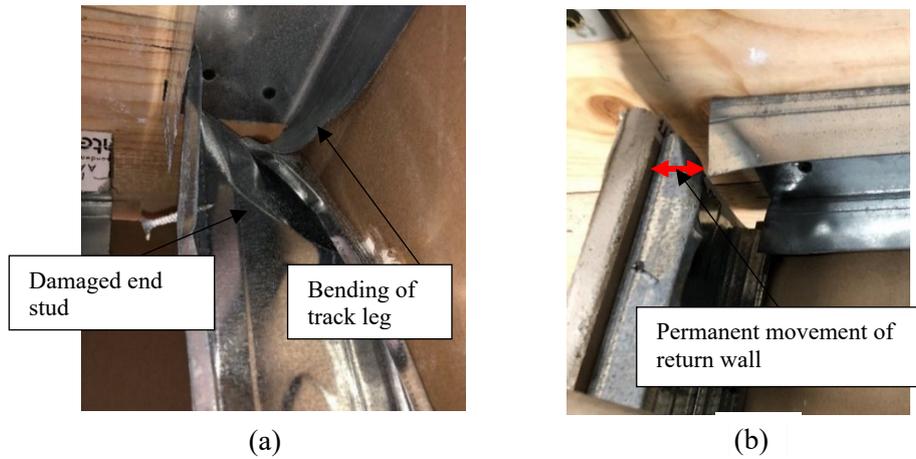
Photos from post-test inspections are shown in Fig. 11 for the corner gap wall and Fig. 12 for the distributed gap wall. In the corner gap wall, end studs were damaged, and the track legs were bent (Fig. 11a). Moreover, the return wall had permanently moved in its in-plane direction (Fig. 11b). In the distributed gap wall, the return wall moved permanently in its in-plane direction for both fire-rated (Fig. 12a) and non-fire rated (Fig. 12b) gap detailing. Besides, in the fire-rated wall intersection, the gap in the return wall also opened, and the studs pushed out through the track legs (Fig. 12c). Since the gaps on both sides adjacent to the wall intersection opened, the small corner section of the wall became unstable. Damage in the non-fire rated wall intersection for distributed gap detailing (Fig. 12d) included the opening of the track leg and studs being pushed out of the track.

Fig. 11: Phase 2 post-test inspections of the corner gap wall: (a) damage in the end stud and bending of the leg of track, (b) permanent movement of the out-of-plane wall in the in-plane direction

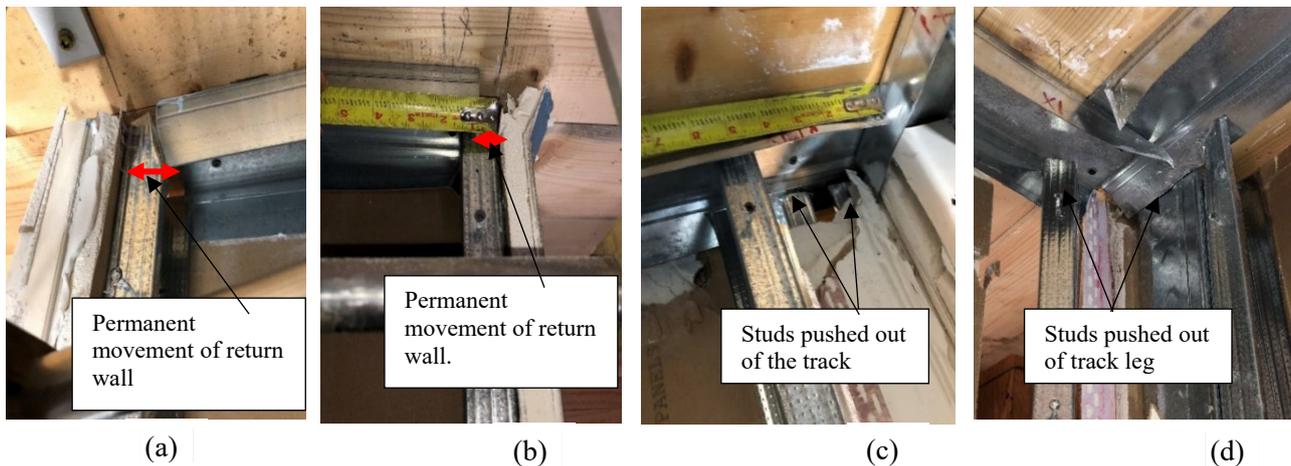
Fig. 12: Phase 2 post-test inspections of the distributed gap wall: (a) permanent movement of the return wall (fire-rated wall intersection); (b) permanent movement of return wall (non-fire rated wall intersection); (c) track opening in the return wall and pushing out of studs (fire-rated wall intersection) (d) track opening, and pushing out of studs (non-fire rated wall intersection)
