Case Studies in Construction Materials

Condition assessment of concrete and glass fiber reinforced polymer (GFRP) rebar after 18 years of service life

Concrete cores containing GFRP bars were extracted from dry-dock no. 4 at Pearl Harbor in Oahu, Hawaii. The original structure for the dry-dock was built in 1942 for the US Navy with reinforced concrete walls of thickness 7.6–9.1 m [27]. The dry-dock walls significantly degraded over time and repairs were performed to the fascia in the early 1990s using steel reinforcement with a 50 mm thick concrete cover. Due to subsequent corrosion of the steel reinforcement used in the first repair (and the consequent delamination and spalling of the concrete), a need rose for additional repairs, which were executed and completed in 2001 by removing affected concrete and steel reinforcement and replacing them using concrete reinforced with GFRP bars [27]. The condition of the dry-dock fascia during the execution of the second round of repair is shown in Fig. 1, depicting the areas where the deteriorated concrete was removed. This picture also shows the approximate locations where the concrete cores were extracted 18 years later for this study.

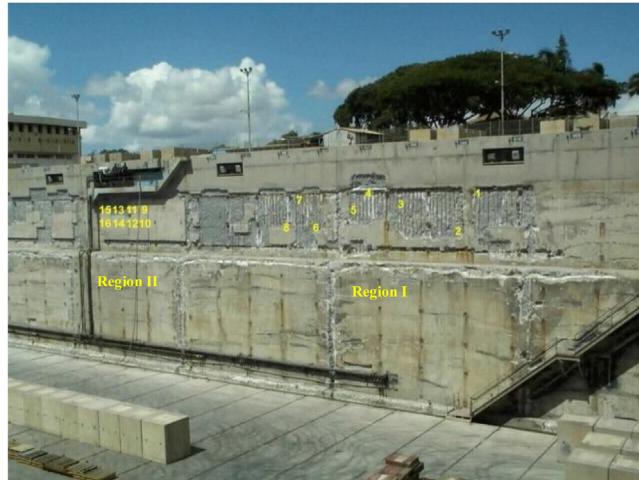
Cores were extracted in 2019 after the repaired dock had experienced 18 years of service. The numbers shown in yellow font in Fig. 1 correspond to the approximate locations where concrete cores were extracted. The cores at locations 1–8 (Region I) were intended to contain GFRP reinforcement and cores at locations 9–16 (Region II) were expected not to contain any GFRP reinforcement. Fig. 1 suggests that the fascia in Region I and Region II experienced different levels of deterioration, presumably as a result of different concrete mixtures or different exposure levels.

Fig. 1. Dry-dock fascia photograph taken at the time of the repair (2001) also showing approximate locations of cores taken in 2019.

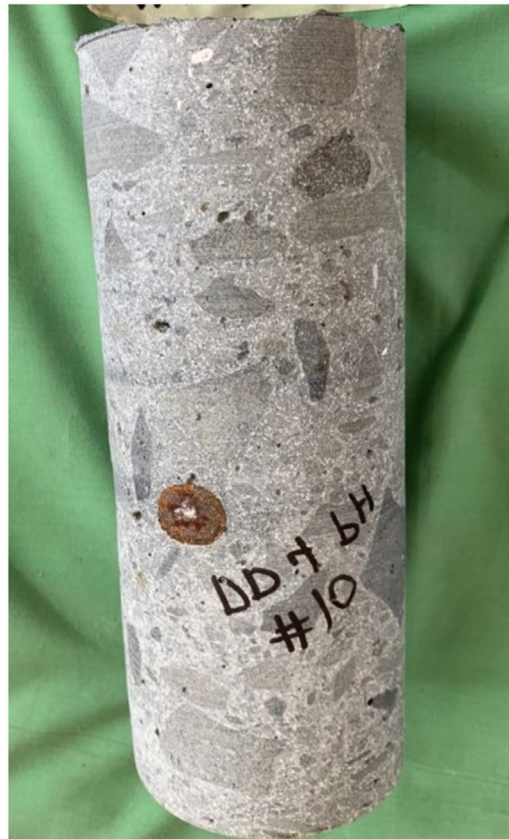
The continual damage of the steel and the concrete is common in structures exposed to seawater. While in principle, numerous methods to mitigate corrosion can be undertaken, it is extremely challenging to prevent corrosion in the long-term in-situ. In this case, the constant chloride ingress (from the seawater) and the wetting and drying cycles resulting from dry-dock operations coupled with a relatively low concrete cover (50 mm) resulted in extensive steel corrosion (seen clearly in Figs. 1 and 2).

Fig. 2. Corroded steel reinforcement in an extracted cored specimen (Core #10 – Region II). The steel rebar is likely from the repairs done in the 1990s.

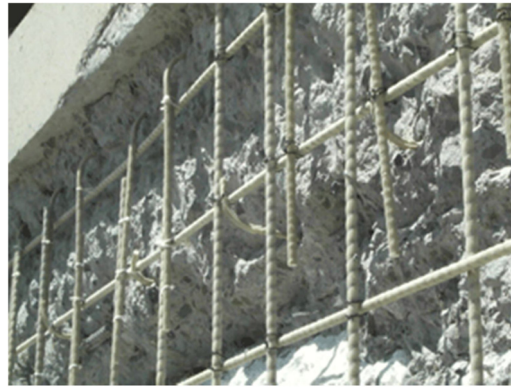
The 2001 repair was carried out by using a grid of GFRP bars held in place by GFRP dowels embedded in epoxy resin as the concrete reinforcement (as shown in Fig. 3). Rebars 9- and 12-mm in diameter (#3 and #4) were used for the straight elements and 9-, 12-, and 16-mm diameter (#3, #4, and #5) bars were used for the bends. Further details regarding the repair can be found in literature [27].

Fig. 3. Doweled GFRP reinforcement grid in the fascia of the dry-dock (Region II).

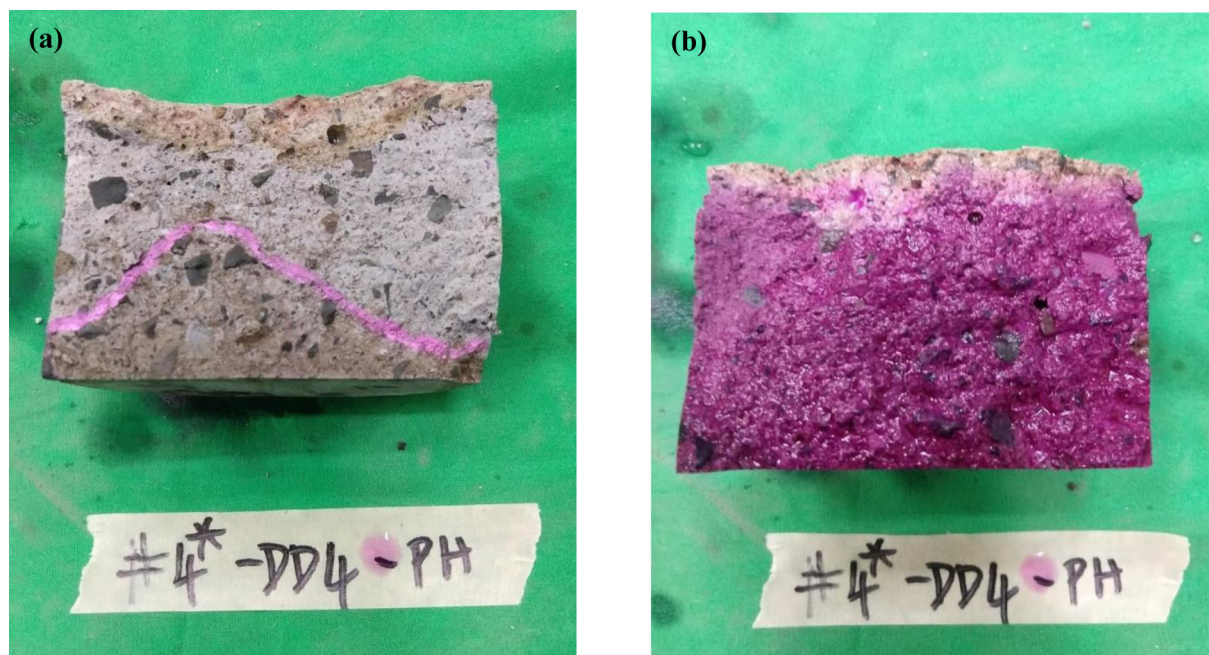
Fig. 5. Representative image of core tested for (a) chloride penetration, and (b) carbonation depth (Core #4 – Region I).

from the surface. The data presented here is qualitative and is only provided to present evidence of chloride penetration and carbonation, which are known to cause deterioration. The average chloride penetration depth is 39 mm with values ranging from 13 to 53 mm. Given that the cover depth is 50 mm on the fascia, and the chloride penetration depth is more than 50 mm in some locations, steel reinforcement in these regions has depassivated and corrosion has initiated [45]. This is confirmed visually in some cores (Fig. 2), where there is clear evidence of corrosion based on visual inspection. Some cores have “full” depth of chloride penetration. There does not appear to be an obvious difference in the chloride penetration behavior of cores from Regions I and II.

Similarly, there is considerable carbonation in the specimens, with the average depth of carbonation being 6 mm and the values ranging from 3 to 13 mm. Cores from Region I show a greater depth of carbonation than cores from Region II. The carbonation depth is lower than values reported in literature for field concrete at a similar age [25], presumably due to marine exposure causing higher chloride ingress than carbonation. However, as stated previously, since full cores were not received from the site, the depth of deterioration can be presented only for the individual cores and not for the structure itself.

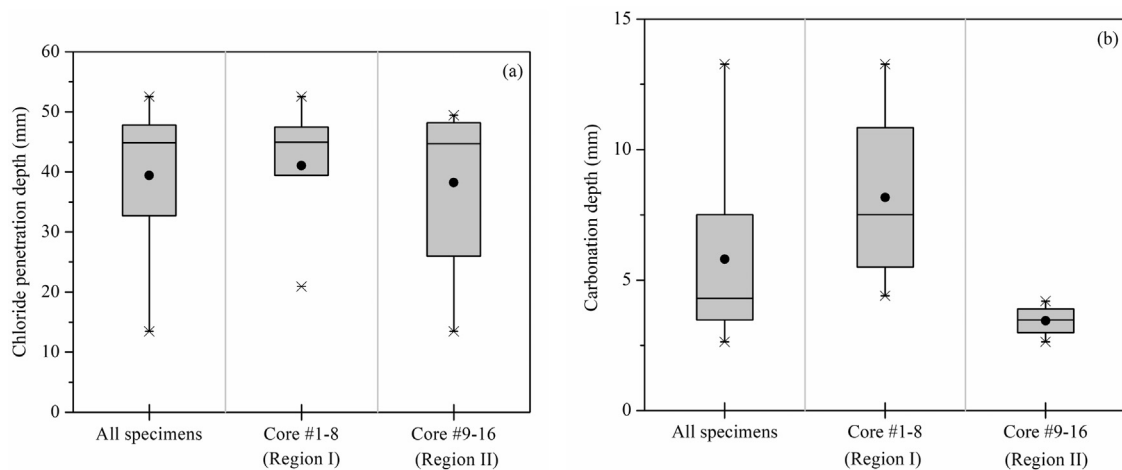
Fig. 13. Ingress of aggressive species (a) chloride penetration and (b) carbonation depths of the core specimens.

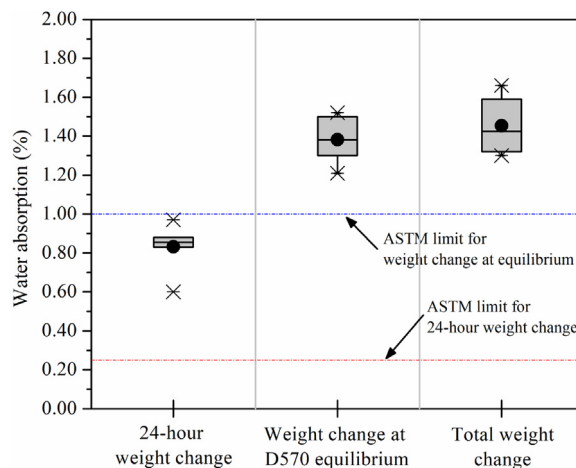
Fig. 14. Water absorption parameters for the GFRP specimens.

Fig. 14 shows the range of values obtained for the different water absorption parameters for the GFRP specimens. The 24-h weight change due to water absorption ranges from 0.60 % to 0.97 %, with an average value of 0.83 %. The average weight change due to moisture absorption at equilibrium was 1.45 % with the values ranging from 1.30 to 1.66 %. These measured values are significantly higher than the ASTM D7957-17 limit of 0.25 % (for 24-h water absorption) and 1% (for weight change at equilibrium). These higher values could be because the GFRP bars used in this project were of older generation manufactured almost two decades prior to the publication of the ASTM specification. High water absorption may indicate deterioration of the matrix and debonding of the fiber. This debonding could cause an increase in the capillary uptake of moisture, resulting in increase in water absorption [48,49]. This deterioration, and the consequent increase in moisture uptake is consistent with literature and similar results for water absorption have been obtained in GFRP samples exposed to extreme environments such as increased temperature and sustained loading [46,50]. Water absorption can be considered an indicator of the quality of the matrix [50] and higher water absorption can be related to a reduction of the mechanical properties [51].

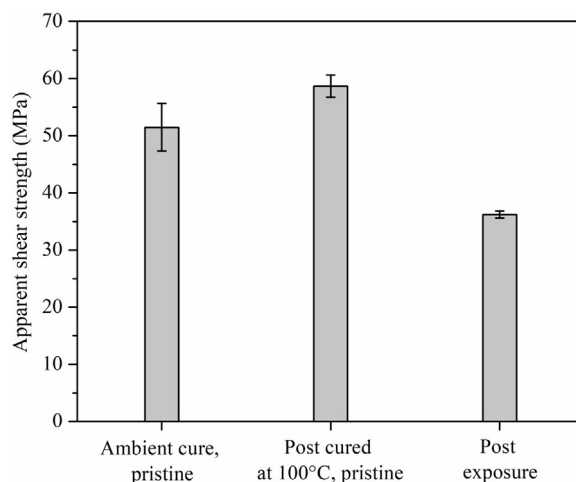
Fig. 15 shows the horizontal shear strength of the GFRP reinforcement after exposure. The results of horizontal shear strength from the original bars tested in 2001 after cure at ambient temperature and for bars post-cured at 100 °C for 12 h are also shown in Fig. 15. Some degradation in the horizontal shear strength after 20 years is apparent. Clear horizontal shear failure was observed in one of the four specimens tested, whereas failure of the other specimens presented as horizontal cracks on the outer surface in the region where loading was applied. Fiber debonding was observed in the cross section of

Fig. 15. Residual horizontal shear strength of the GFRP specimens.

some specimens. The debonding could be due to wetting and drying cycles experienced during the service life, resulting in shrinking and swelling of the matrix, weakening the interface between resin and fiber [48]. Imaging on other rebars appears to confirm some extent of fiber-to-resin debonding.

The decrease in apparent shear strength was 30 % and 38 % from ambient cured and post-cured bars prior to exposure, respectively. This reduction in strength could be due to various factors such as damage of resin [46], delamination between the resin and fibers [48], and the presence of voids in the fiber-resin interface [50]. The trend of decreasing shear strength with exposure to aggressive environment is generally similar to that observed in literature [18,52]. For instance, Khatibmasjedi et al. [18] reported a 27 % reduction in horizontal shear strength after exposure to a 60 °C alkaline solution over a 2-year period for similar GFRP bars made of E-glass fibers and vinyl-ester resin.

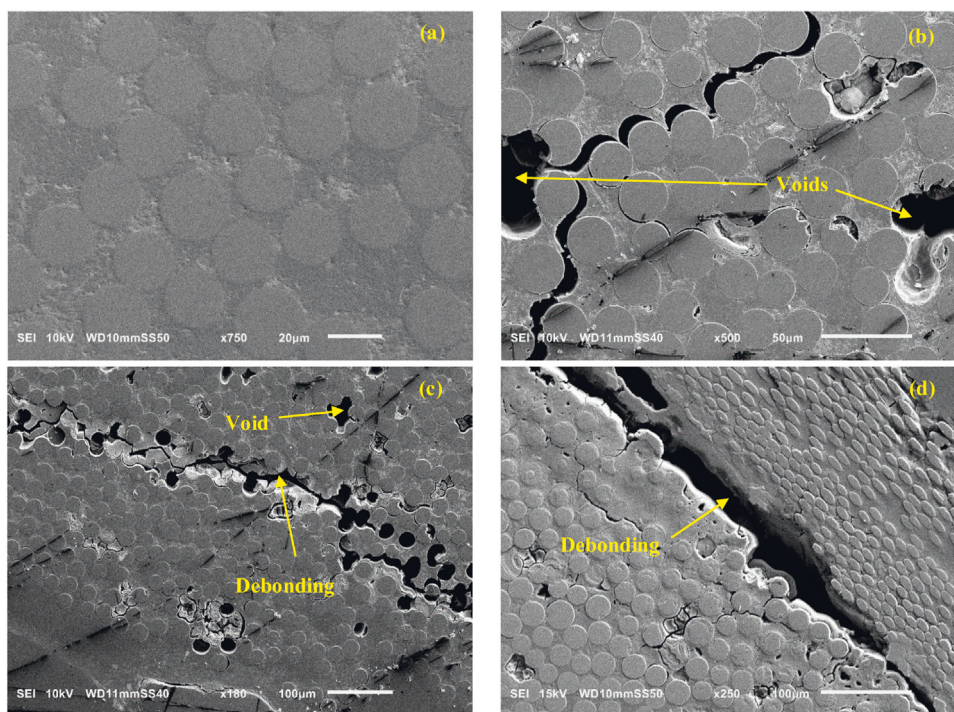
Fig. 16a–d shows representative SEM images of the fibers in the interior and near the skin of the GFRP specimens. No negatively affected fibers were observed on the interior of the bar cross-section. Damage near the bar surface is observed, which is described below. Some voids were observed near the skin of the bars, some of which could be a result of the manufacturing process, but based on horizontal shear strength reduction, they could also be due to the degradation in the fiber-resin interface. Some damaged fibers were observed where there was extensive degradation of resin (seen as voids in the SEM images). Long, continuous debonding cracks travelling towards the core of the specimens were observed in the resin-fiber interface. Debonding between the skin and the interior of the bars, characterized by large voids in the specimens, can be attributed to the wetting and drying cycles and the exposure to the harsh environment over the service life. Similar debonding was observed near the edge as a result of degradation in seawater by Khatibmasjedi et al. [18]. In some specimens, voids were observed closer to the center of the bar. This debonding between resin and fiber could explain the increased water absorption and reduction in apparent shear strength. Such debonding and voids could also explain the increased moisture uptake in the water absorption test. Similarly, a loss of bond at the interface has been observed by Mufti et al. [24]. The observations made here regarding GFRP reinforcing bars are similar to those presented in literature after accelerated testing and field exposure [23,53,54]. In general, the damage was not pervasive and was largely limited to the GFRP surface.

The results of EDS showed minimal presence of Na, Cl and K. The presence of Na was found in both the fiber and resin, and therefore is not an indication of chemical attack. The small amounts of Cl and K, on the other hand, were observed in the resin and could possibly indicate alkali attack. However, information from the original virgin bars would be necessary to confirm this interpretation.

Fig. 16. SEM micrographs of GFRP reinforcement (a) interior of the bar, (b) debonding between resin and fiber, (c) missing fibers and resulting voids, and (d) debonding between the skin and the core of the bar.
