Durability Assessment of 15- to 20-Year-Old GFRP Bars Extracted from Bridges in the US. I: Selected Bridges, Bar Extraction, and Concrete Assessment

Author keywords: Bridges; Concrete durability; Concrete tests; Glass fiber-reinforced polymer; Reinforced concrete.

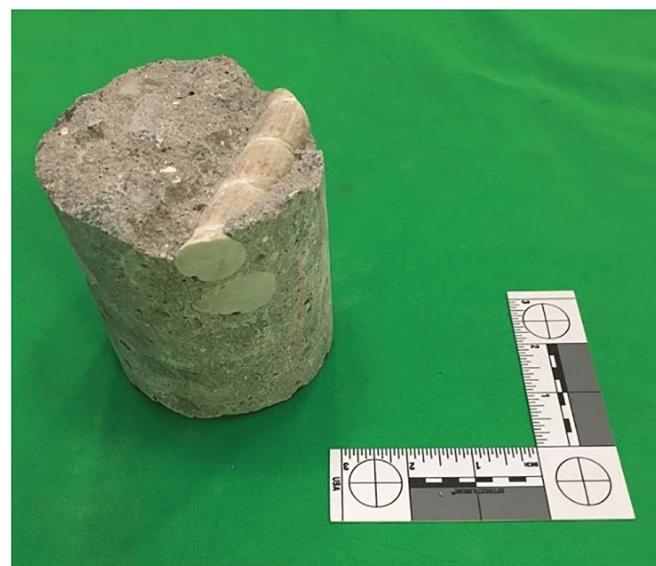
Fig. 1. Gills Creek Bridge core sample.

To extract the concrete cores from the bridges, a barrel of 102 mm (4 in.) in diameter was used. The targeted locations for core extraction were, when possible, areas with cracks or signs of environmental deterioration. No nondestructive method for identifying bar location is yet available. As a result, some concrete cores had no GFRP bars, and others had GFRP bars shorter than 51 mm (2 in.). An extracted core with a short bar is shown in Fig. 1.
