Title No. 117-M99

Assessment Study of Glass Fiber-Reinforced Polymer Reinforcement Used in Two Concrete Bridges after More than 15 Years of Service

by Ali F. Al-Khafaji, John J. Myers, and Antonio Nanni

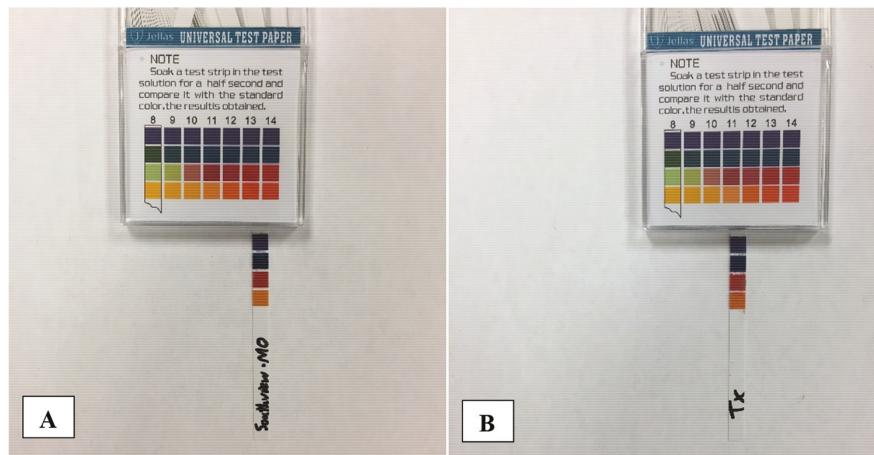
Fig. 8—pH test measurements: (a) Southview Bridge; and (b) Sierrita de la Cruz Creek Bridge.

Bridge	Cores ID	pH	Carbonation depth, mm (in.)	Chloride content, %
Southview	CM1	13	0 (0)	0.0033
	CM2	13	0 (0)	0.0094
Sierrita de la Cruz Creek	CT	11-12	13 (0.5)	0.0031

1. pH of concrete: For Southview Bridge, the pH level was 13 which is high for such a concrete (for example, for most bridge decks in the United States, a 6000 psi cement-based reinforced concrete). High pH indicates high OH and increases the chance for resin and fiber attacks. For Sierrita de la Cruz Creek Bridge, it was 11 to 12, which is within the normal range for such concrete.

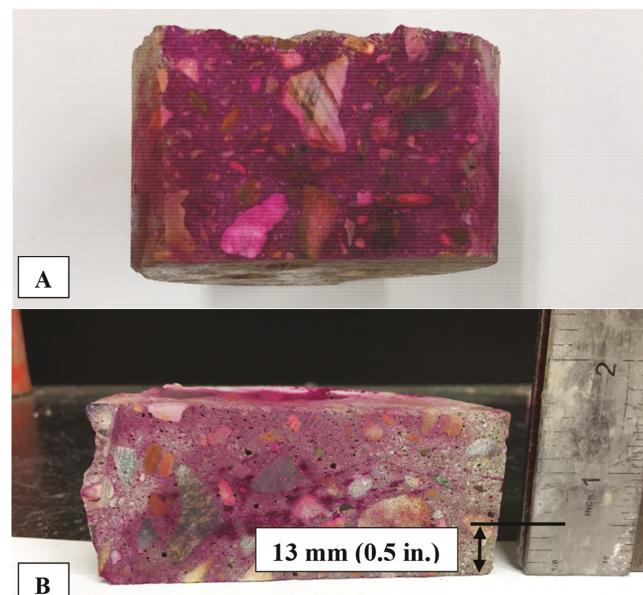
the resulting pH was relatively high for concrete of this age. Figure 9 and Table 2 show the carbonation depth results.

Fig. 9—Carbonation depth test: (a) Southview Bridge; and (b) Sierrita de la Cruz Creek Bridge.

2. Carbonation depth: Carbonation is something undesirable in reinforced concrete (RC) structures, as it can lead to corrosion issues. For Southview Bridge, the tests were conducted on different parts of the core and showed no significant depth of carbonation. For the Sierrita de la Cruz Creek Bridge, carbonation was present with depth of 13 mm (0.5 in.) from the weather-exposed surface. It is believed that it took place due to the alkaline environment surrounding the concrete.

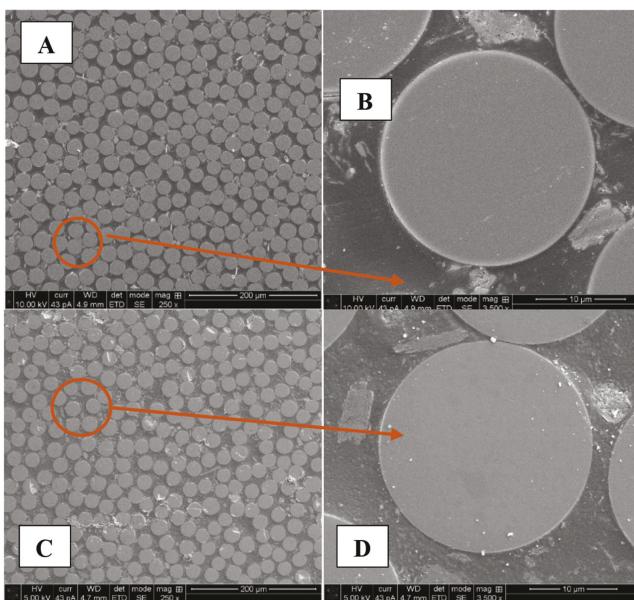
Fig. 10—SEM images of undamaged specimens: (a) Sierrita de la Cruz at 250 \times magnification; (b) Sierrita de la Cruz at 3500 \times magnification; (c) Southview at 250 \times magnification; and (d) Southview at 3500 \times magnification.

magnification grades were employed to examine not only the GFRP bars but also the interfacial transition zone (ITZ) between the concrete and GFRP bar. The main reason for the scanning was to see if there was any microstructural degradation in the GFRP bars and areas in the vicinity of concrete in terms of fiber and resin morphological changes and/or cracks. Images were taken from different locations in each specimen to give a comprehensive view of the specimen. The SEM images depicted that there were no microstructural degradations in fibers, resin, and the neighboring areas of the GFRP bars. Fibers were not damaged and no loss in the cross-sectional area of fiber took place. Furthermore, there was no bond loss between the fibers and resin, and there were no gaps at GFRP-concrete interface (Interfacial Transition Zone). Figure 10 shows representation of the scanned images. It is important to note that, in SEM analysis, sample preparation is very crucial and has a significant impact on the results, as lack of proper preparation may give false results. For example, exposing a specimen to high temperatures (over 55°C [130°F]) at the conditioning stage may result in gaps at the interfacial transition zone of GFRP and concrete. Furthermore, uncontrolled pressure at sand papering stage may damage cross section of fiber and leave dents in the matrix. Figure 11 shows an example of a damaged specimen. One good indication that the damage was due to preparation was that there were cracks all over the specimens and they were distributed evenly.

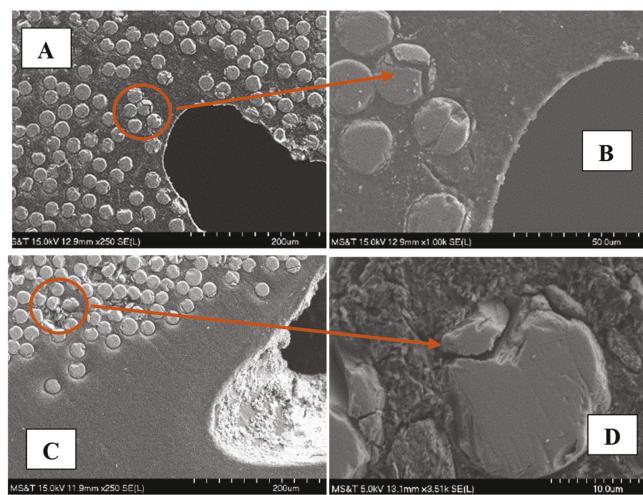
Fig. 11—SEM images of cracked specimens: (a) Southview at 250 \times magnification; (b) Southview at 3500 \times magnification; (c) Sierrita de la Cruz at 250 \times magnification; and (d) Southview at 3500 \times magnification.

4. Scanning electron microscopy (SEM): For both bridges, no microstructural degradation was found in the GFRP bars where the scanning was conducted. All fibers were complete, and the resin was properly and fully bonded to the fibers. Also, there was no loss in the cross-sectional area of fibers. In addition, the interfacial transition zone (ITZ) between the concrete and the glass fiber matrix was fully intact. However, cracks did appear in one specimen, but are believed to be due to the improper preparation of the sample.

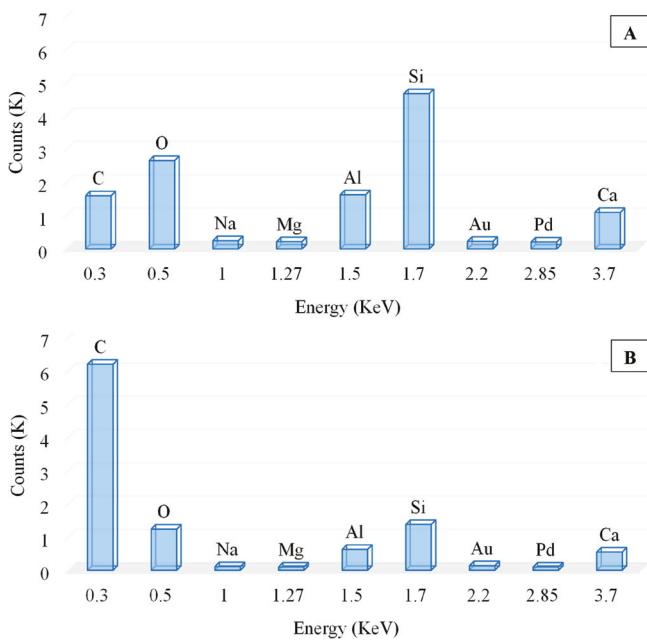
In both bridges, the fibers' chemical composition showed no signs of zirconium (Zr), therefore it confirms that the GFRP bars were not alkaline-resistant (AR).²⁴ Additionally, the main elements of fiber including Al, Ca, Si, Na, and O were found. Besides these elements, Mg was found too in both bridges and that indicates the GFRP bars were not ECR-glass.⁸ Elements such as Au and Pd were also detected in the resin and fiber, which is an indication for coating (gold sputtering) to make the surface of GFRP bar from non-conductive to semi-conductive, so the SEM and EDS apparatus can work. For the resin matrix, the main element, C, was found in both bridges. In Sierrita de la Cruz Creek Bridge, alkaline elements such as Na, Mg, Al, and Ca were found in the resin. In addition, Si was found too. The appearance of alkaline and Si in resin are not welcomed, as their existence can be an indication for alkali-hydrolysis attack and a leaching problem.²⁴ However, in Sierrita de la Cruz Bridge, these elements were found in the control bars too, therefore there is a significant chance that these observed elements were part of filler. Figure 12 shows the EDS results

Fig. 12—EDS analysis of Sierrita de la Cruz Creek Bridge: (a) fiber; and (b) resin.

of the fiber and resin of Sierrita de la Cruz Creek Bridge. Additionally, and to support this claim, the pH of the bridge was not even high enough to induce alkali-hydrolysis attack. Furthermore, carbonation depth was observed, and thus, these signs moderately confirm that these elements were part of the filler of GFRP bar. In Southview bridge, alkaline elements and Si were found in the resin as well. The difference this time from Sierrita de la Cruz Bridge is that the tested pH of Southview Bridge was high, and carbonation was not observed. Additionally, Na was observed only in the resin. Thus, the appearance of Na and Si in the resin can clearly indicate to an alkaline-hydrolysis attack and leaching problem. To contrast, Si sometimes is used as part of a filler in resin. Bank et al.²⁵ stated that the existence of Al, Si, and PO₄₃⁻ in the resin matrix is a sign of a filler. These two elements, Al and Si, and one compound, PO₄₃⁻, form a filler called alumino-silicate phosphate (ASP). Each of Al, and Si were seen in the resin, but there were no signs for the PO₄₃⁻. Therefore, to make sure these alkalis and Si from alkalis attack, FTIR test was carried out to observe the level of OH in the resin matrix. EDS results of Southview Bridge are shown in Fig. 13.

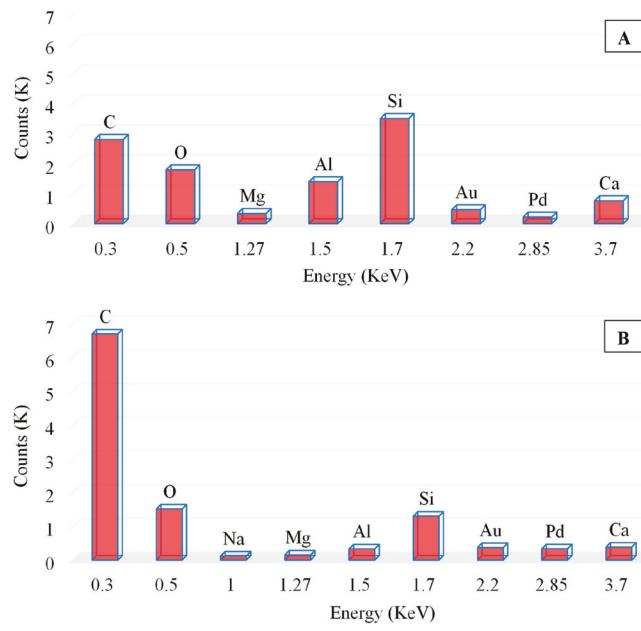
Fig. 13—EDS analysis of Southview Bridge: (a) fiber; and (b) resin.

results of Southview Bridge showed significant signs for alkali-hydrolysis attack as Na was found only in the resin. Also, Si was detected in the tested resin as well which it can be taken as a clear sign for leaching.

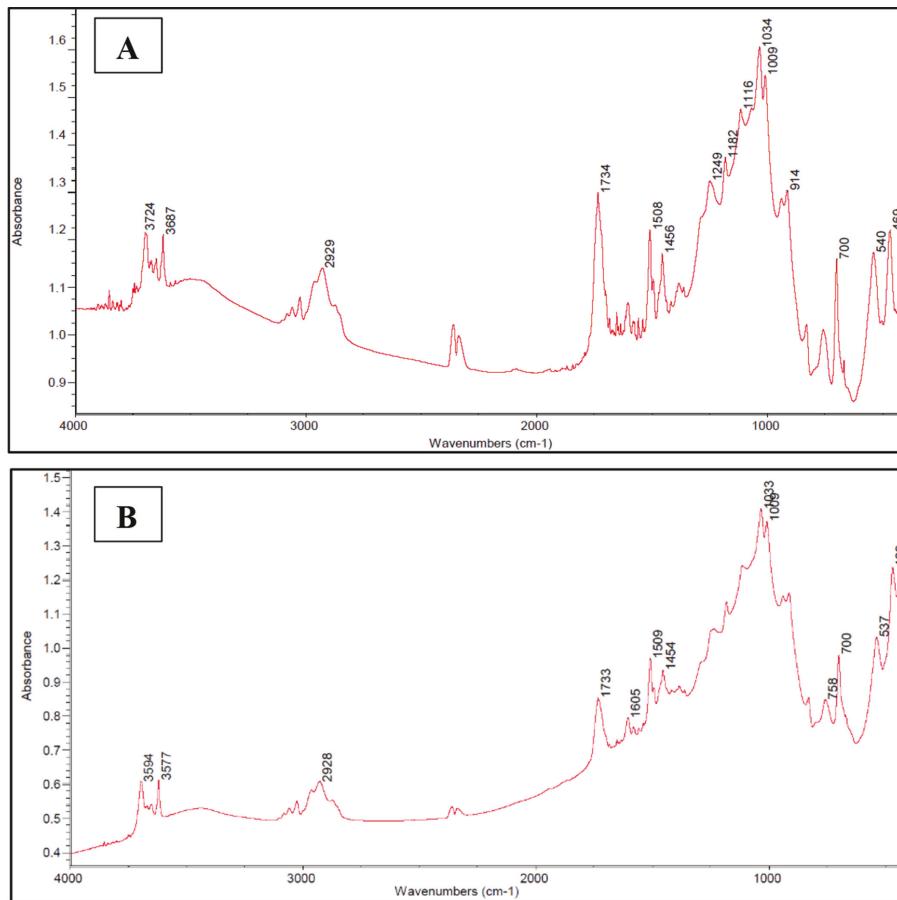
In the Southview Bridge, OH was found to be a little over 3700 cm⁻¹, which now clearly indicates that alkali-hydrolysis and leaching were taking place. Regarding Sierrita de la Cruz Creek Bridge, OH was found to be approximately 3600 cm⁻¹, which met the normal range of OH group. It was anticipated to be on the high side, because even though carbonation was found when its concrete was tested, the pH test was not lower than 11. Representative results are shown in Fig. 14.

Fig. 14—FTIR analysis of: (a) Southview Bridge; and (b) Sierrita de la Cruz Creek Bridge.

6. Fourier transform infrared spectroscopy (FTIR): In Southview Bridge, the results showed that the spectra of the OH group was high (slightly over 3700 cm^{-1}) which confirms that the alkalis elements found in EDS test of resin were from alkali-hydrolysis attack. For Sierrita de la Cruz Creek Bridge, the results were within the normal range at approximately 3600 cm^{-1} . Also, it was expected to be normal as the pH test was not high.
