Performance of externally bonded fiber-reinforced polymer retrofits in the 2018 Cook Inlet Earthquake in Anchorage, Alaska

Earthquake Spectra
I-30

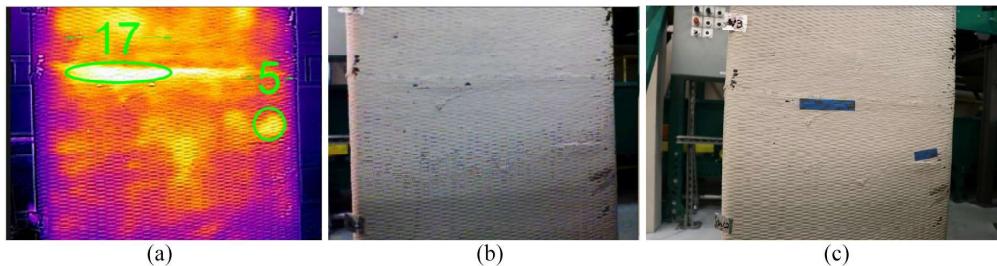
Figure 2. Example infrared thermography and acoustic sounding results on a section of the column: (a) IR image overlapped with photography from FLIR camera (dimensions in cm), (b) photograph of the same area with FLIR camera, and (c) debonded areas marked with blue painter's tape after acoustic sounding. This figure shows a good visual match between the IR thermography and acoustic sounding results.

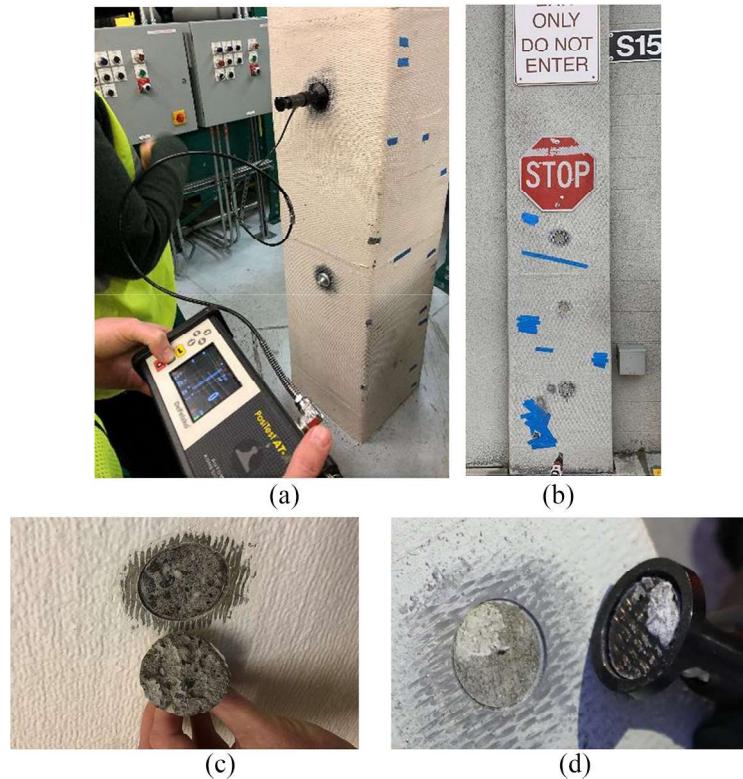
Figure 4. (a) An example of the bond pull-off test setup, (b) a column after bond-pull-off tests and typical bond pull-off test failure modes such as (c) Mode G, cohesive failure mode in concrete and (d) Mode E, interfacial adhesive failure mode.

Classification of failure modes from pull-off tests in aged field samples requires some discretion and engineering judgment due to the uncertainties associated with the application of EBFRP in the field. Some sources of variability include uneven application of paste epoxy tack coat or putty (which can be mistaken for concrete/mortar) during EBFRP installation, non-uniform surface preparation or complete lack thereof, entrapped air bubbles along the EBFRP-concrete bond line, substrate composition (e.g. concrete vs repair mortar), and variations in surface wetting with the epoxy adhesive. As Mode G is a desired failure mode indicating sound adhesion between EBFRP and substrate, one expects this failure mode to manifest itself with the following: (1) a large amount of sand and/or aggregate particles on the fractured surface and (2) a thickness of the pulled-off material that exceeds the thickness of the composite and adhesive layer by a few millimeters, at a minimum. To avoid undue confusion, any bond failure mode that did not satisfy the described two criteria was classified as an interfacial adhesive failure mode (Mode E).

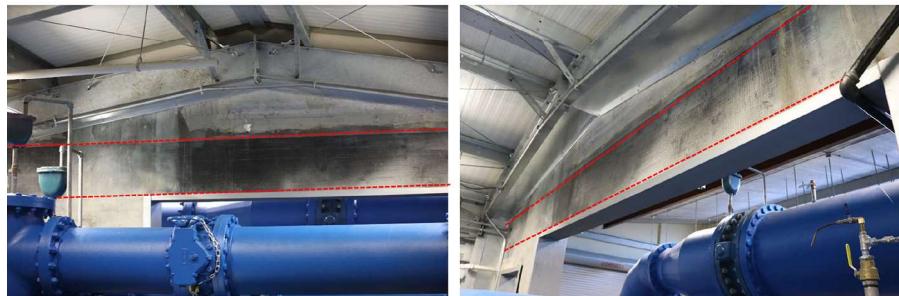
Figure 5. CFRP applied around the perimeter of the portal as denoted by red dotted lines.

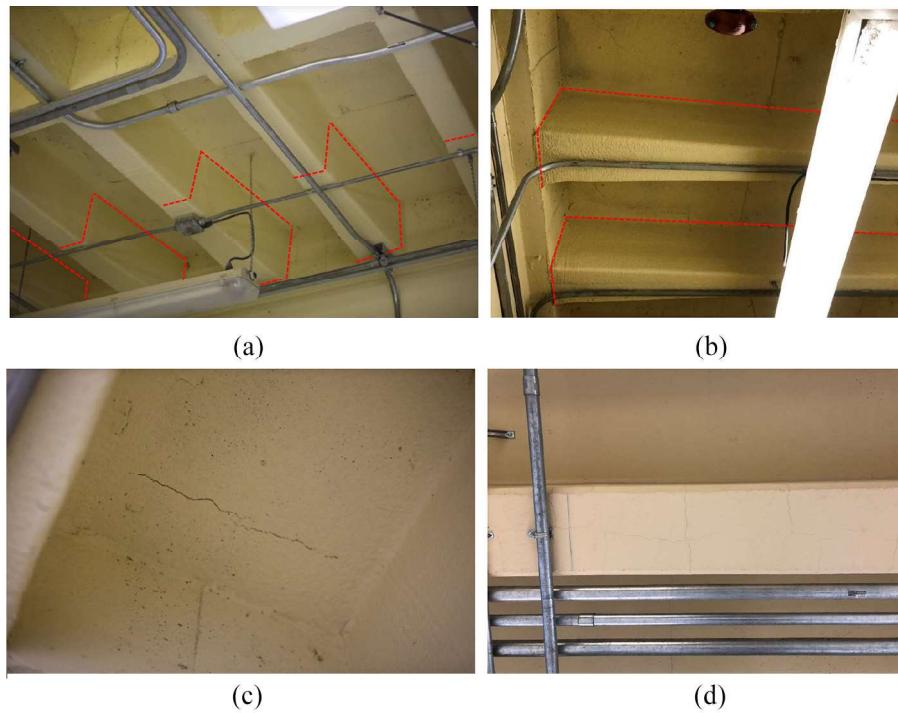
In the water treatment facility, CFRP was applied to increase the shear strength of joists in several rooms. Some hairline cracks were observed in the roof slab supported by the joists (Figure 7c), but it is not known whether those cracks existed before the earthquake. According to the building owner, some cracks observed in the joists (Figure 7d) existed prior to the earthquake. These cracks were likely caused by restrained shrinkage and/or temperature gradients. In addition, no damage to the CFRP or cracks traversing from uncovered concrete to areas with CFRP were observed. In addition, acoustic sounding of multiple joists revealed no defects.

Figure 7. (a and b) Beams retrofitted with CFRP as denoted by dotted red lines, (c) cracking in the supported roof slab, and (d) minor cracking in a beam that was not FRP retrofitted.

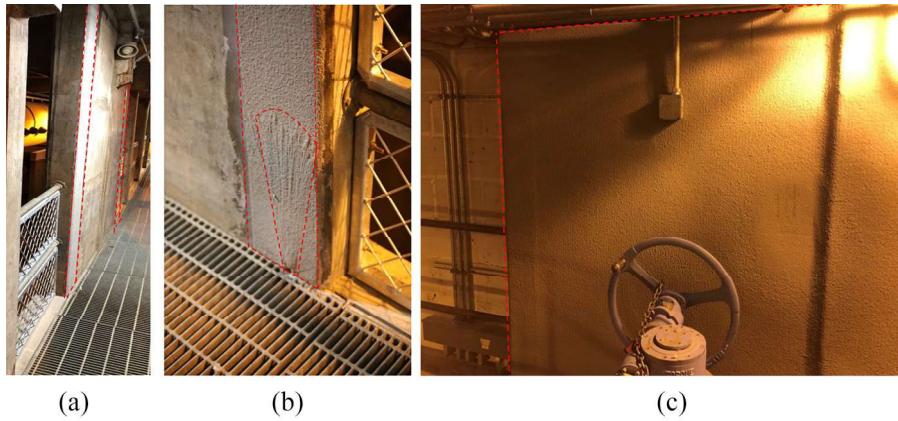
Figure 8. (a) Boundary element with CFRP denoted with a red dotted line, (b) boundary element with CFRP anchored with a splayed fiber anchor where CFRP and anchor perimeter are marked by red dashed line, and (c) a horizontally wrapped GFRP shear wall denoted with a red dotted line wrapped 30 cm behind this wall for confinement.

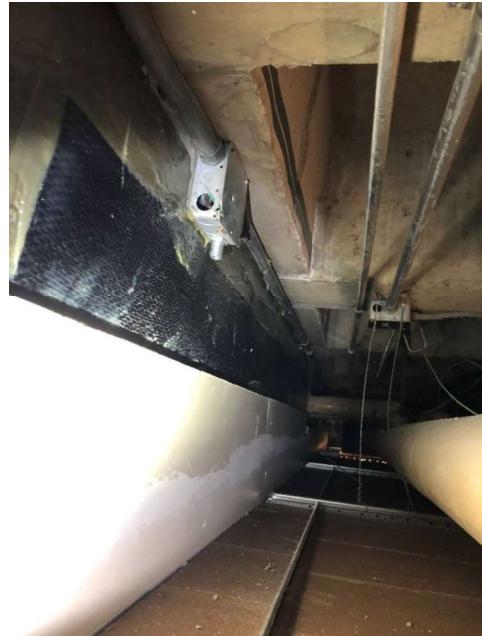
the walls. Most of the CFRP-retrofitted shear walls in the courthouse were covered with paint, grout, drywall, or paneling. The one CFRP retrofit that the team was able to look at was accessed through the ceiling grid (Figure 9). No earthquake damage was observed on the side of the walls retrofitted with EBFRP. In multiple one-sided retrofitted walls, hairline cracks were observed on the non-retrofitted side, but it is not known whether or not those cracks existed before the earthquake. This observation illuminated the need for inspection tools that can assess the condition of the concrete underneath the CFRP.

Figure 9. CFRP retrofit above ceiling grid covered by drywall panels at Boney Courthouse.

- Most EBFRP retrofits are covered with non-structural panels making it difficult to assess the condition of EBFRP. This is problematic because it could lead to reliance on potentially ineffective retrofits. Future research should develop and implement self-sensing methods and non-destructive techniques that will allow to properly assess the condition of EBFRP covered by non-structural components following extreme events (such as earthquakes). In addition, access panels to EBFRP retrofits would help inspectors following seismic events and for long-term inspection of durability.

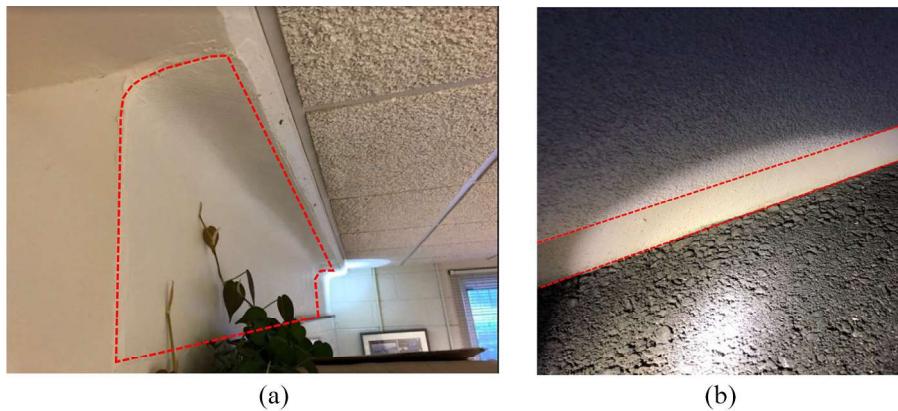
At Joint Base Elmendorf–Richardson (JBER), the Engineering Squadron building was inspected. Based on the visual inspection and information provided by building owners, location of the EBFRP-strengthened members was determined. A single interior beam was CFRP-retrofitted on one side to improve the shear transfer capacity between the beam and the masonry wall (Figure 10a). This CFRP retrofit was added when nearby interior shear walls were removed. Steel bracing was used throughout the rest of the building for seismic bracing. No damage was observed in the retrofits inside of the buildings. On the outside of the building, roughly half of the masonry walls were retrofitted with CFRP but were covered with stucco. These CFRP retrofits extended into the foundation for improving the shear transfer between walls and the foundation (Figure 10b). Some painted CFRP retrofit was exposed near the foundation and no apparent damage to it was observed. The backside of the CFRP-retrofitted walls on the interior of the building were in good condition with no apparent damage.

Figure 10. CFRP application (a) to transfer shear between the reinforced concrete beam and the wall, and (b) to transfer shear between the outer wall and the foundation. CFRP retrofits are denoted by a red dotted line.

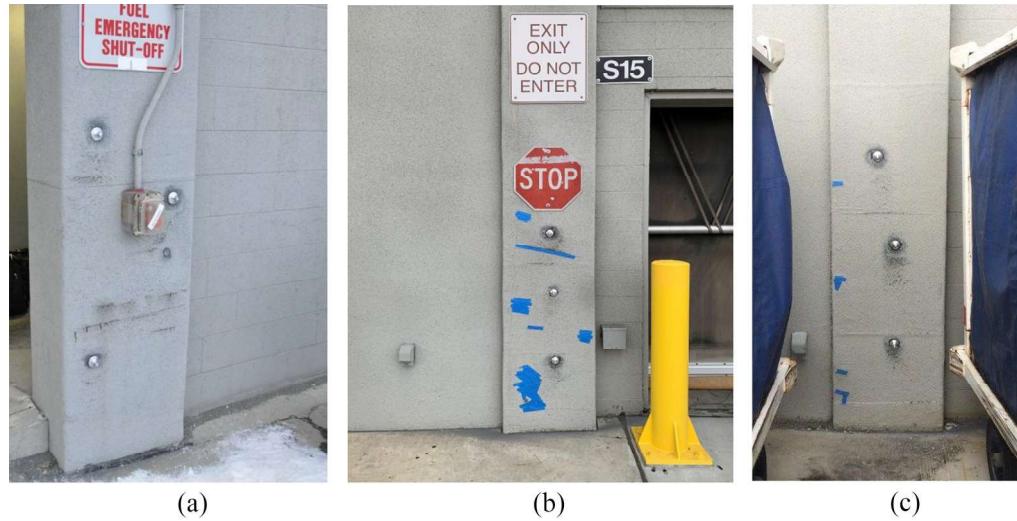
Visual inspection—exterior columns. Three exterior columns retrofitted with CFRP, measuring 60 cm × 60 cm in cross-sectional dimension, on the south side of TSIA were also inspected (Figure 11). These three columns were entirely or partially wrapped with two to three plies of CFRP to be able to sustain the imposed design demands. Exterior column #1 was located adjacent to a wall, so the CFRP retrofit on three sides of the column was

Figure 11. Exterior columns (a) #1, (b) #2, and (c) #3 at TSIA.

exposed (Figure 11a). Overlap splices between CFRP wraps were approximately 2.5 cm. The column had a cement-like protective coating and demonstrated signs of impact damage from vehicles or luggage, owing to its location near a baggage handling area. No obvious signs of earthquake damage were observed. Exterior columns #2 and #3 were positioned between two walls, with only one face of their CFRP retrofits exposed. Debonded areas were identified by acoustic sounding on columns #2 and #3 and were marked with a blue painter's tape (Figure 11). Column #1 was also evaluated by IR thermography (see section "CFRP debonding"). Three bond pull-off tests were conducted on each column and discussed in the section "Bond pull-off test results."

CFRP debonding. IR thermography combined with acoustic sounding was used on the interior column and exterior column #1. Exterior columns #2 and #3 were evaluated for debonding by acoustic sounding only. The quantitative results for these four columns are summarized in Table 2. Data indicate that debonding was more severe for the exterior columns #1 and #2 than the interior column and exterior column #3 (Table 2). The debonded areas on the interior column were within the size range (between 1300 and 16,000 mm²) that should be repaired by resin injection, per ACI 440.2R. Five out of eleven debonded areas on the exterior columns #1 and #2 exceeded the area of 16,000 mm² which, per ACI 440.2R, should be repaired by cutting out the affected sheet and applying an overlapping CFRP patch at the top of it. Exterior column #3, by contrast, had a few debonded areas that were of relatively small size, similar to those observed on the interior column.

In the pull-off test experiments conducted on exterior columns #1 and #2, the failure surface was not flat, pointing to possible bond degradation or inconsistencies in initial surface preparation. The occurrence of Mode E and low bond pull-off strength values were in good correlation with the debonding observed with acoustic sounding and IR thermography on exterior columns, which implies that CFRP retrofits on exterior columns #1 and #2 were likely affected by environmental degradation or inconsistent surface preparation. It should also be noted that immediately following the pull-off experiments on exterior column #2, a damp concrete surface was noted underneath the retrofit, which indicated that moisture was accumulating in the underlying concrete substrate (this was not observed on exterior column #1 in January during low temperature conditions). The observed dampness further suggests that environmental effects from freeze-thaw may have contributed to the low pull-off strength, if not being completely responsible for poor adhesion between CFRP and concrete on this column. Interestingly, exterior column #3 was an anomaly as all three bond pull-off strength values on exterior column #3 exceeded the load capacity of the adhesion tester and passed the minimum ACI bond strength requirements. Although columns #2 and #3 similarly had one face on the interior and the other one on the exterior of the building, the different pull-off test strengths could be due to possible differences in

moisture transport from the interior of the concrete to the exterior EBFRP/concrete interface at different locations in the building. Moisture transport from the interior of the concrete could occur from temperature gradients that form between the interior and exterior of the concrete (depending on the level of concrete insulation), which could lead to condensation below the dew point and subsequent moisture transport to the EBFRP/concrete bond. Capillary transport of moisture from the soils below the concrete to the EBFRP/concrete bond may also have occurred. In both cases, moisture build-up at the EBFRP/concrete interface can lead to expansion and internal stress at the interface during freeze-thaw. While the source of moisture in column #2 cannot be definitively determined based on the available information, it is possible that moisture transport from the building interior at exterior column #2 location was more severe than in exterior column #3, leading to accelerated CFRP-concrete bond deterioration. Furthermore, exterior column #2 and exterior column #1 both had signs and non-structural components attached with bolts that went through the CFRP and may have led to exterior water ingress that would not be present in exterior column #3. Inconsistent surface preparation may have created voids at the EBFRP/concrete interface, which became locations where moisture transport from the concrete occurred. Cracks or debonded areas at the EBFRP/concrete interface, formed from differences in thermal expansion of concrete and CFRP at low temperatures, may have also provided additional sites of moisture transport from the concrete. In both scenarios, freeze-thaw expansion stresses of moisture may have contributed to the low pull-off strengths and Mode E failures on exterior columns #1 and #2.

Although installation procedures, location, and environmental conditions were similar for exterior column #3 and exterior columns #1 and #2, bond pull-off test results were in significant disagreement, which poses concerns regarding the ability of the ASTM D7522 test method to adequately assess quality of bond by sampling locations selected at random. This issue could potentially lead to different retrofit or repair decisions depending on the selected structural component and the location of the pull-off test on the retrofitted component. Further guidance on the number of pull-off tests and locations of the test, especially since the pull-off test is so localized, are needed for clearer assessment of bond strength and failure mode. Although columns are contact critical, the failure modes were often not Mode G in bonded areas and pull-off tests are the only real means of assessing bond strength and bond failure modes. Thus, records of initial pull-off tests should be maintained as a baseline for comparison to pull-off tests conducted during inspection of EBFRP retrofits used in service over the long term to adequately assess durability concerns for both contact-critical and bond-critical applications.

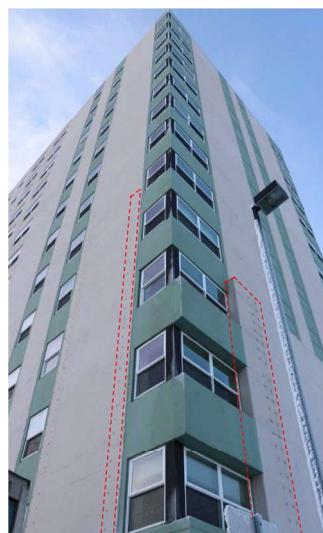
Visual inspection. No apparent earthquake damage to the EBFRP retrofits was observed in the post-earthquake inspections (Figure 12). However, like other inspected structures, most of the retrofitted structural components were not directly accessible as they were covered with nonstructural elements or architectural features. A few interior columns were identified as having exposed GFRP. Exterior GFRP and poorly epoxy-saturated carbon fibers on the North and South side of MKT, which manifested itself with readily apparent exposed dry fibers; fully saturating EBFRP with epoxy during wet layup in the field is known to be a common challenge and can possibly contribute to debonding (Figure 13a and b). Premature debonding is one of the main drawbacks of EBFRP-retrofitted systems and significant research effort has been made to develop effective anchoring using EBFRP spike anchors. Similar to EBFRP sheets installations, installation of EBFRP anchors depends on the skill of the installer and is critical for adequate performance (del Rey Castillo and Kanitkar, 2020; Grelle and Sneed, 2013). The authors also reported that inadequate fiber saturation can significantly affect the effectiveness of EBFRP-strengthened system. Exposed retrofits at MKT were evaluated for debonding by acoustic sounding. Quality of bond between EBFRP and concrete was assessed by bond pull-off tests.

Figure 12. Boundary elements confined with EBFRP and bolts on MKT, marked by red dashed lines.
