# Liquefaction and Related Ground Failure from July 2019 Ridgecrest Earthquake Sequence

#### **ABSTRACT**

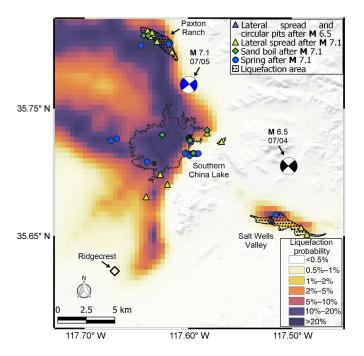
**Figure 4.** Map of the Indian Wells Valley, observed liquefaction features, and USGS near real-time liquefaction hazard map. The color version of this figure is available only in the electronic edition.

Figure 4 shows the near real-time liquefaction probability map produced by USGS following the M 7.1 mainshock. The map predicts high probability of liquefaction within China Lake, the Salt Wells Valley, and in the Paxton Ranch area. The spatial distribution of liquefaction surface manifestation in these regions seems to be consistent with the prediction of the liquefaction hazard map. In these areas, the predicted probability of liquefaction ranges between 5% and 20%. In the western portion of Figure 4 and Figure S19, west of China Lake, the predicted probability map does not appear to be consistent with our on-ground and overflight observations.

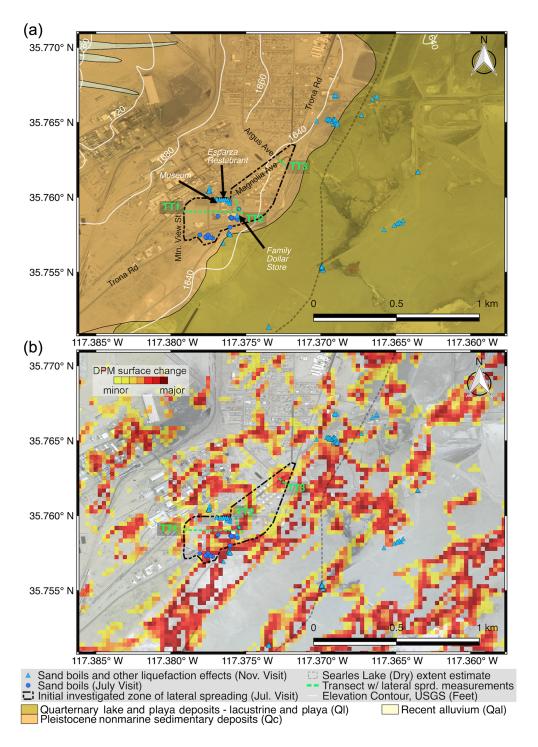
Figure 5 shows locations of observed liquefaction features (sand boils and cracks in hardscape and paving) in Trona and a portion of Searles Lake. Sand boils were encountered along the southern edge of Trona near the northern margin of Searles Lake (e.g., Fig. 6a). Sand boils frequently occurred at discontinuities on the ground surface such as pavement edges, utility fixtures, pre-existing cracks (prior to earthquake sequence), and developed cracks (created as a result of the earthquake sequence). Examples of these various sand boil features are available in the accompanying supplements as well as Brandenberg et al. (2019) and Brandenberg, Stewart, et al. (2020).

**Figure 5.** Map of Trona showing locations of observed liquefaction effects and lateral spreading measurement transects overlayed on (a) surface geology map and (b) DPM. Geologic units are labeled following descriptions from Smith (2009). Areas without indications of ground failure within investigated zone were inspected and hence are confirmed no ground-failure zones. The color version of this figure is available only in the electronic edition.

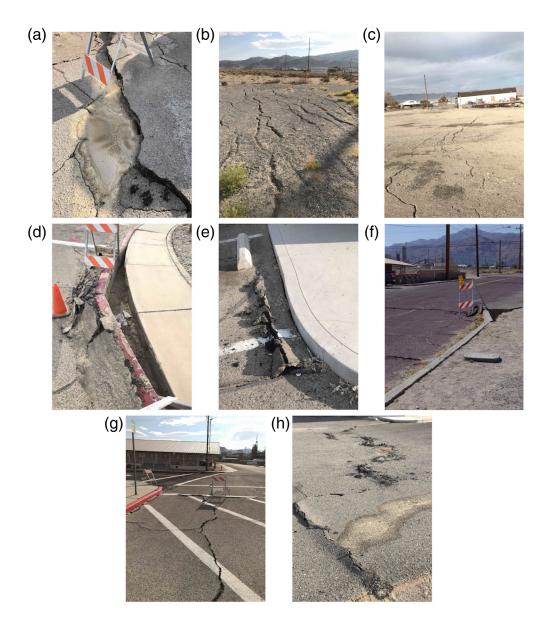
Ground cracks caused by extensional strain due to lateral spreading were apparent near the sand boils and throughout the investigated region (Fig. 6b,c,g). The orientation of the extensional cracks was variable. Many cracks trended toward the northeast, parallel to the lake perimeter, but other cracks

**Figure 6.** Ground failure from liquefaction in Trona. (a) Sand boil along a pavement crack created from lateral spreading (35.757483°, -117.37806°). (b,c) Extensional cracks caused by lateral spreading (35.757325°, -117.377705°; 35.75966°, -117.375892°). (d,f) Damaged asphalt from buckled curb edge (35.75936°, -117.37676°; 35.762387°, -117.372586°). (e,h) Compressional features from lateral spreading (35.75897°, -117.37561°; 35.75909°, -117.37552°). (g) Compressional and adjacent extensional features caused by lateral spreading and ground oscillation (35.75986°, -117.37651°). The color version of this figure is available only in the electronic edition.

the ground-failure region and ending at the Family Dollar parking lot. Transect TT2 is approximately 122 m long with elevations (from Google Earth Pro) that range from 503 – 500 m AMSL (north to south-southeast), indicating an average gradient of approximately 2.3%. As shown in Figure 7, the sum of the ground crack widths measured along TT2 is 71 cm. Example images of ground cracks along Transect TT2 are shown in Figure 6c.

the intersection of Argus Avenue and Trona Road. Transect TT3 is approximately 53 m long, and the elevation difference (from Google Earth Pro) is estimated as 2 m, indicating an average ground-surface slope along the transect of approximately 4%. The sum of the ground crack widths measured along TT3 is 45 cm. Example images of ground cracks along Transect TT3 are shown in Figure 6f.

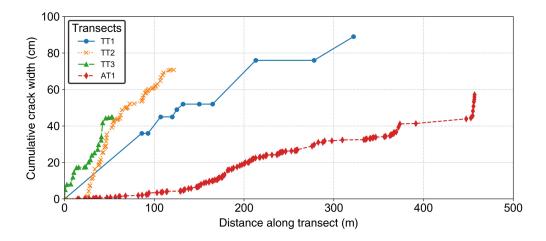
Field mapping to record locations of cracks and approximate crack widths were performed along three transects in Trona (shown in Fig. 5). Transect TT1 was initiated at Mountain View Street, ultimately ending near the northeast corner of the Family Dollar store. Transect TT1 is approximately 325 m long with elevations (from Google Earth Pro, see Data and Resources) that range from 506 to 501 m AMSL (west to east), indicating an average ground-surface slope along the transect of approximately 1.6%. Figure 7 shows cumulative crack width versus distance along the transect. The sum of the ground crack widths measured along TT1 is 89 cm. Example images ground cracks Transect TT1 are shown in Figure 6h. We acknowledge that the sum of crack widths along a transect, as shown in Figure 7, may underestimate

**Figure 7.** Cumulative crack width along transects in Trona and Argus. Transection locations are shown in Figures 5 and 8. The color version of this figure is available only in the electronic edition.

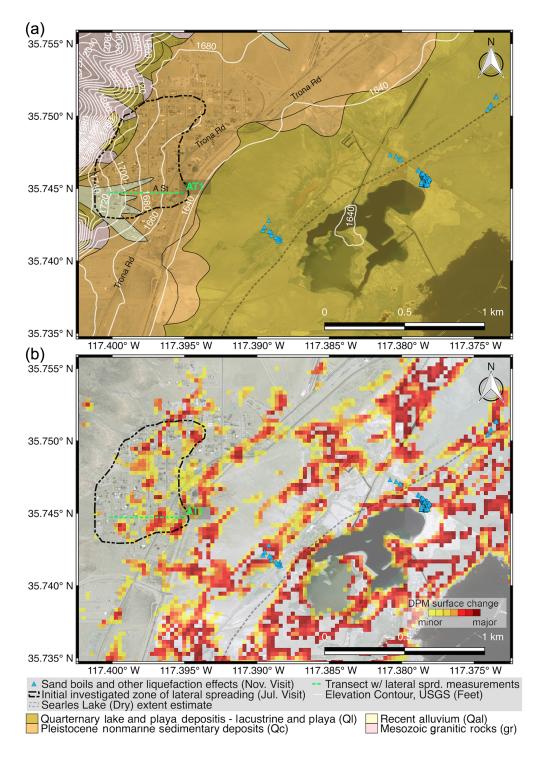
Liquefaction-related features were also observed in Argus (Fig. 8). The ground surface in the area shown as experiencing liquefaction has a gentle slope (~5%). The ground surface exhibited extensional cracks ranging from less than a millimeter to approximately 10 cm in width. The lateral spreading features became less frequent with proximity to the hills west of

Whereas in Trona the documented lateral spread features were collocated with or nearby sand boils or other liquefaction surface manifestations, ejected material was not observed in Argus. Figure 8b shows transect AT1 along with the DPM produced following the earthquake sequence. At the intersection of A Street (AT1 transect) and Trona Road, nonzero damage proxies occur toward the southwest of the transect. At this location, the DPM helps identify the edges of this lateral spread feature.

**Figure 8.** Map of Argus showing locations of observed liquefaction effects and lateral spreading measurement transects overlayed on (a) surface geology map and (b) DPM. Geologic units are labeled following descriptions from Smith (2009). Areas without indications of ground failure within investigated zone were inspected and hence are confirmed no ground-failure zones. The color version of this figure is available only in the electronic edition.

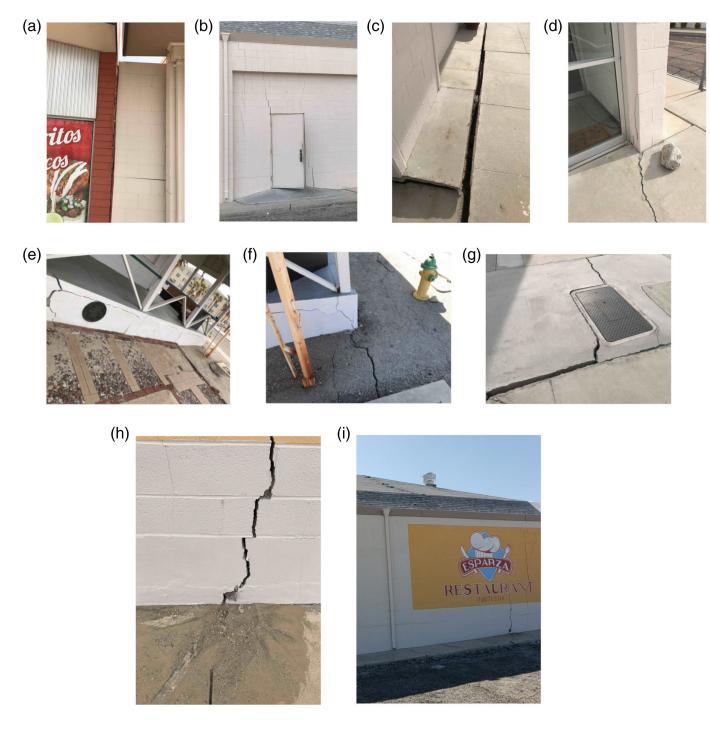
Structures in the Towns of Trona and Argus appear to have been affected by liquefaction-induced ground failure and movement, primarily from lateral spreading. Figure 9 shows examples of buildings that experienced damage in Trona, some of which may have been liquefaction related. Figure 9a shows a 2.5 cm wide crack in the wall connecting the Esparza Restaurant and the adjacent building that occurred as a result of lateral spreading in combination with ground shaking.

Figure 9b shows wall cracks on the eastern side of the Esparza Restaurant that has misaligned the door frame and caused the door to remain ajar. Figure 9c,d shows significant displacement and cracking of a sidewalk due to lateral spreading (there is a 0.5 L plastic bottle within the crack in Fig. 9c). Figure 9e,f shows structural damage in the form of large cracks in the floor slab of a museum due to lateral spreading, whereas Figure 9d shows a compressional crack in a sidewalk, along with damage to the adjacent building column. Figure 9h shows the

Esparza Restaurant, which experienced wall cracks from lateral spreading in the M 6.5 event that were widened in the M 7.1 event, which the GEER team photographed after each event. It is possible that some of the observed cracks predated the earth-quake sequence and were subsequently widened by the earth-quake. The crack shown in Figure 9h on the eastern wall of the Esparza Restaurant building continued up to the roof, and the roof diaphragm was pulled apart, as shown in Figure 9i. Apparent effects of liquefaction on structures also occurred in Argus where structures that were heavily damaged were located on or near the alluvial fan, which exhibited evidence of lateral spreading in the form of tension cracks. Structural damage took the form of chimney separations from buildings, masonry cracks from extensional movements, toppled walls, and punch through in retention walls (Stewart et al., 2019).

**Figure 9.** Ground failure effects on buildings in Trona. (a) Crack at screen wall between two buildings (35.75979°, -117.376315°). (b,h,i) Wall cracks at the eastern side of the Esparza Restaurant with associated sand ejecta and roof damage (35.75957°, -117.37611°). (c,d,g) Sidewalk pavement crack and offset likely from lateral spreading and ground oscillation (35.75982°, -117.37637°; 35.75978°, -117.37658°; 35.75980°, -117.37606°). (e,f) Cracks in floor slab from lateral spreading and ground oscillation (35.759802°, -117.376808°). The color version of this figure is available only in the electronic edition.

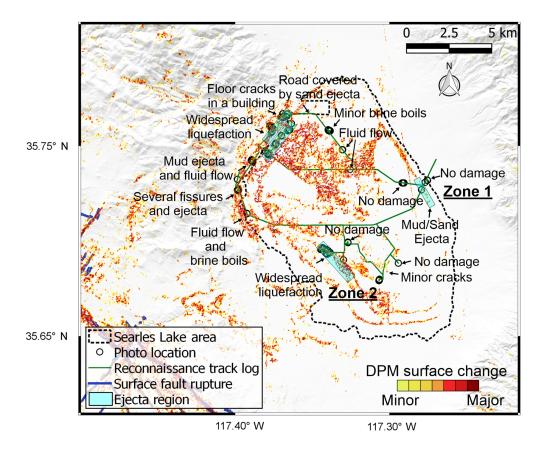
**Figure 10.** DPM produced following the **M** 7.1 event, route of the November 2019 reconnaissance mission, geotagged photo locations, and reconnaissance findings. The color version of this figure is available only in the electronic edition.

Observations at Searles Lake confirmed ground deformation patterns reported in the DPM. Zones 1 and 2 in Figure 10 represent clear examples of DPM true positives (areas where nonzero damage proxies are present and ground-failure features are observed). True positives from the DPM were also observed in the area immediately southwest Trona and at the southwest edge of the lakebed. Some spot checks were performed to

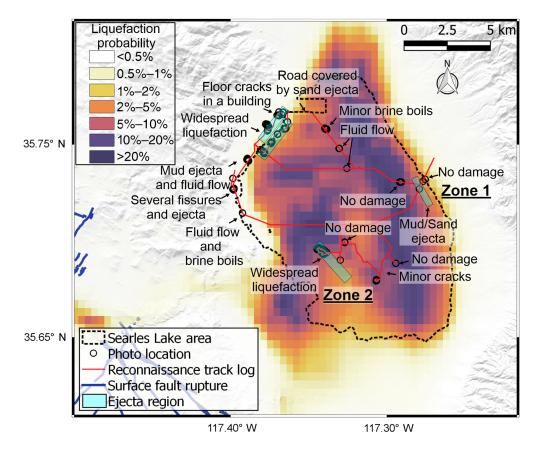
The USGS liquefaction hazard map predicts liquefaction in the lakebed region, but the actual observed deformation patterns are not consistent with the map. The mismatch is especially pronounced along the margin of the lakebed in which liquefaction was observed at various locations, but predicted liquefaction probabilities are low. False positives were also observed in the USGS liquefaction hazard maps. At two of the four locations labeled as "No damage" in Figure 11 (west of Zone 1), the USGS liquefaction hazard map predicted a

**Figure 11.** USGS liquefaction hazard map produced following the **M** 7.1 event, route of the November 2019 reconnaissance mission, geotagged photo locations, and reconnaissance findings. The color version of this figure is available only in the electronic edition.

relatively high probability of liquefaction of  $\sim$ 10%. This map correctly predicted a low (1%–3%) probability of liquefaction at a location east of zone 1, where no damage was observed.

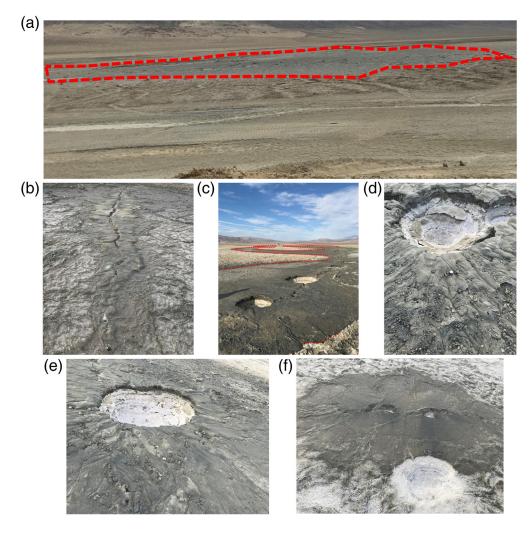
Figure 10 shows the track log from the reconnaissance and locations of geotagged photos. Figure 10 also provides an overview of the reconnaissance findings. Figure 12a shows a photo of the central zone of the eastern edge of the lake (zone 1 in Fig. 10). This photo was taken from the road located southwest of the linear damage zone highlighted by the DPM. It shows a relatively narrow (about 110 m wide) zone covered by grayish ejecta with different coloration than surrounding material.

Massive liquefaction was observed near the southwest edge of the lake (labeled zone 2 in Fig. 10). Thousands of sand boils (Fig. 12c), ground fissures and cracks (Fig. 12d), and abundant sand, gravel (Fig. 12d,e), and brine-evaporite ejecta (Fig. 12f), were observed along the relatively narrow northwest-southeast line depicted on the DPM. We use the term brine-evaporite to indicate that after the brine fluid was ejected onto the surface, evaporites precipitated out of the solution, as it evaporated. Figure 12f shows a sand boil entirely covered by a thin brine-evaporite layer. This sand boil covers an area containing sand from two smaller (and older) boils. Two hypotheses can be formulated to explain this phenomenon: (1) both manifestations occurred during the same event—the smaller sand boils were caused by liquefaction occurring in a more surficial layer, whereas the brine boil occurred in a deeper layer, or (2) the two liquefaction manifestations were triggered by separate events. The correct hypothesis cannot be identified from the available data, because reconnaissance was performed following the major events in the earthquake sequence. Within zone 2, the USGS liquefaction hazard map predicts a probability of liquefaction ranging between 5% and 8%.

**Figure 12.** (a) Narrow liquefaction ejecta zone located in the central portion of the northeast edge of Searles Lake (35.72701°, -117.27801°). (b–f) fissures, sand boils with sand, gravel, and brine–evaporite ejecta observed toward the southwestern edge of the lake (35.694858°, -117.339622°; 35.6955°, -117.34235°; 35.695913°, -117.34113°; 35.695208°, -117.340462°; 35.695217°, -117.341072°). The color version of this figure is available only in the electronic edition.
