# The impact and resolution of the GPS week number rollover of April 2019 on autonomous geophysical instrument platforms

Shane Coyle<sup>1</sup>, C. Robert Clauer<sup>1,2</sup>, Michael D. Hartinger<sup>3</sup>, Zhonghua Xu<sup>1,2</sup>, and Yuxiang Peng<sup>1</sup>

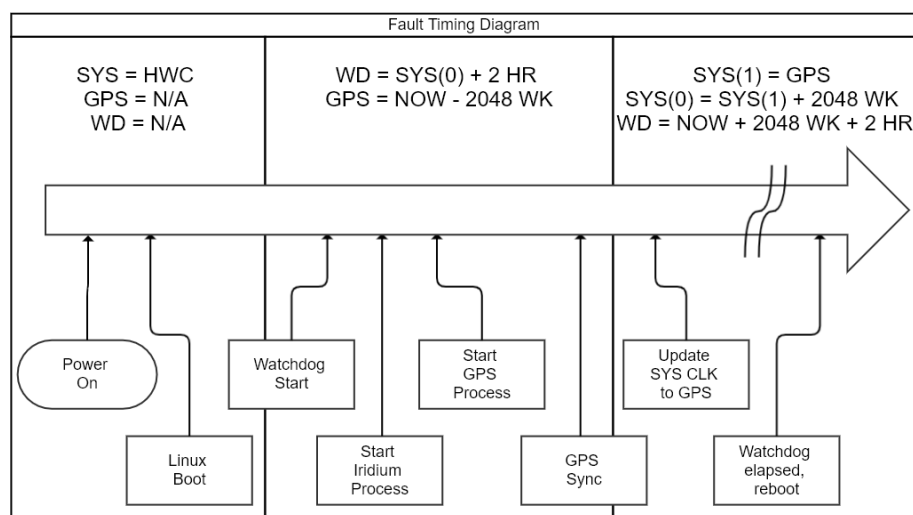
During simulated operational testing of the hardware on-site in Blacksburg, VA, it was determined that the GPS module was providing an erroneous date and time. A constant negative offset of 2048 weeks was found, which is consistent with the GPS rollover period. Further analysis discovered the source of the communications fault, which occurs as a result of updating the system time while an active communications link is established. A communications watchdog is supposed to monitor unusual circumstances relating to “hung” or stalled communications links, but the watchdog relies on the system clock and is effectively disabled because of the bug. The process of determining how much time has elapsed between successful communications attempts is a simple subtraction of a watchdog start time from the current system clock time. However, when the system time went through its update process, it set the system clock back 19 years, and the subtraction to determine the elapsed time yielded a negative result. In the case of the AAL-PIP watchdog, an elapsed time of 2 h without successful communications will trigger the watchdog. For the bugged negative result to ever reach that threshold after the fault occurs would take 19.6 years and 2 h. This process of updating clocks and watchdogs is illustrated in Fig. 2.

**Figure 2.** Diagram showing the process of updating the multiple clocks on an AAL-PIP. After the Linux OS finishes initialization, the AAL-PIP software sets the watchdog (WD) timer and spawns separate processes for communication and GPS synchronization. In this diagram,  $SYS(0)$  refers to the value of the system clock after boot, whereas  $SYS(1)$  is the system clock value after GPS sync. The fault occurs in block three, where the system clock  $SYS(1)$  is set to the erroneously offset GPS time.

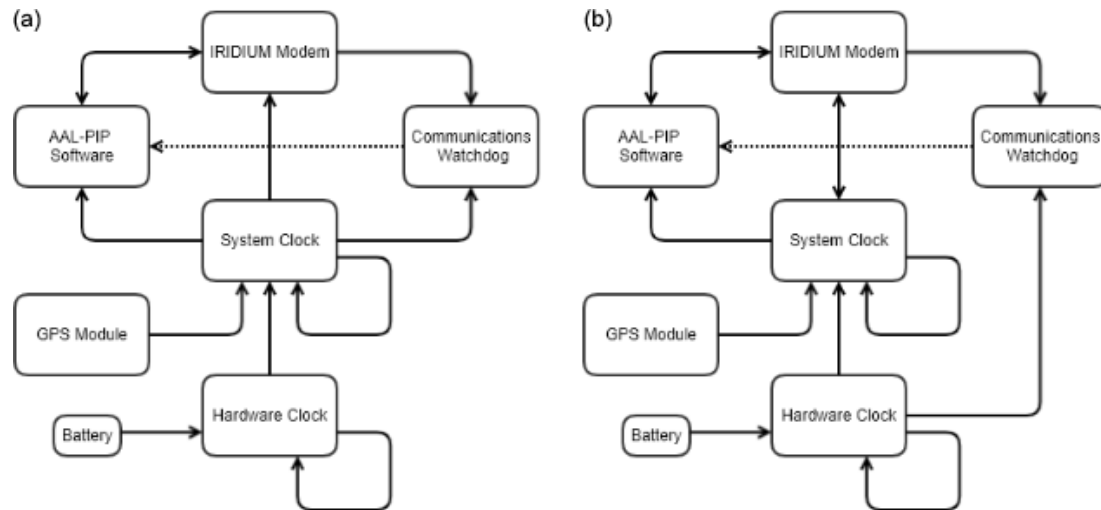
**Figure 3.** Diagrams contrasting the original flow of time information on the AAL-PIP systems (a) with the current method (b). Note the use of the hardware clock as an input for the communications watchdog, as well as the availability of Iridium network sourced time for the system clock. The dotted line represents a reset signal presented by the watchdog.

Determining the source of the fault was a crucial first step in restoring the operational status of the AAL-PIP array. Following the fault isolation, it was necessary to develop a software patch that addressed the rollover related time setting bug. There were two important issues to resolve in writing any potential solutions. First, because of differences in GPS firmware, determination of whether the bug was present had to take place. It was noted that one remote system had not entered the fault state, and it is suspected that this is because it was built several years after the initial platforms. Likely, this later GPS module had a firmware update that could handle the rollover. Isolating fault occurrence was achieved by first determining if the reported date was prior to the current GPS epoch start date. Second, if the date was incorrect, the reported difference in date and time had to be offset, in this case by simply adding a constant value to the recovered value. This software patch was developed in December 2019 in advance of the austral summer field season. Figure 3 shows the differences in timing information flow within the AAL-PIP systems as a result of this patch. The first attempt to deploy

In the case of the AAL-PIP system, there are two important software design considerations that had to be addressed during the patch process. First, the communications watchdog timer issue had to be resolved. Typically, the watchdog will automatically reboot the system after either staying connected or disconnected for more than 24 h. When the watchdog first starts, it obtains the current time and then sets a trigger for 24 h later. This reboot process was prevented by rolling the clock back to a time several years before the trigger time. A different, more robust solution to using the full date and time for timers like this would have been to strip the date from the trigger. However, this can still lead to some confusion as a result of making adjustments to the system clock. Using a monotonic hardware clock for this timer would provide a more robust solution, as these clocks typically are not adjusted by any software process.
