Coastal Engineering Journal

Impacts of Hurricane Dorian on the Bahamas: field observations of hazard intensity and performance of the built environment

SURVEY REPORT

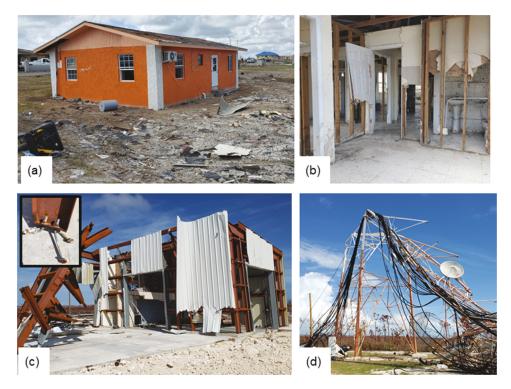
Figure 1. (a) Example of Class 1 home in Sweeting's Cay employing a mixture of lightly framed construction with a variety of sheathing materials and an annex of unreinforced masonry; (b) Example of Class 2 home near the West End; (c-d) Examples of Class 3 homes in Marsh Harbour with progressively higher levels of elevation of the primary living space.

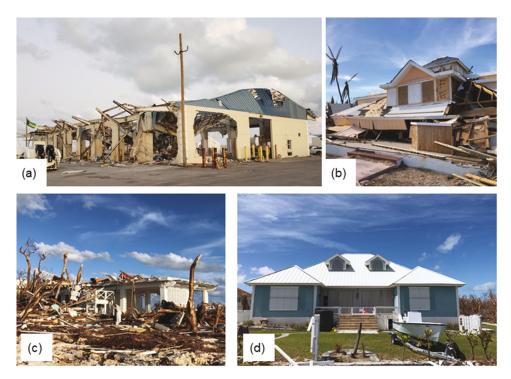
Throughout the port area, evidence of significant wave runup was observed, resulting in failures of multiple metal frame and CMU masonry warehouses/industrial buildings. As noted in Figure 6, a HWM of approximately 8 m was documented in this area. Steel frame buildings experienced wash-throughs, stripping the metal envelope or punching through the masonry infill (Figure 11a), as well as system-level failures due to insufficient foundation anchorage (both with respect to embedment length and edge distance).

Figure 11. Illustrative performances in the Marsh Harbour (Great Abaco Island) region: (a) failure of masonry infill on steel moment frame port warehouse at (26.542944, -77.064664); (b) example of surge-induced "soft story" failure in wood framed Class 2 residence at (26.545954, -77.046597); (c) complete destruction under storm surge leaving only the elevated foundation of an assumed Class 3 home at (26.551910, -77.037554); and (d) minor/no structural damage in a coastal Class 3 masonry home at (26.552433, -77.060514).

due to debris/road wash out, though those accessible were severely damaged if not completely destroyed by storm surge (Figure 11b), with failures of even elevated Class 3 homes as a result of insufficient freeboard (Figure 11c). Documented wall-to-foundation failures in Class 3 wood-framed residential construction were characterized by limited to no visible evidence of metal straps to connect wood stud walls to sill plates.

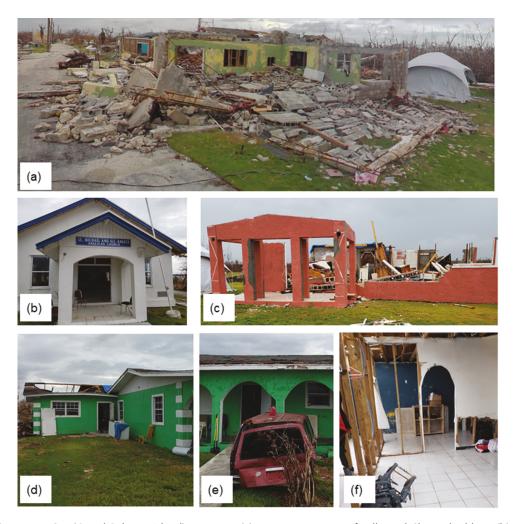
Figure 13. Sweetings Cay (Grand Bahama Island) overview: (a) panoramic image of collapsed Class 2 building; (b) St. Michael's Church at (26.609564, -77.878146); (c) complete destruction of Class 2 home at (26.609161, -77.891425); (d) well-confined Class 2 home at (26.609926, -77.877274) with (e) displaced vehicle impacting front porch column indicative of storm surge on site resulting in (f) significant interior flood losses.

Local construction practices failed to consistently implement sound detailing, such as lap splices in rebar, stirrups in tie columns, and proper load transfer from masonry walls to foundation. The use of coral stone in concrete structural elements was also observed. With few exceptions, these homes were severely damaged to completely destroyed (down to bare slabs) with significant debris fields remaining even weeks after landfall. Masonry wall failures were instigated by both roof uplift tensioning unreinforced walls and lateral pressure from storm surge (Figure 13c), both of which often propagated to complete collapse (Figure 13a).

Even for structures that performed well structurally, storm surge caused considerable interior contents damage, rendering the buildings uninhabitable. Notable examples include St. Michael's Church (Figure 13b), which was one of three churches in the community that performed well under Dorian's wind loads. St. Michael's was exposed to an estimated 5.5 m of interior flooding due to storm surge. Figure 13d provides another positive outlier, a well-confined Class 2 residence whose reinforced concrete elements

used a local aggregate that is stronger than the coral stone used for concrete elements in surrounding homes. The confinement proved effective in resisting the propagation of wind-induced uplift failures (Figure 13d) and the effects of storm surge evidenced by a displaced vehicle that impacted the concrete front porch column (Figure 13e), consistent with eyewitness reports of 3.5-4.5 m of storm surge at this site. This resulted in 1.0-1.5 m of standing water inside the property, leading to significant interior losses (Figure 13f).

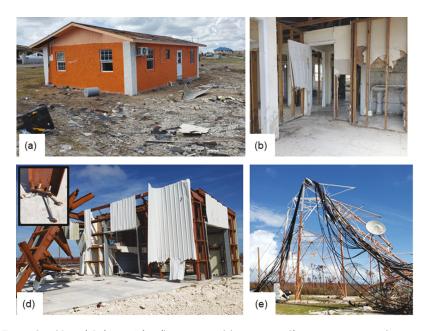
Moving along Grand Bahama Highway (GBHW) westward to McLean's Town Cay (Figure 2c), Class 2 structures east of Dorian's track remained uninhabitable, with few exceptions. Wind speeds here were estimated at approximately 65 m/s (234 km/h; 145 mph) and storm surge depths, while not formally documented by the Coastal Survey team, were reported by eyewitnesses to be 6 m at some sites. There was consistent evidence of sediment and debris deposition 14a) coupled with interior (Figure 14b) in surviving Class 2 structures that had sufficient wind resistance. In many cases, structures destroyed down to bare slab had debris swept away with the retreating surge. Engineered structures also exhibited severe damage, including a steel-frame marine facility with evidence of surge wash-through (Figure 14c) and a collapsed lattice communication tower (Figure 14d). The observed damage gradient, progressing from moderate roof damage to complete destruction (bare slab), increased north of GBHW, away from the south coast of Grand Bahama Island consistent with the direction of increasing depth of storm surge overland.

Figure 14. McLean's Town Cay (Grand Bahama Island) overview: (a) surviving Class 2 structure at (26.648639, -77.947904) with good wind resistance but (b) extensive interior damage due to storm surge; Examples of failures in other structural classes: (c) steel marine facility at (26.646725, -77.952984) with inset of anchor failure and (d) lattice communication tower at (26.648297, -77.947030).

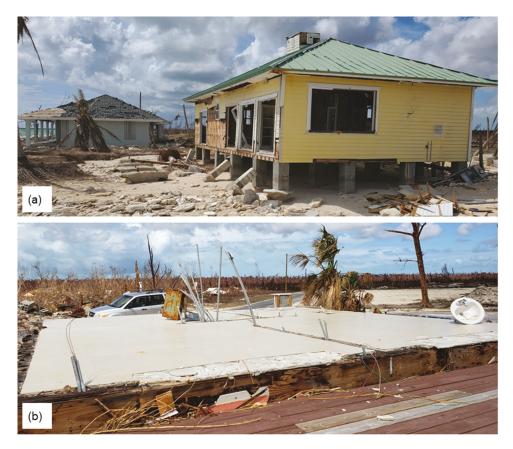
Figure 15. Examples of varying damage levels observed in Class 2 wood-framed homes on elevated CMU piers in Pelican Point (Grand Bahama Island), including (a) surge wash-through of a single-story wood-frame home at (26.649183, -78.092826); note that a deck present on the coast-side of the home was removed but could not be found in nearby debris piles; and (b) complete destruction of the superstructure of a wood-frame home built atop a wood floor platform supported by CMU piers (26.649183, -78.092826).

At Pelican Point, a small community of about 30 buildings located just east of the second landfall point (Figure 2c), properties north of GBHW show higher incidence of structural wall damage to complete collapse (see Figure 15b for example of bare slab), though the trend was not as pronounced as in areas further east. A limited number of performance assessments and review of the street-level panoramas reveals variable performance, with four structures destroyed down to the slab, nine experiencing only roof cover damage, and two with no visible exterior damage. Wind speeds in this region were estimated to be 55 m/s (198 km/h; 123 mph) with eyewitness reports of significant storm surge. Note that while most buildings are Class 2, some may be interpreted as Class 1 construction with respect to quality and details, thus translating into higher rates of collapse. There was also a greater prevalence of wood-framed Class 2 construction in this region, in some cases elevated above grade on CMU piers (Figure 15a).

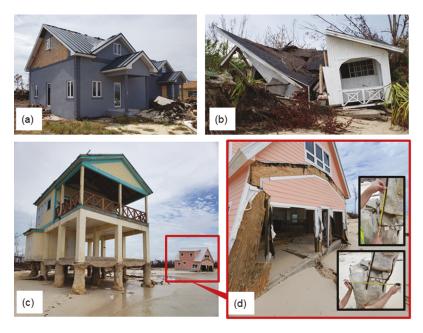
At Golden Grove while newer Class 3 construction performed exceptionally well, significant coastal erosion resulted in severe foundation scour, drift, and/or complete collapse of multiple Class 2 and 3 beachfront homes (Figure 16b-d). While the roof and superstructure of the pair of homes in Figure 16c performed well, substantial scouring of the foundations was observed in the surviving home, with complete foundation failure at a neighboring elevated home, unseating the

Figure 16. Varying performance levels in East Grand Bahama (Grand Bahama Island), including (a) brand new Class 2 masonry home at (26.611846, -78.354843) with minor cladding damage; (b) complete destruction of a beachfront Class 3 home in Golden Grove at (26.606874, -78.361771); Additional examples of (c) scour and (d) resulting foundation failure of beachfront Class 3 homes at (26.606950, -78.360959) and (26.614456, -78.346353), respectively.

house. The failed concrete piers were approximately 30 cm square with four longitudinal bars and #3 stirrups at 30.5 cm spacing (Figure 16d). Scour depths of 2.0-3.0 m were documented across the sites at this location.

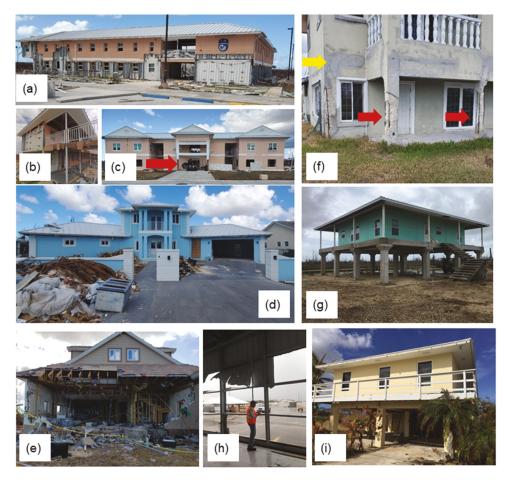
The University of the Bahamas-North Campus, on the east side of Freeport, had extensive damage to two of its buildings due to storm surge. The more severely damaged building was a unique modular system of shipping container units, stacked, studded, and stucco finished (Figure 17a). The exterior cladding was completely stripped off from the first floor (note a standard container is 2.6 m high), ground-floor windows were blown out, and some container units themselves were damaged (Figure 17b). A second more conventionally constructed reinforced concrete and masonry building showed similar evidence of first story damage due to storm surge, with most windows blown out. Note the concrete cover on a pair of steel columns supporting the entryway roof was completely spalled off by the storm surge (see arrow in Figure 17c). Interior losses in both buildings were substantial, destroying the metalstudded partitions, false ceilings, and other finishes.

Figure 17. Freeport Metro Area (Grand Bahama Island) overview: Storm surge damage at University of the Bahamas-North campus to (a) stacked shipping container building at (26.583368, -78.570521) including (b) damage to container walls; (c) a more conventional concrete and masonry structure also sustained flood damage to its ground floor with arrow indicating spalling of concrete cover under storm surge; (d) Class 3 home with minor exterior damage but extensive interior water damage at (26.578872, -78.573360); (e) complete destruction of Class 3 home at (26.573176, -78.606356); (f) surge-induced spalling (red arrows) to concrete columns of Class 3 residence south of GBHW at (26.577974, -78.572962), with high-water mark (yellow arrow) evidencing surge inundation levels; (g) undamaged precast elevated Class 3 home at north shore of island (26.548214, -78.700064); (h) evidence of wash through at hangar at Grand Bahama International Airport (26.600281, -78.615322); (i) elevated Class 3 home in Queen's Cove, site of eyewitness surge evolution account (26.541744, -78.744403).

grade) in some residences, at times resulting in partial collapses (Figure 17e). Figure 17f shows an example of the observed high-water marks just above the first story of a Class 3 home (yellow arrow) as well as spalling of reinforced concrete columns at the base of the house (red arrows).

Just north of Queen's Highway, at the Grand Bahama Airport, hangar buildings displayed characteristic wash-through patterns suggesting flow depths of 2.5 to 3.0 m (Figure 17h). Due west of the airport, a survey of Class 2 and 3 properties in Queen's Cove (on Victoria Lane) similarly documented extensive surge-induced damage, with measured HWMs of 4 m (see Figure 8) and fairly high velocity leading to major damage to lower elevation structures. Elevated structures performed well, though some unreinforced/ ungrouted break-away walls did not fail as intended.
