Seismic and Durability Assessment of Externally Bonded FRP Retrofits in Reinforced Concrete Structures After 2018 Anchorage, AK Earthquake

Abstract. Externally bonded fiber-reinforced polymer (EBFRP) composites are a cost-effective material used for repair and seismic retrofit of existing concrete structures. Even though EBFRP composites have been extensively utilized over the past 20 years as seismic retrofits, there are few data documenting their performance in a real shaking event or after long-term use on concrete structures. In this study, semi-destructive and non-destructive techniques were employed to evaluate the performance and durability of EBFRP-retrofitted buildings that had experienced the 2018 Cook Inlet Earthquake in Anchorage, AK. The performance of EBFRP was evaluated and documented through photographic evidence. Acoustic sounding, infrared thermography, and bond pull-off tests were utilized to evaluate the quality of bonding between the EBFRP and concrete. EBFRP samples were also collected from building interiors and exteriors for chemical and thermal analysis to evaluate the long-term effects of environmental exposure. Although environmental conditions were foun

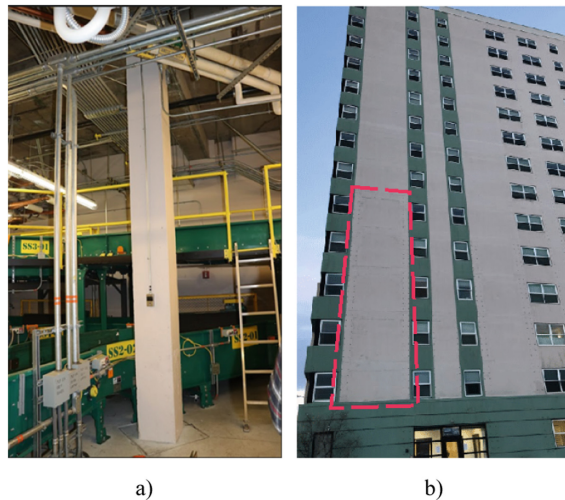
Field assessment data acquired through visual inspection of eight representative buildings retrofitted with EBFPR showed no visible signs of earthquake damage to EBFPR composite retrofits. Figure 3a shows an example of an interior column at TSIA. Interior columns, wrapped with 2 plies of CFRP for confinement, were undamaged by the earthquake. For MKT, an exterior shear wall retrofitted with GFRP is shown in Fig. 3b. Wall boundary elements were formed by applying horizontally oriented unidirectional GFRP and CFRP on three sides of the window corner opening. Additional bolts were installed through the wall to confine the boundary elements. No obvious earthquake damage to the EBFPR retrofits was observed in the post-earthquake inspections. It should be noted that the team inspected only visible, exposed, EBFPR retrofits; during inspections of many of the buildings, the team faced accessibility problems as many EBFPR retrofits were located behind drywall, panels, or other architectural finishes.

Fig. 3. Examples of typical EBFPR retrofits: a) interior column at TSIA; b) shear wall at MKT retrofitted with GFRP (marked by a dashed red line).

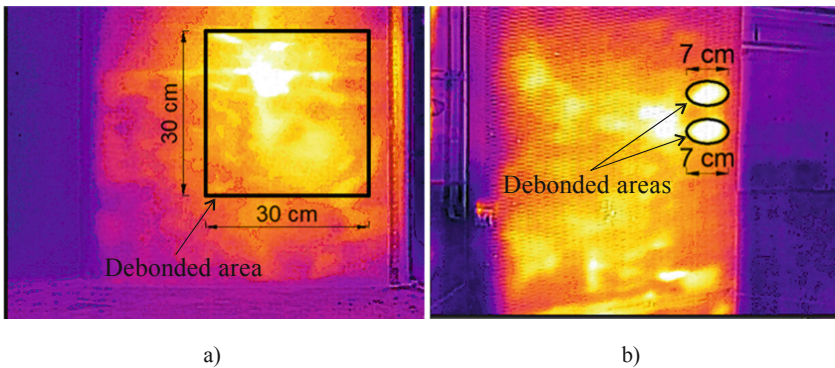
Acoustic sounding and Infrared (IR) thermography. Several debonded areas of varying size and shape were identified within the EBFPR composite system using acoustic sounding and the debonded areas were marked with tape. Qualitative IR thermography measurements were then taken and the debonded areas identified with tape were later matched up to IR thermography images (Fig. 4). On the interior column, thirteen relatively small debonded areas (between 10 cm^2 to 40 cm^2) were detected. In contrast, four larger debonded areas that exceeded 160 cm^2 were observed on the exterior column.

Fig. 4. Thermal IR image of debonding at TSIA: a) an exterior column and b) interior column. Bright areas were marked based on the location of tape from acoustic sounding.

According to ACI 440.2R (2017), debonded areas larger than 160 cm^2 can affect the performance of EBFRRP retrofits and should be repaired by selectively cutting away the affected sheet and applying an overlapping sheet patch of equivalent plies. It is unknown whether these debonded areas formed because of environmental deterioration, or due to construction defects. But, considering that debonding was more severe on the exterior column compared to the interior column and presuming that surface preparation and construction methods were the same between the columns, we conclude that environmental conditions likely had some influence on the EBFRRP debonding in the exterior column. For field investigations, initial bond durability data would be useful as a baseline for researchers assessing bond quality after long-term outdoor exposure and hazard events.

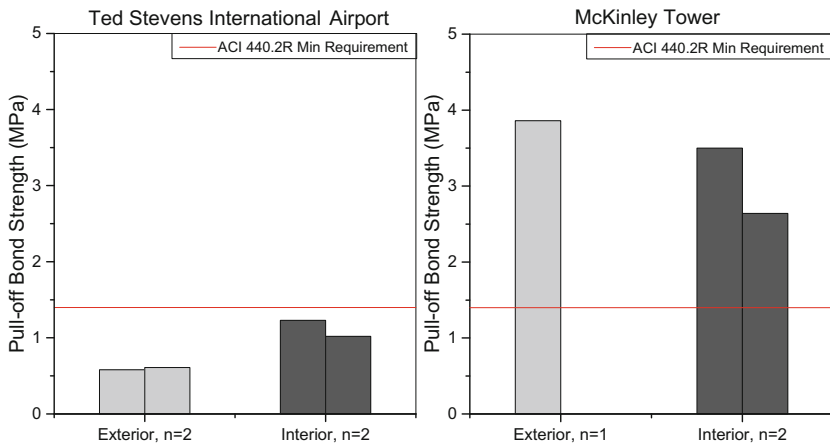
Bond pull-off tests. Bond pull-off strengths were compared against the ACI 440.2R minimum bond strength requirement of 1.4 MPa (Fig. 5). Initial bond pull-off strength data was not available for any of the building components investigated. In future FRP retrofit installations, it would be useful to obtain and maintain this baseline data for long-term field inspections. Four different failure modes were observed in the bond pull-off tests (ASTM D7522): cohesive failure in the concrete substrate; adhesive failure at the EBFRRP/concrete interface; mixed adhesive and cohesive failure; and, bonding adhesive failure at the loading fixture. Representative photographs of different failure modes are shown in Fig. 6. Cohesive failure in concrete (Fig. 6a) is desirable as it indicates sound adhesion between EBFRRP and concrete, while the failure modes in Fig. 6b and Fig. 6c indicate improper adhesion between EBFRRP and concrete, which can be caused by improper concrete surface preparation, environmental conditioning, or a combination of the two. Bonding adhesive failure at the loading fixture (Fig. 6d) occurred when the epoxy used to attach the fixture did not fully cure by applied heat in the extremely cold temperatures ($< -12 \text{ }^\circ\text{C}$) experienced during inspection. This failure mode was a non-result and was mostly avoided during subsequent pull-off tests on the same building component by applying heat for a longer period of time. Pull-off test strength data for this failure mode was not useful and is thus not included in Fig. 5.

At TSIA, measured bond pull-off strengths, both on the exterior and interior columns, were lower than the minimum requirement. Of note, pull-off bond strengths measured on the exterior column were lower compared to the interior column. Furthermore, two adhesive failures at the EBF_{FRP}-adhesive interface, which is an indication of poor bond properties, were recorded for the exterior column. The lower bond pull-off strengths on the exterior column at TSIA and the presence of adhesive failure modes provide evidence that there are some issues in regard to the durability of the bond between the CFRP and concrete.

All pull-off tests at MKT passed the 1.4 MPa minimum bond strength recommendation. Cohesive failure modes were observed in all experiments (with the exception of one bonding adhesive failure of the fixture on the exterior of the building) indicating good adhesion properties between the GFRP and concrete. Better bond performance observed at MKT in comparison to TSIA could be due to the mismatch in coefficients of thermal expansion (CTE) between the concrete and CFRP at TSIA. Carbon fibers have a negative CTE which leads to expansion under low ambient temperatures and, consequently, differential movement between the concrete and the EBF_{FRP}. On the other hand, the CTE of glass fibers is similar to the CTE of concrete, resulting in compatible deformations.

Fig. 5. Bond pull-off test strengths for all failure modes except bonding adhesive failure at the loading fixture. Each bar represents one pull-off test strength and the red line indicates the minimum bond pull-off test strength according to ACI 440.2R. Only one replicate was possible for the MKT exterior at the time of this field study because of a bonding adhesive failure at the loading fixture for the first pull-off test conducted.

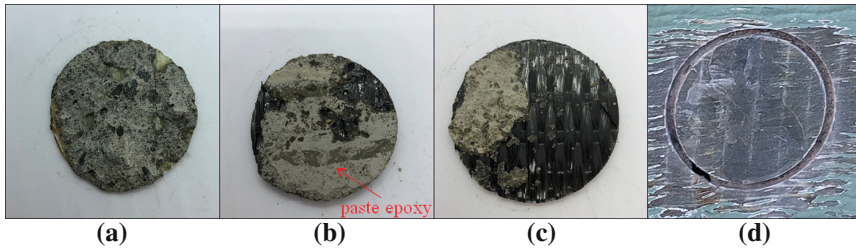
Fig. 6. Typical bond pull-off test failure modes: a) cohesive failure in the concrete substrate, b) adhesive failure at the EBFPR/concrete interface, c) mixed adhesive and cohesive failure mode, and d) bonding adhesive failure at the fixture-EBFRP interface.

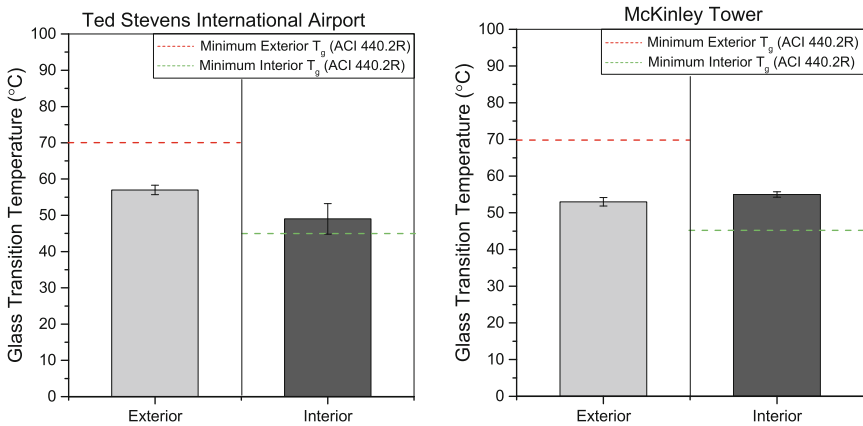
Thermal analysis – The average T_g values obtained for CFRP retrofits from the interior and exterior column at TSIA are shown in Fig. 7. The observed T_g values for exterior CFRP retrofits at TSIA were in the 56 °C to 58 °C range. Interior retrofits at TSIA had lower T_g values which varied from 47 °C to 56 °C. The T_g values were likely greater for the exterior samples since higher outside temperatures during the summer season may have stimulated post-curing of the epoxy, leading to more cross-linking density.

The T_g values of GFRP samples from MKT were in the 53 °C to 54 °C range with no statistically significant difference between interior and exterior samples. During the service life of GFRP samples from MKT, the highest interior and exterior ambient temperatures most likely reached similar values as a result of less strictly controlled ambient conditions typical for residential buildings. Taking into account this assumption, similar values of measured T_g on the interior and exterior of MKT, can be attributed to a similar degree of post-curing.

The minimum recommended exterior T_g (55 °C + 15 °C), based on the previously described exterior service temperature and the ACI 440.2R recommendation, was compared to the measured T_g values at MKT and TSIA. The measured T_g values of the exterior samples did not satisfy the minimum criteria from ACI 440.2R, for the suggested exterior service temperature of 55 °C, which may have adversely affected the mechanical properties of the EBFRR retrofits. In contrast, the measured interior T_g values were greater than the recommended minimum interior T_g (30 °C + 15 °C) which indicates that there was no impact of T_g on the mechanical properties of the interior EBFRR retrofits at both MKT and TSIA.

Fig. 7. The average T_g values of triplicate (8 mg to 16 mg) circular punched-out EBFRR specimens from individual samples collected at MKT and TSIA (error bars indicate one standard deviation). The minimum interior and exterior values indicate the threshold at which the T_g value of the EBFRR must exceed to maintain optimal mechanical properties.

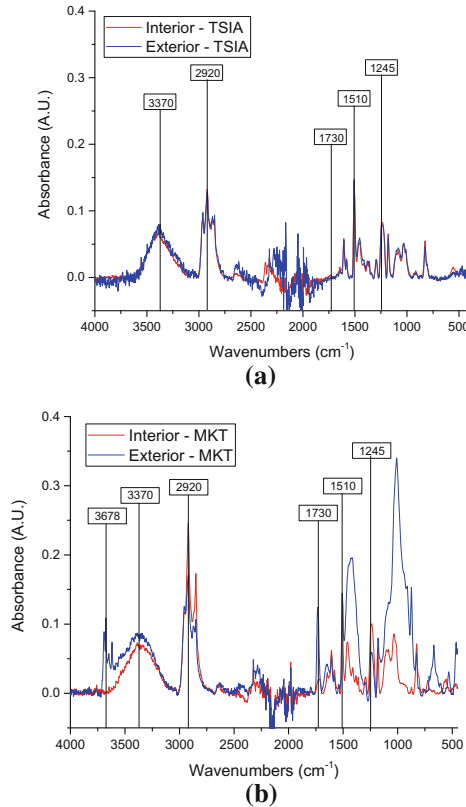
ATR-FTIR. Typical spectra collected on the exterior and interior EBFRR samples are shown in Fig. 8. The peaks at 2920 cm^{-1} and 2850 cm^{-1} are related to C–H bonds of the monomer units, the peak at 1245 cm^{-1} corresponds to C–O bonds in epoxy, the peak at 1510 cm^{-1} corresponds to benzene ring, and the broad peak at 3370 cm^{-1} is related to hydroxyl groups (Cysne Barbosa et al. 2017). The band at 1730 cm^{-1} , when present in the spectra, corresponds to the carbonyl group and can indicate oxidation (Rezig et al. 2006).

The results suggest that the epoxy matrix at TSIA did not chemically change due to the field exposure to the subarctic climate: the spectra are qualitatively similar between the interior and exterior sample. Further analysis is underway with newly collected CFRP samples from TSIA to determine if any chemical changes are present among several other retrofitted columns. For the exterior EBFRR sample from MKT, the glass fibers were poorly saturated with epoxy, making it difficult to investigate epoxy degradation. There were some dissimilarities in peaks and peak intensities between the interior and exterior GFRP samples. The exterior GFRP sample was thought to be contaminated—the peaks

around 3680 cm^{-1} likely correspond to silica sand particles in the paste adhesive that was used to bond the EBFPR to the concrete substrate. The carbonyl peak at 1730 cm^{-1} was also present in the samples; the research team is currently conducting additional experiments to determine whether this peak is associated with oxidation of the epoxy matrix or is caused by contaminants that may have been present in the specimen (*e.g.*, paint). Further analysis is underway with newly collected GFRP samples from MKT exterior.

Fig. 8. Qualitative comparison of spectra on exterior and interior EBFPR from: a) TSIA, and b) MKT. Each spectrum is the average of three spectra from different areas of the same EBFPR sample. Bands of interest are denoted in boxes with units of cm^{-1} .
