FIELD INVESTIGATION OF TWO RETROGRESSIVE BREACH FAILURES AT AMITY POINT

NICOLA BRILLI¹, NINA STARK¹, PETER NIELSEN², DAVID CALLAGHAN²,
MADELINE MANNING¹, JEFF CULP¹

Abstract: A 27-day field study was conducted to explore Retrogressive Breach Failures (RBF) at Amity Point, Queensland. Two events were documented over the course of the study, and videos and photographs were obtained of one event in progress. Beach profiles and recovering shoreline position were measured along with deployments of a simple penetrometer to obtain a proxy for surficial sand density. The sand appeared to be in a loose state prior to the second event, being controversial to theory of RBF. The recovering shoreline showed rapid accretion in the first 24-48 hours along with tidal erosion of the beach face. Wind speeds reached ~35 kilometers/hour out of the NNW on the day of each event, representing the only time these conditions were observed.

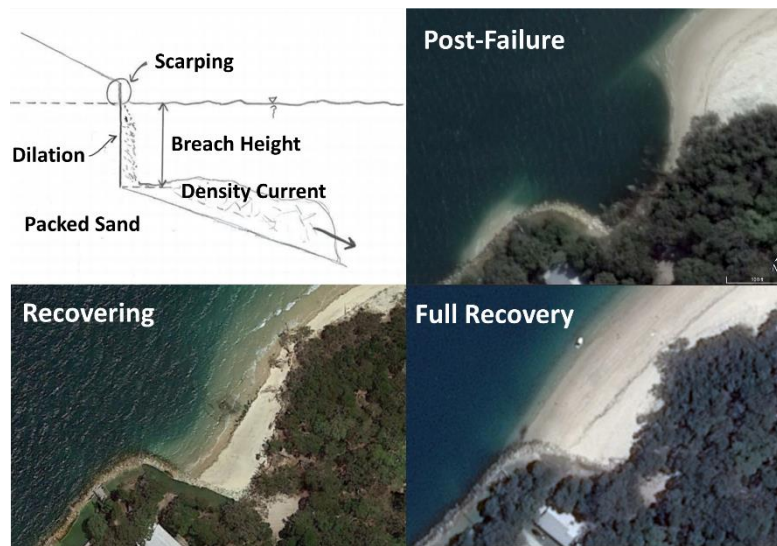
events are characterized by a near-vertical wall, retrograding onshore at a steady rate of approximately 0.8 meters per minute (Figure 2), leaving an amphitheater shaped scar (Van den Berg et al. 2002; Beinssen et al. 2014).

Figure 2: Mechanics of RBF Events (Top Left), Representative Beach States: Post-Failure (Top-Right), Recovering (Bottom-Left), Full Recovery (Bottom-Right). Google Earth Pro V 7.3.2.

vertical wall to retrograde (Beinssen et al. 2014). Note in Figure 2, dilation merely shows the location of the process, not the full mechanism.

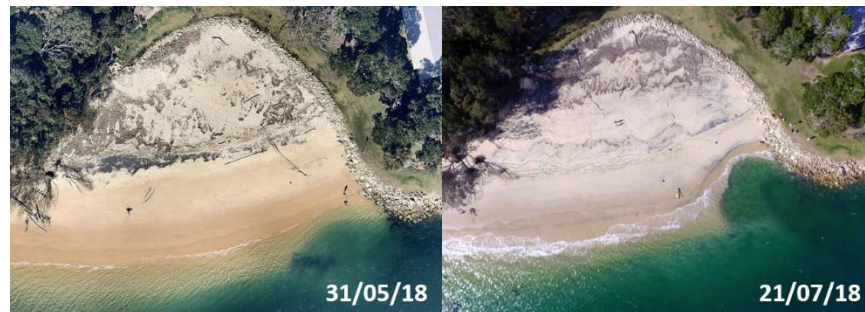
Two RBF events (Event 1 & Event 2) occurred during the study period. Event 1, on July 6th, occurred while the research team was on site, which allowed for video recording, drone photographs, and erosion rate measurements to be taken. During this event, the beach retrograded at approximately 0.5 meters/minute and eroded approximately 200 square meters of beach. Event 2 occurred two weeks after the first, and eroded 300 square meters of the beach. This event happened over night, so only drone photographs were used to document the site (Figure 5).

Figure 5: Typical Pre-Failure (Left) and Failed (Right) Beach, Source: NearMap & Drone Imagery

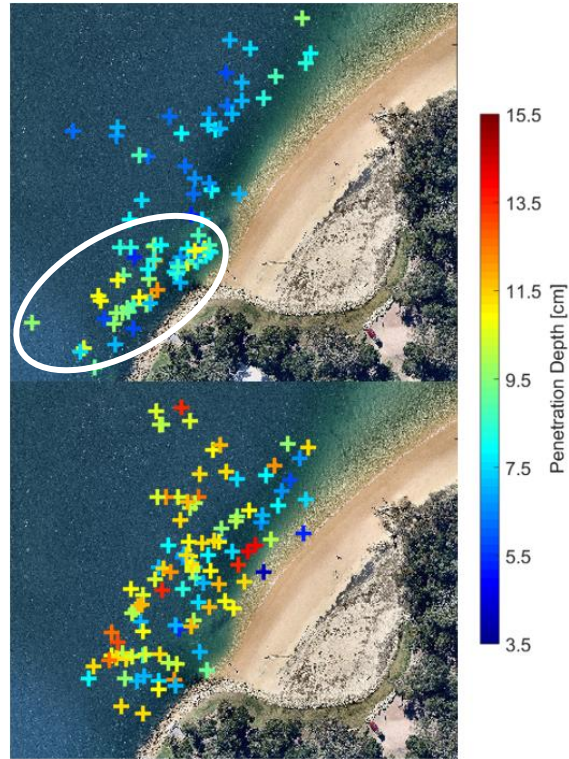
Figure 6 displays the deployments recorded in the first 4 days after Event 1 (Top), and in the 4 days before Event 2 (Bottom). Penetration depths ranged between 3.5-15 centimeters. Since the penetrometer was not calibrated, the data only serves as a qualitative measure of bulk density relative to other deployments during the study. A majority of the deployments right after the first event achieved small penetration depths (cooler colors), compared to right before the second event, when deeper penetration depths were reached (warmer colors). This shows that the penetrometer went deeper into the soil for these deployments, and that the slope was looser right before Event 2 than after Event 1.

Figure 6: Penetrometer Drops Taken during the Recovery Stage (Top) July 7-11th, and the Stable Period (Bottom) July 14-19th, Area of Post-Failure Deposition is Circled

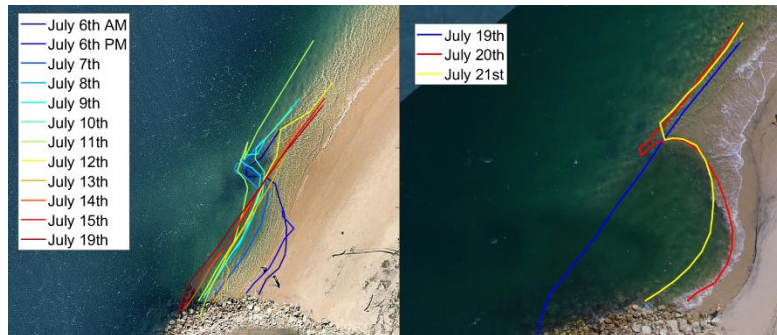
Figure 7: (Left) Event 1 Recovery Cycle, (Right) Event 2 Recovery Cycle

The shoreline recovered quickly in the first 24-48 hours post-event, after which the rate of accretion slowed until the original shoreline was restored. This process took around 5 days for the first event, and the position did not vary significantly for the remaining 9 days until the Event 2. The field study concluded two days after the Event 2, preventing more data acquisition on the second event's recovery.

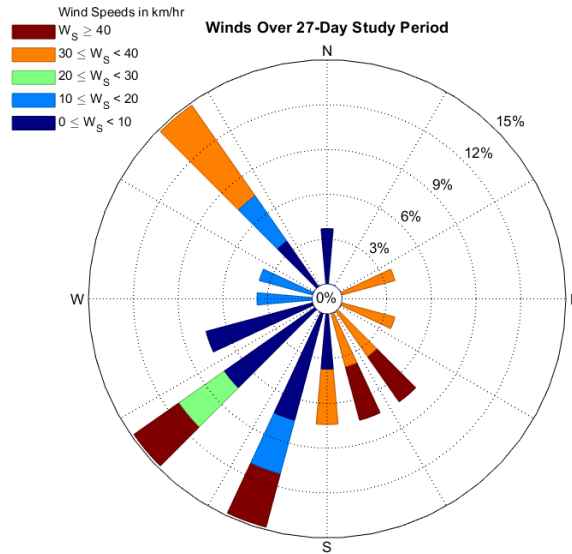
Wind speeds were also documented using data available from the Australian Government Bureau of Meteorology, measured on the Eastern side of the island, 10km from the site. It was noted from field observations that the predominant wind direction was strong out of the North-Northwest (NNW) on the day of each event. Further exploration of wind data from ... over the study period showed that this was indeed the case: on both event days, the wind was blowing at ~35 kilometer/hour out of the NNW. Not only was the wind magnitude and direction

Figure 8: Wind Rose for Wind Speeds, Directions, and Frequency over the Study Period

the same on both days when an event occurred, but these were the only two days that this wind pattern was observed over the 27-day period (Figure 8).

Perhaps the most important finding of the study came from observation of the wind. Wind measurements were not originally planned, but once noticed, it became clear that the wind was an important factor for both events. Strong winds of ~35 kilometers/hour out of the NNW were observed and documented on the days of both events and on no other day during the study (Figure 8). This raised an important question regarding the role of the wind during RBF events at Amity Point.

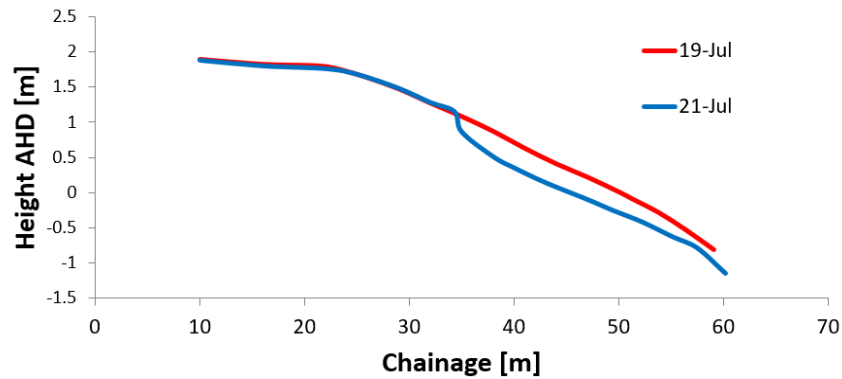
Consistent with observations by Beinssen et al. (2014), the beach rebuilt rapidly after each event. Since the two observed RBF events were small compared to the entire beach area, they rebuilt in a matter of days. Beinssen et al. (2014) reported that the rapid rebuild is due to longshore transport. However, results from the current study show that this may not reflect the complete picture. After each event, beach profiles showed a distinct decrease in elevation of the entire beach face. Figure 9 details this change in topography for the day before (19-Jul) and day after (21-Jul) Event 2. Only the Breaching Profile (Figure 3) is shown for clarity, but this decrease in elevation was consistently observed across both profiles after both events.

Figure 9: Profile Showing Topography Change Due to RBF Event

The decrease in elevation was around 0.3 meters along the breaching profile (closest to the event scar) and around 0.1 meters along dead tree profile. Using the known area of the beach face from drone imagery, it was estimated that approximately 100 cubic meters of sand eroded from the beach face in the first 24-48 hours after the event. Using drone photographs of the erosion scar, the TSI measurements of the recovering shoreline (Figure 7 – Right), and water depth measurements from the echosounder, the amount of accretion in the first 24-48 hours post-event was also estimated to be around 100 cubic meters of sand.

This result explains the rapid accretion seen initially after the event. Tides erode the upper portion of the beach face, and this sand fills the hole left behind. Once the initial erosion is finished, all that is left to fill the hole is longshore transport, which explains why the accretion slows after the first 2 days.

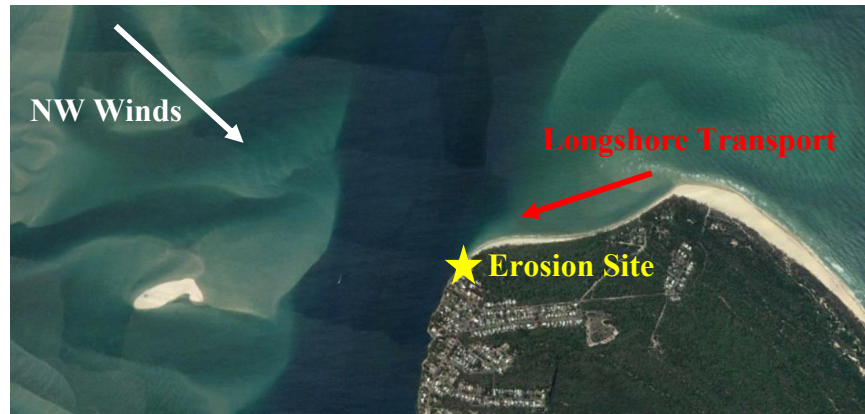
Due to the predominant longshore transport direction (Figure 10), sand that is not deposited on the channel slope at the site is deposited in the channel and moved away by the tidal currents. The site is well protected from waves, as the

Figure 10: Wind and Transport Direction at the Site

predominant wave direction from sea swell is on the other side of the island to the Southeast. However, on days when the wind is strong out of the NNW, the wind points directly at the beach, increasing the height of the waves, and encouraging more transport and deposition onto the channel slope at the site. This increased transport could over steepen or overload the slope, causing a shear failure similar to that proposed by Masterbergen and Van der Berg 2003. Also, the increased waves could induce liquefaction processes (Turner and Nielsen 1997; Sumer 2014).
