# **Downstream Impacts on Geosttructures of the Michigan Dam Failures**

**Elliot Nichols,<sup>1</sup> Joe Smith, P.E.,<sup>2</sup> J. David Frost, Ph.D. P.E.,<sup>3</sup> and Youssef Hashash, Ph.D.<sup>4</sup>**

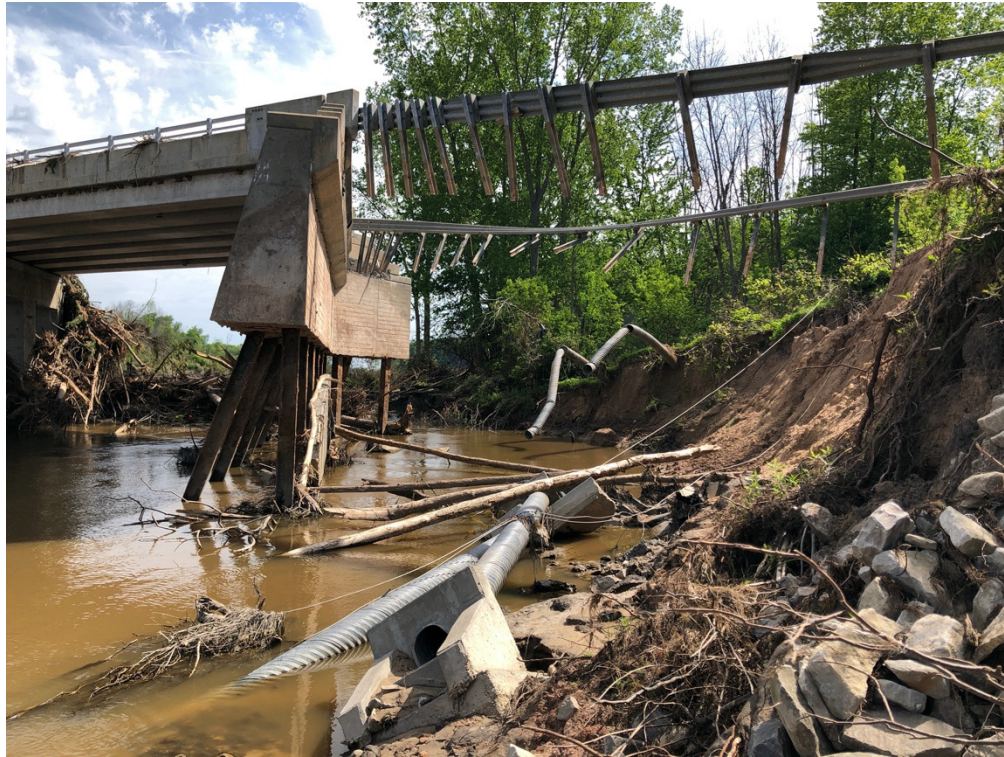
As a result of the disaster being closely contained to Lake Wixom, Sanford Lake, and the Tittabawassee River, the majority of the geostuctures impacted by this event were bridges. This section will discuss the impacts on 10 bridges that were visited by the GEER team, moving from north to south along the Tittabawassee River. The south end of the M-30 bridge (43.80552, -84.38616) south of Wixom Lake experienced a 19 meter-wide embankment failure, which resulted in the collapse and washing away of a 14 meter stretch of road between the sloped embankment and the first set of pile foundations (Figure 2). The southern approach to the

embankment displayed a significant amount of slumping towards the river, exhibited by guardrail piles that have up to 1 meter of vertical sediment eroded, leaving the bottoms of many guardrail piles south of the failure also completely exposed and unsupported. The scouring of the M-30 bridge embankment left the driven pile foundations and cast-in-place pile cap exposed. The 5 meter long vertical and internal raking piles showed minor damage but no evidence of any movement.

**Figure 2: M-30 Bridge embankment failure**

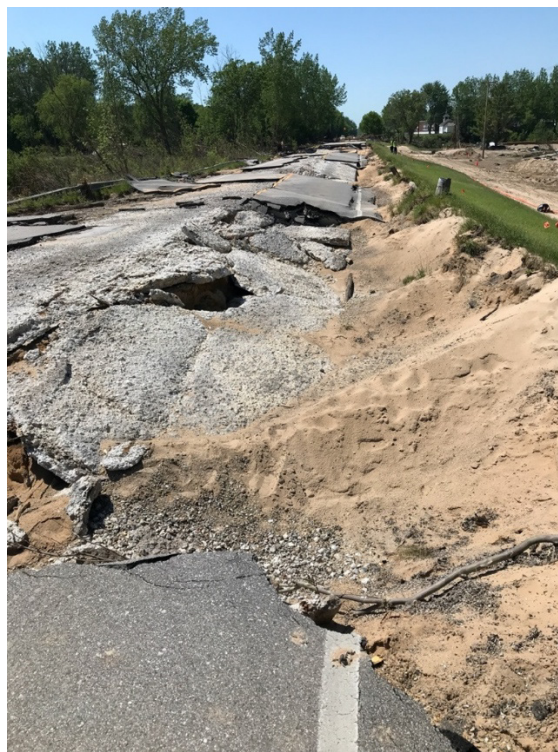
The town of Sanford was the location of not only the most dramatic building damage, but also road and bridge damage. As evidence by the trees, sand, and water on top of the W. Saginaw Road bridge in Sanford (43.67458, -84.38649), the flood waters overtopped the bridge as well as the adjacent Pere Marquette bike path, which is built on top of a dis-used railway embankment. The eastern side of the bridge approach embankment experienced a 167 meter long failure and complete collapse, and displayed scour depths of up to 8 meters (Figure 3). The uplift and displacement of the road shoulder revealed the difference in fill beneath the shoulder and main road. The shoulder was placed on two layers of hot mix asphalt (HMA) approximately 12 cm thick overlaying 9 cm of asphalt concrete, whereas the main road fill consisted of 7.5 cm of HMA overlaying 10 cm of asphalt concrete, which then overlaid 20 cm of reinforced concrete. Pieces of asphalt 25 m<sup>2</sup> in size were ripped up and carried by floodwaters and then deposited in lawns and in front of businesses. Of the 167 meters of embankment and road failure, all of the asphalt was either missing or significantly displaced. The base of the eastern abutment for the W. Saginaw Rd bridge experienced scour reaching upwards of 0.33 m in the middle of the abutment and 0.5m at the northern pile cap. Although the pile cap was exposed, the pile itself remained underground and no damage was observed to the structure of the abutment or the piles. There was significant accumulation of trees, roots, and other various flood debris against the eastern abutment, which also showed signs of historic concrete corrosion at the pier head and failures of badly corroded duct brackets along the side of the bridge.

**Figure 3: W Saginaw Rd approach embankment failure**

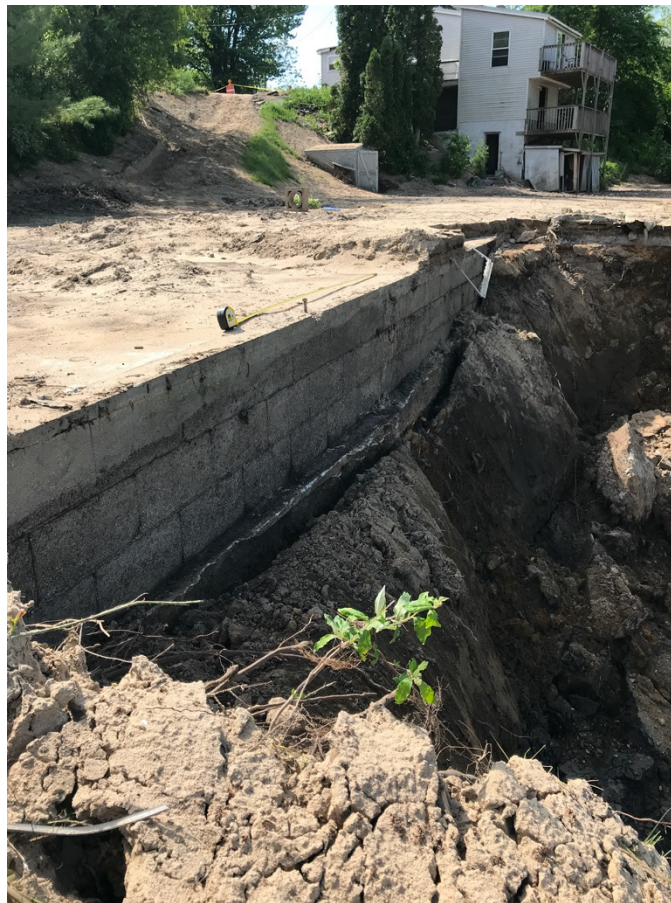
As observed by the GEER team, building damage was constrained to two main areas: between the M-30 and W. Curtis Rd bridges in Edenville and the town of Sanford, along W. Saginaw Rd. Of the four observable residential buildings along the eastern bank of the Tittabawassee River, three homes sat upon the top of an approximately 8 m high slope, all of which experienced an intrusion of flood waters. The one home that was not atop the slope sat approximately 2 m above regular water level and was completely swept off of its foundation and washed away. Floodwater left deep scours in the foundation and the riverbank adjacent to the home; the kitchen floor and part of the foundation were still visible and all else was washed away (Figure 4). The home directly next to the destroyed home has a foundation that rests at the same height above the regular water level, but has taller stories built into the side of the higher slope to provide more stability. This home experienced catastrophic flooding on multiple stories, although the extent of structural damage is unknown.

**Figure 4: Exposed foundation of home near the bank of the Tittabawassee**

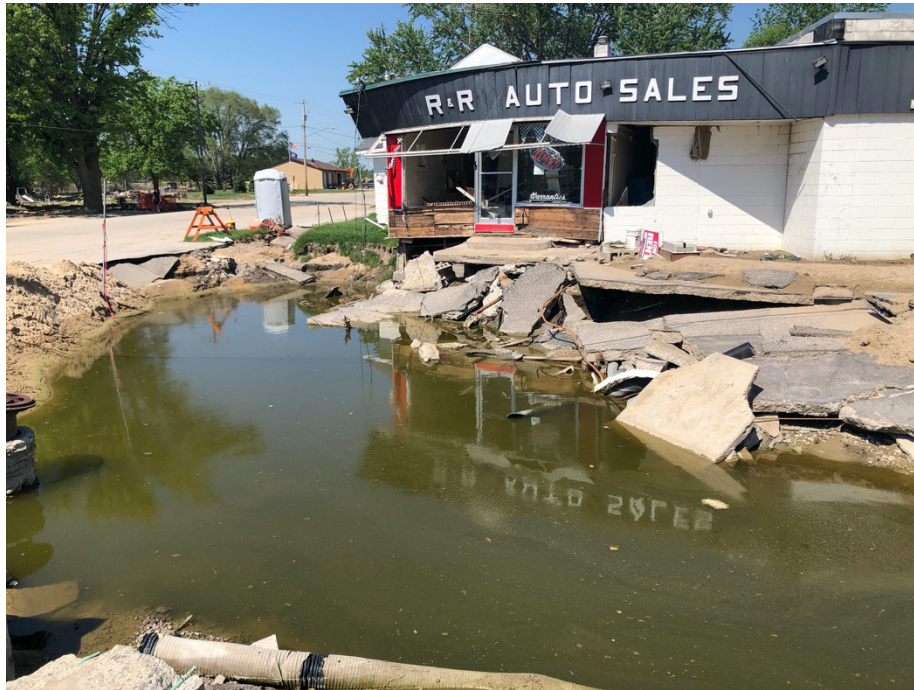
In the city of Sanford, four residential homes along W. Saginaw Rd and W. Center St were swept off of their foundations and washed away in the flood waters; four residential other homes and two commercial buildings were also heavily damaged in the flood. Damages to these buildings ranged from severely flooded to significant foundational damage due to scour. The commercial properties on the corner of W. Center St and W. Saginaw Rd had the front of the

building foundation and sidewalk completely washed out; a drainage pipe underneath the sidewalk and a sewer drain were still present in the area and could have contributed to this failure (Figure 5).

**Figure 5: Sidewalk and road failure plus foundation damage due to scour**

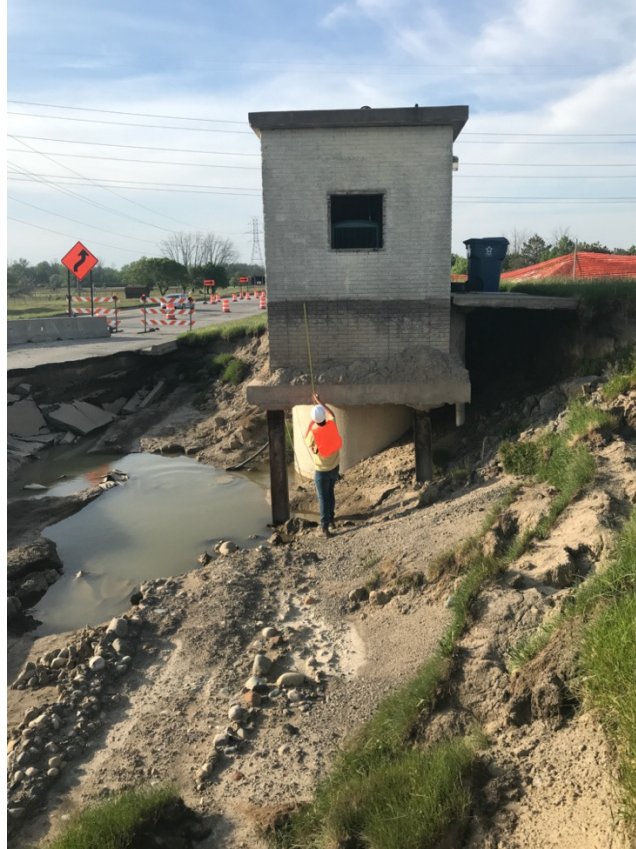
On the morning of May 20<sup>th</sup>, emergency officials ordered an evacuation of people living on Ashby Road due to the breaching of the Poseyville Dyke (43.59656, -84.24758). The purpose of this dike is to protect residential homes from the potential flooding of the Midland Cogeneration Venture plant cooling ponds, which is the largest gas-fired cogeneration plant in the country. The dike failure occurred at a pump station where a buried pipe underneath the dike embankment pumps excess water back into the pools on the non-road side of the dike; the piping is a possible contributing factor to the overall failure. In addition to the failure of the dike and its embankment, one lane of the adjacent S Poseyville Rd was destroyed due to significant scour, which reached depths of 2.1 m. The dike embankment failure exposed the foundation of the pump station, including two piles. The pile on the west end of the station, closer to the road, had 1.8 m of exposure and the eastern pile, closer to the ponds, had 1.2 m of exposure. The 0.3 m thick base slab at the top of the piles was also exposed, with visible water marks reaching 1.3 m above the top of the base slab of the station (Figure 7). An overlook of the ponds, less than 1 km directly south of the Poseyville dike, provided an opportunity to see that there was no evidence of damage to any of the cooling ponds or any part of the cogeneration plant.

**Figure 6: Poseyville Dike failure**

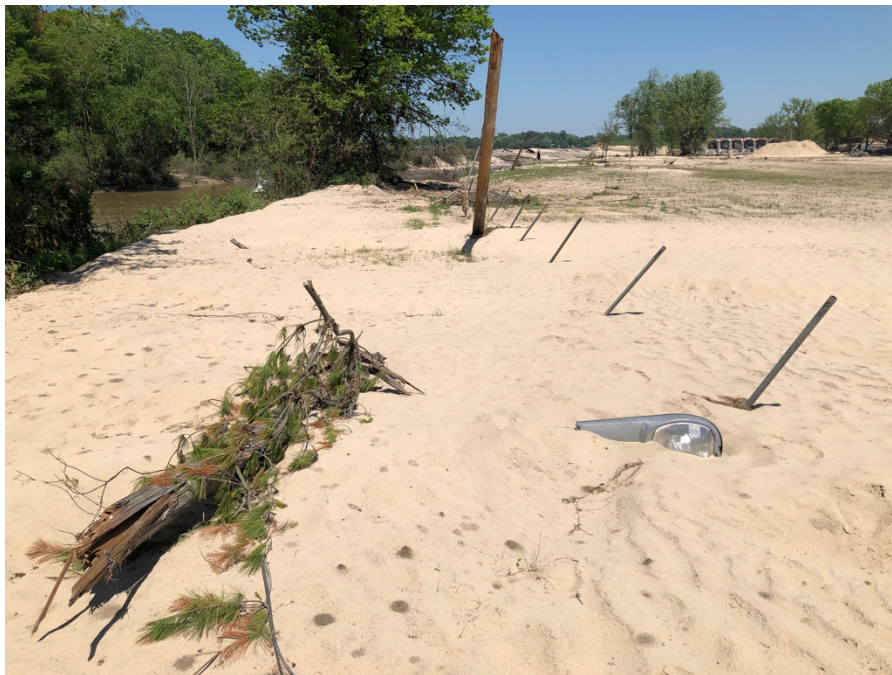
**Figure 7: Burial of light post beneath sand deposits from flood water**
