Earthquake and Postearthquake Fire Testing of a Midrise Cold-Formed Steel-Framed Building. I: Building Response and Physical Damage

Tara C. Hutchinson, M.ASCE¹; Xiang Wang²; Gilbert Hegemier³; Praveen Kamath⁴; and Brian Meacham⁵

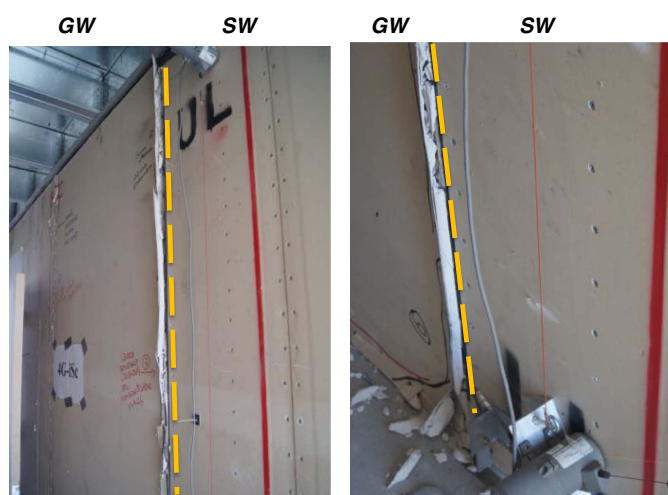
Due to the low seismic demands during the service-level tests at all levels of the test building [peak floor acceleration (PFA) $< 0.5g$ and PIDR $< 0.1\%$], the interior sheathing sustained only a few instances of minor damage in the form of incipient screw withdrawal and localized gypsum crushing and bulging at corners and adjacent panel locations. This type of damage was detected only at Levels 3 and 4, and no visible damage to interior gypsum sheathing occurred at other levels. The extent of gypsum sheathing damage, however, was considered minimal. Damage to the interior sheathing continued to develop as the seismic drift demand increased during the design (EQ6) and MCE (EQ7) events. Screw withdrawal and gypsum crushing of the corridor shear walls and gravity walls became more pervasive at all but the uppermost levels, in particular at the corridor shear wall–gravity wall boundaries as well as the window and door openings (Fig. 8).

In contrast, damage to the exterior shear walls sheathing remained restricted because they occurred only in the form of localized gypsum crushing at the corner and formation of gaps between

Fig. 8. Gypsum sheathing damage of the Level 4 corridor shear wall and gravity wall at the end of the prefire earthquake test phase. SW = shear wall, and GW = gravity wall, and dashed line indicates the boundary between shear wall and gravity wall. (Images by Xiang Wang.)

gypsum panels. Following the completion of the prefire earthquake test sequence, the room-side gypsum panels of the northwest compartment at Level 4, the level with the largest drift demands during the prefire test sequence, were removed to allow for inspection of the shear wall framing and sheathing steel of the corridor-side structural panels (Fig. 9).

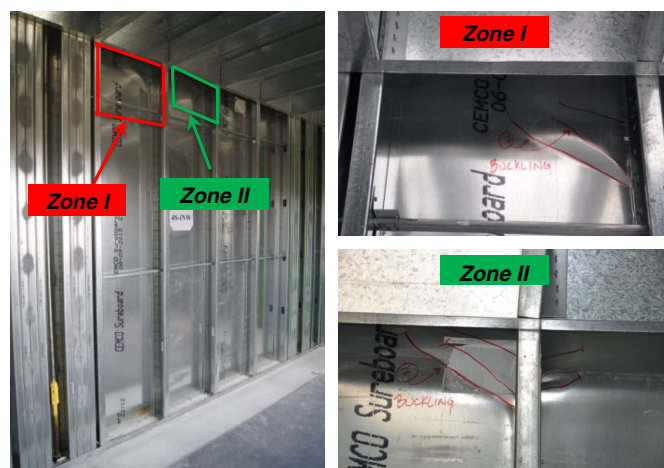
Fig. 9. Structural sheathing sheet steel local buckling of the Level 4 corridor shear wall at the end of the prefire earthquake test phase. (Images by Xiang Wang.)

This inspection revealed that localized buckling of the sheathing steel occurred at the top of the shear wall, whereas its framing studs and tracks did not sustain apparent damage. In addition, very loose tie rods were observed at the end of the prefire test sequence. However, attributing the occurrence of tie-rod loosening to a specific earthquake test was not feasible because the tie rods were not accessible until removal of the gypsum sheathing, which occurred at the end of the prefire earthquake test sequence. In contrast, the exterior shear wall in the same compartment sustained no apparent damage to the wall framing and sheathing steel, nor the occurrence of loosened tie rods. Because the tie rods provide the essential uplift resistance in CFS lateral systems, further investigations are recommended to assess the system-level uplift-resisting behavior of the CFS structures due to the occurrence of tie-rod loosening as well as its impact on the overall structural response.

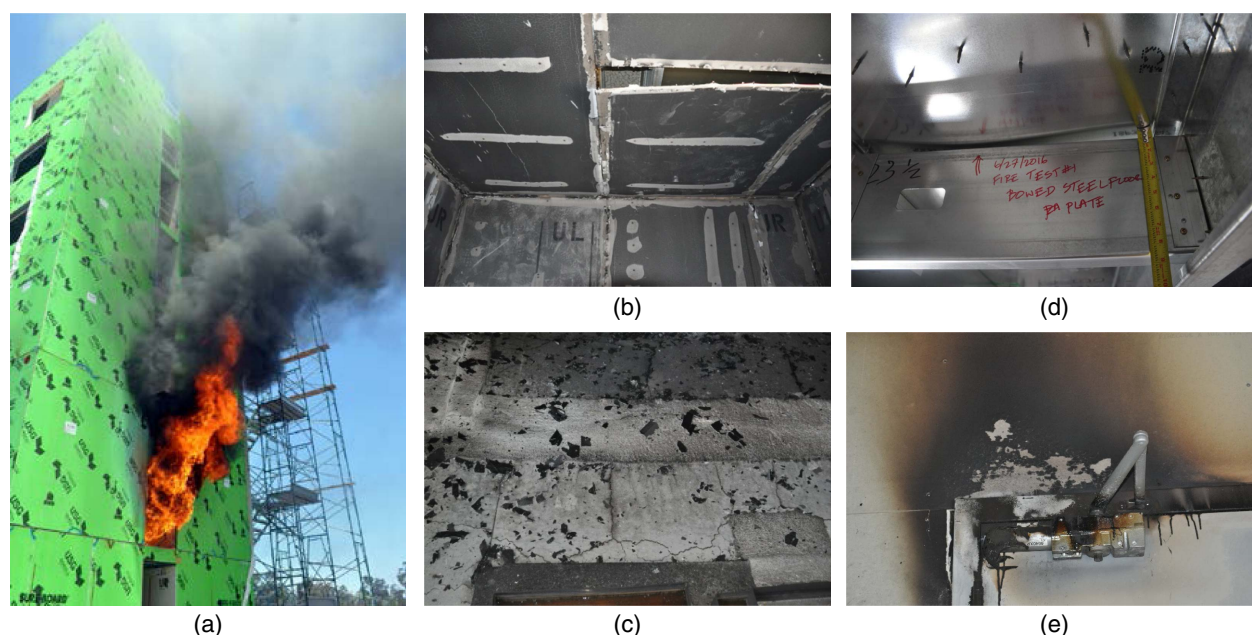
The elevated compartment temperatures during the fire tests resulted in dehydration and shrinkage of the wall and ceiling gypsum boards and fiber cement boards on the floor diaphragms [Figs. 11(b and c)]. Fire-induced damage to the wall and floor sheathing resulted in significant strength and rigidity loss of these structural components. Specifically, the fire-induced structural damage occurred in the form of (1) partial detachment of gypsum ceilings [Fig. 11(b)], and (2) significant deflections (~ 1.5 cm) of the floor diaphragm at the second floor as a result of deteriorated cement boards on top of the sheet steel [Fig. 11(d)]. In addition, the building egress was compromised following the fire tests as a result of the loss of functionality of the doors due to the fire-induced damage to the door components [Fig. 11(e)].

Fig. 11. Fire-induced damage to the building system: (a) flame and smoke extension through the east corridor opening (Fire test 3); (b) partially detached ceiling gypsum board; (c) shrinkage and cracking of the cement board on the floor; (d) excessive floor deflection due to diaphragm sagging; and (e) melted door closer latch. (Images by Xiang Wang.)

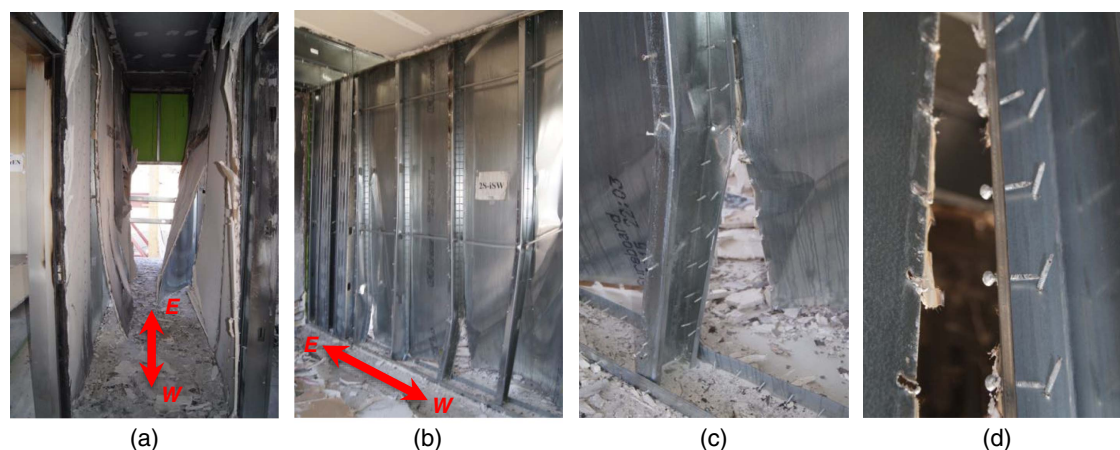
The final building inspection (post-EQ9) involved detailed documentation of the damage of the gypsum sheathing and subsequently the steel framing and the sheathing steel of the structural panels by removing the room-side interior gypsum panels. Importantly, the severe damage to the structural components of Level 2 revealed the ultimate damage mechanism of the building lateral-loading resisting system. Evident in the final inspection was the near-complete tearing of a large extent of the structural sheathing, partial or full delamination of sheathing face gypsum, and associated detachment of the gypsum on the opposite side of the shear walls (Fig. 13).

Consequently, the structural integrity of the shear walls was compromised due to extensive global and local buckling of the wall framing members [Figs. 13(b and c)]. The test building, however, resisted collapse largely due to redistribution of loads and the framing action provided by the continuous tie-rod and compression stud

Fig. 13. Interior view of the Level 2 corridor shear wall damage at the end of the test program (arrow denotes the direction of shaking): (a) corridor (viewing eastward); (b) southwest room; (c) buckling and bending of framing stud precipitated by loss of sheathing fasteners; and (d) structural panel fastener tearing. (Images by Xiang Wang.)
