## Case Study Evaluation of Farm and Commercial Grain Bins during the August 2020 Iowa Derecho Windstorm

Christine E. Wittich, Ph.D.<sup>1</sup>; and Benjamin Praeuner<sup>2</sup>

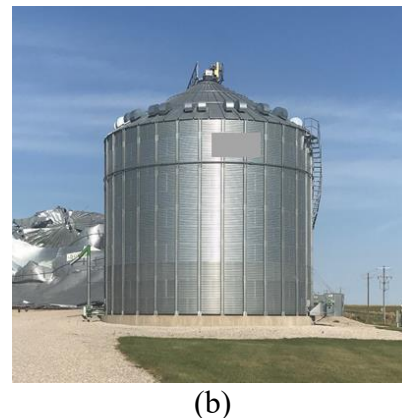
Figure 3b is a photograph of Bin 5 from the west taken during reconnaissance. As can be seen, the sidewall of the bin includes vertical stiffeners along the wall height and a single wind ring. The wind ring is located 31 ft from the base of the bin and is connected to the vertical stiffeners. The vertical stiffeners, which consist of steel channels, are placed approximately every 5 ft along the circumference of the bin. The channels are continuous for 88 inches and are bolted to the corrugated panels every 4 inches. The vertical stiffener is connected to the anchorage at the base of the bin by a  $\frac{3}{4}$ -inch embedded anchor. A close-up of the anchorage of this stiffener is shown in Figure 4a.

**Figure 3. (a) Layout of the grain bins including identification of farm vs commercial styles and diameters. (b) Photograph of Bin 5 (commercial bin). Photograph by C.E. Wittich.**

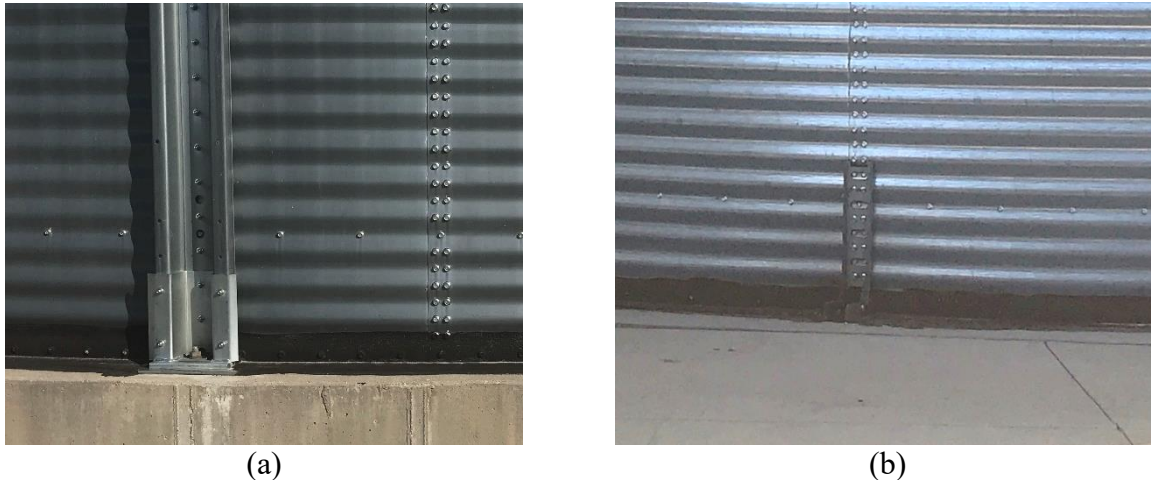
Bins 1 – 4 (farm bins) were by the same manufacturer and of identical overall geometry to Bin 5 (commercial bin). Similar to Bin 5, Bins 1 – 4 were characterized by a single wind ring that was located 31 ft from the base of the bin. In the absence of vertical stiffeners along the height of the sidewall, the wind ring was attached to short, steel channels that are similar to the vertical stiffeners of Bin 5. However, these short channels only span one corrugated wall panel (3.75 ft). These short channels are similarly attached to the corrugated wall panels by bolting every 4 inches. Bins 1 – 4 primarily differed from Bin 5 by the absence of vertical stiffeners. As a result, the anchorage of Bins 1 – 4 also differs from Bin 5. Figure 4 compares the different anchorage techniques. While Bin 5’s anchorage is directly connected to the vertical stiffeners, Bins 1 – 4 incorporate a short channel section of approximately 16 inches that is bolted to the corrugated panel every 4 inches. While Bins 1 – 4 have a similar anchorage spacing of 5 ft along the circumference of the bin, the embedded anchors are  $\frac{1}{2}$ -inch in diameter compared to the  $\frac{3}{4}$ -inch embedded anchors of Bin 5.

**Figure 4. (a) Vertical stiffener and anchorage for Bin 5 (commercial bin). (b) Typical anchorage clip for Bins 1 – 4 (farm bins).**

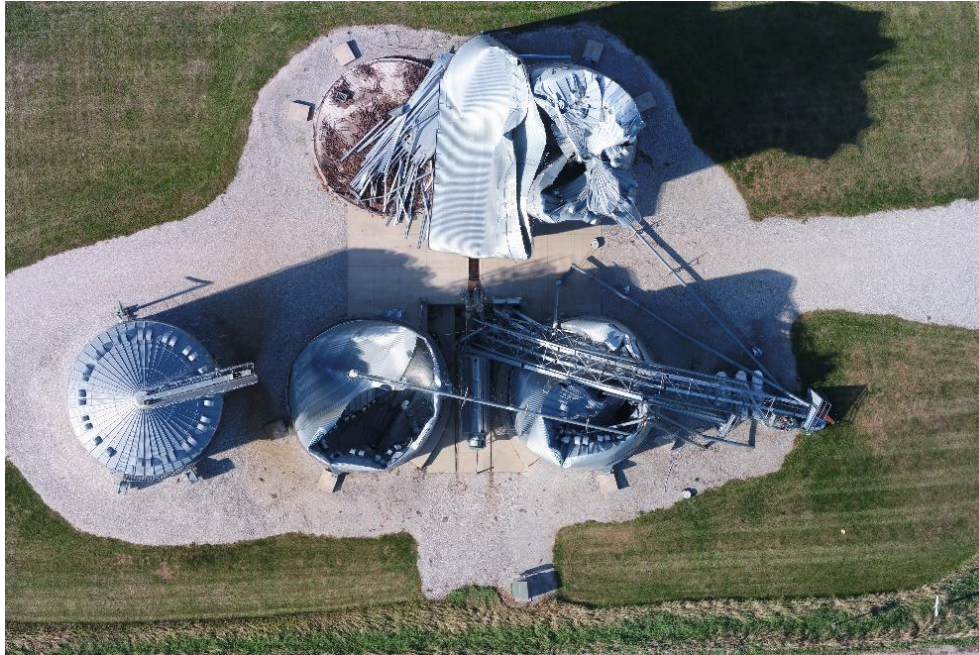
As shown in the orthomosaic of Figure 5 and the point cloud of Figure 6, Bins 1 – 4 were completely destroyed in the windstorm while Bin 5 survived undamaged. The wind direction was predominantly from the west-northwest causing Bins 3 and 5 to be on the windward side of the bin group. Bin 3 evidenced roof tearoff and sidewall buckling, which was followed by anchorage tearout from the concrete foundation (see Figure 7a). A centrally-located truss structure associated with filling of the bins also collapsed. The truss was found to be bent over Bin 2 with the short concrete foundation completely uplifted off the ground. Failure of this truss resulted in the crushing of Bin 2, rather than a wind failure of Bin 2 (see Figure 7b).

**Figure 5. Orthomosaic of case study site following August 2020 derecho.**

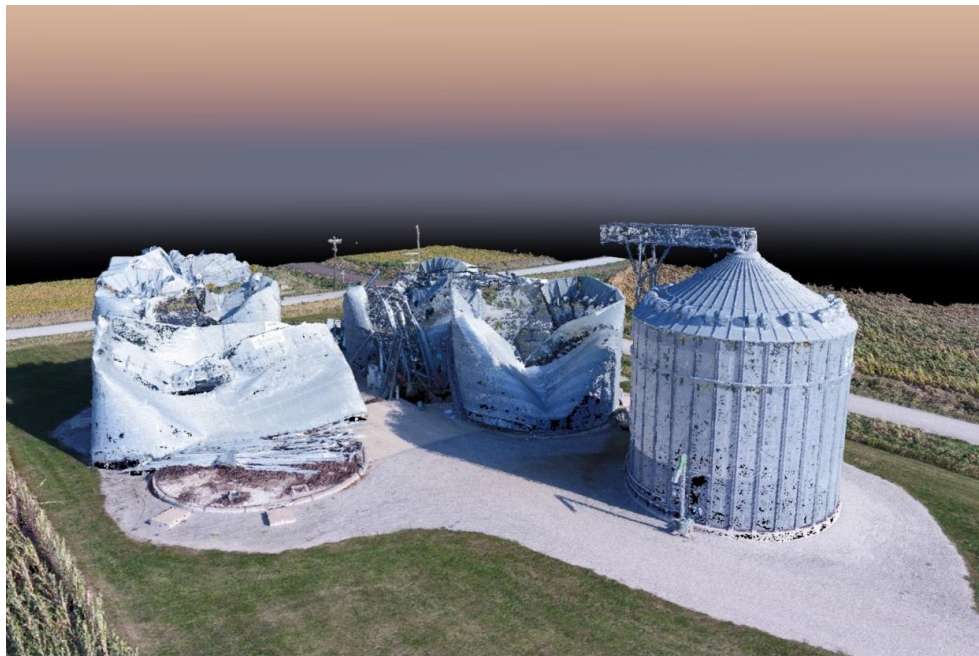
**Figure 6. Isometric view of the three-dimensional point cloud of the grain bin site.**

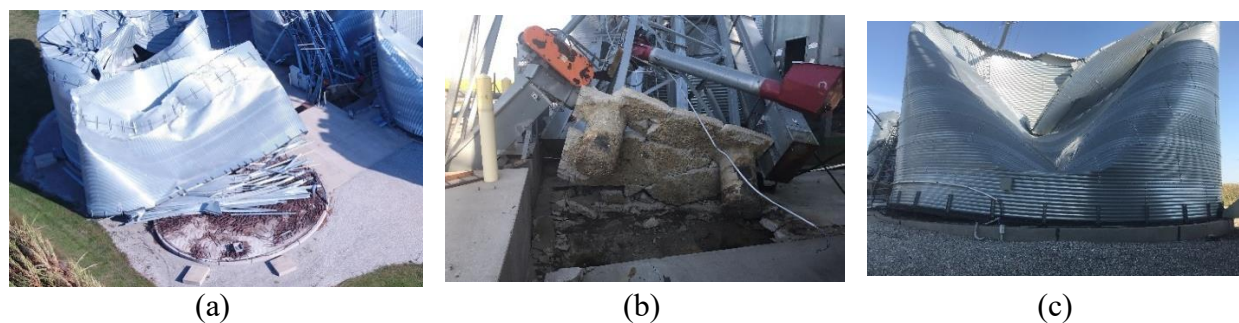
Bin 4, which was exposed on its northwest side, similarly collapsed due to wind pressure (see Figure 7c). The conical roof structure failed and collapsed inwards with several roof-sidewall attachments failing during this process. The sidewall on the northwest (windward) side similarly buckled and the embedded anchors tore out of the concrete foundation on the windward side. Bulging of the sidewall panels on the leeward side was also observed. The buckling failures

observed for Bins 3 and 4 compared with the undamaged state of Bin 5 highlight key differences in the design and construction. While geometrically similar and rated for the same grain capacity, Bin 5 was classified as a ‘commercial bin’ compared to Bins 1 – 4 which were ‘farm bins’. The primary design difference is the presence of vertical stiffeners (steel channels) along the height of the sidewall that connect the roof structure to the foundation through embedded anchors. The vertical stiffeners are well connected to the sidewall through bolts approximately every 4 inches. The stiffeners are placed circumferentially at approximately 5 ft on center. While the design of commercial bins targets large-scale farm operations, these additional design considerations result in a substantial gain in wind resistance for bins of smaller size that are typically comparable with ‘farm bins’.

**Figure 7. (a) Bin 3 with roof tearoff, sidewall buckling, and anchorage tearout. (b) Foundation uplift of central truss structure. (c) Bin 4 with roof collapse, sidewall buckling, and anchorage tearout.**
