Microstructural Defects Governing Torsional Fatigue Failure of Additively Manufactured As-Built and Heat-Treated Inconel 718

Sanna F. Siddiqui^{1*} and Elise Araiza¹

¹Mechanical Engineering Department, Florida Polytechnic University,
4700 Research Way, Lakeland, Florida, US, 33805

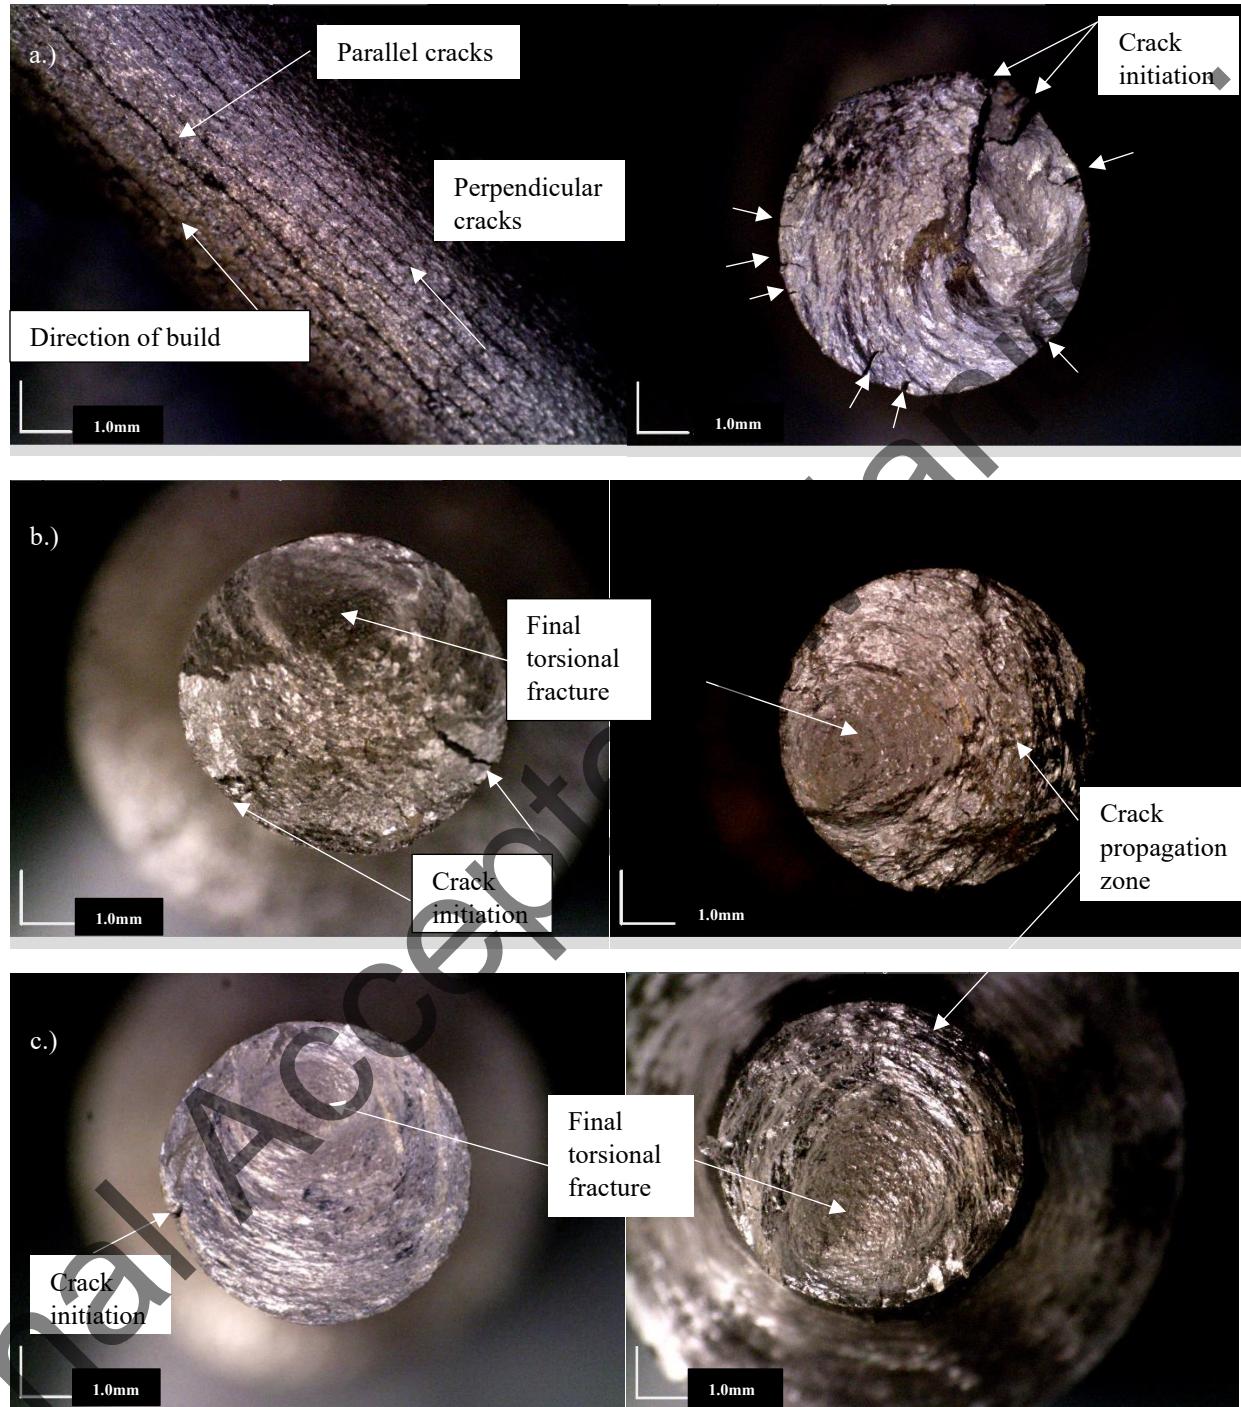
In terms of fracture mechanics response, Figure 3 presents optical micrographic images comparing the torsional fatigue fracture response between as-built and heat-treated DMLS Inconel718, with Figure 3a for horizontal-as-built and horizontal-heat treated specimen, Figure 3b for diagonal-as-built and diagonal-heat treated, and Figure 3c for vertical-as-built and vertical-heat treated specimens respectively. Comparison between the horizontal-as-built and heat treated specimens reveals variation in the torsional fatigue fracture response with torsional fatigue crack propagation evident parallel and perpendicular to direction of build layers for a more brittle fracture response [3, 16] for the horizontal-as-built specimen. This brittle fracture response was also reported in [8] for as-built additively manufactured Inconel 718 specimens, which was suggested to be a result of the specimens not being subject to stress-relief post-processing. In contrast, the horizontal-heat treated specimen exhibits the presence of multiple fatigue cracks initiating at the surface perimeter propagating inwards within the sample. Also evident is the coalescence of 2 major fatigue cracks that initiated from the as-built specimen surface of the horizontal-heat treated specimen, leading to the final torsional fracture zone. With the as-built surface of the specimens maintained, and only variation between the specimens being subjected to the heat-treatment process, the phenomena for torsional fatigue crack initiation appears to be similar, initiating at the surface. This supports findings reported in [1, 26], in which fatigue crack initiation for the as-built specimen condition was found to proceed at the surface regardless of post-processing heat-treatment for axial fatigue studies on AM metal superalloys. Similar fatigue crack initiation sites at the surface are also evident for the diagonal as-built and heat-treated specimens as well as the vertical as-built and heat-treated specimens. Ductile failure mode appears

to dominate for the diagonal and vertical build orientations, which is explored further through SEM analysis.

Figure 3: Optical micrographs of specimen fracture surfaces: a) horizontal-as-built & heat treated; b) diagonal- as-built & heat treated; c) vertical- as-built and heat treated.

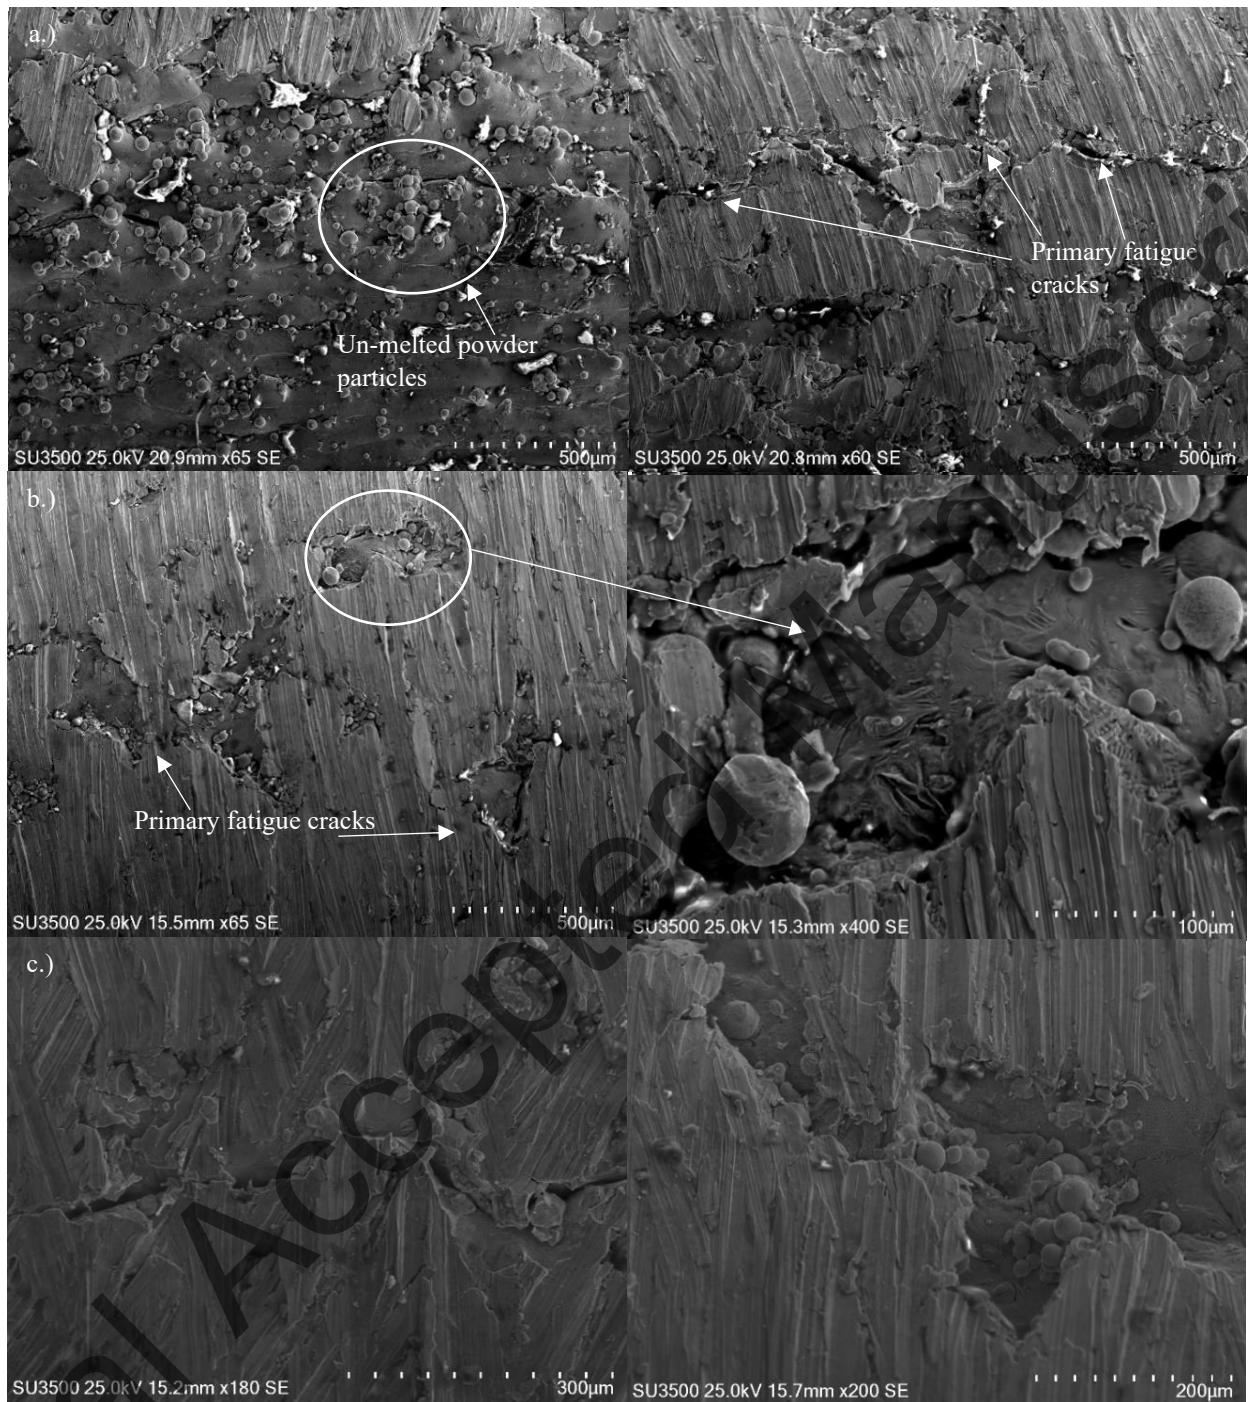
SEM micrographic images were taken on samples manufactured along each build orientation (horizontal, diagonal, and vertical), and under each post-processing condition (i.e., as-built, heat-treated) to identify the microstructural defects induced through the additive manufacturing process in driving torsional fatigue failure. Figure 4 presents SEM images of surfaces of the horizontal-built samples, in the as-built condition, where torsional fatigue cracks were observed to initiate and propagate. Primary torsional fatigue cracks are observed to propagate along regions of unmelted powder particles on the rough sample surface. At higher resolution, as shown in Figure 4b, it appears that lack of fusion regions may be apparent, from which torsional fatigue cracks are commencing. This torsional fatigue crack propagation response is similar for all as-built samples, which were manufactured in the horizontal xy build plane, and supports their exhibited similar shear properties reported in [3]. Upon SEM analysis of heat-treated DMLS Inconel 718 horizontal-build fracture surface (Figure 5), multiple cracks initiating at the surface are evident, with crack sizes varying in size with smaller cracks ranging from approximately 0.10mm to 0.36mm in size to larger size cracks ranging from 0.84mm to 3.06mm in size. The larger cracks appear to coalesce and propagate to the final torsional fracture zone. A similar phenomena was reported on torsional fatigue testing of AM Ti-6Al-4V [28]. In terms of additively manufactured induced microstructural defects, regions of lack of fusion and un-melted powder particles appears near the sample surface perimeter and are suggested to have led to torsional fatigue crack initiation. The size of lack of fusion regions appears on the order of 38 μ m with un-melted powder particles of approximately 6 to 7 μ m apparent in SEM images.

Figure 4: SEM micrographic images of L-PBF Inconel 718-horizontal-as-built specimens: a) un-melted particles within crack propagation paths on sample surface; b)-c.) primary fatigue crack paths.

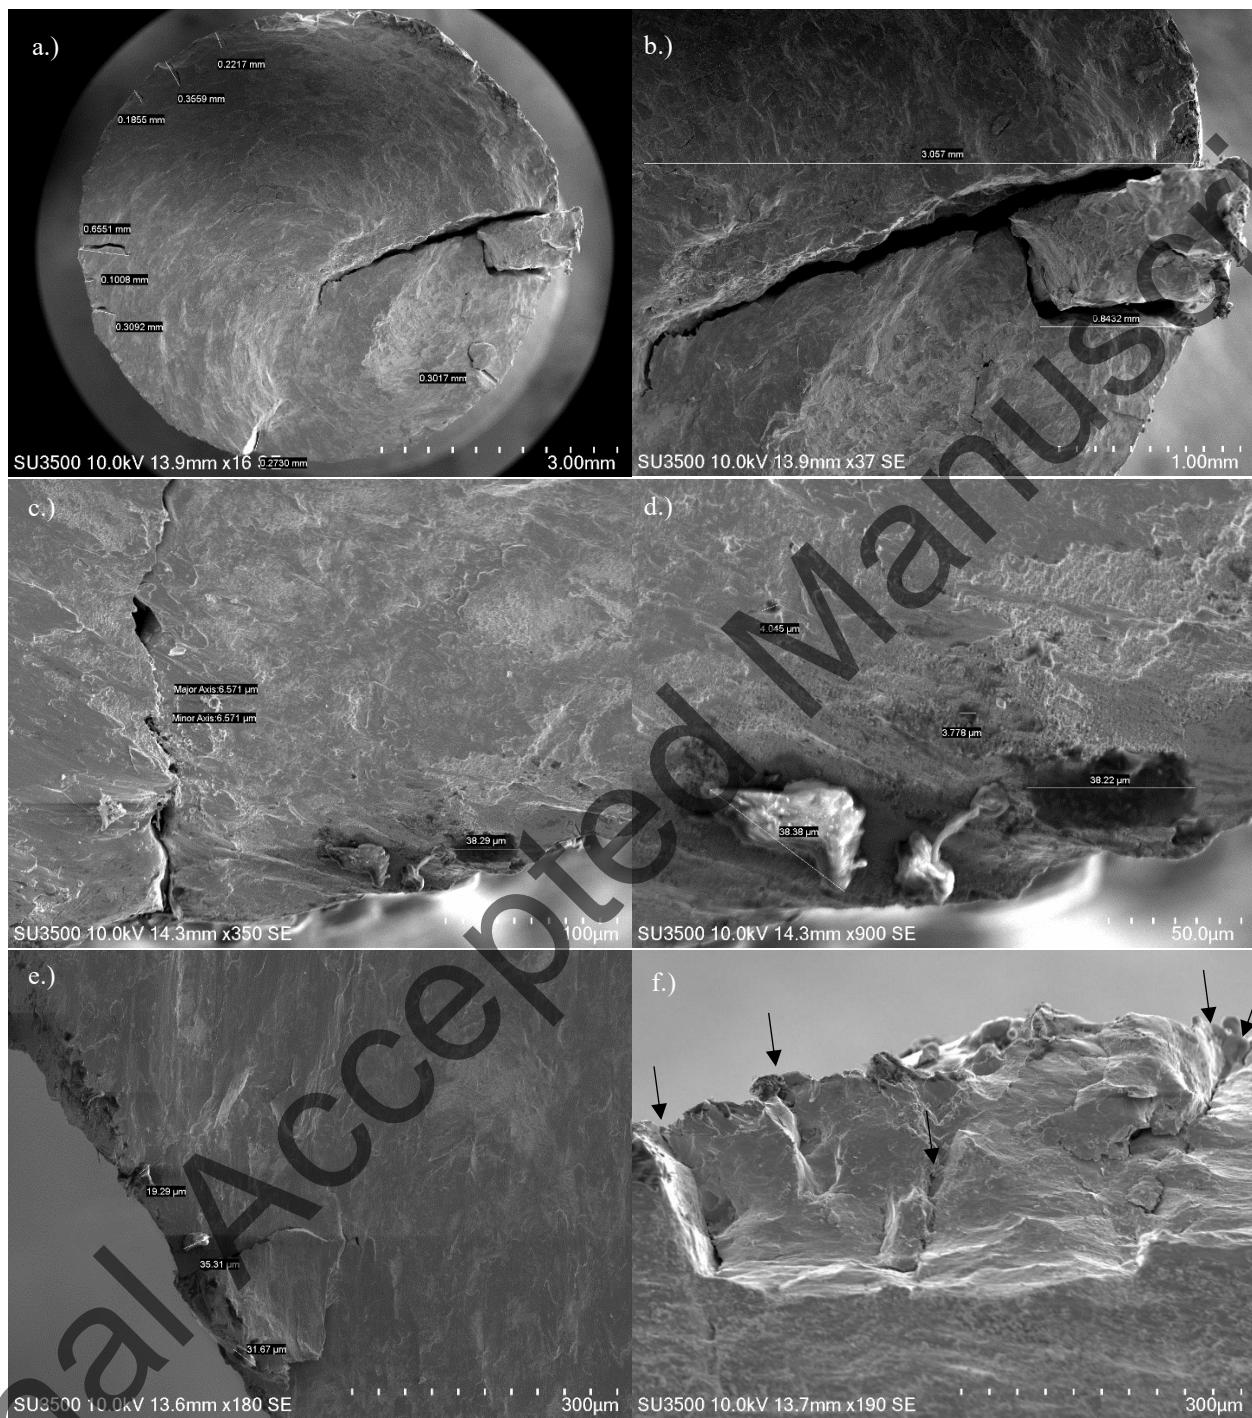
Figure 5: SEM micrographic images of L-PBF Inconel 718 horizontal-heat treated: a) overall fracture surface; b) coalescence of primary fatigue cracks initiating from surface; c), d), and e) lack of fusion regions and un-melted powder particles near sample surface resulting in multiple crack initiation sites shown in f.).

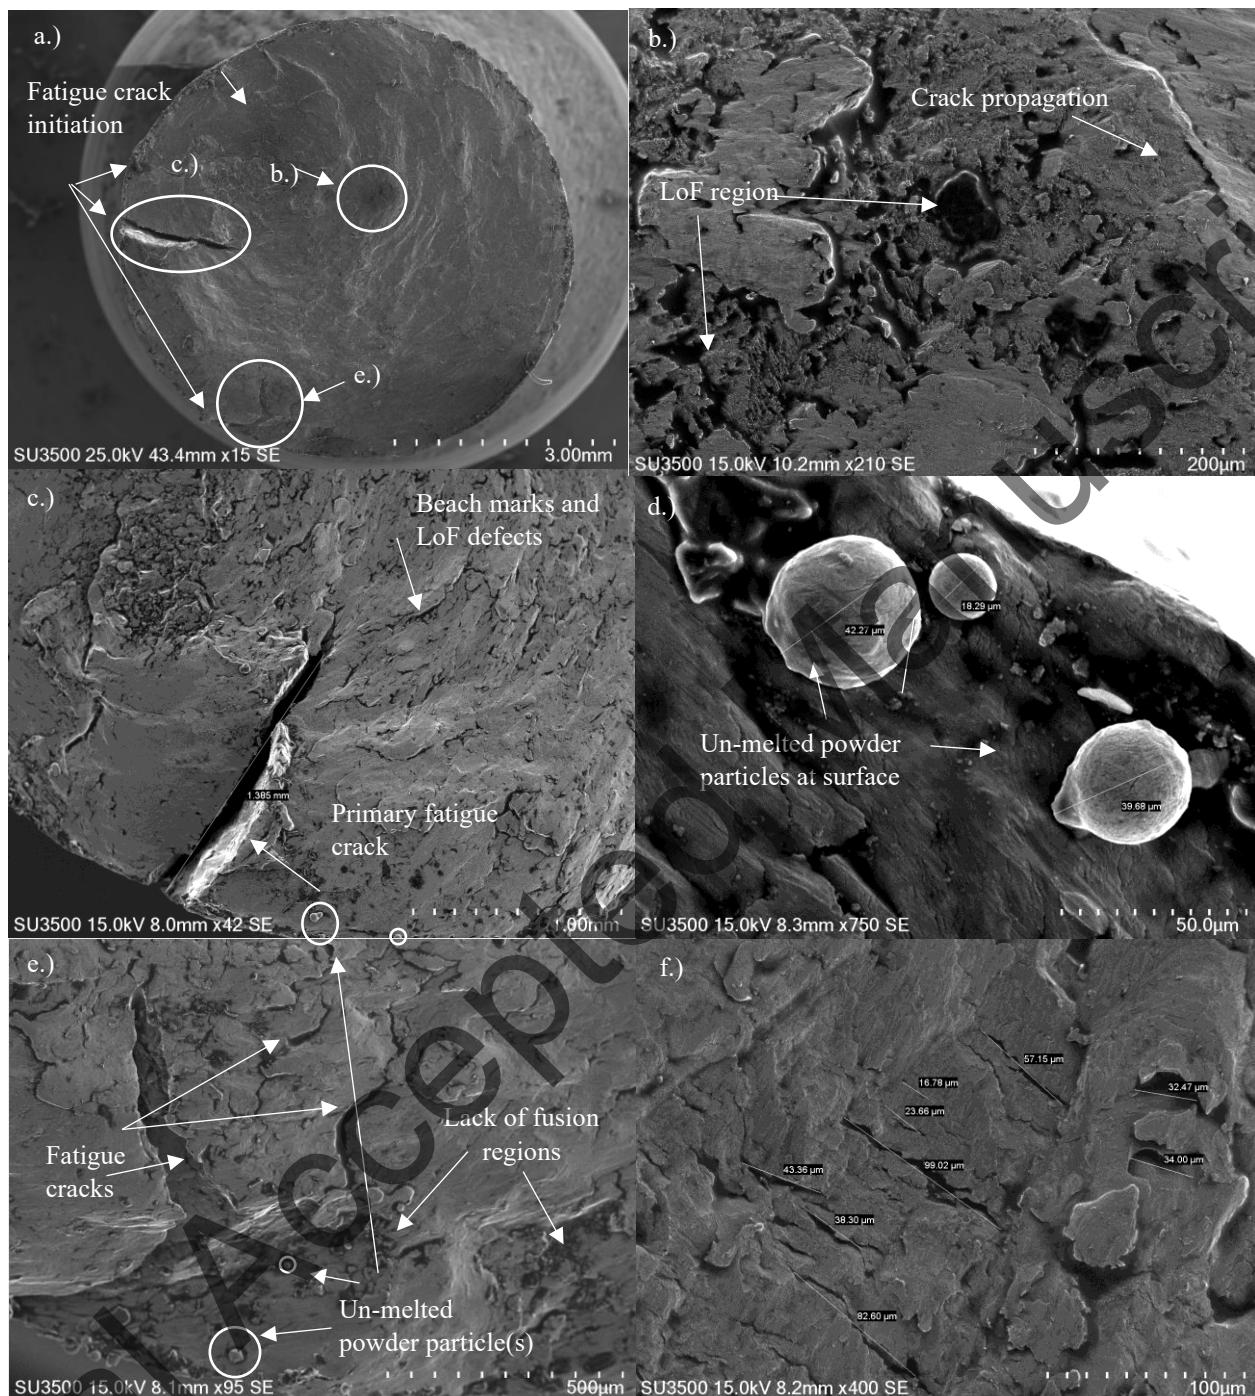
SEM analysis of microstructural defects driving torsional fatigue failure of as-built diagonal-build samples is as shown in Figure 6 and 7 respectively. Compared to the horizontal-build samples, there is a significant quantity of lack of fusion regions and un-melted powder particles evident around the sample perimeter that appear to serve as sub-surface defects at which torsional fatigue crack initiation is evident. Un-melted powder particles at the surface ranged in size from approximately 18 μ m to 42 μ m. Considerable lack of fusion defects are also evident within torsional fatigue crack propagation region of fracture surface for the as-built diagonal build orientation. SEM images from heat-treated diagonal-build reveal traces of scattered un-melted powder particles on fracture surface. Due to the as-built surface, torsional fatigue crack initiation was also observed to initiate at sub-surface defects of lack of fusion regions and un-melted powder particles at the surface, regardless of the heat-treatment process. The final torsional fracture zone exhibits a dimpled rupture evident by microvoid coalescence, suggesting that ductile failure mode dominated fracture.

Figure 6: SEM micrographic images of L-PBF Inconel 718 diagonal as-built: a) overall fracture surface; b) visible lack of fusion area within crack propagation beach mark region; c) primary fatigue crack initiating at surface/subsurface defects; d) unfused metal particles on surface of material near edge; e.) and f.) multiple fatigue cracks initiating near lack of fusion regions.

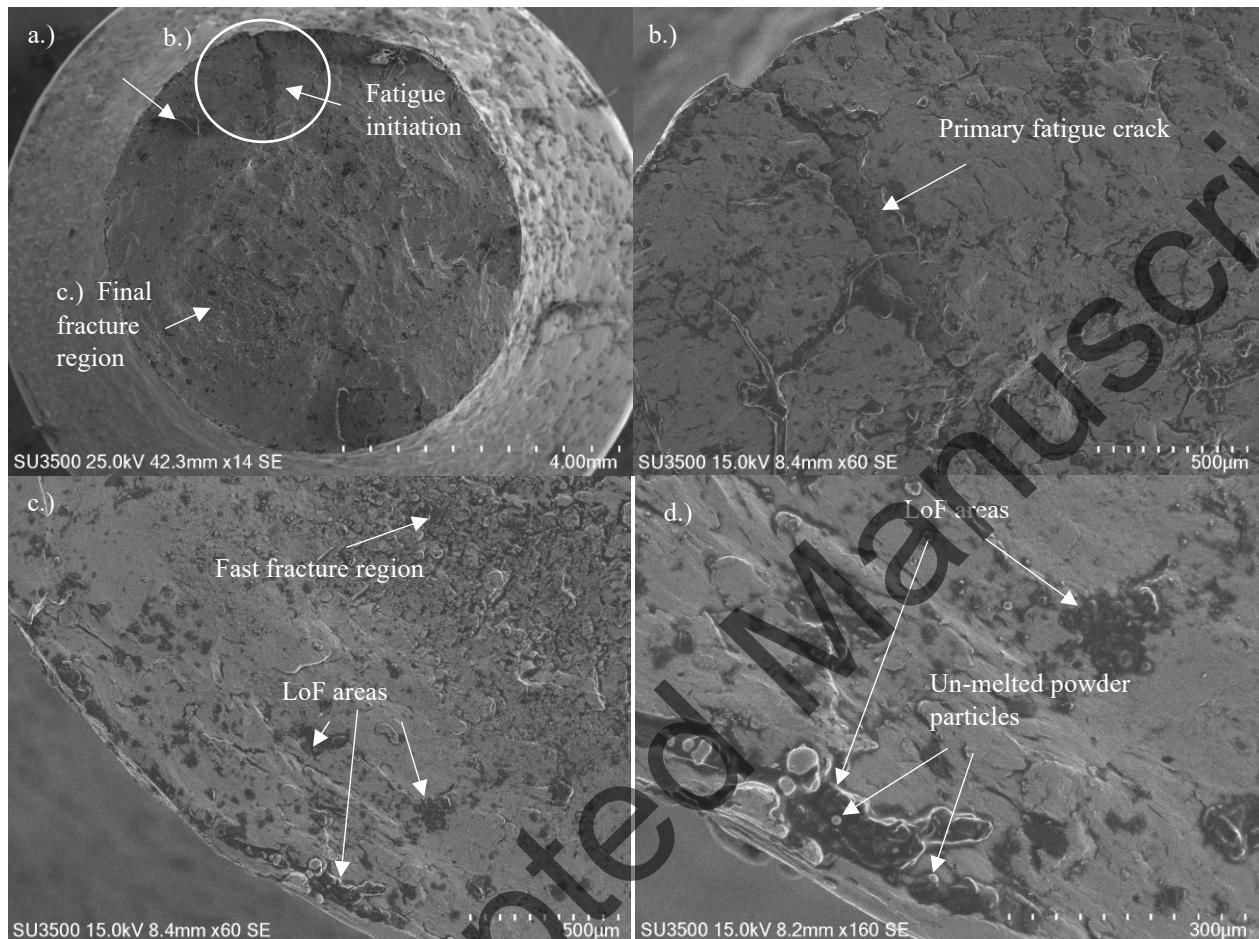
Figure 7: SEM micrographic images of L-PBF Inconel 718 diagonal as-built: a) overall fracture surface; b) primary fatigue crack initiating at surface; c) fast fracture region with lack of fusion regions evident along sample perimeter; d) high resolution of lack of fusion regions with un-melted powder particles near sample surface.

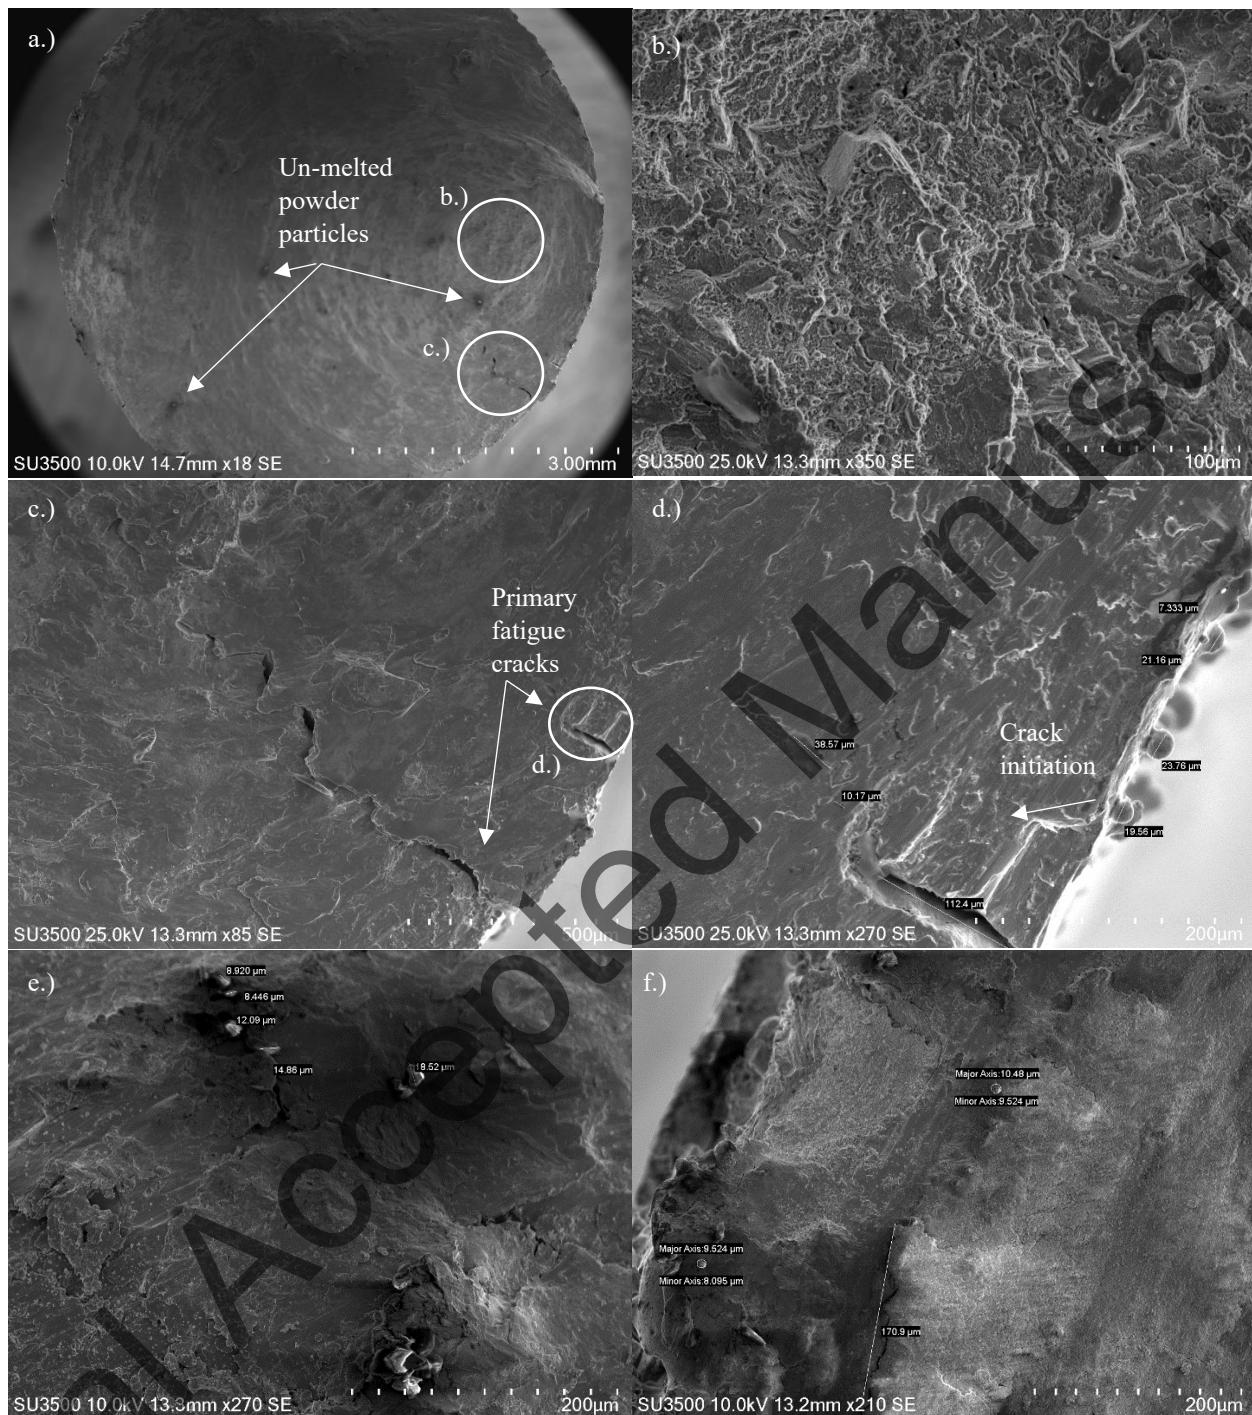
Figure 8: SEM micrographic images of L-PBF Inconel 718 diagonal-heat treated: a) overall fracture surface; b) microvoid coalescence at final torsional fracture zone; c) and d.) primary fatigue cracks initiating at surface; e.) and f.) lack of fusion regions and un-melted powder particles defects within sample.

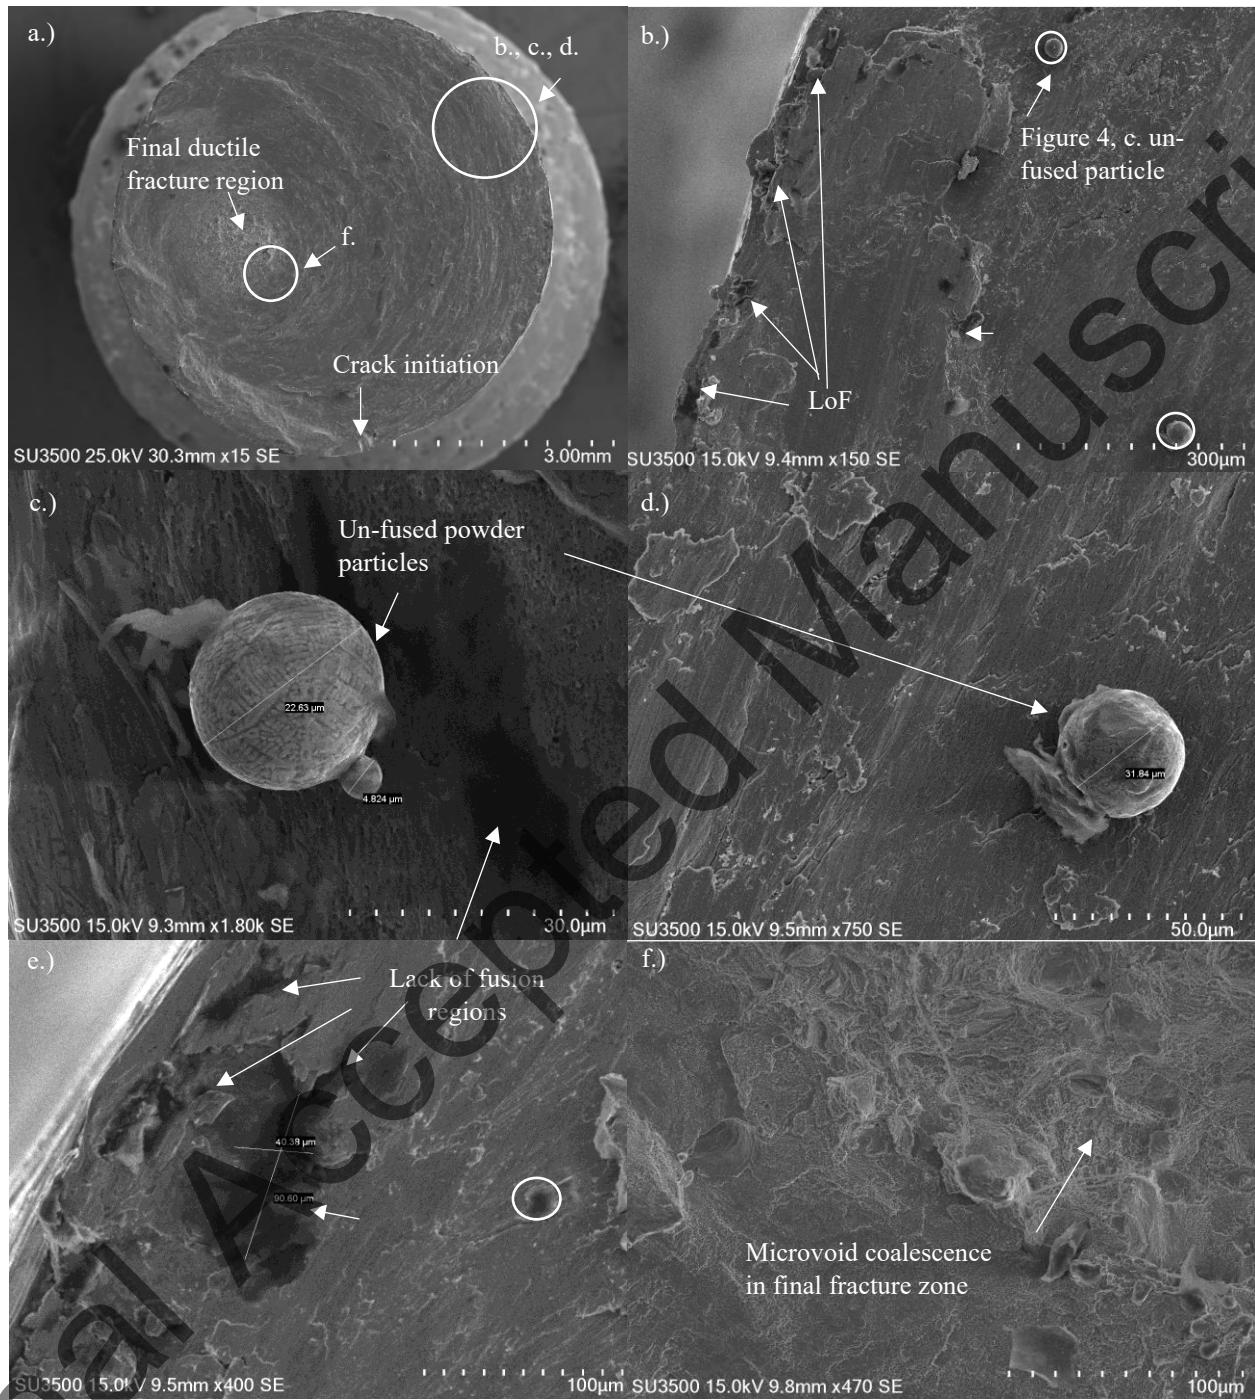
Upon analysis of the vertical-build DMLS Inconel 718 as-built specimen (Figures 9 and 10), scarce traces of lack of fusion regions and un-melted powder particles are evident around sample perimeter, from analysis of fracture surface. Ductile fracture mode dominated failure as evident by microvoid coalescence. Analysis of heat-treated vertical-build DMLS Inconel 718 specimen reveals multiple fatigue crack initiating around surface perimeter where lack of fusion regions are evident. Due to the as-built surface, torsional fatigue crack initiation was also observed to initiate at sub-surface defects of lack of fusion regions, regardless of the applied heat-treatment process. Microvoid coalescence in final peak fracture region revealed evidence of ductile fracture response.

Figure 9: SEM micrographic images of L-PBF Inconel 718 vertical as-built: a) overall fracture surface; b) un-melted powder particles, balling, and lack of fusion defects evident near sample edge; c)-d) high resolution image of un-fused metal particle alongside a lack of fusion region; e) lack of fusion region near the specimen edge; f) region of microvoid coalescence leading to peak of failure.

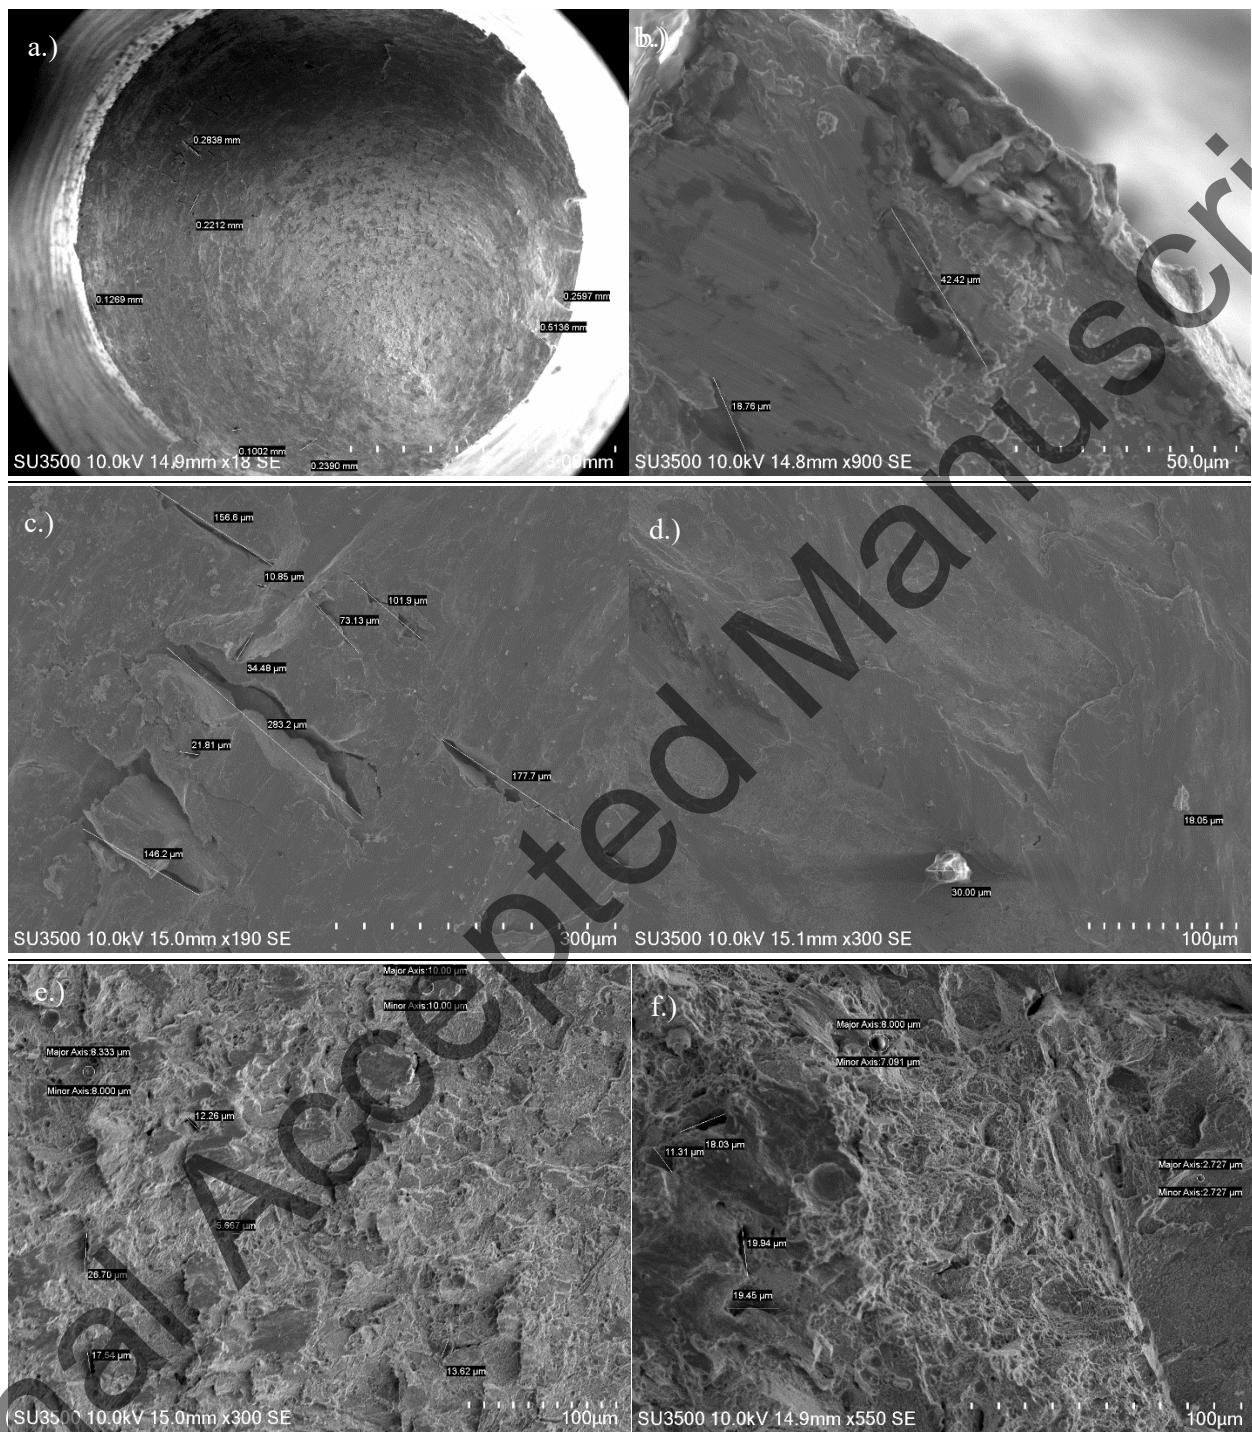
Of interest, are traces of un-melted powder particles and lack of fusion regions around dimpled rupture. The presence of these defects may correlate to the reported lower shear modulus reported [7] for heat-treated DMLS Inconel 718 as compared with as-built DMLS Inconel 718 [3], manufactured with the same EOS optimized additive manufacturing processing parameters.

Figure 10: SEM micrographic images of L-PBF Inconel 718 vertical-heat treated: a.) overall fracture surface; b.)-f.) lack of fusion regions and un-melted powder particles apparent in fracture surface.

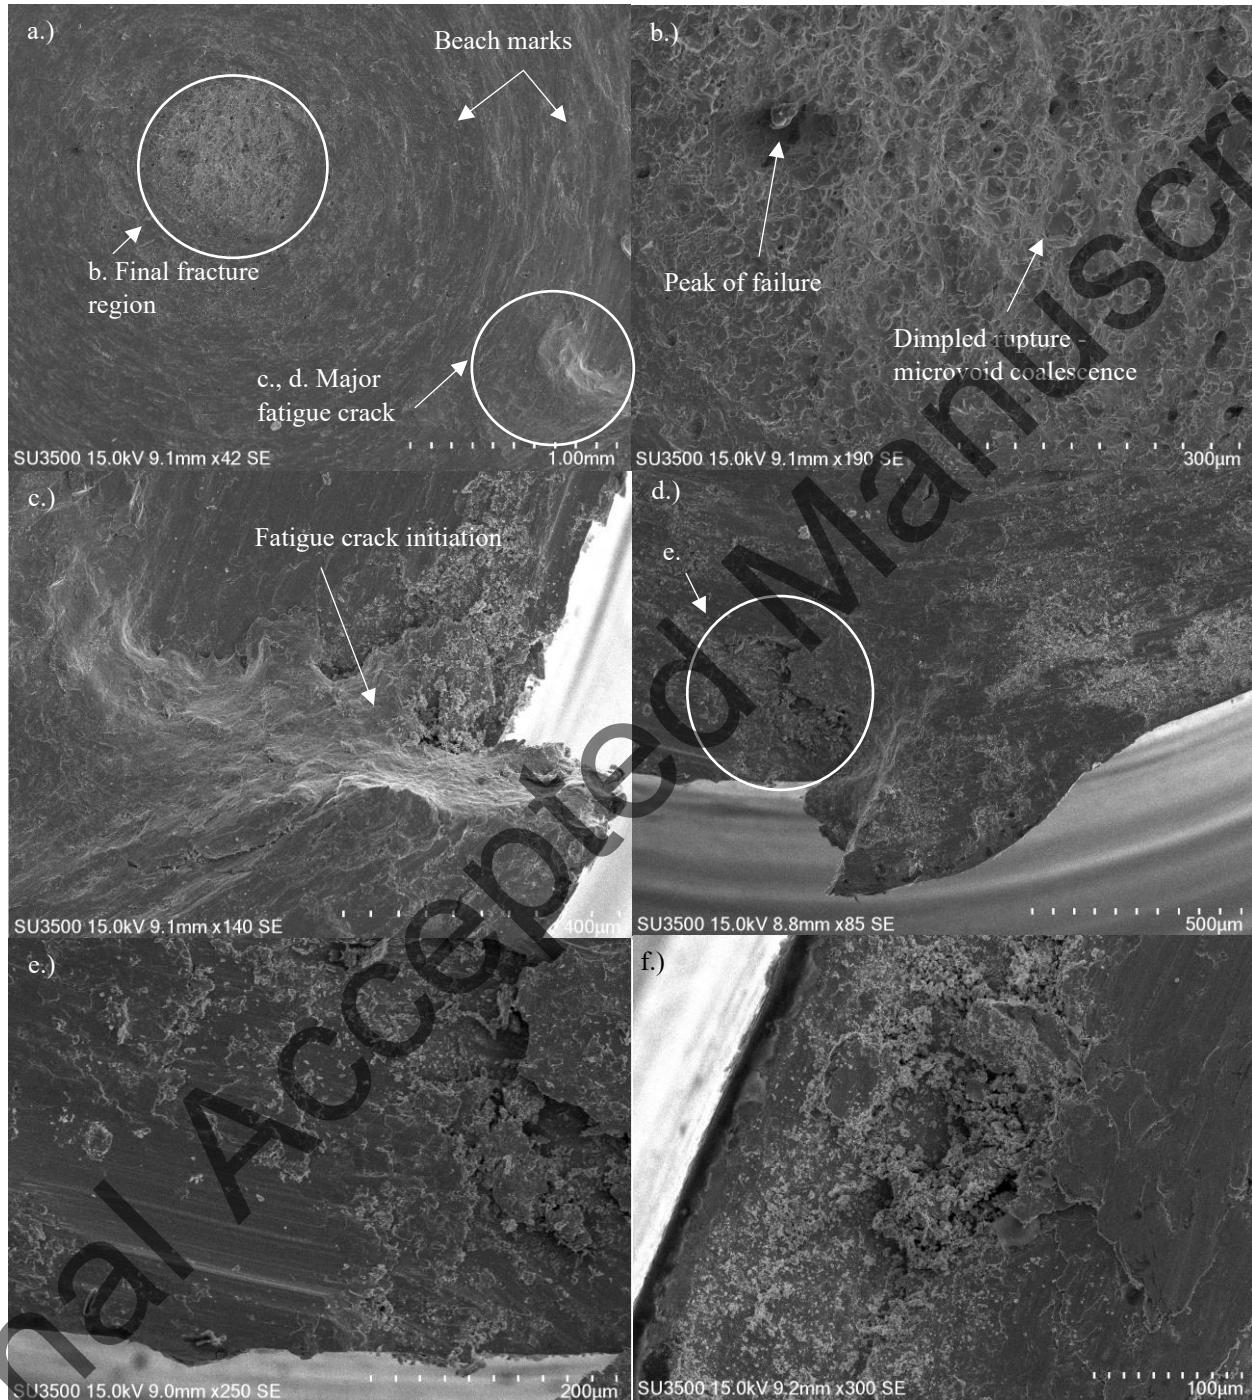
To compare the fracture mechanics response under torsional fatigue loading conditions exhibited by additively manufactured specimens, wrought Inconel 718, with a temper rating of softened (annealed) was subjected to similar experimental conditions. It was reported to yield shear properties similar to the vertical-build as-built DMLS Inconel 718 specimen [3]. An analysis of the fracture surface in Figure 11 revealed a ductile fracture response, evident by microvoid coalescence, similar to the final fracture response exhibited by the vertical-build DMLS Inconel 718 specimens. An analysis of the surface topography revealed considerable texture especially in the region of torsional fatigue crack initiation, which was in contrast to the surface topography exhibited by the vertical build DMLS Inconel 718 samples.

Figure 11: SEM micrographic images of Inconel 718 wrought (soften annealed): a) overall fracture surface; b) dimpled and microvoid coalescence region leading to peak of failure, c)-f.) fatigue crack initiation site.
