## Geotechnical reconnaissance findings of the October 30 2020, Mw7.0 Samos Island (Aegean Sea) earthquake

### Abstract

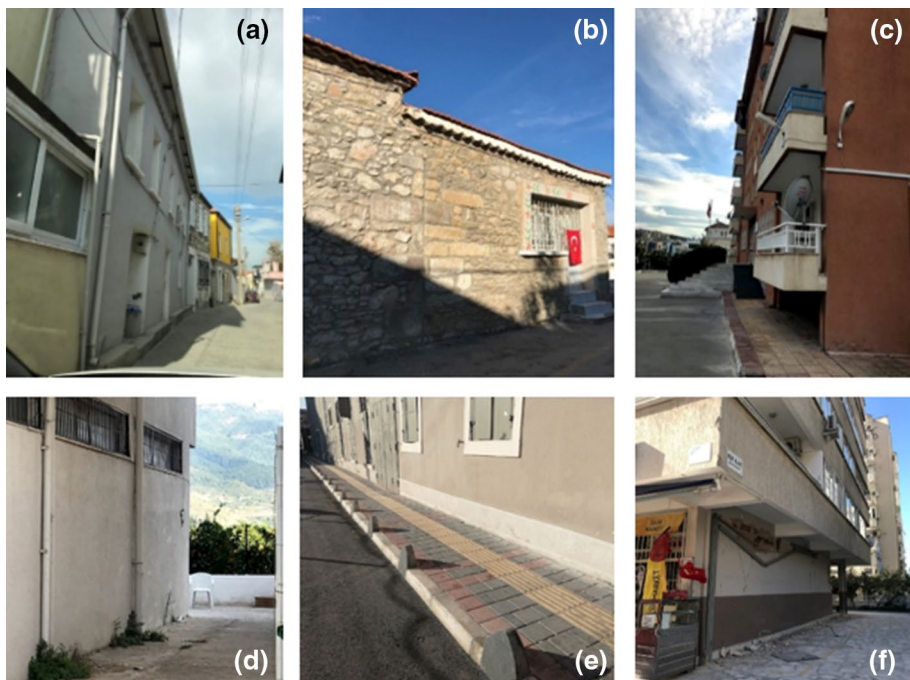
**Fig. 1** Indicative cases of satisfactory foundation performance on the Anatolian side: **a** Urla, **b** Cesme, **c** Kusadasi, **d** Gumuldur, **e** Izmir Konak, and **f** Izmir Bayrakli

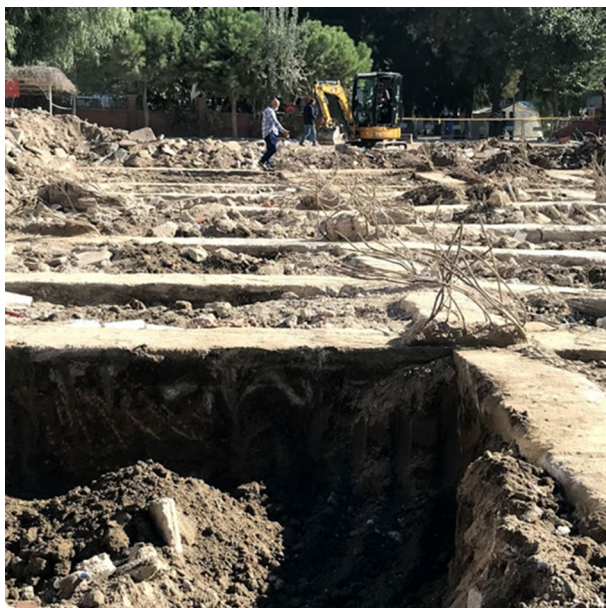
**Fig. 2** Two-way combined footing system (grid spread footing foundation) of one of the heavily damaged buildings in Bayrakli, whose collapse is not foundation induced

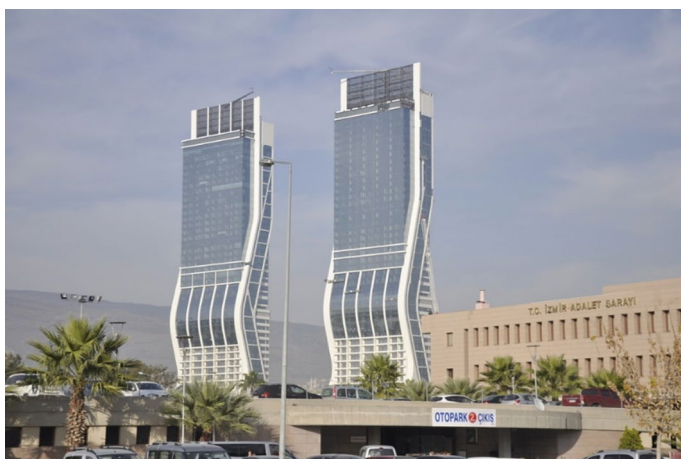
**Fig. 3** 200 m high Twin Folkart Towers in Bayrakli supported on a piled raft system. No earthquake-induced damage was identified or reported for such foundation systems

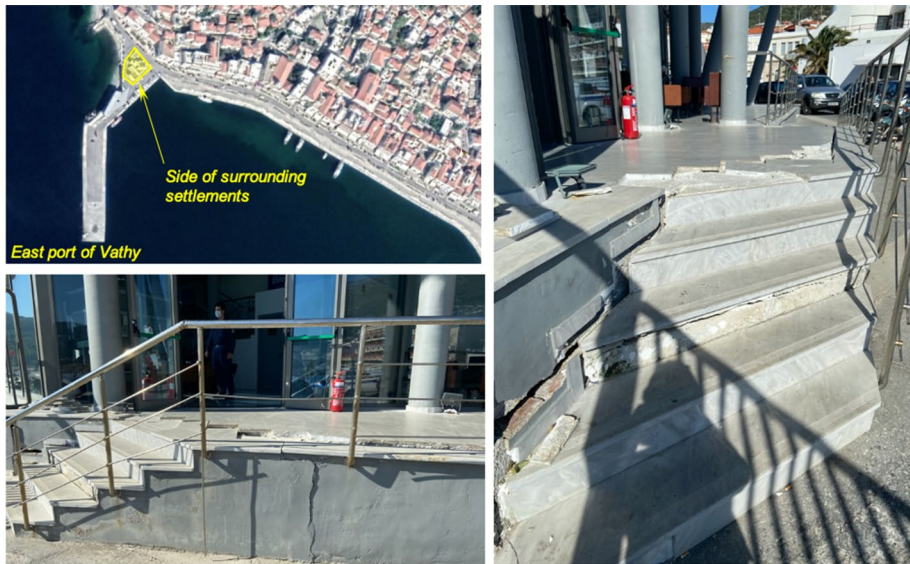
**Fig. 4** Damage observed around the Port authority building in Vathy, Samos (location:  $37^{\circ}45'27.0''$  N  $26^{\circ}58'15.4''$  E). The cracks indicate soil settlement/distortion around the building which remained intact and functioning 8 days after the earthquake

On the island of Samos, no foundation failures were observed in the visited areas, with the possible exception of structural damage due to lateral spreading (see later Sect. 3). Figure 4 illustrates the Port authority building at the Eastern port of Vathy, where the observed damage patterns indicate a satisfactory piled foundation performance. Indeed, despite cracks and settlements around the building, the structure per se remained intact and was operating normally eight days after the earthquake when the HAEE/ETAM team inspected the site. At this point, it remains unclear whether these settlements are related to liquefaction, dynamic compaction, or failure of the retaining wall and an associated overall displacement of the backfilled soil (see Sect. 5 on the performance of the quay wall at the same site.)

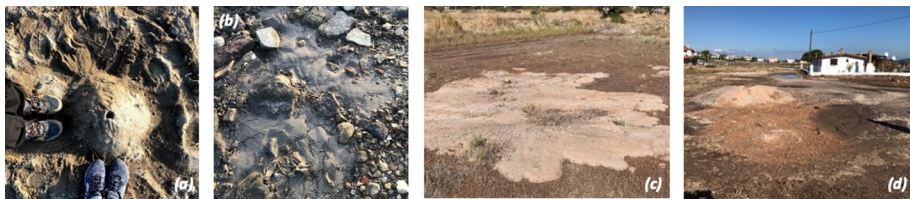
**Fig. 7** Surface manifestations of earthquake-induced soil liquefaction in the form of sand boils at shores of Icmeler and Gulbahce district: **a**  $38^{\circ}20'18.4''$  N  $26^{\circ}38'51.0''$  E, **b**  $38^{\circ}18'37.3''$  N  $26^{\circ}40'47.1''$  E, and **c-d**  $38.338088$  N,  $26.647763$  E

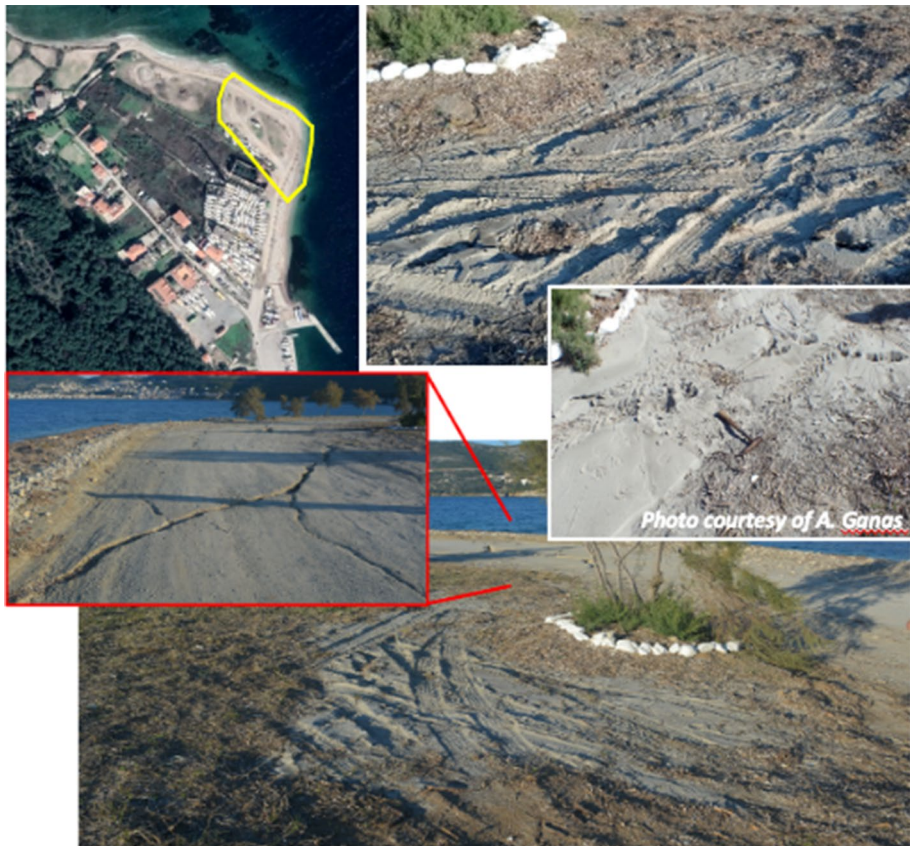
Manifestation of earthquake-induced liquefaction in the free field was observed in the area of Malagari, north-west from the town of Vathy, capital of the island of Samos. Specifically, the reconnaissance team located nearshore surface manifestations of liquefaction in the form of sand ejecta of grey color. As can be seen in Fig. 10, by the time the HAEE/ETAM team visited the site of interest (8 days after the earthquake), the ejecta had been slightly distorted due to the passage of vehicles. Nevertheless, the sand boils and their ejecta alongside with

**Fig. 10** Surface manifestations of earthquake-induced soil liquefaction in the form of sand boils in Malagari (location:  $37^{\circ}45'24.6''$  N  $26^{\circ}57'28.8''$  E—aerial imagery from 3001 ft) [photos taken by the HAEE/ETAM reconnaissance team and Dr. A. Ganas from NOA]

their broader extent were still easily visible and distinguishable. In the same area, ground cracks compatible with a lateral spreading mode of failure were observed and are emphasized in the inset of Fig. 10. The combination of the aforementioned with a free face to water, like in Malagari, eases the process, but lateral spreading has been manifested also in case histories with no free face (e.g. Balboa Boulevard failure during the 1994 Northridge earthquake—e.g. Stewart et al. 1996, Pretell et al. 2020). Trenching and soil sampling at two locations at the Malagari site were performed, which yielded two rough cross-sections and three grain size distributions for samples at three distinct depth intervals at the site illustrated in Figs. 11 and 12 respectively. The fines portion in all three samples was found to be non-plastic.

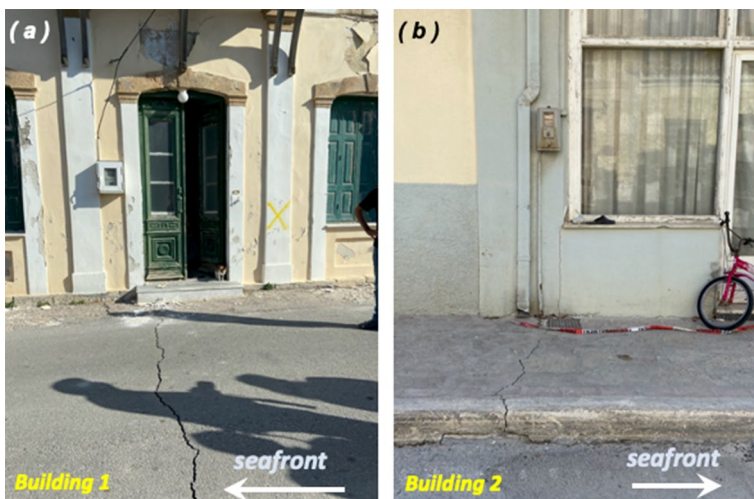
**Fig. 16** Buildings likely affected by lateral spreading towards the seafront in the neighborhood of Vyrsopepsia in Karlovasi **a**  $37^{\circ}47'57.6''$  N  $26^{\circ}42'12.5''$  E and **b**  $37^{\circ}47'59.3''$  N  $26^{\circ}42'20.0''$  E [photos taken by the HAEE/ETAM reconnaissance team]

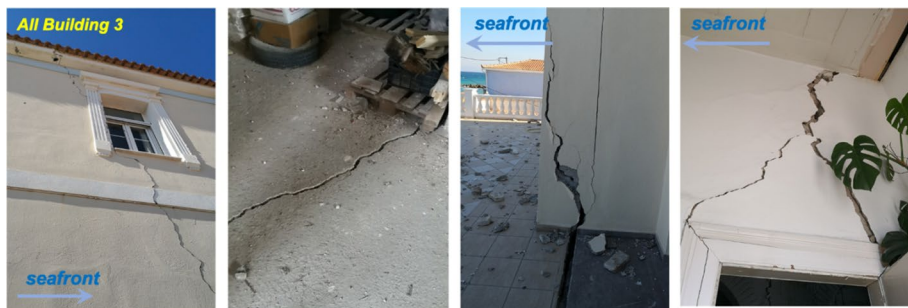
**Fig. 17** Building affected by lateral spreading towards the seafront in the neighborhood of Vyrsopepsia in Karlovasi ( $37^{\circ}48'01.1''$  N  $26^{\circ}42'20.6''$  E). The cracks observed running across the building indicate 3–5 cm of movement [photos courtesy of Prof. K. Antonopoulos]

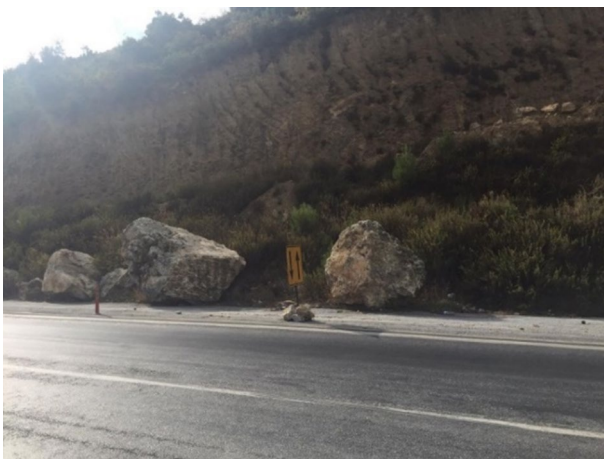
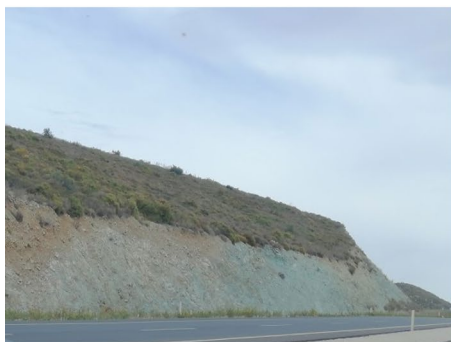
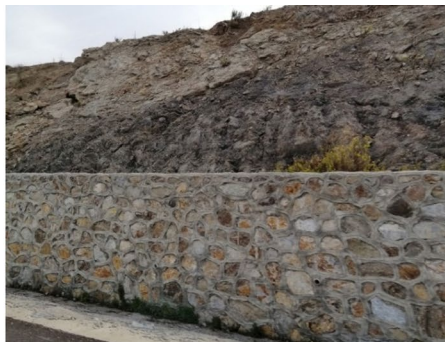
**Fig. 18** Fallen rock blocks in the Anatolian side ( $37^{\circ}53'50.4''$  N  $27^{\circ}22'06.2''$  E)

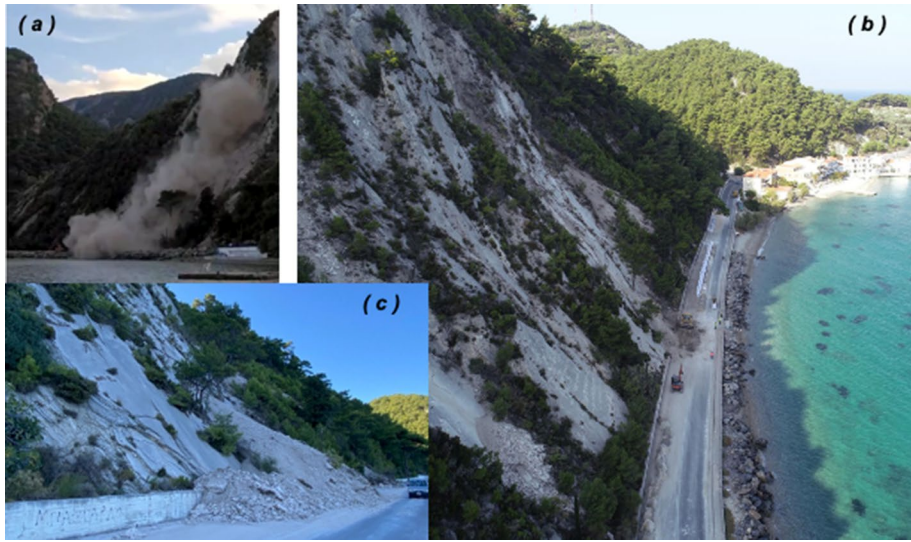
A weathered rock slide was recorded at a steep slope close to Avlakia region (Fig. 21), which caused a temporary closure of the road. The main geological formations in the above area are marbles with intercalations of schist (Cetin et al. 2021). However, the road access

**Fig. 21** **a** Snapshot of Avlakia rockslide from a video recorded during the failure (source: <https://www.cnn.gr/ellada/story/240726/seimos-samos-vinteo-apo-katolisthisi-sta-aylakia>) **b** aerial photograph of the slide 2 weeks after the earthquake (courtesy of I.N. Spyrou and Prof. K. Ziotopoulou 37°47'48.0" N, 26°51'27.7" E), and **c** a closer view of the rockslide illustrating the rock formation more clearly (picture by HAEE/ETAM reconnaissance team)

was quickly recovered after a few days by temporary restraining measures with large concrete blocks placed at the slope toe (Lekkas et al. 2020). Detachments of sandy marls and marly limestones were recorded very close to a residential building in Kokkari region (Fig. 22), while lighter failures referring to rockfalls and detachments of limestones, were observed close to the villages of Potami and Koumeika (Fig. 23a and b respectively). Slope

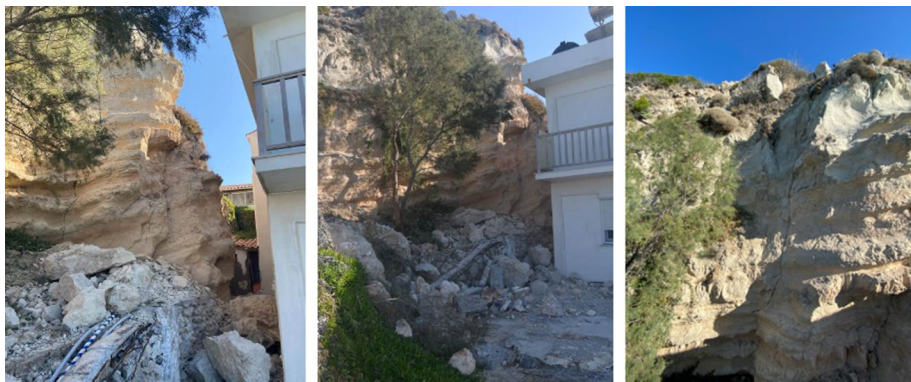
**Fig. 22** Detachment of sandy marls and marly limestones recorded very close to a residential building in the Kokkari region (photos taken by the HAEE/ETAM reconnaissance team, 37°46'49.9" N, 26°53'35.0" E). Vertical open cracks are visible, clearly susceptible to detachment and toppling

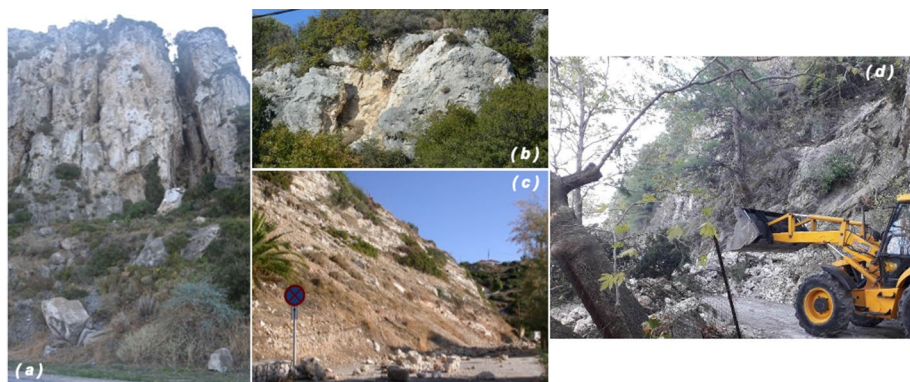
failures of similarly low intensity were also recorded by other reconnaissance teams. These include limestone segments falls in the area of Remataki (next to Pythagorio—Fig. 23c) or rockfalls close to the village Stavrinides (Fig. 23d).

**Fig. 23** **a** Rockfalls observed at the road network close to the village of Potami (photo taken by the HAEE/ETAM reconnaissance team,  $37^{\circ}47'17.6''$  N,  $26^{\circ}40'00.5''$  E), **b** Detachment of limestone segments close to the village of Koumeika (photo taken by the HAEE/ETAM reconnaissance team,  $37^{\circ}42'33.7''$  N,  $26^{\circ}44'52.9''$  E), **c** Falls of limestone segments on a provincial road in the Remataki region (photo reported by Lekkas et al. 2020), and **d** Slope failure close to the village of Stavrinides (photo reported by HSGME 2020)

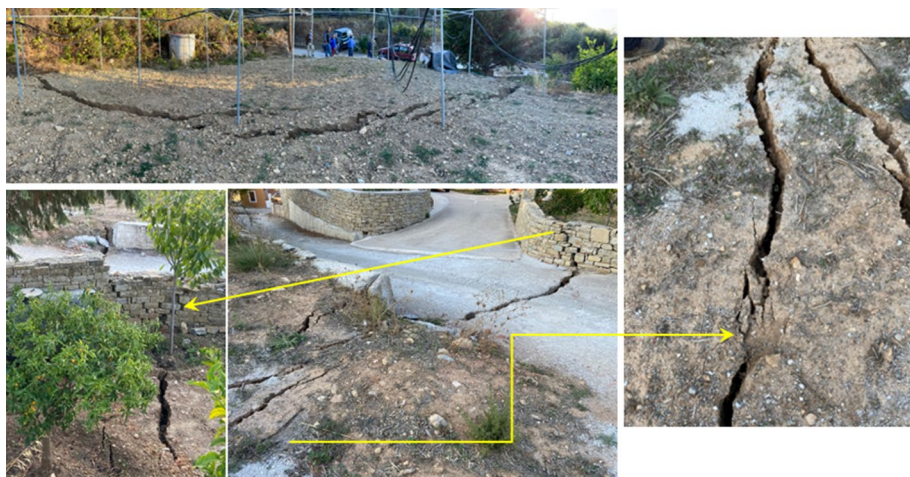
In the village of Kontakeika, extended ground cracks (openings of about 10–20 cm) were observed that were compatible with the mobilization of a larger, albeit very mild, slope or could be more broadly characterized as seismically-induced secondary ground failures (Fig. 24). The HAEE/ETAM team did not locate other similar indications of ground cracking in the near or extended vicinity of Kontakeika so, at this point in time, it is challenging to draw conclusions regarding the nature of this observation. According to local engineers, the Municipality of Samos had repaired the pavement in that particular location several times in the past, which suggests a pre-existing creeping landslide that could have been reactivated by the earthquake. The cracks extended on both sides of the street through soft soil formations (Fig. 24).

**Fig. 24** Ground and pavement cracks in the village of Kontakeika (Samos), indicative of the mobilization of an extended but mild slope or more broadly characterized as seismically-induced secondary ground failures. The cracks extended on both sides of the street through soft soil formations. Arrows in the figure explain the relative location of the cracks

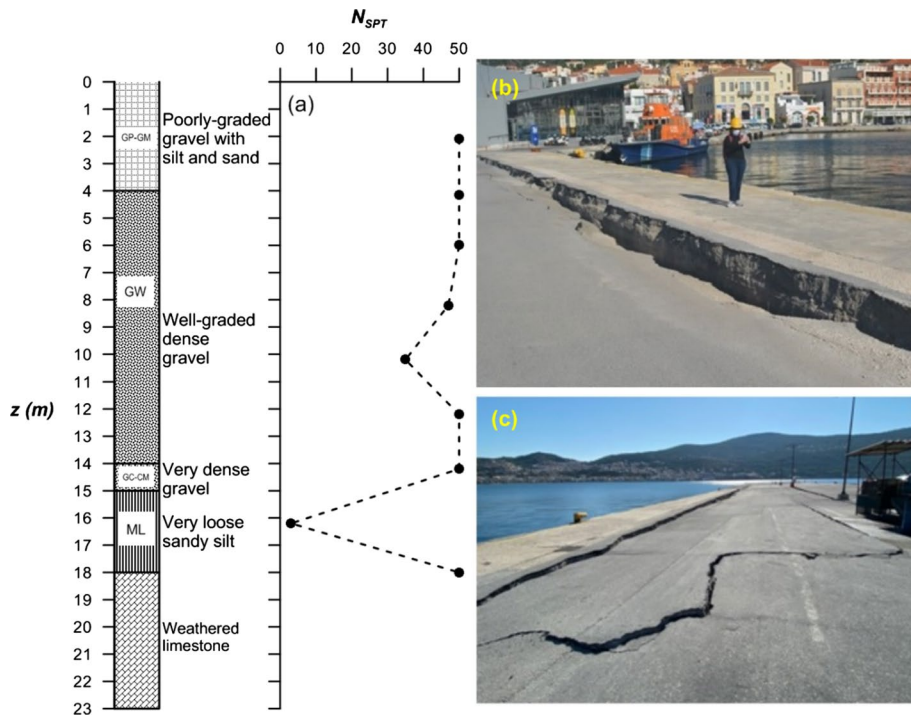
The jetty of the eastern (old) port experienced extensive longitudinal and transverse open cracks—several centimeters wide—whilst the backfill behind the quay wall experienced a subsidence that locally exceeded 50 to 60 cm (Fig. 34). In Fig. 34b, traces of gravels and sand are visible behind the quay wall. These might be remnants of ejecta partially washed out by the tsunami. The presence of ejecta could be the result of liquefaction of a very loose sandy silt layer located 15 to 18 m deep, right beneath the backfill material (Fig. 34a). Similar observations of ejecta behind quay walls have been made in many previous earthquakes (Professor G. Bouckovalas—*personal communication*), even in the absence of any native liquefiable soil layer. As such, any observed ejecta may be due to liquefaction and wash out of a loosely deposited fine silty-sand phase which fills the voids of a typically much coarser backfill gravel skeleton that does not participate in the load-carrying capacity of the wall (Professor G. Bouckovalas—*personal communication*). This could explain the lack of excessive displacements and rotations of the wall towards the sea. Construction records from the said ports and further investigations can elucidate this further.

**Fig. 34** **a** Crude log of borehole BH1 located at the jetty of the old port of Vathy, where the liquefiable layer of the very loose sandy silt layer is located at a depth of 15 m (data provided by G. Milionis—elaboration by Em. Rovithis) and SPT blow count with depth. **b** Subsidence of backfill material behind the quay wall at the eastern (old) port, measuring up to 60 cm. **c** 10–15 cm wide longitudinal and transversal open cracks, located on the pavement over the backfill material, in contact with the quay wall

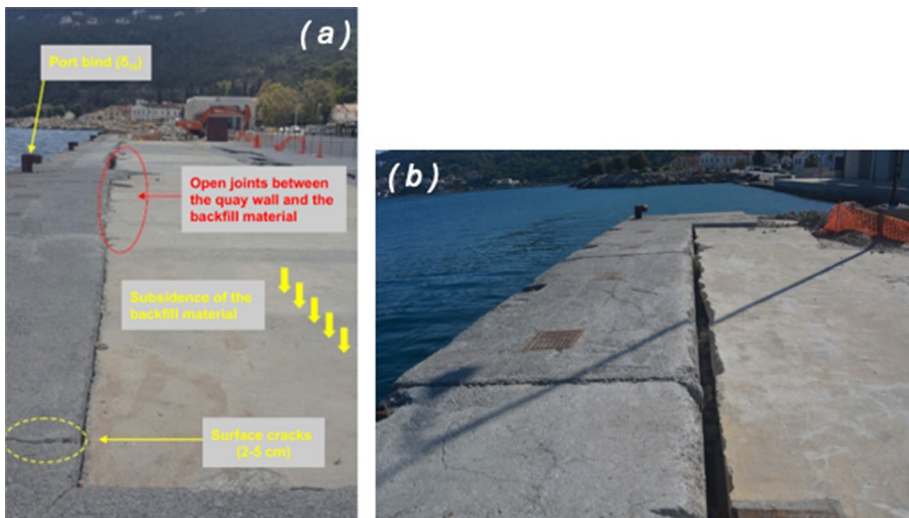
**Fig. 36** View of the quay wall at new (Malagari) port, Vathy, from NW to SE direction: **a** photo taken 3 years before the earthquake (Triton 2017); **b** photo taken a few days after the earthquake (HAEE/ETAM reconnaissance report 2020)

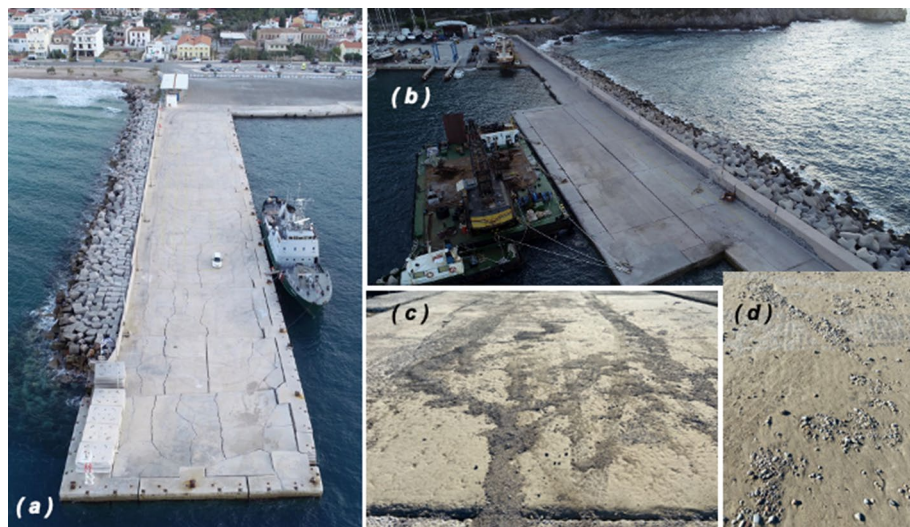
The port of Karlovasi suffered damage to both jetties, namely: subsidence of the backfill material (or the subsoil), mild tilting and displacement of the quay walls towards the sea, cracks (both transversely and parallel) to the quay walls. Also, grey-brown ejecta of sand-gravel mixture was found on the west quay wall, which possibly emerged through the cracks. Even in the absence of sufficient data to substantiate the occurrence of liquefaction, it appears that liquefaction is a reasonable scenario. This possibility is reinforced considering that the surface layer of grey-brownish silty sand identified at the high school area, seems to be continuing and getting thicker close to the sea shore. However, without additional geotechnical data, it is impossible to draw conclusions and this is only a hypothesis in accordance to the subsurface structure at Vathy. Last but not least, the construction details of each port need to be accounted for, since the placement of a backfill under “wet” or “dry” conditions can severely affect its dynamic response in seismic events. Figure 38

illustrates both jetties (east and west), as well as ejecta observed on the western quay wall. Nevertheless, it is hard to tell whether the cracks and subsidence/tilting patterns are earthquake induced, or merely pre-existing gravity-induced effects.

**Fig. 38** **a** East quay wall of Karlovassi port, **b** west quay wall of Karlovassi port, **c** ejecta on the west quay wall, presumably the product of liquefaction occurrence, and **d** a detailed view of the ejecta, brownish to grey color, mostly sandy and silty with some gravels (aerial photographs courtesy of I.N. Spyrou and Prof. K. Ziotospoulou)

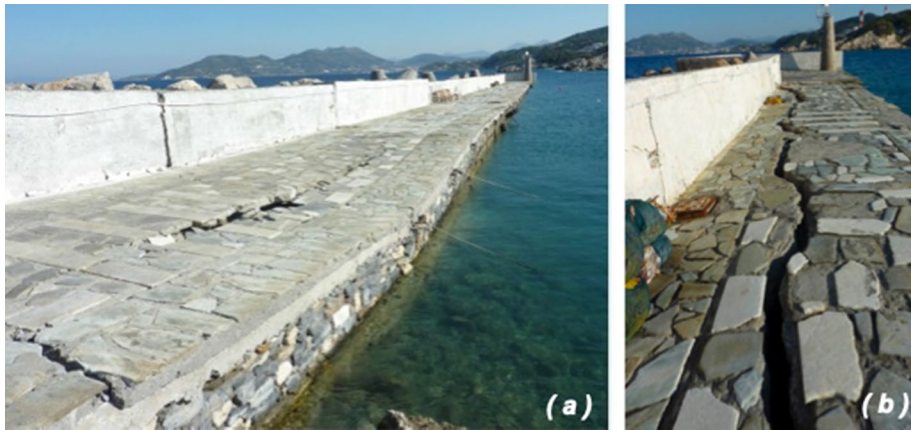
Kokkari is a small village in the northern part of Samos, situated about 10 km NW from Vathy. It has a small port mainly serving fishing boats and small yachts. The reconnaissance team of HEAA visited Kokkari and observed that the quay wall had suffered severe subsidence, 10 to 20 cm wide open cracks alongside the sea front, and mild tilting towards the sea, as shown in Fig. 39. It is unclear whether the deformations were pre-existing i.e.

due to the low quality of the quay wall construction and the lack of protection of its underwater part from scour. Problems related to low bearing capacity and differential settlements due to a soft and compressible surface soil layer at the foundation of the jetty cannot be excluded. However, no clear traces of liquefaction were detected following the earthquake.

**Fig. 39** **a** Differential subsidence of the quay wall of Kokkari port with wide open cracks alongside and transversely, **b** close view of an open crack of 10 to 15 cm alongside the sea front (HAEE/ETAM 2020)

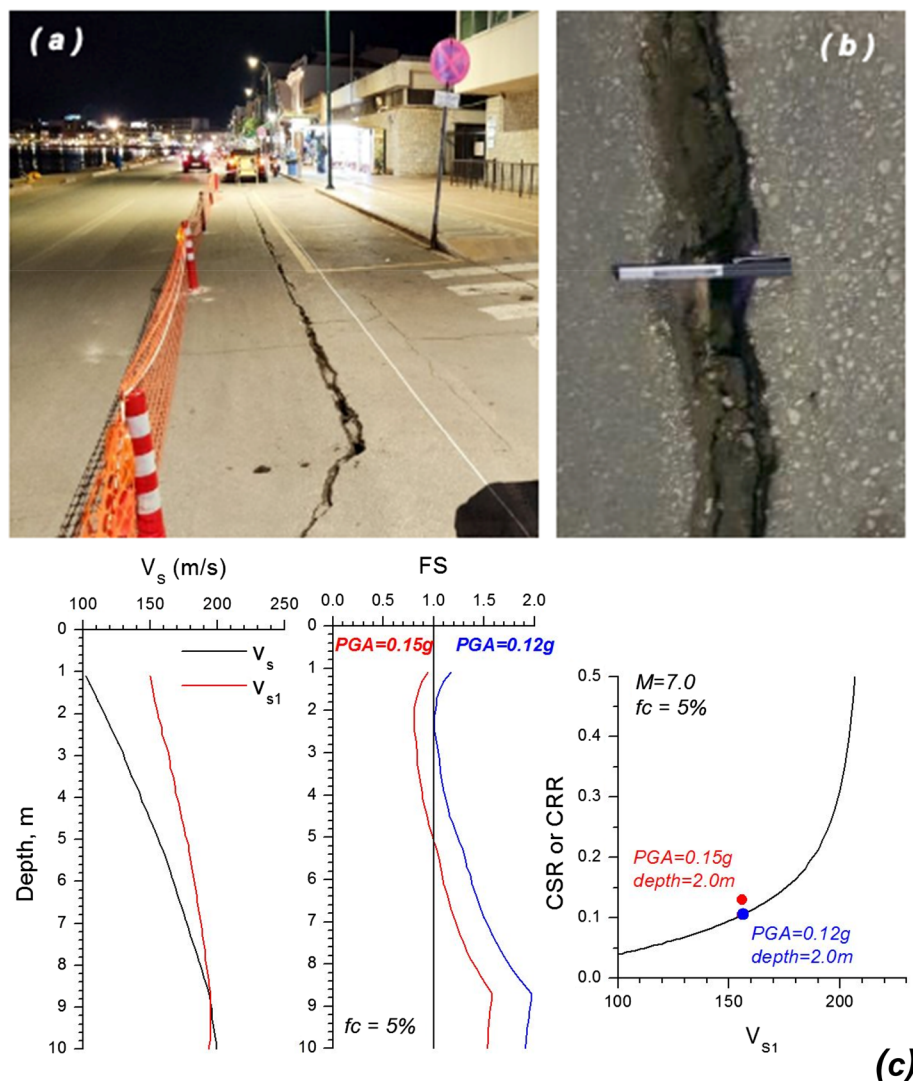
Earthquake-induced failures were also observed in the port of Chios island, situated approximately 80 km north of the fault, referring mainly to surface cracks of considerable width and depth (Fig. 40a), as reported in the post-earthquake preliminary report by Pelekis and Roumelioti (2020). At specific locations these cracks were about 10–15 cm wide and about 40 cm deep (Fig. 40b). Such type of failures in the port of Chios may indicate soil liquefaction that was marginally triggered during the earthquake, and ensuing lateral spreading effects towards the shoreline, as suggested by Pelekis and Roumelioti (2020). The existence of inclined strata below the filling material of the quay walls and pre-earthquake damage due to gravity loads (e.g. scour of its foundation) should be considered when interpreting the observed seismic behavior. The possibility of marginal triggering of soil liquefaction was reinforced following a series of MASW field tests, which revealed the existence of soft/low-strength surficial soil layers with shear wave propagation velocity of about 100 m/s. A preliminary  $V_s$ -based assessment of the safety factor against soil liquefaction (Andrus and Stokoe, 2000) revealed a potential triggering of the phenomenon during the  $M_w=7.0$  event for PGAs above approximately 0.12 g (Fig. 40c).

**Fig. 40** **a** Earthquake-induced surface cracks parallel to the quay wall front in the port of Chios, **b** close-up view of 10–15 cm wide and 40 cm deep surface cracks, and **c** preliminary Vs-based assessment of the safety factor against soil liquefaction at the depth of 2 m for PGA equal to (i) 0.15 g and (ii) 0.12 g (Pelekis and Roumelioti, 2020)
