# Understanding the Performance of Historic Masonry Structures in Mayfield, KY after the 2021 Tornadoes

Saanchi S. Kaushal<sup>a</sup>, Mariantonieta Gutierrez Soto<sup>b</sup>, Rebecca Napolitano<sup>a,\*</sup>

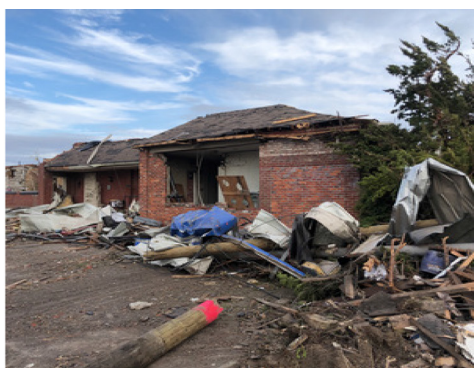
(a) Icehouse Gallery: Destroyed

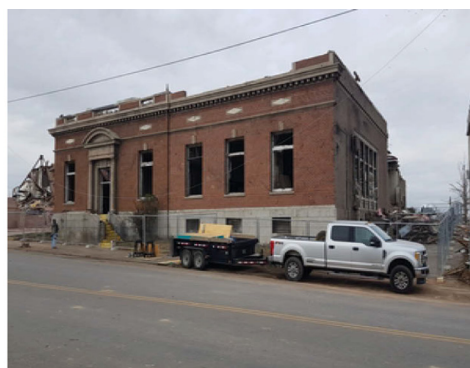
(b) US Post Office: Moderately Damaged

meters from the tornado path, experienced damage limited to the walls and roof and was classified as moderately damaged. While the other retrofitted one-storey structure was the Icehouse Gallery, which was described as destroyed even though it was located further from the tornado's path. This illustrates the variation in damage levels irrespective of the retrofit status of the structure. Thus, not considering their retrofit levels, the distance from the tornado significantly affected the damages observed.

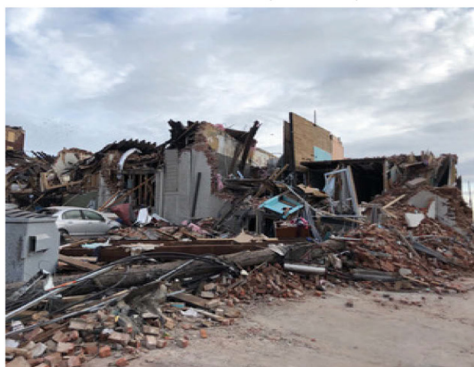
structures on West Broadway versus those on N 7th Street, where the buildings were categorized as destroyed and severely damaged, respectively.

(c) Row Buildings on Broadway: Destroyed

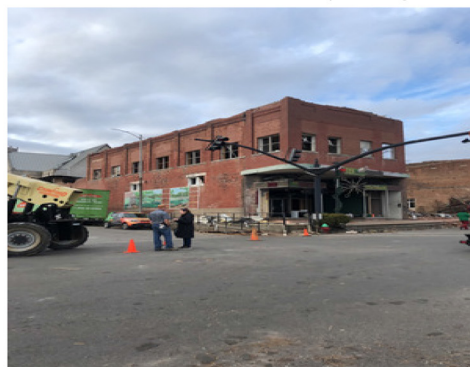
(d) The isolated two-storey structure: Severely Damaged

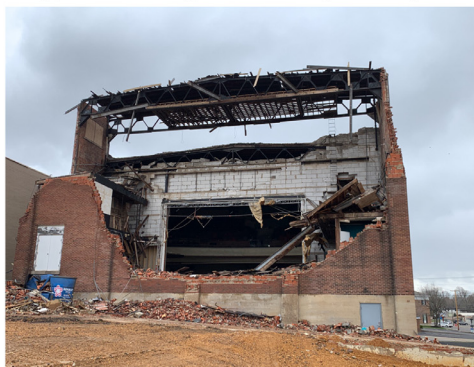
(e) Damage to the American Legion: Severely Damaged

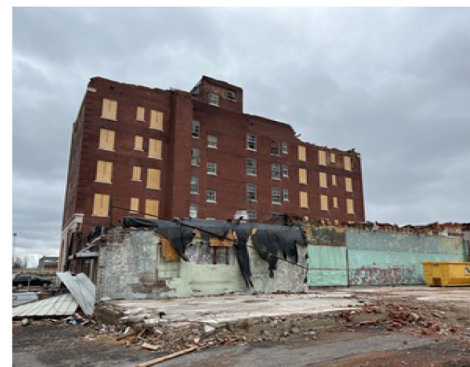
(f) Damage to the Hall Hotel: Severely Damaged

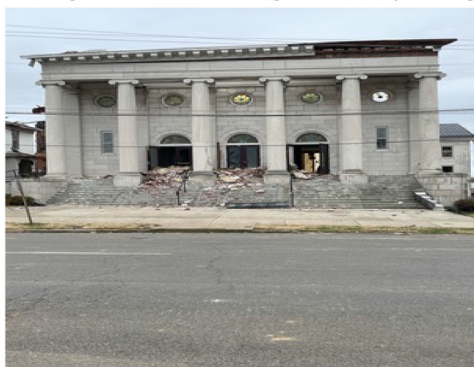
(g) Damage to the Methodist church: Destroyed

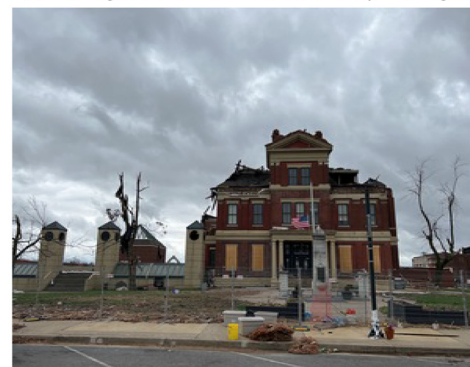
(h) Damage to the Graves County Courthouse: Destroyed

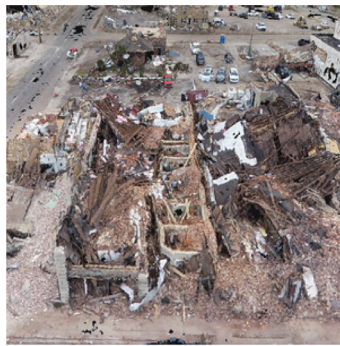
Typically, roof failure begins with the increased internal pressure which results from sheathing material failure or a breach in the building envelope. Razavi et al. [45] experimentally compared the uplifts that different roofs may incur, only to conclude that flat roofs experience maximum uplift and shear as compared to gable or hip roofs.

(a) Roof Collapses

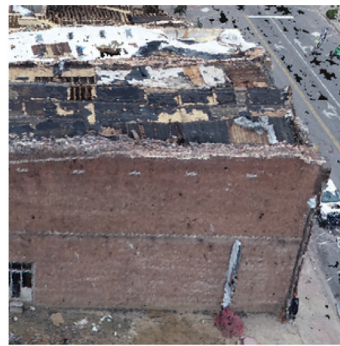
(b) Loss of sheathing

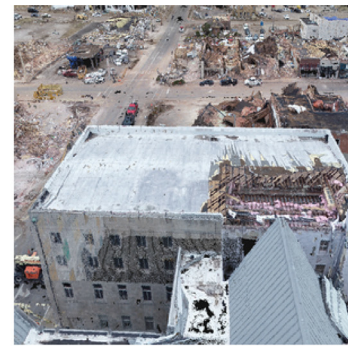
(c) Minor damages to the roof

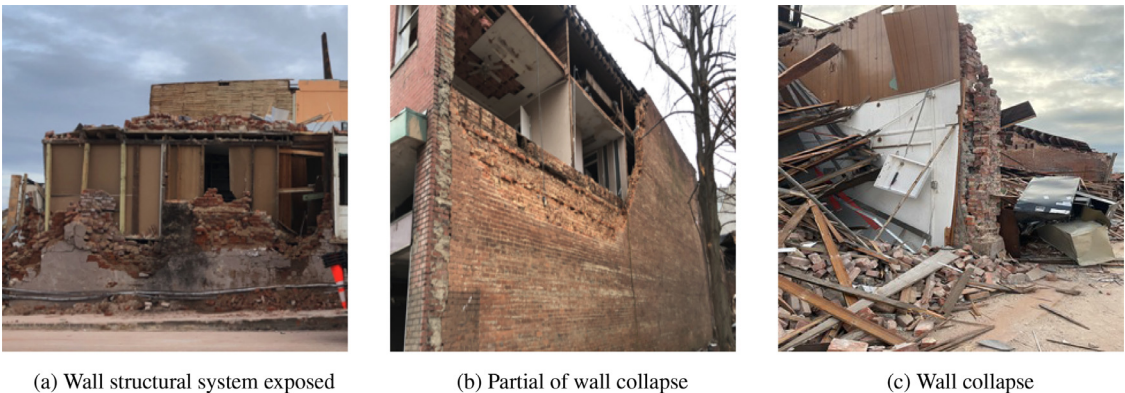
Wall failures for wind-impacted structures often depend on the loss of the roof and its connections to the roof or foundation. A strong correlation was observed between an extensively damaged roof and its impact on the load-bearing capacity of the wall. The impacted walls depended on the direction of the tornado or the

wind-borne debris, leading to damaged cladding without altering the current load path. For structures whose roof's structural system was still intact but had a loss of sheathing, there was lesser damage to the walls. The table below provides additional qualitative data highlighting the relationships between the damage levels and wall MWFRS (Fig. 10).

**Fig. 10.** The different wall damages observed in Mayfield.
