# Lateral spreading and flooding along the İskenderun coast in the 2023 Kahramanmaraş earthquake sequence

## ABSTRACT

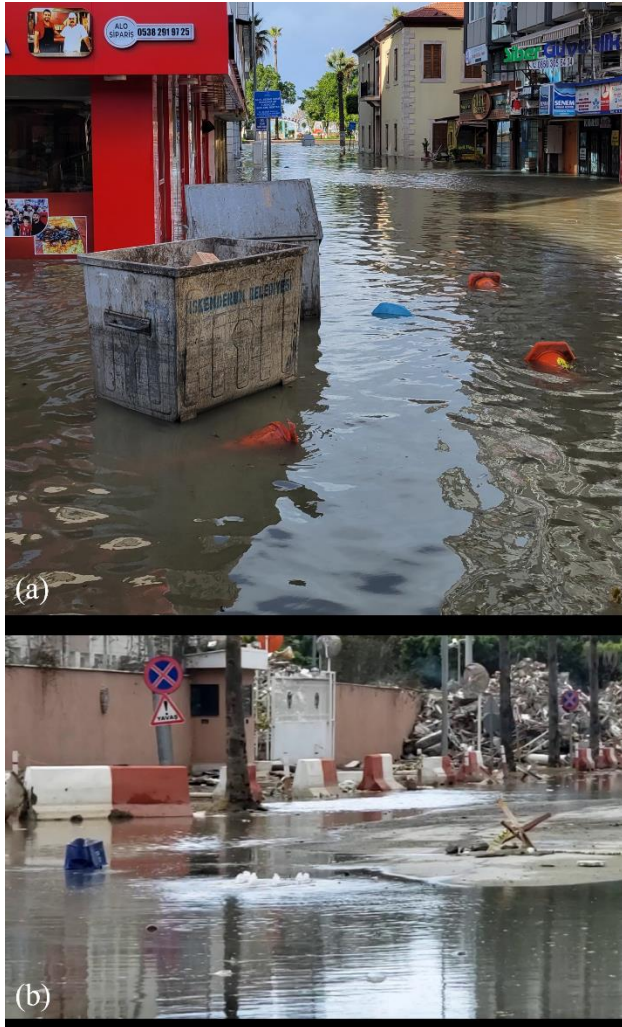
Fig. 3. Observed coastal flooding in İskenderun on March 29, 2023: (a) flood water and debris observed along Mareşal Fevzi Çakmak Street, over 250 m from the shoreline (36.5912N, 36.1698E); and (b) flood water expelling from drain along Bahçeli Sahil Evler Street in the Çay District (36.5900N, 36.1768E).

The GEER team encountered notable flooding on March 29, 2023 (Fig. 3). On this day, moderate rainfall and strong southwesterly Lodos winds impacted the İskenderun area. The flooding extended from about 150 m to over 250 m inland, as indicated in Fig. 2. Flooding advanced at least two roads in from the shoreline, including past Mareşal Fevzi Çakmak Street (Fig. 3a). Along Bahçeli Sahil Evler Street in the Çay District, water was observed to flow out of a storm drain cap (Fig. 3b), likely due to reports of a damaged water drainage system (METU 2023). The coastal storm surge on March 29 uplifted and displaced rubble mound stones making up the seawall and caused the partial collapse of the

Several other factors likely contributed to increased flooding risks in İskenderun. The loss of freeboard due to settlement of the seawall, has been unable to adequately inhibit coastal storm surge. Nonetheless, settlement and instability of the seawall may have similarly been initiated by the liquefaction and lateral spreading within subsurface soils. Damage to the water drainage system (METU 2023, Cetin et al. 2023) and the consequent build-up of water along pavement and other non-draining surfaces likely slowed the ability for water to recede following each storm. Change detections of Synthetic Aperture Radar (SAR) images also indicate that İskenderun has been continually subsiding over the four years prior to the earthquake at rate of over 40 mm/year (Papageorgiou et al. 2023). This could suggest other large-scale subsidence or tectonic mechanisms.

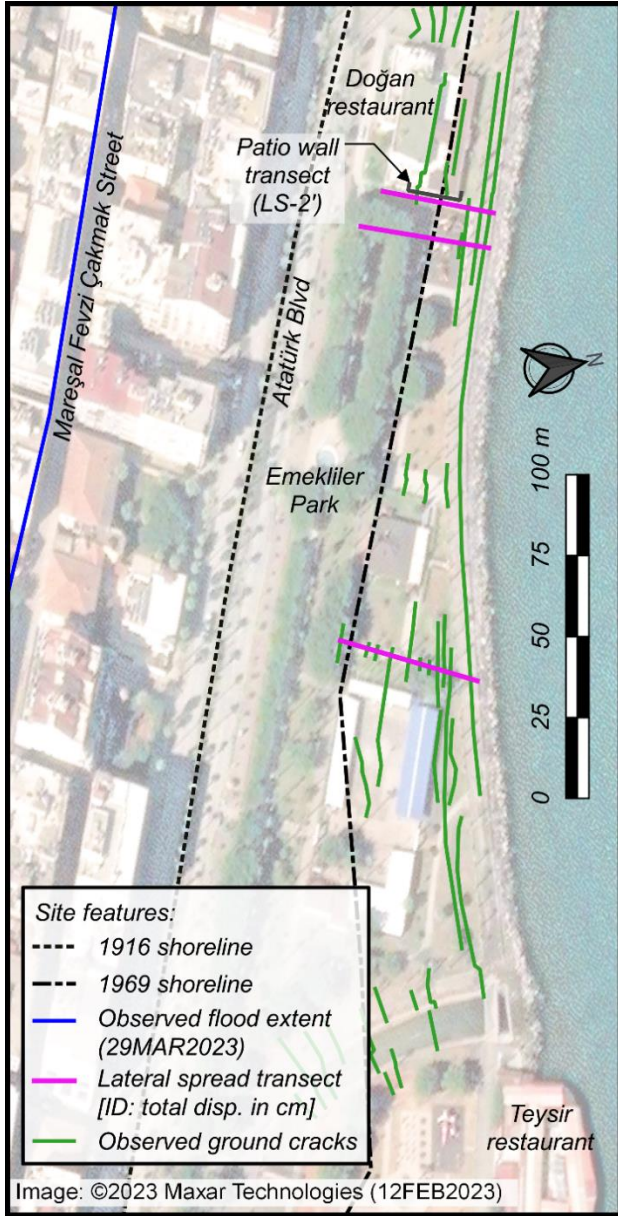
The Doğan restaurant (36.1671N, 36.5934E) and Emekliler park case history site is located along the central shoreline of İskenderun, in the Yenişehir District, as indicated in Fig. 2 and detailed in Fig. 4. The ground surface generally has a gentle slope towards the shoreline of 1-2°. Several extensive ground cracks were observed parallel to the shoreline between the seawall and Atatürk Boulevard (Fig. 5a). A park bench situated along the shorefront walkway appeared stable during a reconnaissance visit on March 28, 2023, but had sunken into the ground following the March 29 storm surge and flood (Fig. 5b). A one-story patio dining structure within the restaurant exhibited several large ground cracks through the floor and exterior walls (Fig. 5c).

On March 28, the armor stones making up the seawall in this area appeared to have settled by up to 0.5 to 1 m relative to pre-earthquake street-view imagery (Google 2022). On April 1, the armor stones were re-arranged about 1 m higher, and the reinforced concrete parapet wall behind the stones was more heavily damaged (Fig. 5a-b). It is unclear whether the existing stones displaced to this configuration during the March 29 storm surge, or additional stones were manually added for temporary coastline protection.

Fig. 4. Map of Doğan restaurant and park lateral spread site. Background image from Maxar (2023) is dated February 12, 2023.

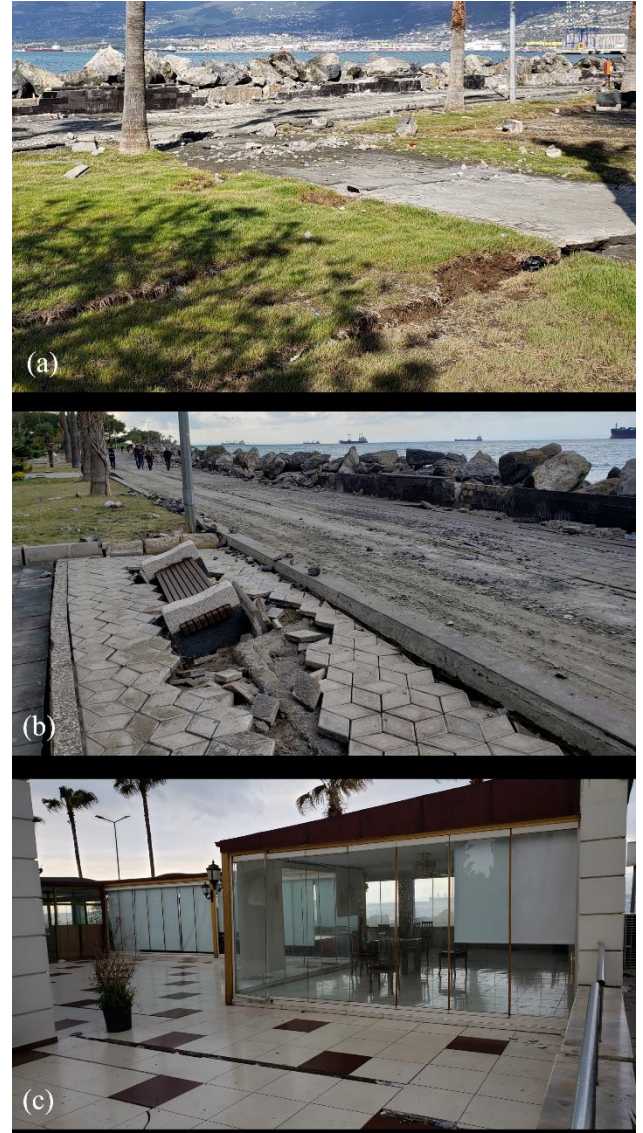
Transect LS-2' only considered cracks along the base of the exterior patio wall and concrete fence of the Doğan restaurant (right side of Fig. 5c). The cracks were measured over a limited distance from the north edge of the patio to the north edge of the two-story restaurant building. This transect was plotted in Fig. 6a to allow a direct comparison with LS-2, by matching the accumulated displacements at the north edge of the patio (i.e., 14.8 m from the seawall). Cracks were concentrated with a total width of 10.5 cm along the column at the south edge of the patio (~25 m from the seawall), and a width of 14 cm at the north edge of the restaurant building (~28.5 m from the seawall). Despite this structurally-induced concentration of cracking along the building at certain locations, the total displacements along the extent of LS-2' approximately matched those along LS-2 and LS-3.

Fig. 5. Lateral spreading damage observed on April 1, 2023: (a) park area along transect LS-4 (36.5930N, 36.1687E); (b) sunken park bench and ground deformation behind Doğan restaurant patio (36.5937N, E36.1672E), and (c) cracking in patio along back of Doğan restaurant building (36.5935N, 36.1671E)

Transect LS-4 was measured on March 28 and April 1, 2023 (before and after the 29 March storm) with respective maximum lateral ground displacements of 140 cm and 147 cm over the same distance of 52 m. The spread extended from the seawall to an area within the Emekliler park beyond which cracks were no longer visible. The entirety of spreading observed along this transect extended seaward of the estimated 1969 shoreline, with the exception of a 10 cm wide crack located 3 m south of the 1969 shoreline. No other cracks were observed south of this transect. Figure 6b depicts a fairly constant rate of accumulated lateral displacements along the length of LS-4. This displacement rate approximately matches LS-2 and LS-3 within 15 m of the seawall (i.e., the portions of those transects seaward of the 1969 shoreline). The inconsistency of the 1969 shoreline relative to the transects may indicate

differences in the subsurface soils that would cause LS-4 to spread nearly twice as much as LS-2 and LS-3. Additionally, there may be differences in the free-face heights at these sites. The measured increase in maximum displacements at LS-4 by 7 cm before and after the storm may have been due to scour and dislocation of surficial features (e.g., concrete pavers) during the storm, additional movements continuing since the earthquake or worsened by storm surge loading, measurement errors, or other effects.

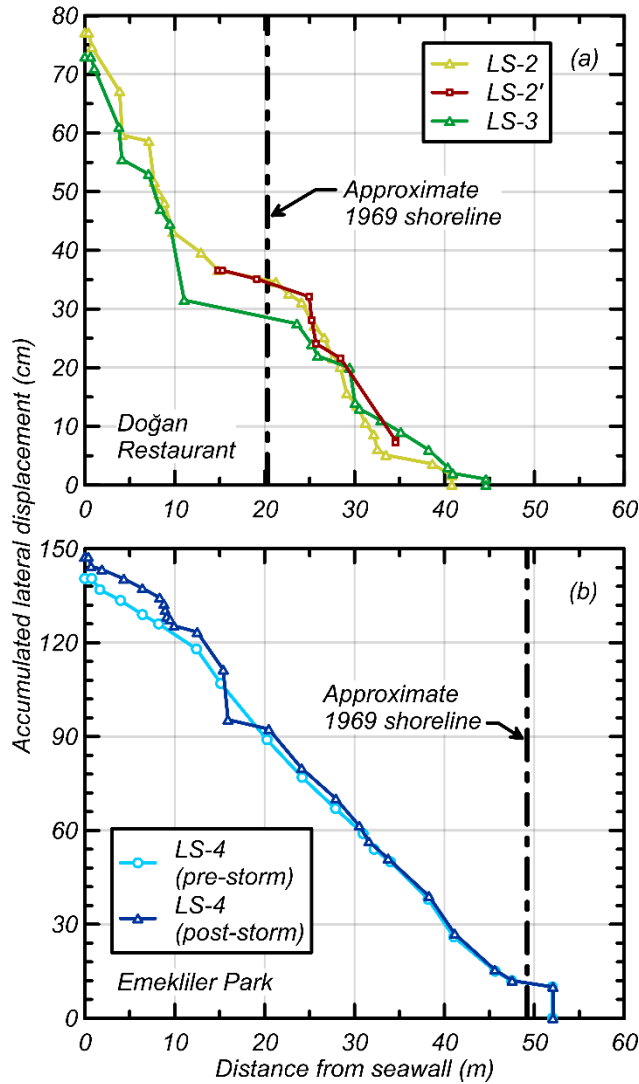
Transects LS-2 and LS-3 measured on April 1, 2023 indicated maximum lateral ground displacements of 77 cm and 73 cm over distances of 41 m and 45 m, respectively. Both transects extended from the rubble mound seawall to the front (south side) of the Doğan restaurant. LS-2 was taken about 1 m away from the Doğan patio exterior walls, and LS-3 was taken 10 m to the east of LS-2. While both transects are within post-1916 reclaimed land, about half of the transect lengths are located seaward of the approximate post-1969 shoreline. The distribution of accumulated lateral displacements along LS-2 and LS-3 are depicted in Fig. 6a to be fairly consistent with each other. Interestingly, higher displacement rates (i.e., increased shear strain) along LS-2 and LS-3 were measured within 15 m from the seawall, which may coincide with post-1969 reclaimed fill.

Fig. 6. Accumulated lateral displacements obtained from crack measurements relative to distance from the seawall, for transects located: (a) adjacent to the Doğan restaurant, and (b) within Emekliler park (~150 m east of the Doğan restaurant). Note that symbols indicate individual crack measurements that accumulate from the landward extent of the transect (where no movement is assumed).
