# 1 Full-Scale Shake Table Test Damage Data Collection Using Terrestrial Laser 2 Scanning Techniques

3 Mohammad Aghababaei<sup>1</sup>, Christian Okamoto<sup>2</sup>, Maria Koliou<sup>3\*</sup>, Takuya Nagae<sup>4</sup>, Chris P.  
4 Pantelides<sup>5</sup>, Keri L. Ryan<sup>6</sup>, Andre R. Barbosa<sup>7</sup>, Shiling Pei<sup>8</sup>, John W. van de Lindt<sup>9</sup>, Shideh  
5 Dashti<sup>10</sup>

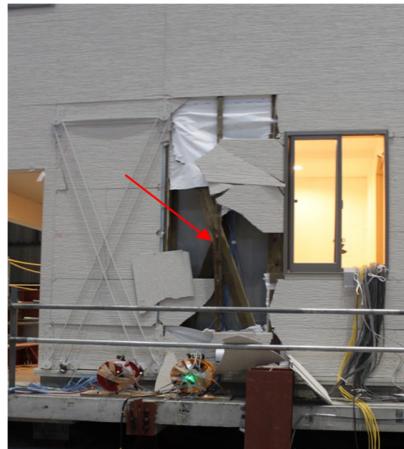
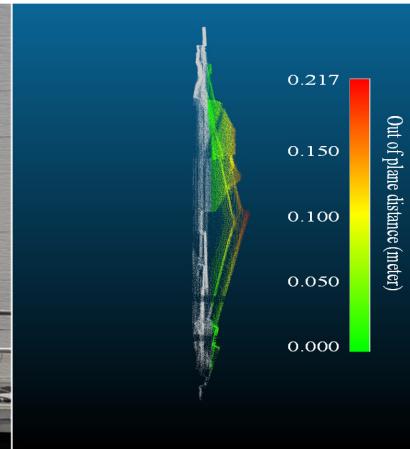
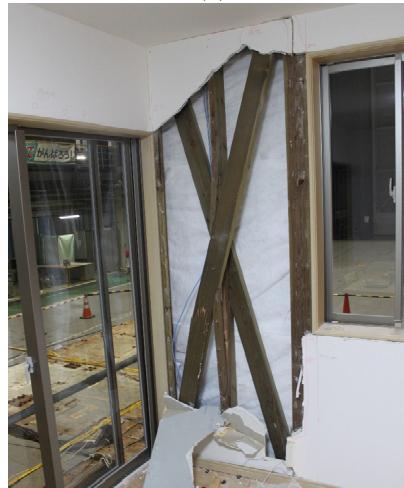
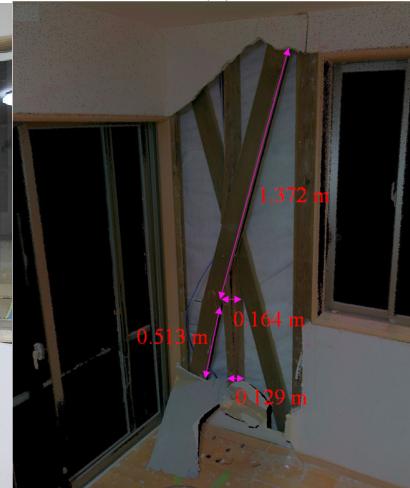
329 structural damage of two elements of ruptured wood bracing on the east and west sides of Building  
330 A through photographs and screenshots of the point clouds. The damaged wood bracing on the  
331 east side (Figure 13a and b) was exposed because the façade wallboards spalled off the surface,  
332 and as a result, both ordinary cameras and LiDAR scanners captured it. Similarly, the damaged  
333 wood bracing on the west side (Figure 13c and d) was exposed since the gypsum wallboards

334 spalled off the interior perimeter walls, and the damage was apparent from visual inspections and  
335 LiDAR scans. Figure 13b presents a side view of the damaged wood bracing of Figure 13a, from  
336 which the out-of-plane buckling of the bracing elements relative to the wall surface was measured,  
337 as presented by a color map. The measurement indicates that the wood bracing buckled out-of-  
338 plane approximately 0.217 m (0.696 ft) at its ruptured location. Figure 13d illustrates the use of  
339 LiDAR scan data to capture high-quality point clouds of the damaged components in three  
340 dimensions, while the photographs taken using high-quality cameras (Figure 13c) only provide  
341 two-dimensional representations of the damage. Thus, the point cloud data can be used to observe,  
342 assess, and conduct quantitative and qualitative measurements virtually from multiple points of

343 view after the experiments have occurred. A number of measurements (such as the distance from  
344 the rupture point to the ends of the braces, the dimensions of the bracing elements, etc.) are marked  
345 on this point cloud to illustrate how various measurements are obtained using LiDAR point clouds.

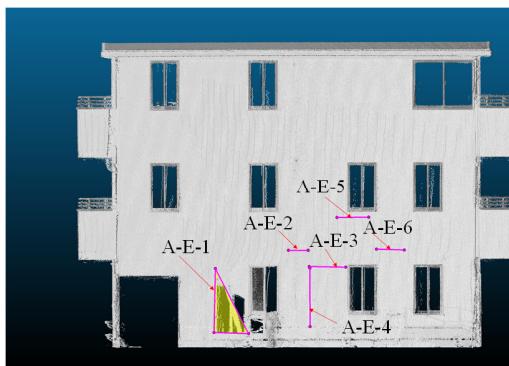
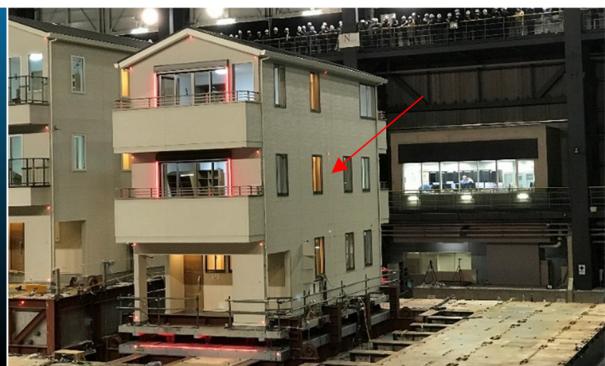
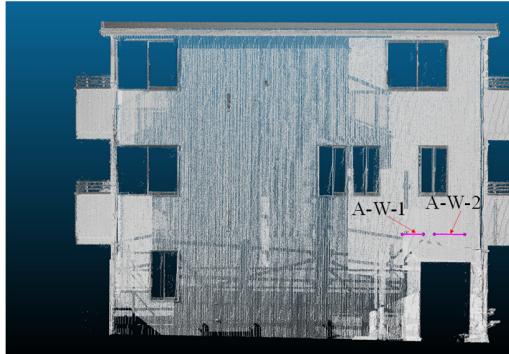
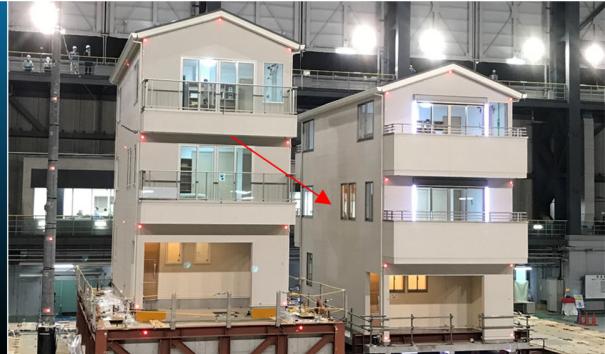
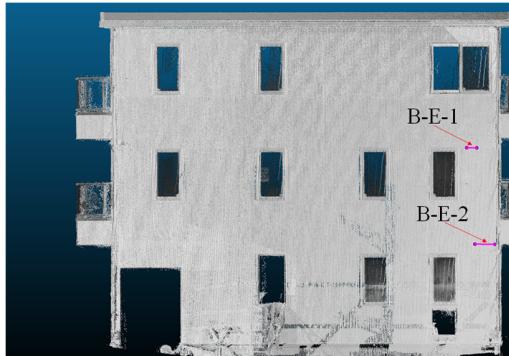
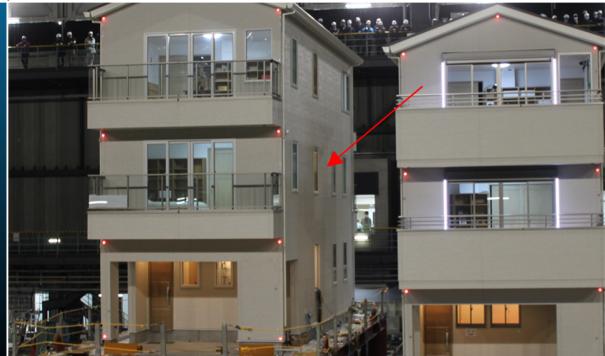
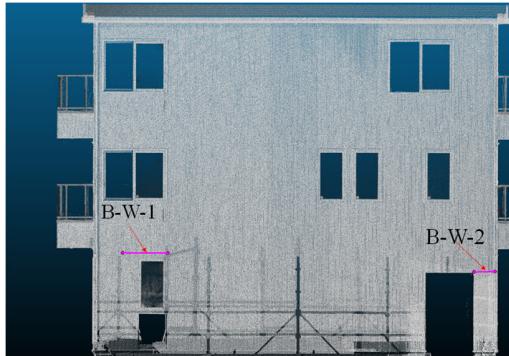
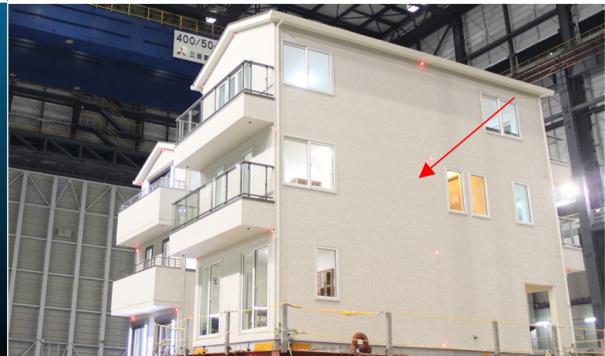
347 Visible damage to the building facades was observed during the last two days of testing. Figure 14  
348 and Figure 15 present photographs taken from the east and west sides of Buildings A and B on test  
349 day 3 and 4, respectively, along with photographs of the damage detected through post-processed  
350 LiDAR point clouds. Because of the short distance between the two buildings the façades on the  
351 adjacent sides (i.e., Building A west side and Building B east side) were not easily accessible  
352 compared to the other two sides, and hence, neither the camera photographs nor the LiDAR scans  
353 produced quality acquisitions, as Figure 14b and Figure 15b and 15c also indicate. However, by  
354 increasing the number of scans in the region between the buildings and setting scanning stations  
355 to maximize the coverage of the walls, it was possible to enhance the quality of the point clouds

357 Tables 4 and 5 list the measurements for locations of detected damage as labeled in Figure 14  
358 and Figure 15 for test days 3 and 4, respectively. Three types of damage are reported for the  
359 façades: cracks, spalling of the plasterboards, and façade damage caused by distortion of an  
360 exterior column in Building B. The measurements include crack lengths, areas of spalled sections,  
361 and the rotation angle relative to vertical of the distorted column. As mentioned earlier in this  
362 paper, cracks were detected and quantified using LiDAR data, which contains both point clouds

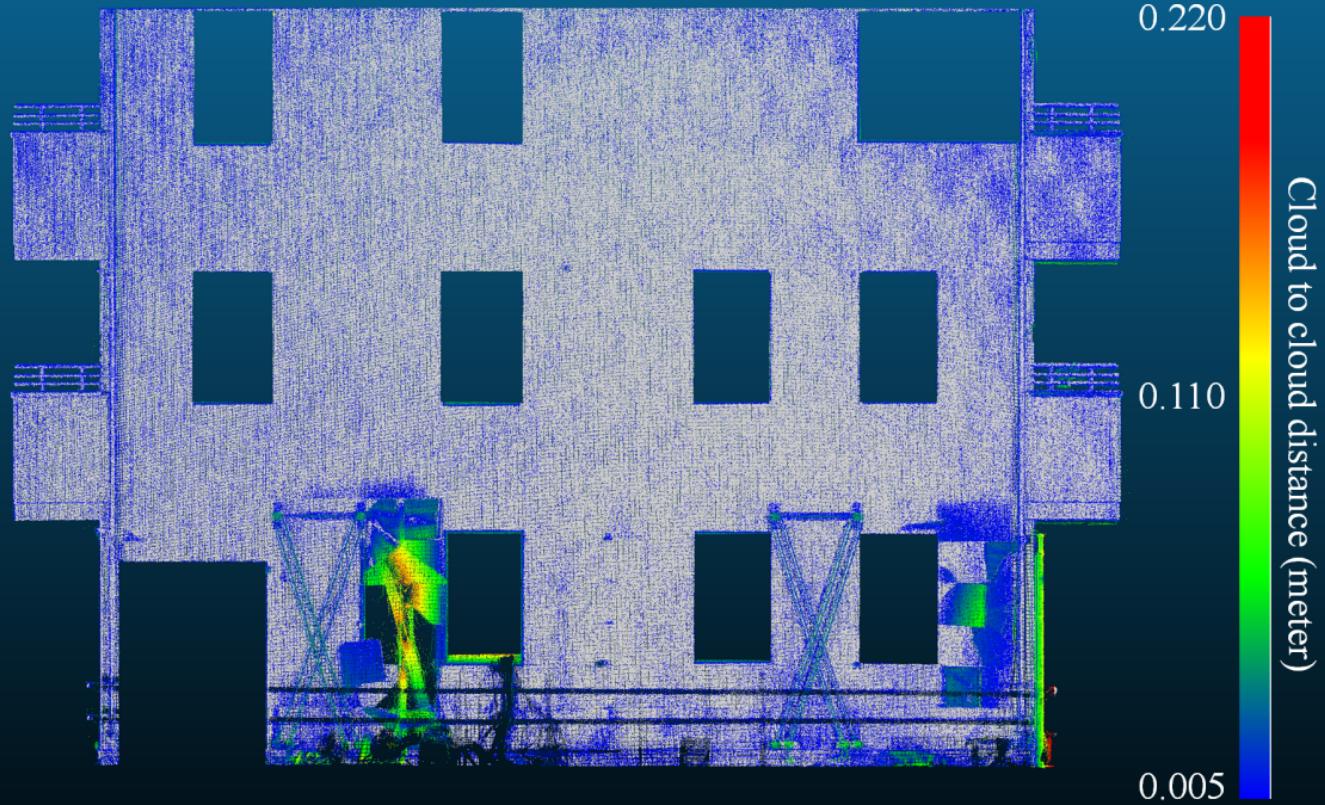
Figure 18: Damage detected on the Building A – east side exterior façade using cloud to cloud comparison.

402 aligned on top of each other with minor deviation, and the out-of-plane point-to-point distance  
403 between the two clouds was computed over the wall area. Figure 18 shows the distance  
404 distributions throughout the selected wall; distances below 0.005 meters are white, while distances  
405 exceeding 0.005 meters – indicating damage – appear in color according to the colorbar.
