**PVP2024-123473**

## **CASE STUDY ON A CRACKING FAILURE IN UNS N06693 WELD FOR STEAM GENERATOR APPLICATIONS**

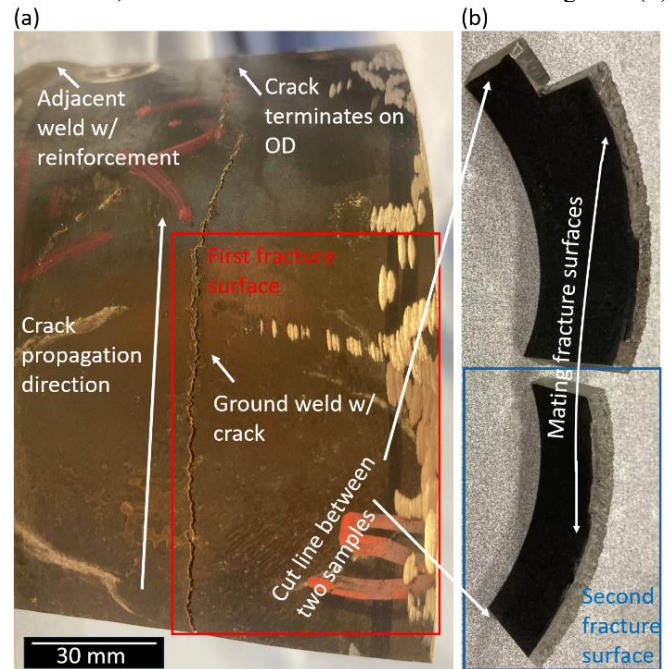
Figure 1 shows as-received half of the tube weld and other fractured samples cut from the pipe. The crack was in the ground weld centered 40 mm from the field weld with reinforcement, as seen in Figure 1 (a). The ground weld was completed in the shop prior to the initial field weld with reinforcement, likely to minimize flow disruptions and stress risers. A repair to the field weld was completed a few months prior to fracture of shop, ground weld. The first fracture surface analyzed is outlined by the red rectangle in Figure 1 (a) with crack terminating in the OD of the weld, and the second one outlined in blue in Figure 1 (b).

**FIGURE 1: (a) Half-pipe section of cracked similar weld in N06693 pipe. The crack is located on a ground similar weld and crack terminated on OD. (b) Another cut section of fracture surfaces.**

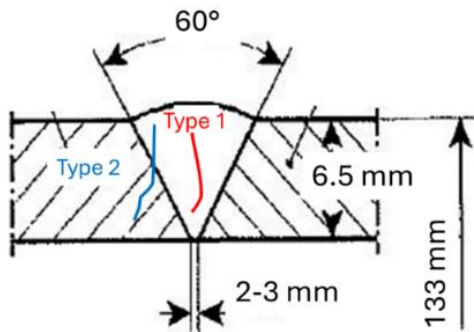
**FIGURE 2: Weld joint geometry overlaid with crack types observed in cracking failure.**

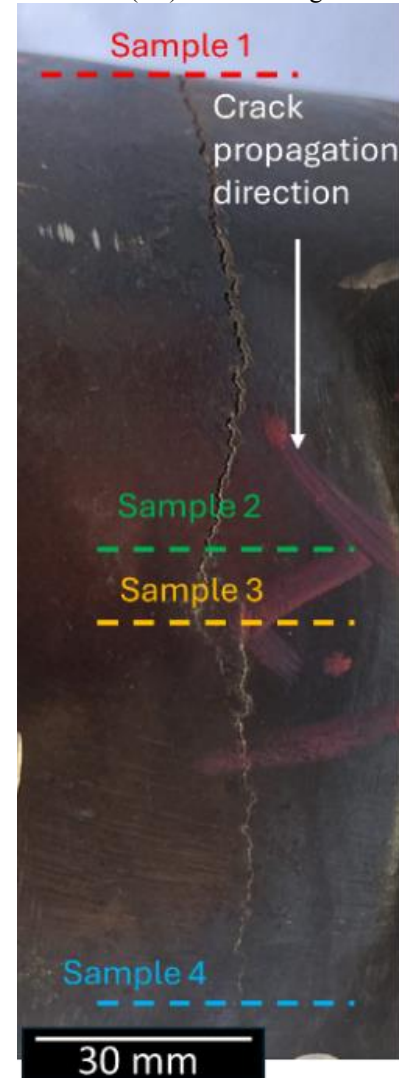
**FIGURE 3: Optical micrograph showing four cross-sectioning locations on pipe. Sample 4 is taken where crack propagation terminates.**

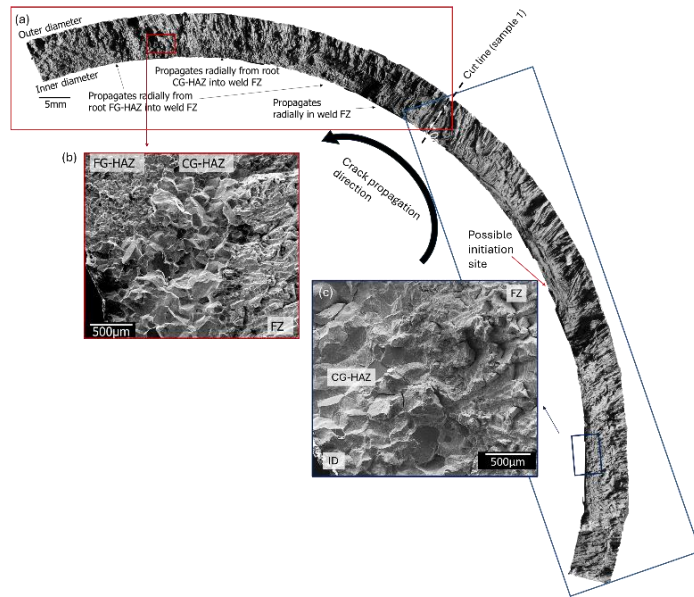
Figure 4(a) shows the fractographic stitched image of two fracture surfaces along the same crack path, where the crack seems to initiate in the inner diameter (ID) of the pipe either in the weld FZ or HAZ. The crack propagates both radially outward towards the outer diameter (OD) and circumferentially. Some locations showed the cracks appearing to start in the fine grained HAZ and coarse grained HAZ on the ID and then transit into the FZ towards the OD. Generally, the fracture surfaces as shown in Figure 4 (b-c) are intergranular cracking in the HAZ and interdendritic cracking in the FZ. No microvoid coalescence was observed, and transgranular cleavage fracture was not evident on most of the fracture surfaces observed. Fracture surfaces were referenced with respect to fractographic examples shown in ASM Handbook Volume 11A [24]. However, the appearance of some slight marks on the ID may indicate crack initiation in the weld FZ as labeled by “possible initiation site” in Figure 4 (a).

**FIGURE 4: Fractography: (a) two macro fracture surfaces side by side, (b) SEM-SEI image showing intergranular fracture in HAZ of ID, (c) SEM-SEI image showing intergranular fracture on second sample**

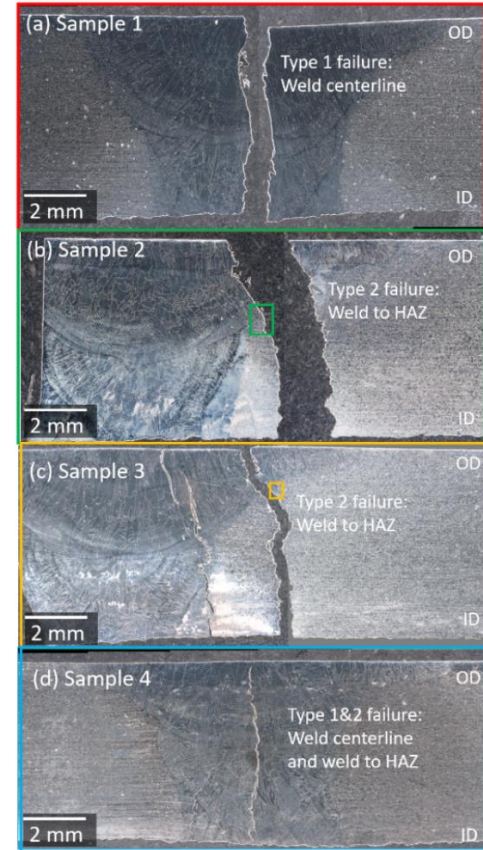
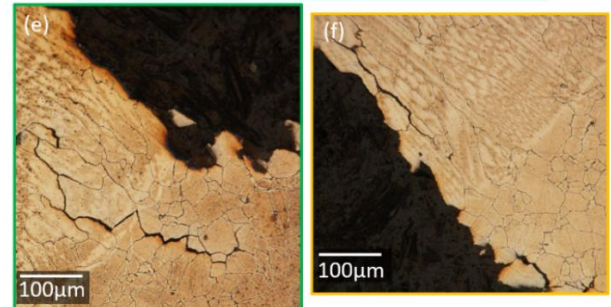
The etched macroscopic cross sections in Figure 5 (a-d) show the crack paths through thickness at various locations along the circumference. Sample 1 shows Type 1 failure along the weld

centerline, while sample 2 and 3 shows Type 2 failure either from the weld FZ to the HAZ or the opposite. Sample 4, where the crack terminates at the OD in the weld centerline, shows both Type 1 and 2 failure, with both centerline weld cracking and a crack going from HAZ on ID through the weld FZ, as seen in Figure 2. In all, fracture seems to initiate on the ID, propagate through thickness and terminate in the FZ in the OD. Figure 5 (e-f) shows some secondary intergranular and interdendritic cracking in the FZ and HAZ transition in samples 2 and 3.

**FIGURE 5: Optical micrographs of samples 1-4 cross sections (a-d) and secondary cracks in samples 2(e) and sample 3 (f).**

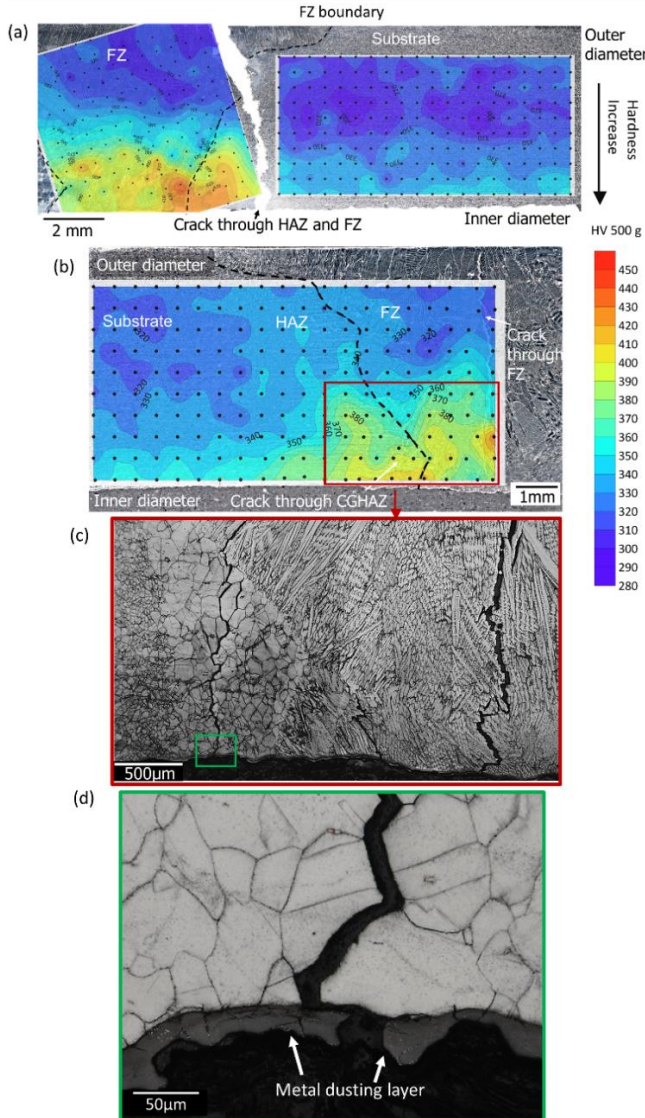
Microhardness maps are overlaid on sample 2 and sample 4 in Figure 6 (a) and Figure (b), respectively. Two main observations can be made for both samples. The first observation is hardness increases from the OD to the ID in the base metal,

and the second observation is hardness increases in the coarse grained HAZ (CG-HAZ) and root pass FZ. Figure 6(c) shows the crack initiation locations on the ID in both the FZ and HAZ for sample 4, which correspond to the high hardness region. The microcrack initiation on ID seems to correlate with the high hardness regions in general. Higher microhardness regions are predictors of failure locations and likely indicate the possibility of more plastic deformation in the weld root regions, higher volume fraction of  $\gamma'$  or carbonitrides, or both. Figure 6 (d) shows a higher magnification optical micrograph of the ID interface where crack initiates in CG-HAZ. The metal dusting layer can be observed to have a wavy, inconsistent thickness.

**FIGURE 6: Microhardness maps of (a) sample 2 and (b) sample 4 weld cross sections, (c) optical micrographs of ID of sample 4 showing centerline FZ and CG-HAZ cracks initiating on the ID by oxalic electrolytic etch, and (d) higher magnification optical micrograph of CG-HAZ crack initiation on ID showing wavy metal dusting layer by Kroll's reagent etch.**

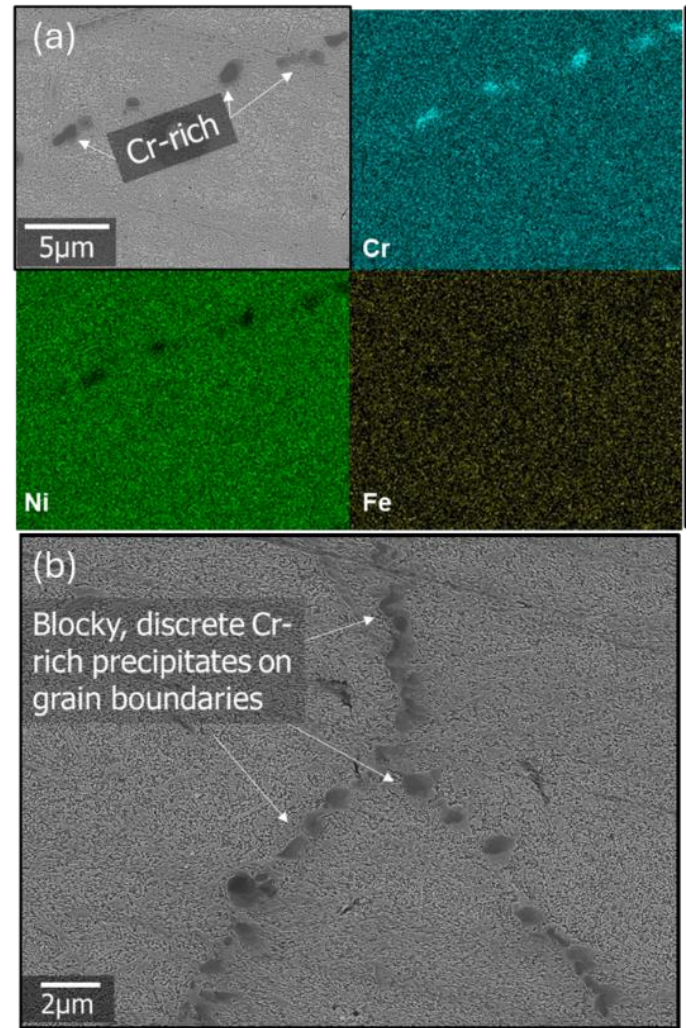
Cr-rich precipitates are seen to be present mostly along grain boundaries in Figure 7 ahead of secondary cracks in CG-HAZ of sample 4. Blocky, discrete Cr-rich precipitates decorate the grain boundaries, as seen in Figure 7 (b). With respect to sensitization, Cr-depletion on grain boundaries may be present if Cr is tied up in a carbide (e.g.,  $M_{23}C_6$ ) or  $\alpha$  phase as a result of solutionizing, welding, and PWHT temperature and cooling rate conditions [21]. No obvious precipitate free zones (PFZs) were observed using the LOM and SEM methods.

**FIGURE 7: (a) Electron dispersive spectroscopy (EDS) map of sample 4 ahead of secondary crack tip in HAZ, and (b) triple point grain boundaries showing blocky Cr-carbides**

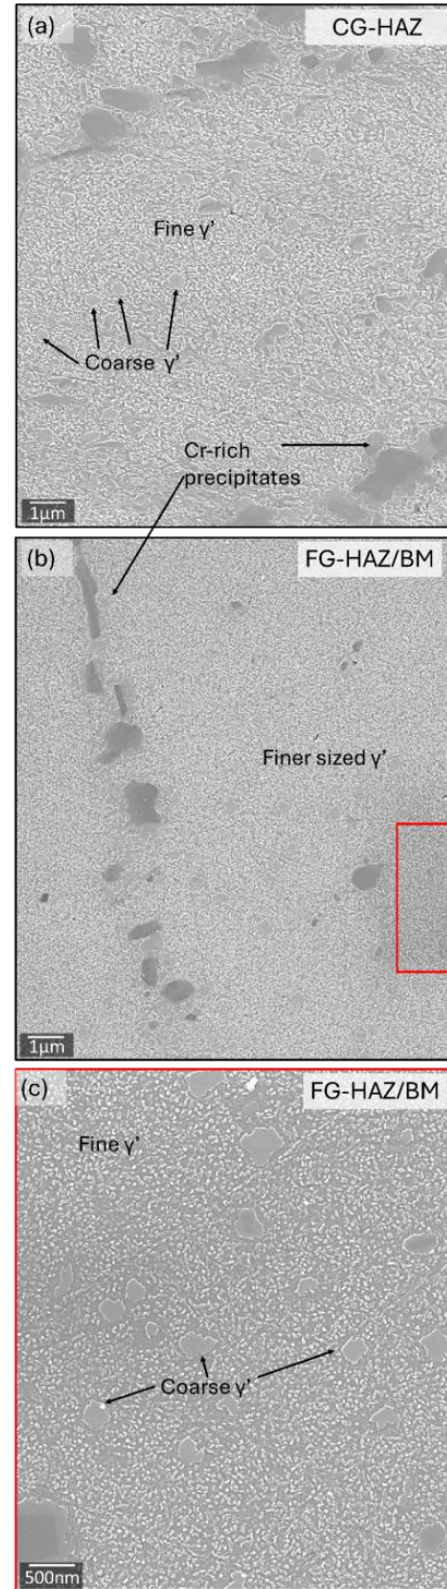
The comparison between microstructures in the CG-HAZ and fine-grained-HAZ (FG-HAZ) is shown in Figure 8. Cr-rich precipitates are seen in both locations, and the size of  $\gamma'$  is coarser in the CG-HAZ than that in the FG-HAZ. A bimodal distribution of  $\gamma'$  seems to be present in both the CG-HAZ and FG-HAZ (as seen in Figure 8 (a, c)), which means there are both coarse and fine  $\gamma'$  precipitates in both HAZ regions. Overall, the

$\gamma'$  precipitate size appears coarser in the CG-HAZ. The aging of  $\gamma'$  primarily occurs during service conditions or during slow cooling from PWHT, since PWHT temperature (1040°C) is above the  $\gamma'$  solvus and does not include an aging step. The bimodal distribution can be attributed to coarse  $\gamma'$  growth during cooling from welding or cooling from PWHT and fine  $\gamma'$  particles may nucleate and grow during service temperatures. With respect to cracking mechanisms, the active aging of the microstructure without prior microstructural stability may influence cracking along grain boundaries via strain age cracking mechanism. In combination with active aging of intragranular  $\gamma'$ , the presence of blocky, intergranular Cr-rich precipitates may facilitate intergranular cracking via grain boundary sliding or creep void development along PFZs, which contributes to a strain aging cracking (SAC) or stress relaxation cracking (SRC) mechanism. On the other hand, Cr-rich intergranular precipitates could contribute to localized sensitization for SCC or embrittlement of grain boundaries.

**FIGURE 8: Higher mag SEM-SEI image of (a) CG-HAZ and (b) finer grained HAZ, with (c) higher mag image showing bimodal distribution of  $\gamma'$  particles in sample 4.**

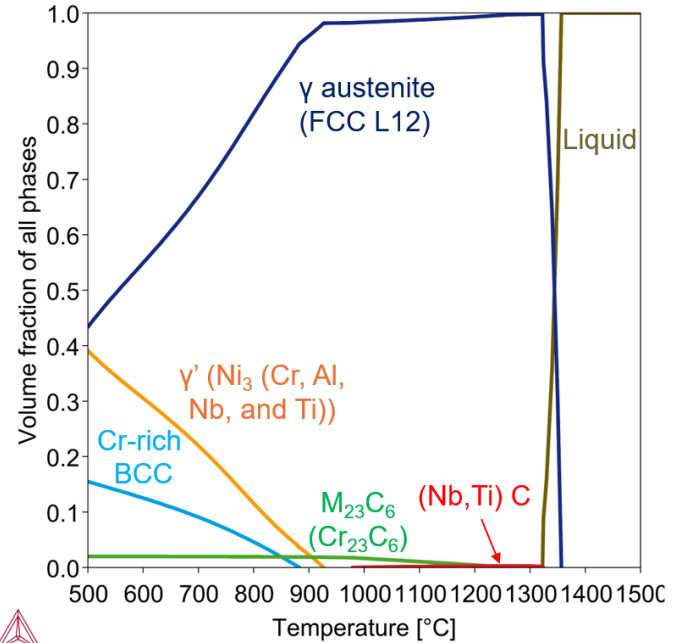
CALPHAD equilibrium single axis diagram of weld metal, with a composition matching base metal standard limitations, is shown in Figure 9, based on XRF measurement and assumed carbon content of 0.1wt%. This assumption was based on the likelihood of potential carburization over a 10-year service period and a slight increase in microhardness from OD to ID in the base metal.  $\gamma'$  would be the second dominant phase to develop during elevated service temperatures or during slow cooling from PWHT. An equilibrium volume fraction of 0.35  $\gamma'$  is predicted to develop with a temperature of 550°C. Another phase that could develop during service conditions would be a Cr-rich BCC phase. Additionally, smaller volume fractions of  $M_{23}C_6$  and (Nb, Ti) C are predicted to develop, with  $M_{23}C_6$  having a wider temperature formation range of 500-1200°C and (Nb, Ti) C having a temperature range of 980-1310°C.

**FIGURE 9: CALPHAD thermodynamic single axis equilibrium of weld filler composition showing volume fraction of phases as a function of temperature (assume C=0.1 wt%).**

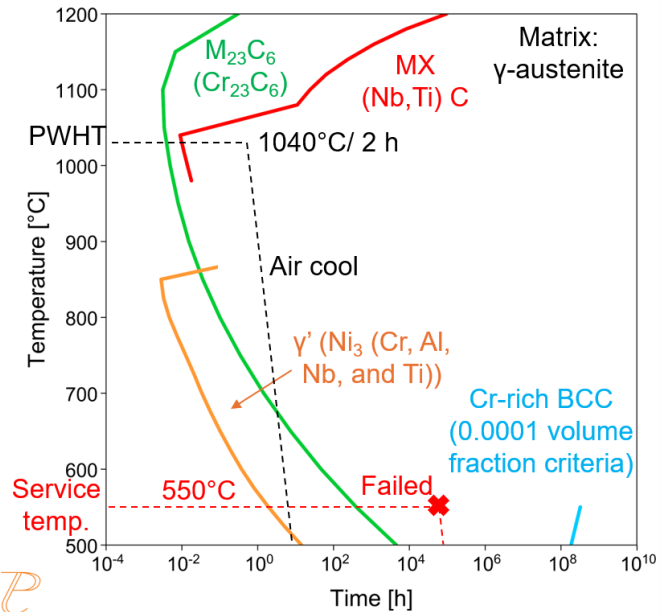
Figure 10 shows the TTT diagram for the weld filler region with overlaid PWHT and service temperature and time schedules. The matrix phase is  $\gamma$ -austenite and the stop criteria for the calculation is 0.5 of the equilibrium volume fraction of each phase, except for Cr-rich BCC, which has a much lower stop criteria of 0.0001 volume fraction. For instance, the equilibrium volume fraction of  $\gamma'$  at 550°C is approximately 0.35, and the 50% equilibrium volume fraction stop criteria means the TTT calculation for  $\gamma'$  at 550°C is based on a 0.175 volume fraction. Peak nucleation and growth rates of  $M_{23}C_6$  and (Nb, Ti) C is predicted at a 1040°C PWHT temperature, while  $\gamma'$  aging occurs mostly during service temperatures and during cooling from PWHT but not during isothermal hold since 1040°C is above the solvus for  $\gamma'$ . While the kinetics for Cr-rich BCC are very sluggish, the most likely phase to develop for a 10-year period time period at service would be  $\gamma'$  and  $M_{23}C_6$ . The failure time is indicated roughly by the “failed” symbol in Figure 10.

**FIGURE 10: CALPHAD kinetic precipitation TTT diagram of weld filler composition (assume C=0.1 wt%). Stop criteria is equilibrium 50% volume fraction of each phase, except for Cr-rich BCC. PWHT and service temperatures are included for reference, and “failed” indicates the time the sample was in service prior to fracture.**

Modification of welding procedures and PWHT could possibly benefit the performance, even for joints influenced by local repair welding. First, the WPS for the shop weld allowed for higher than required heat input with a range of 0.75-2.93 kJ/mm, which exceeds the maximum heat input recommendation of 1.5 kJ/mm from ISO standard 15614-1[25]. Simply, the weld heat input needs to be maintained below 1.5 kJ/mm to minimize grain coarsening in the CG-HAZ, which can lead to a higher SRC susceptibility [13, 26]. Additionally, too high of a PWHT temperature without stabilization of  $\gamma'$  prior to service could contribute to SAC or SCC during service. Therefore, a potential recommended change to the PWHT would be to reduce the peak temperature to 1000°C followed by fast cooling to a second aging step at 750-800°C to stabilize microstructure prior to service conditions or subsequent manufacturing steps.
