Overview of Damage Observed in Regional Construction During the Passage of Hurricane Irma over the State of Florida

¹Department of Civil Engineering and Construction Management, Florida Institute of Technology, 150 W. University Blvd, Melbourne, FL 32901; e-mail: pinelli@fit.edu

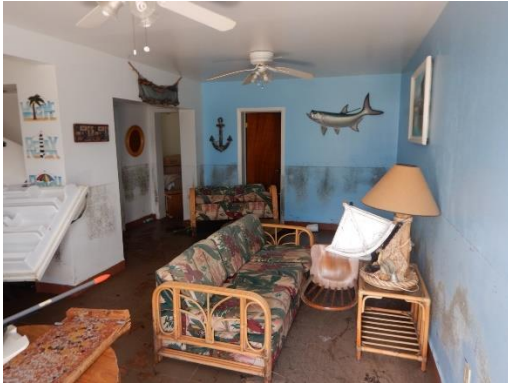
Figure 1a: Interior Damage

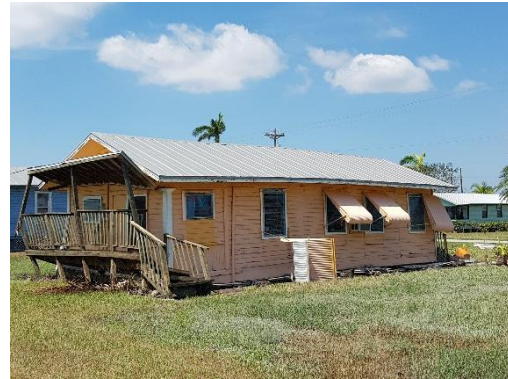
Figure 1b: Storm surge damaged house toppled off its piers in Everglades City, FL.

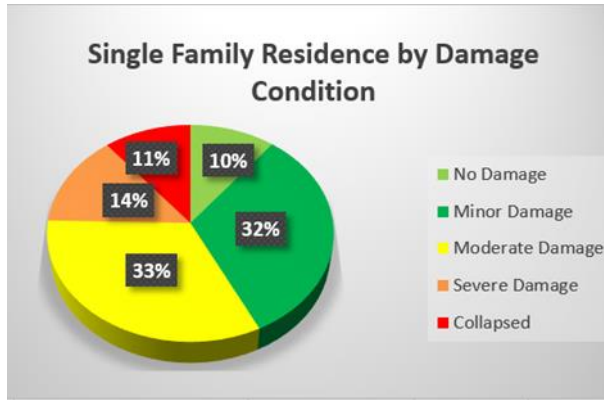
Figure 3a: Damage distribution of single-family homes in the Keys

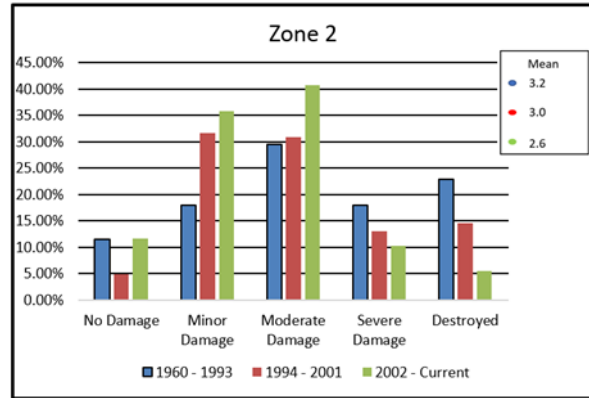
Figure 3b: Distribution of damage by year built or last retrofitted for single-family homes

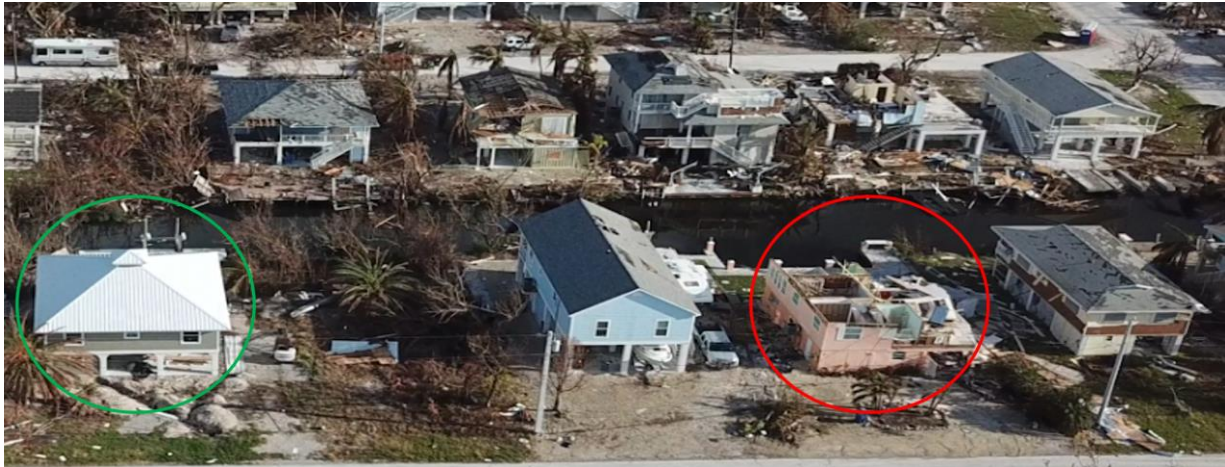
Figure 4: UAV image shows damage to low-rise houses along two streets of Ramrod Key. The green circle marks a new construction while the red circle shows an older construction.

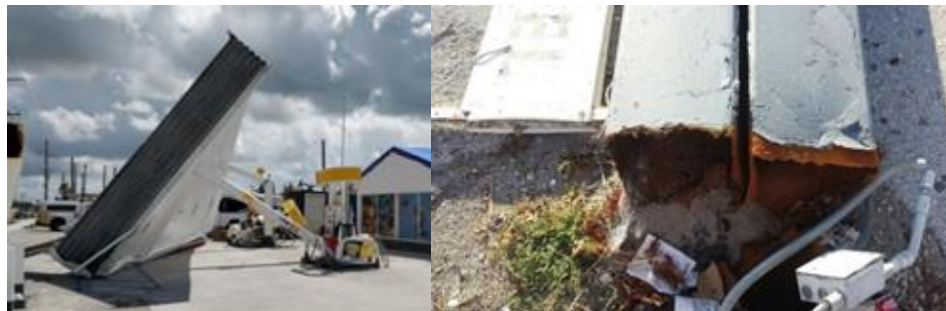
Figure 5: Damage to gas stations

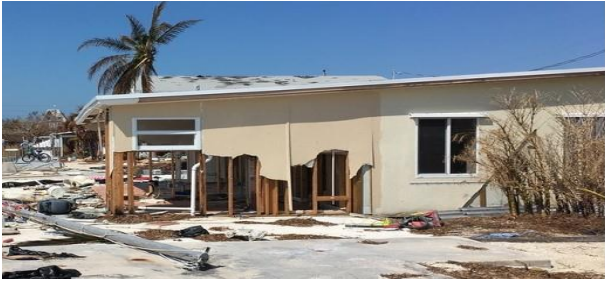
Figure 6a: surge damage to walls

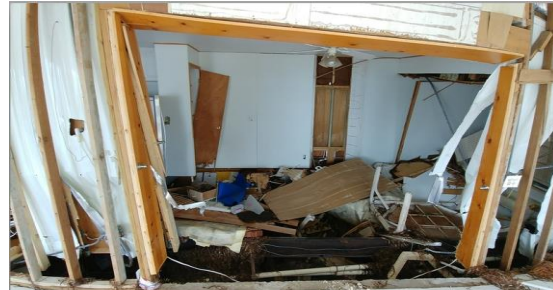
Figure 6b: surge interior damage
