Hurricane Michael in the Area of Mexico Beach, Florida

Abstract: Category 5 Hurricane Michael made landfall near Mexico Beach, Florida on October 9, 2018, with measured high water marks (HWMs) reaching 7.2 m NAVD88. The town itself received great damage, with many areas destroyed down to the foundations. In this study, we document the storm and its effects on the greater Mexico Beach area: hazard, structural damage, and their relationships. Wave and surge damage was nearly total for low-lying properties, but damage decreased greatly with increasing elevation. Major wave and surge damage was noted in Federal Emergency Management Agency (FEMA) X zones, which are out of the 100-year floodplain, and it is suggested that the 100-year storm is a deficient measure for categorizing flood risk. **DOI: 10.1061/(ASCE)WW.1943-5460.0000590**. *This work is made available under the terms of the Creative Commons Attribution 4.0 International license, https://creativecommons.org/licenses/by/4.0/*.

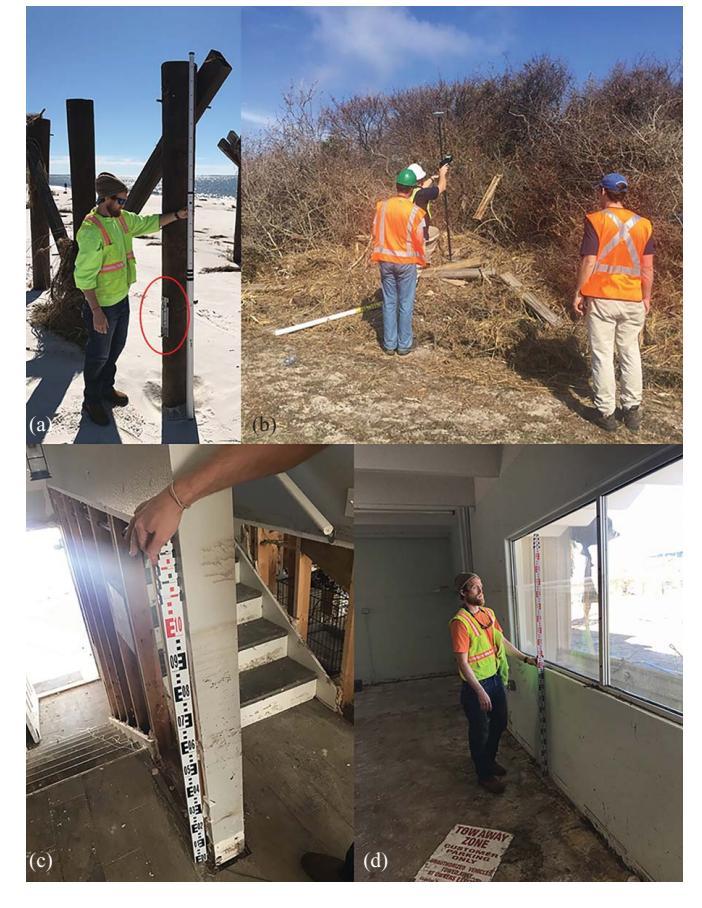
rapid gauge FLBAY03283, which was mounted on one of the pilings on the Mexico Beach Pier (Byrne 2019). The deck and almost all of the pilings seaward of the gauge were destroyed, but the gauge itself survived and provided good measurements. Fig. 2 shows a time series of the instantaneous water levels (computed using the hydrostatic assumption, and with atmospheric pressure, corrections using a nearby noninundated pressure gauge) measured every 30 s on October 10, and a 15 min average of these water levels which will be taken as the surge elevation. Fig. 3 shows the overall gauge location in Mexico Beach, and Fig. 4(a) shows a photograph of the gauge location poststorm.

Fig. 4. (Color) Examples of water level measurements: (a) location of USGS water level gauge at the Mexico Beach Pier, with bracket location circled; (b) highest wave runup location; and (c and d) examples of interior watermarks. (Images by authors.)

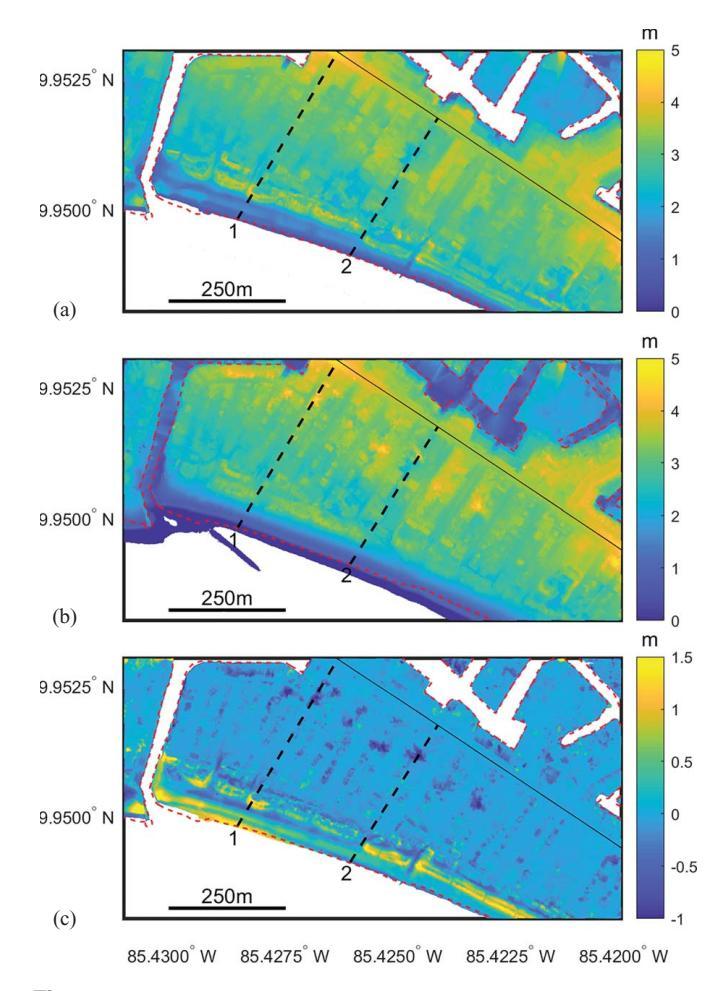
Fig. 5 shows a small but typical section of the beach and the erosion that occurred during Michael. Poststorm (October–November 2018, US Army Corps of Engineers) and prestorm lidar (April–May 2017, Northwest Florida Water Management District) are used to create a difference map, with positive numbers showing the locations of erosion. Both datasets have standard errors listed as 10 cm, which are much lower than the differences seen pre to poststorm. Apart from Michael, there were no major storms in the region in between survey periods.

The major difference in prestorm and poststorm onshore data arises from the complete erosion of the coastal dune system, with up to several meters of elevation loss. Areas of deposition are seen landward in some locations and represent debris piles generated from more seaward houses and other moveable objects. Fig. 6 shows the two transects identified in Fig. 5 before and

Fig. 5. (Color) Erosion example showing elevations in NAVD88 datum: (a) before; (b) after; and (c) difference. Erosion is shown as positive and deposition as negative. Elevations for transects 1 and 2 are shown in Fig. 6.

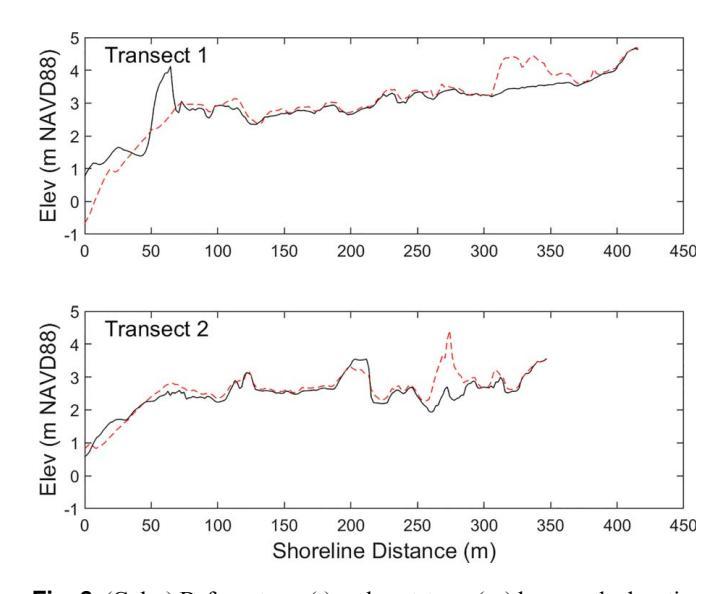
after the storm, which demonstrates the dune erosion. The dune crest elevations of approximately 4 m in transect 1 might also be compared with the peak surge value of 5.16 m NAVD88 and peak wave crest of 6.28 m NAVD88 measured at the nearby pier. These measured water levels greatly exceed the dune crest elevations, placing the system well into the inundation regime (Sallenger 2000) where sediment transport increases significantly and heavy dune erosion is expected. Once dune erosion was complete, large waves would have been able to penetrate inland with relatively little to impede them before encountering the many structures located close to the shoreline. Transect 2 provides a second example with no large fronting dunes, showing little overall erosion or accretion in the immediate beachfront area. However, both transects were chosen to intersect large debris piles, which were found in many inundated locations and will be assessed in more detail in the following sections. These debris piles showed large increases in elevation to the tops of debris, however, actual ground elevations underneath the debris had little to no erosion or accretion.

Fig. 6. (Color) Before storm (-) and poststorm (--) bare earth elevation transects in NW Mexico Beach from the nominal shoreline to HYW98. Locations for Transects 1–2 are shown in Fig. 5.

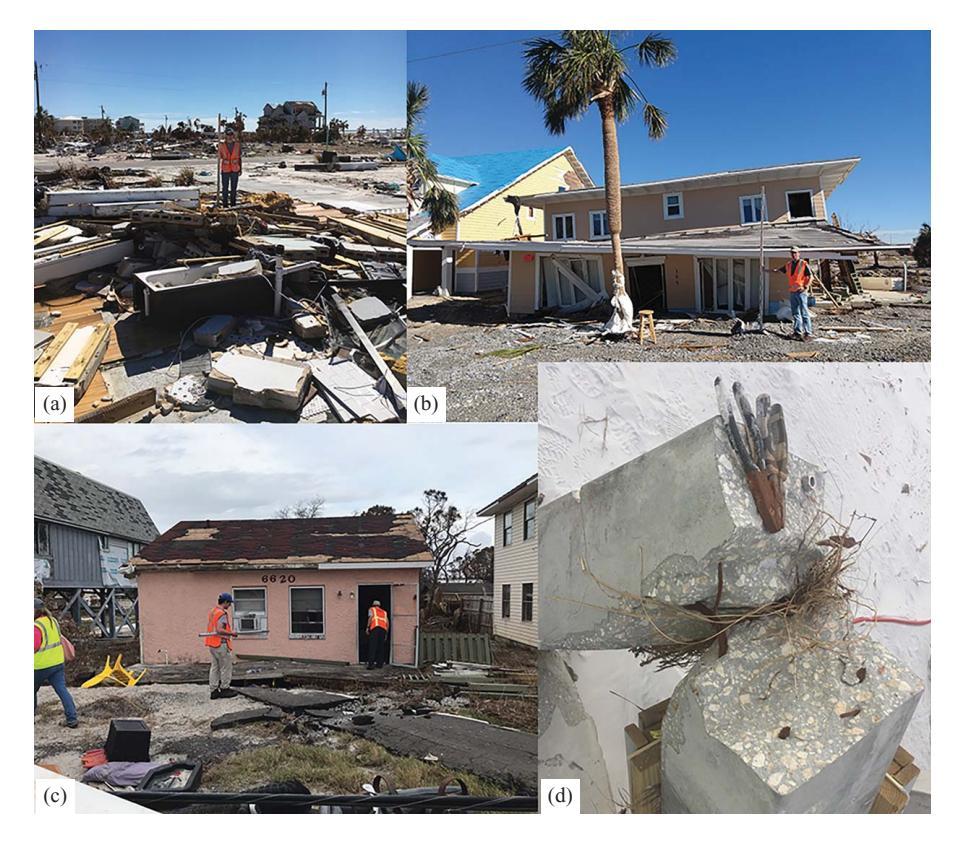
Fig. 7. (Color) Examples of structural damage: (a) destruction of at-grade house (DS6); (b) at-grade house detached from its foundations by waves and surge (DS6); (c) damaged at-grade house (note sheets of asphalt detached from road) (DS3); and (d) failure of prestressed concrete piling (DS6). (Images by authors.)

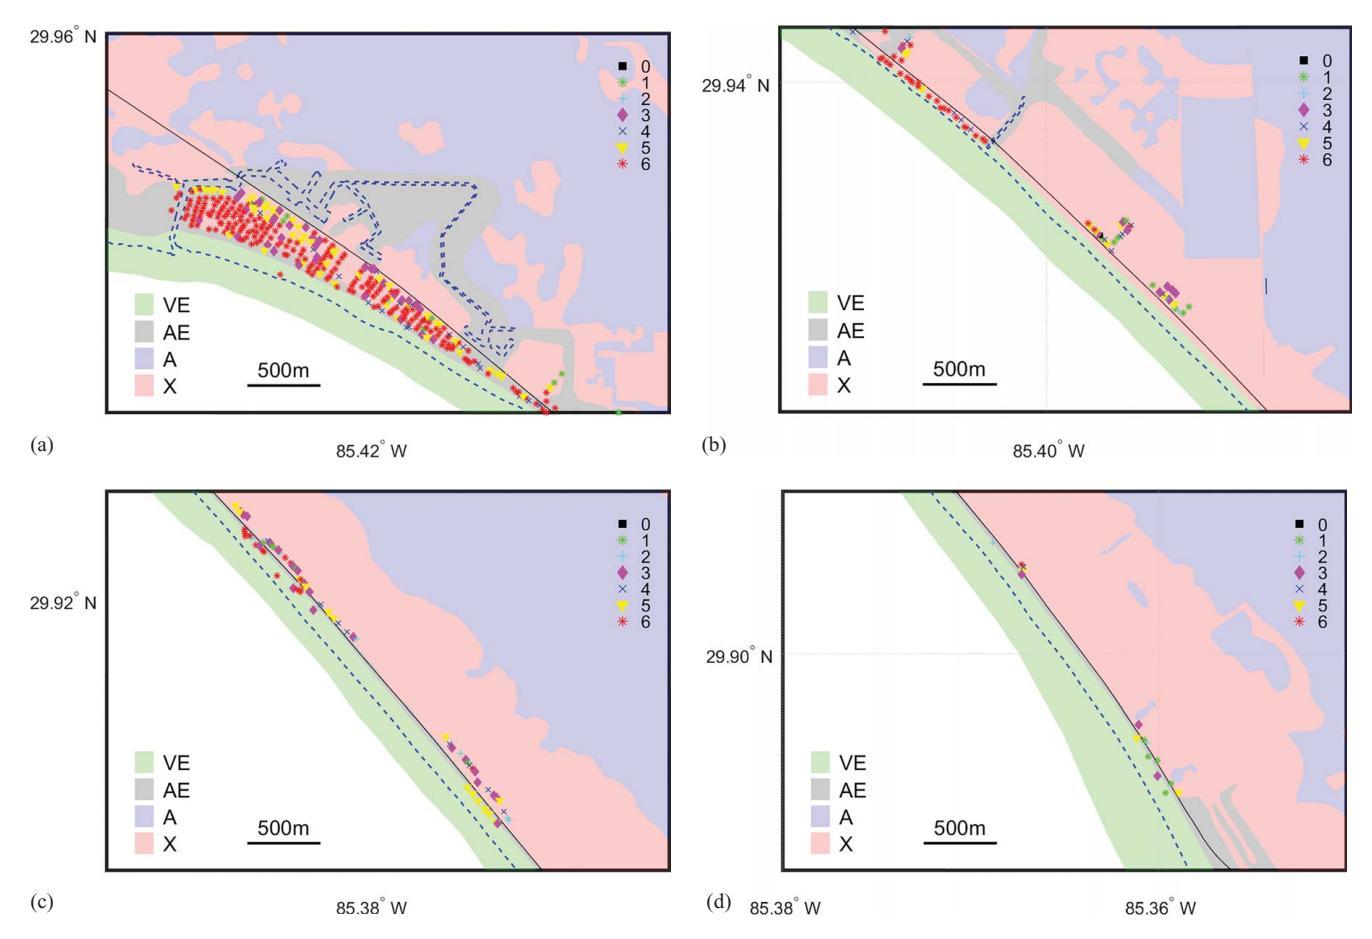
Fig. 10 shows the overall surge and wave induced damage ratings for all structures surveyed by the team in the Mexico Beach area, divided into the four subregions shown in Fig. 9. It is clear that in area (a) (furthest NW), large areas near the shoreline suffered complete damage, while the furthest SE section (d) showed areas near the shoreline with damage, but not anywhere near the extent of (a), with (b–c) demonstrating intermediate levels of damage.

Fig. 10. (Color) Surge and wave induced structural damage states as in Tomiczek et al. (2017). Black square = DS0; green diamond = DS1; cyan + = DS2; magenta diamond = DS3; blue x = DS4; yellow triangle = DS5; red * = DS6: (a) subregion a; (b) subregion b; (c) subregion c; and (d) subregion d. FEMA DFIRM flood zones are as labeled.

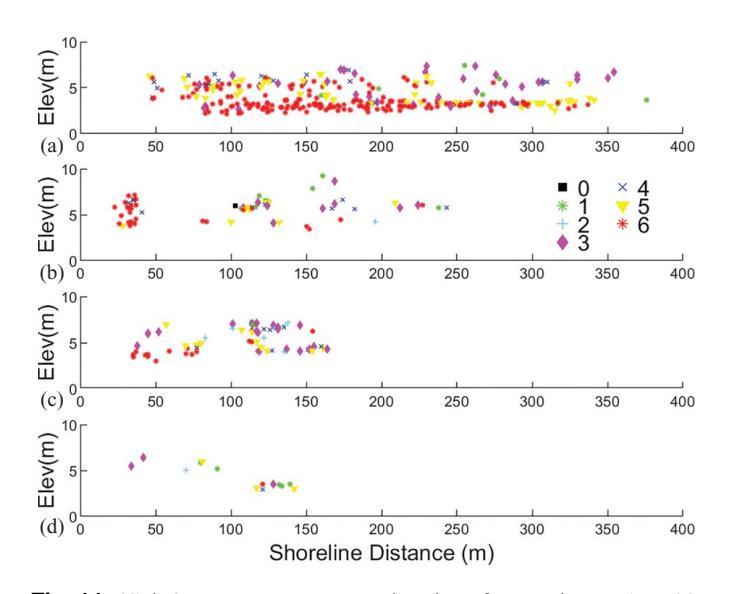
The damage state was found to be a strong function of structural elevation as shown in Fig. 11, in particular, close to the shoreline. This is not at all surprising, because structures at higher elevations may encounter waves and surge for a shorter length of time, or not at all if they are sufficiently elevated. Structures built at-grade were almost universally destroyed in the most severe conditions near the shoreline (DS6) and were largely older single family houses. Structures at higher elevations demonstrated much higher survivability,

Fig. 11. (Color) Damage state versus elevation of LHMs in m NAVD88, and distance from shoreline in the subregions (a–d) as shown in Fig. 9.

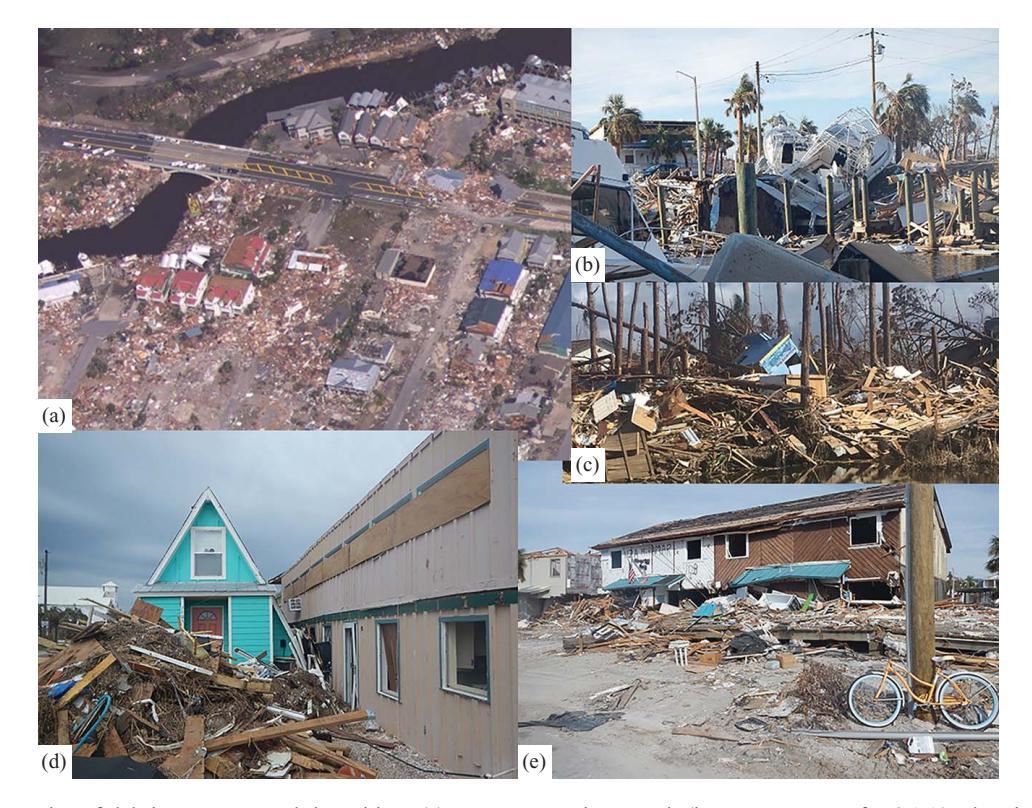
The destruction of structures and infrastructure generated large amounts of debris, much of which was transported inland. Fig. 14 shows typical examples of debris and debris piles. These could be quite large at times for both plan area and height above ground, as shown in the transects in Fig. 6. On a large scale, this debris was composed of entire structures detached from their

In some cases, shown in Figs. 6(a) and 14(a) which depict elevations and imagery from the same region, debris clusters had very high heights above ground and may have been grounded during the storm, that is,, the cluster was higher than water levels and reached the ground, acting as a dam, collecting additional debris, and preventing further transport. Although, to the best of our knowledge, no systematic study has been carried out, very large clusters not backed by a surviving structure often had large debris objects (LDOs) such as transported houses, roofs, or other large objects as nuclei. Fig. 16 shows LDOs, defined here as transported intact or semi-intact structural assemblies or whole structures, travel trailers, and recreational vehicles (RVs). Although structures are clear when out of place, trailers and RVs are fundamentally mobile

Fig. 14. (Color) Examples of debris transport and deposition: (a) Western Mexico Beach (image courtesy of NOAA), showing large debris piles; (b) boats and terrestrial debris; (c) waverunner rental shack and other debris in forested area; (d) large pile of woody debris and transported A-frame house grounded next to larger building; and (e) 34 m-long section of Mexico Beach Pier deck grounded against houses. (Images (b–e) by authors.)
