# Impacts of Hurricane Ian along the Low-Lying Southwest Florida Coast (USA) in 2022: Lessons Learned

Ping Wang\*, Elizabeth L. Royer, Kendal Jackson, and Sophia Gutierrez

School of Geosciences  
University of South Florida  
Tampa, Florida 33620, U.S.A.

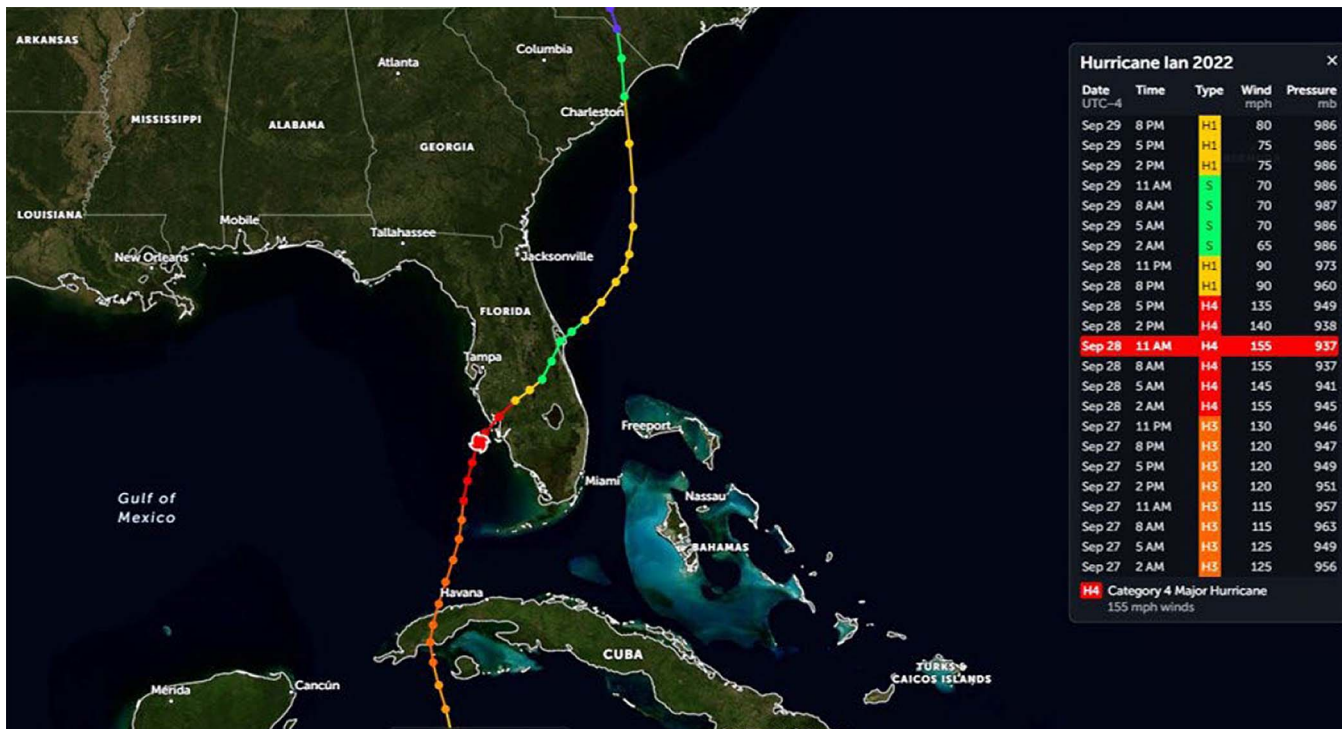
Figure 1. Best track positions, center pressure, and maximum wind speed for Hurricane Ian, 27–29 September 2022 (modified from Clark, Murshid, and Weeks, 2023).

Overall, Hurricane Ian made four landfalls over low-lying areas at a slow forward-moving speed without rapid loss of strength (Figure 1). The first landfall was at the southwest coast of Cuba on 27 September 2022 as a strong category 3 hurricane with maximum sustained wind speed of 110 kt (204 km/h) (Bucci *et al.*, 2023). The second and third landfalls were only 1.5 hours apart along the southwest Florida coast on 28 September 2022, at Cayo Costa and Punta Gorda, respectively. The Cayo Costa landfall came with a maximum sustained wind speed of 130 kt (241 km/h), or a strong category 4 hurricane. The storm only weakened slightly to 125 kt (232 km/h) at the Punta Gorda landfall. The fourth landfall was at Georgetown, South Carolina, on 1 October 2022 as a 70 kt (130 km/h) category 1 hurricane. The most energetic landfalls in terms of wind velocity, size of the storm, and storm forward movement speed occurred in southwest Florida (Figure 1), which was the focus area of this study. The extremely energetic atmospheric forcing over a shallow, broad, and gentle continental shelf generated very high storm surge flooding over expansive low-lying terrain and caused catastrophic damage over a large area.

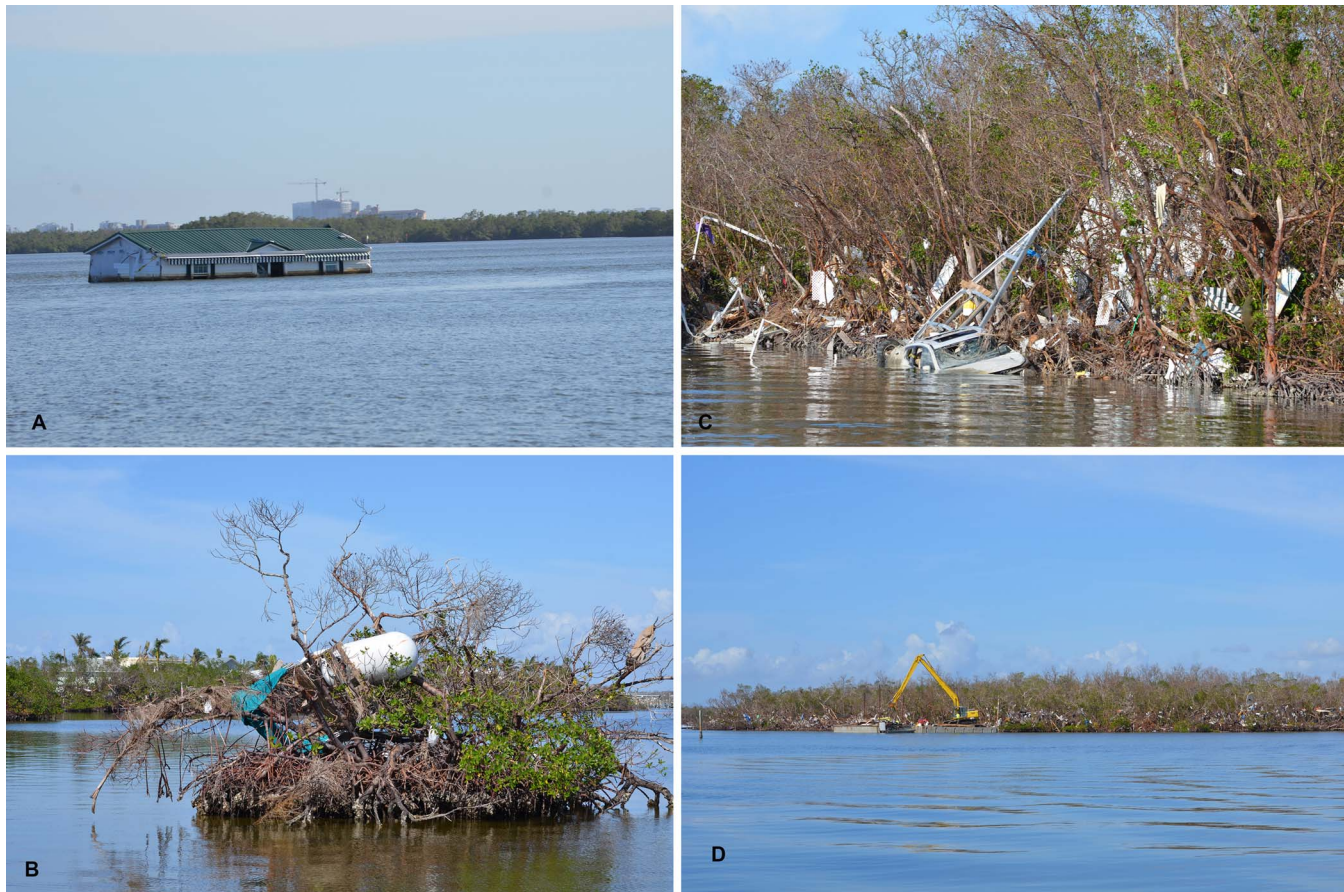
Tremendous amounts of artificial debris were washed into the estuary waterbody, with a significant portion trapped in the numerous mangrove islands (Figure 10). Figure 9 provides an example illustrating that everything associated with a waterfront mobile home community was washed into the estuary, ranging from building and insulation materials to all kinds of household goods (Figure 10D) to cars and small vessels (Figure 10C). Many permanent buildings, residential as well as commercial, were also completely destroyed or severely damaged, with the debris washed into the estuary. Permanent waterfront buildings, particularly those along the bayside, carry a similar development scheme to that shown in Figure 9A, although spaced much further apart with slightly higher boat docks and larger vessels. Nevertheless, substantial destruction occurred, with newer and higher buildings faring modestly better than older and lower ones, as expected. The debris washed into the estuary varied widely in size, ranging from an entire house (Figure 10A) to various-sized recreational vessels

Figure 10. Numerous non-biodegradable and harmful materials were washed into Charlotte Harbor and associated mangrove forest. (A) An entire house was washed into the estuary. (B) A small mangrove island was severely damaged with a storage tank and various, mostly plastic, debris. (C) A large amount of debris from the mobile home community, as shown in Figure 9, was washed into a mangrove forest. (D) Efforts to remove the debris. The upper limit of the debris indicates the level of storm surge. All photos were taken landward of developed barrier islands.

e.g., single-use plastics (Figures 10B, C, D and 12), storage tanks (Figure 10B), and numerous household appliances (air-conditioning units and water heaters, etc.), can be better controlled through simple preparation. For example, plastics should be more securely stored to prevent them from being washed or blown away. Household appliances, if placed on the nonliving first floor of elevated buildings, should be anchored more securely. It would not make much sense if a building is elevated to avoid the first floor being flooded by storm surge, while in the meantime, it is being used for almost everything ranging from costly essential appliances to general storage. At the very least, the materials on the flood-prone lower floor should be adequately anchored to prevent them from being washed into sensitive environments.

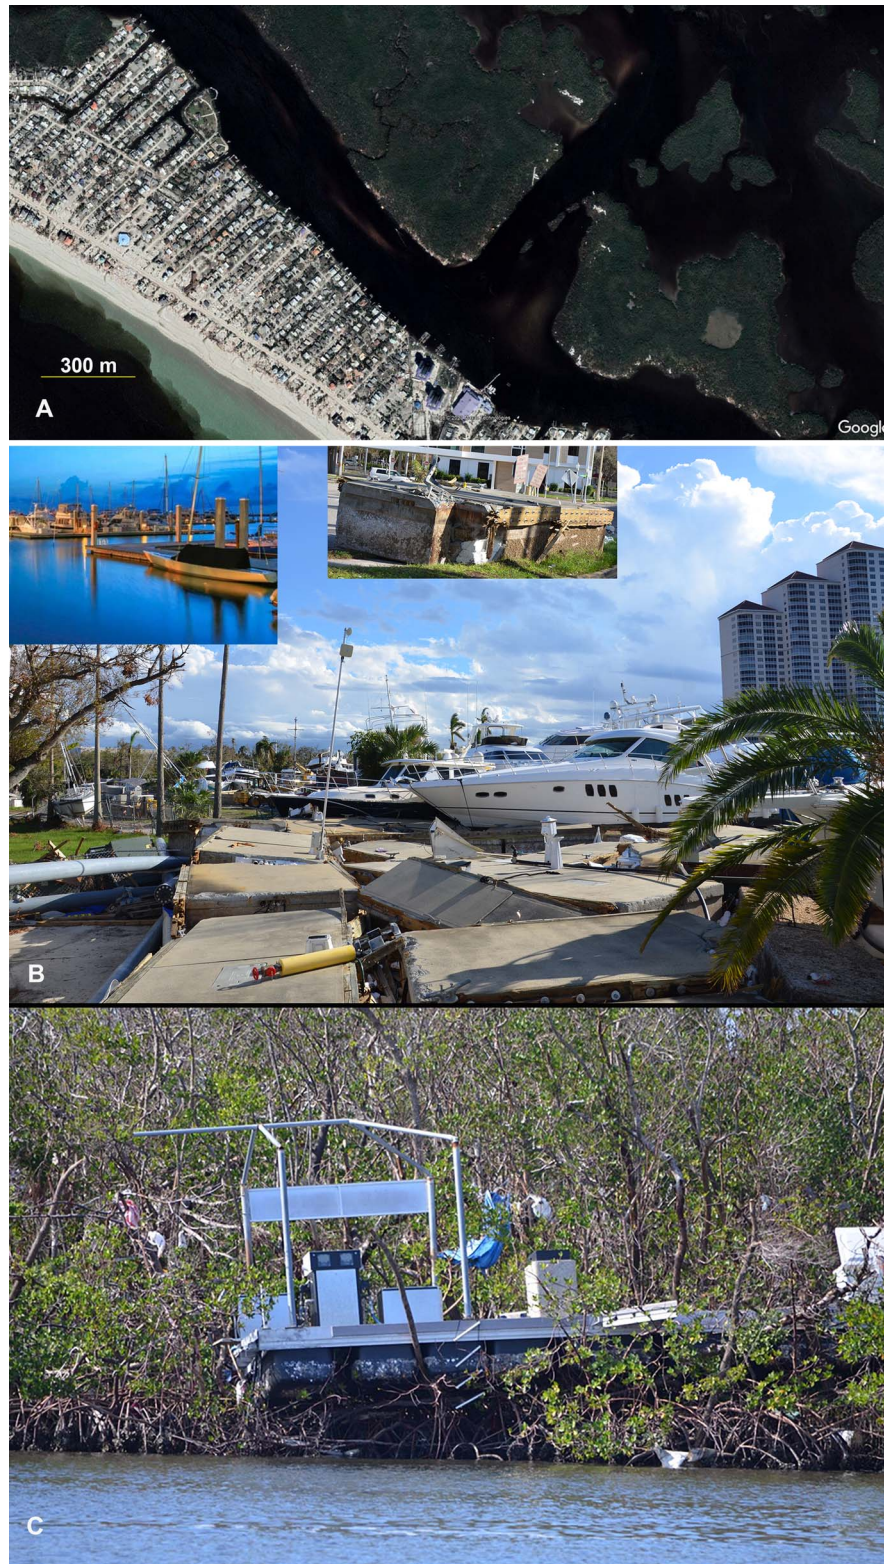
Numerous vessels of various sizes were washed on land (Figure 11B) and into mangrove islands (Figure 11A, C). Field investigations revealed that many of these vessels were tied to floating marina types (Figure 11B, top-left inset). A major convenience of floating marinas is that the docks and vessels move together with the rising and falling of tides, making it easier to get on and off the vessels from the dock. Many of the floating docks failed during Hurricane Ian because the extreme storm surge exceeded the height of the anchor pilings. The docks along with the vessels, some quite large (Figure 11B), floated over the anchor pilings onto land (Figure 11B) or into mangrove islands (Figure 11A). Figure 11C illustrates a floating dock and an associated fuel station being washed into a mangrove island. Figure 11B illustrates a foam-filled concrete floating dock washed on land with one piece on the sidewalk of a main road in downtown Ft. Myers (Figure 11B, middle inset). Some of the rather large vessels were still tied to the dock (Figure 11B). A marina directly next to the one shown in Figure 11B with fixed docks fared significantly better, with most of the vessels in place, although some

sunk. These observations suggest that floating docks, although potentially more convenient, can fail catastrophically if storm surge exceeds the height of the anchor pilings. Similar floating dock failures, *i.e.* the docks and vessels floated over the anchor pilings, were observed after Hurricane Idalia (2023) near its landfall site along the Big Bend coast of Florida about 350 km north of Charlotte Harbor.

Figure 11. Widespread artificial debris generated by Hurricane Ian. (A) The amount of non-biodegradable and harmful debris washed into the mangrove islands within Charlotte Harbor is closely related to the nearby heavily developed areas; example is from Estero Island (aka Ft. Myers Beach). (B) The high storm surge exceeded height of the anchor pilings of a marina, resulting in all the vessels being washed on land; example is from downtown Ft. Myers. (C) A section of a floating dock and associated fuel station was washed into a mangrove island; example is from southern Estero Bay. See Figure 2 for general locations.

Numerous vessels with a wide range of sizes suffered anchor failure and were washed on land (Figure 11B) or into mangrove habitat (Figure 11C). Although there were various causes of anchor failure, we identified one common cause relating to floating docks. Floating docks are commonly used in southwest Florida and elsewhere. They rise and fall with tides and provide convenient boat access. However, many of the floating docks failed during Hurricane Ian because the storm surge exceeded the height of the anchor pilings, and the docks simply floated off the pilings. In some cases, although the pilings were taller than the peak surge, they failed to maintain their integrity

against the forcing exerted by the elevated dock and vessels. Tilted anchor pilings were observed during the field investigations. Stronger anchor pilings and more secure design are necessary for floating docks to prevent the entire system from being washed into sensitive environments such as mangrove islands, although damage to the vessels and docks might still occur.

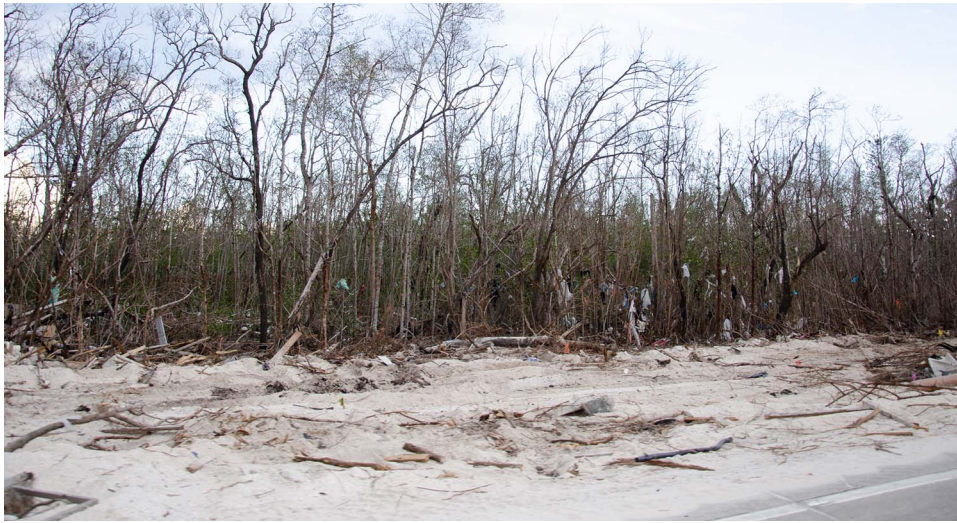
oceanfront buildings (Figure 12). Compared to the debris washed into the mangrove islands within the estuary as discussed above, this debris is relatively easier to remove, although the process is still time-consuming. Mechanical and manual debris-removal efforts were observed at various locations during field investigations over the winter months after the hurricane impact in September. Long-term ecological impacts of this non-biodegradable debris on the environment, including many pristine mangrove islands, are not clear and are beyond the scope of this study.

Figure 12. Numerous non-biodegradable and harmful materials were washed into interior wetlands of a barrier island. Example here is from Barefoot Beach in Bonita Springs (Bonita Beach area in Figure 2). The upper limit of the debris indicates the level of storm surge.

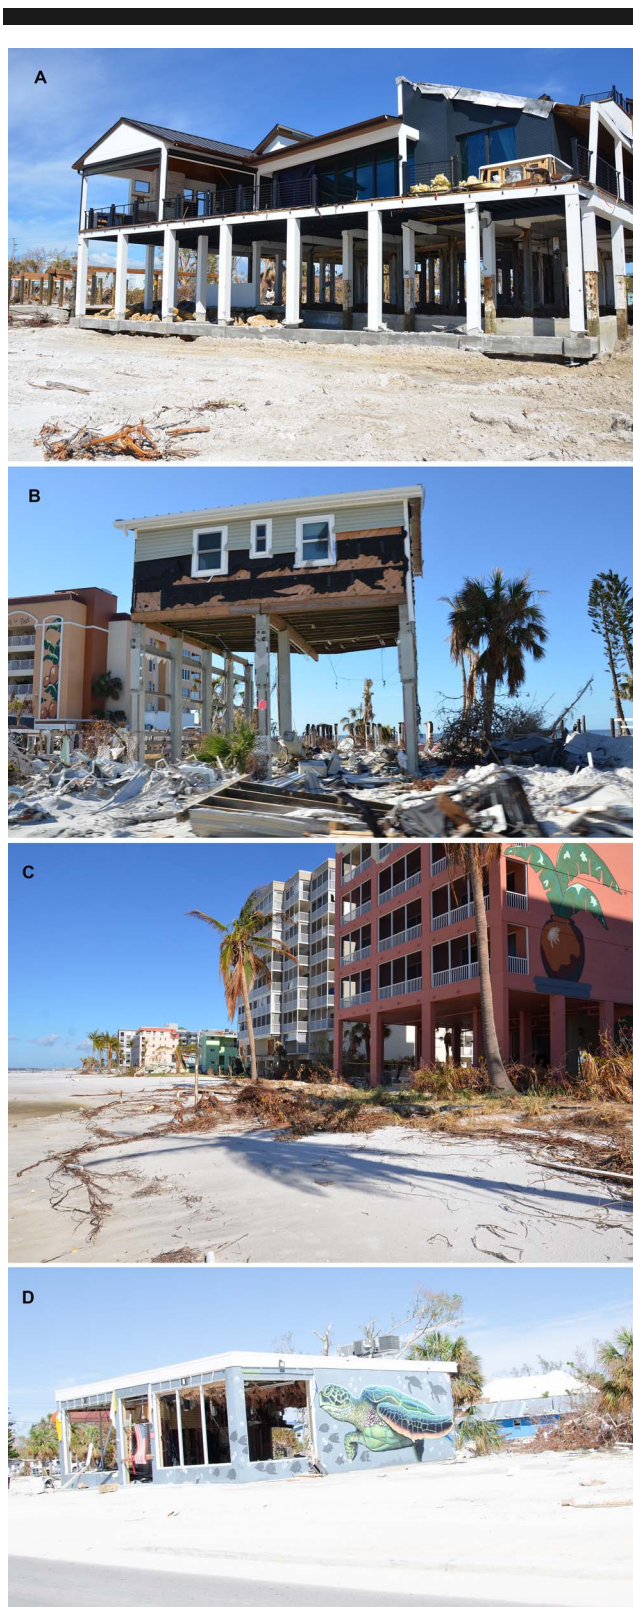
Beachfront buildings suffered severe damage due to the high waves superimposed on extremely elevated water level. Figure 13 provides several representative examples illustrating the damage to beachfront buildings. Systematic assessment of infrastructure damage can be found in Clark, Murshid, and Weeks (2023). Figure 13A illustrates a newer elevated single-family home. The overall structure appears to be intact, with part of the concrete slab foundation scoured underneath. The second living floor appears to be intact but with visible damage such as at the hot tub. The fibrous insulation material was exposed and trapped behind the damaged fence. This material can be observed at numerous locations, including on many previously pristine mangrove islands (Figures 8A, 9D, 10C, D, and 12). Part of the roof was damaged. It is not clear if the elevated living floor was flooded. The nonliving first floor was severely damaged. Based on the many dangling cables, the first floor likely housed many appliances that were washed away. Many of such appliances, *e.g.*, air-conditioning units, various types of storage tanks, and water heaters, were washed into the back-bay and trapped in mangrove islands far from their sources (Figures 9D and 10B, C, D). Although severely damaged, this newer building fared better than the house to the left, which was lifted off the pilings and cannot be seen in this photo. Figure 13B

illustrates an example of an older, highly elevated building. This building was deemed destroyed, as indicated by the red poster on the middle piling. One of the oceanfront pilings fell over. Similar to the above case of a newer building, everything on the nonliving first floor was washed away, leaving many dangling cables and destroyed fences. A couple of buildings seaward were washed away, leaving empty pilings. Figure 13C illustrates two examples of multistory buildings. The building to the right fared unusually well, with almost everything appearing to be intact, even the screens on the patios. The building to the left was not elevated as high. The first living floor appears to be severely damaged with two patio decks washed away. Modest damage to the patio screens on higher floors occurred, likely by wind forcing. It is worthy of note that palm trees are quite resilient, and most remained upright, even when nearly 1 m of the root system was scoured out (Figure 13C, left edge). Figure 13D illustrates an example of a nonelevated single-story gift shop along the landward side of the main road on Ft. Myers Beach. The building was destroyed, as marked by the red poster next to the flag. It is apparent that the waves were still quite high at this location, which is over 130 m from the Gulf of Mexico shoreline. The shredded and dangling insulation materials from the ceiling were likely caused by waves crashing at the ceiling. The air-conditioning units on the roof remained, in contrast to the two other single-story examples (Figure 13A, B), where the air-conditioning units washed away along with other appliances were likely on the nonliving first floor.

Figure 13. Damage to beachfront buildings. All examples are from the very densely developed Ft. Myers Beach (Figure 2B for location). (A) A relatively new single-family house on concrete pilings. The house to the left on wood piling was washed away. (B) An older single-family house on

tall concrete pilings. Nearby houses on pilings were washed away. (C) Multistory buildings: The building that is elevated higher (right) appears to have fared better than the one that is elevated lower (left). (D) Unelevated single-story shop that was completely destroyed.
