# Geotechnical and Geo-Environmental Damage and its Impacts on Critical Community Infrastructure during the 2021 Western European Floods: The Case Study of Altenahr, Germany

**Keywords:** 2021 Western European flood, infrastructure damage, reconnaissance observations, Altenahr Germany

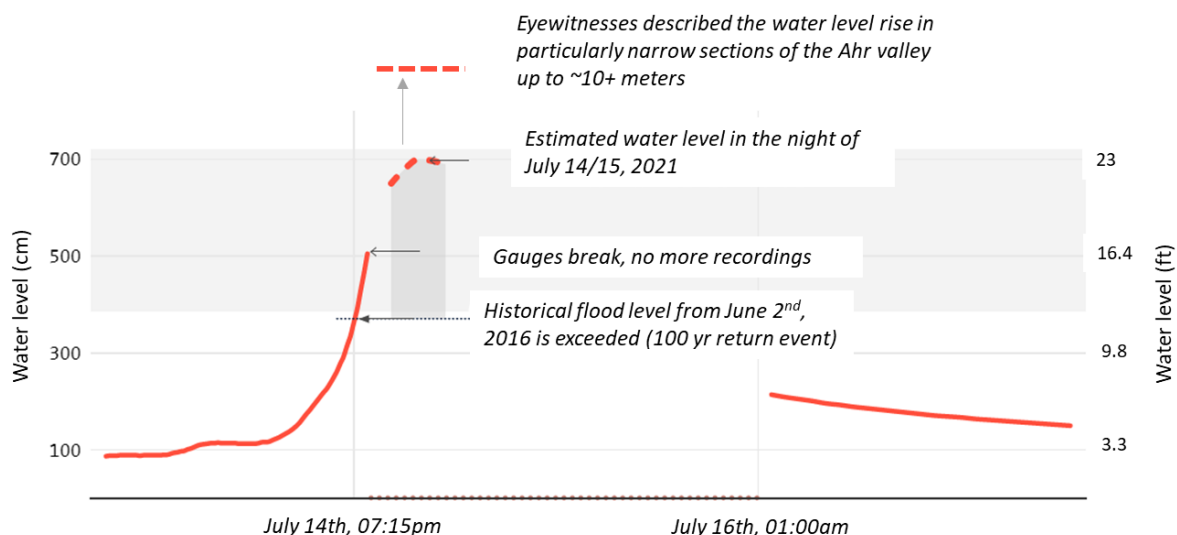
**Figure 2.** Water level rise during flood event in the district of Altenahr and loss of gauge readings (adapted from Schmid-Johannsen et al. (2021), data obtained from Hochwasserzentrale RP (2021))

Altenahr is a small district with a population of 1914 people in the county of Ahrweiler. The district consists of four smaller municipalities, namely Altenahr, Altenburg, Kreuzberg, and Reimerzhofen. However, most often all four municipalities are combined and referred to as Altenahr. The district as well as the individual municipalities of Altenahr were heavily featured in various media sources due to their extensive flood damage to infrastructure and the total number of fatalities (33), which was the second highest reported amongst any of the single districts (Schmid-Johannsen et al., 2021). Altenahr has an elevation of about 170m above sea level, and an area of 15km<sup>2</sup>. The Ahr bend (Ahrschleife) in Altenahr, a tight meander wrapping around central parts of the town, contributed substantially to the heavy, localized damage and high number of fatalities. The water level gauges along the Ahr in Altenahr exceeded its previous record of 2016: 3.71 m, discharge: 236 m<sup>3</sup>/s (Schaefer et al., 2021). In July 2021, the measuring stations broke due to flooding at a value of 5.05 m (and a discharge of 332 m<sup>3</sup>/s). Estimates for this event suggest a water level between 7 and 8 m, (in selected locations up to 10 m, Figure 2) with a discharge between 400 and 700 m<sup>3</sup>/s. Compared to the two particularly significant flood events previously recorded in the Ahr valley in 1804 and in 1910, the 2021 event suggests lower flood levels than in 1804 (estimate: ~ 1100 m<sup>3</sup>/s), and similar magnitudes as in 1910 (~ 500 m<sup>3</sup>/s) (Schaefer et al., 2021).

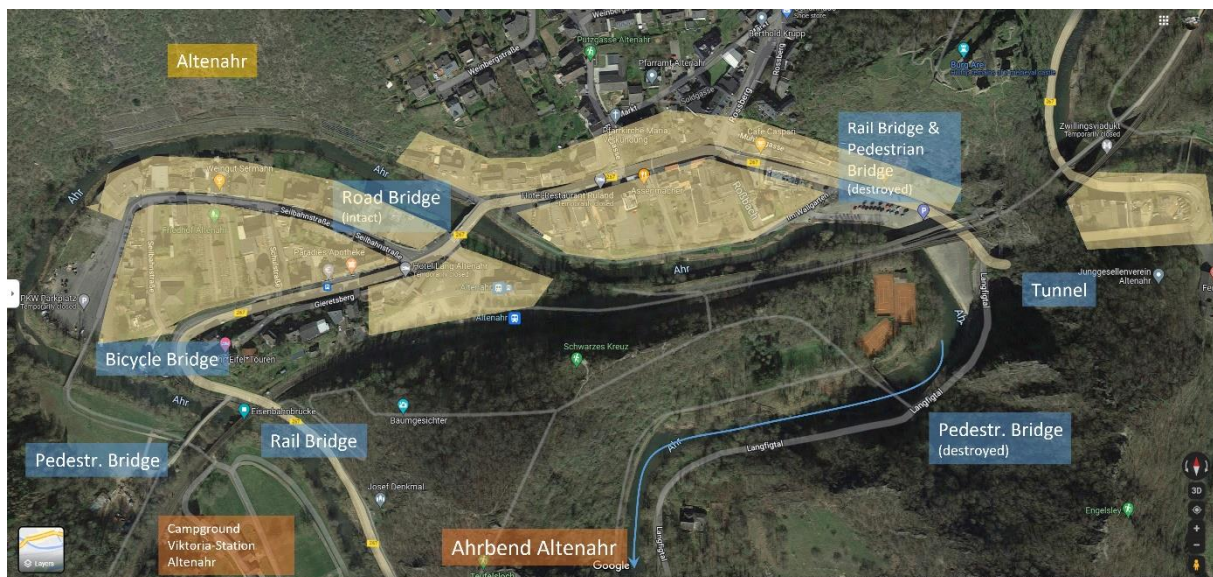
Figure 3 depicts an aerial image of Altenahr. The yellow shaded areas experienced severe damage with partial to full destruction of residential, commercial, and transportation infrastructure. Furthermore, these

**Figure 3.** Aerial map of Altenahr with heavily flood damaged areas.

areas experienced soil erosion, particularly near the sloped Ahr riverbanks, as well as sediment and debris re-deposition. In total, the Altenahr district reported 480 (80%) of all residential buildings to be heavily damaged (SWR.de, 2022). Approximately 150 of the 480 affected buildings had to be (or will be) demolished due to severe water damage and/or oil contamination, and many of them will not be given permission to rebuild in the same location due to the newly published inundation maps. Reconnaissance observations suggest the primary damage was associated with building facades, damage to lower floors due to the impact of wood and debris transported by the flood waters, as well as soil erosion near the foundation level. Figure 4 depicts examples of damage to residential buildings in Altenahr. Typical story heights in Germany are approximately 2.30m, suggesting water levels reached at least 4.0 m in many parts of Altenahr, as indicated in Figure 4. Besides the frequently observed above-ground damage shown in Figure 4 (top), Figure 4 (bottom) also depicts the remains of a washed-out residential structure, with only basement walls remaining. This failure scenario suggests acceptable geotechnical/foundation performance but indicates the lack of structural connection between the basement walls and the floor slab at the ground level (e.g., lack of continuous rebar). Several similar examples were observed in other regions of the Ahr valley, however, this type of extreme failure was less frequent than facade damage/ or removal of only parts of the superstructure.

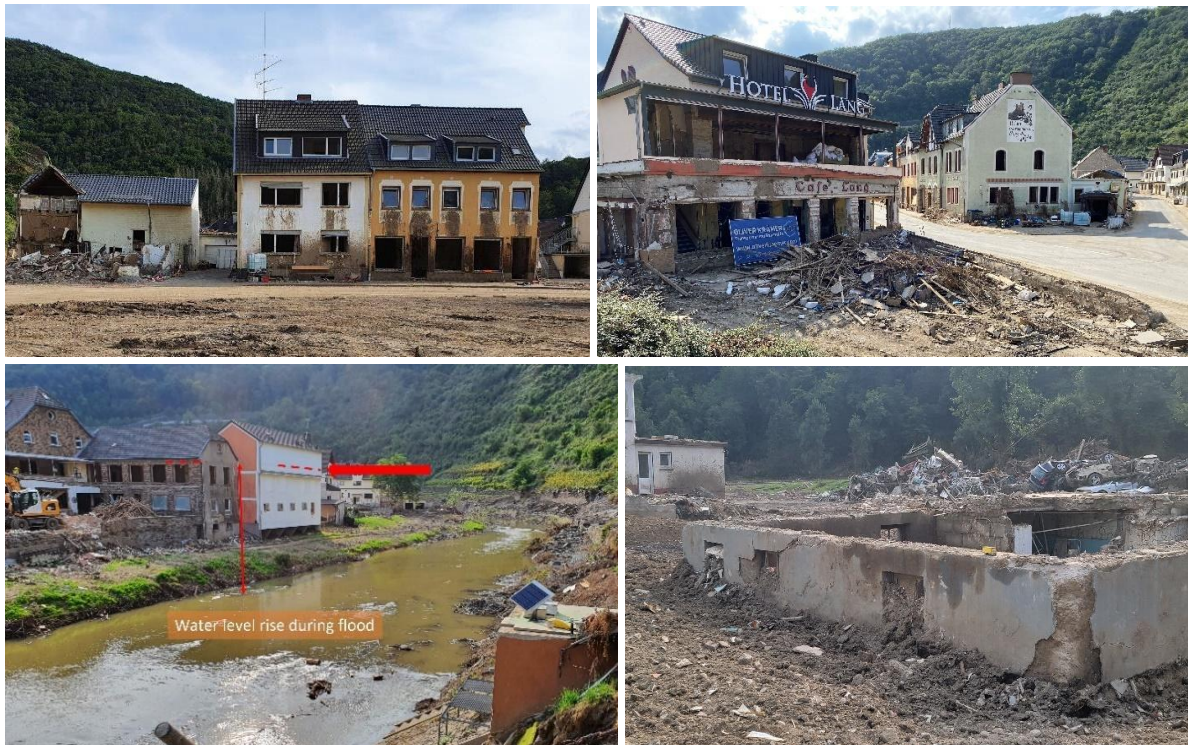
**Figure 4.** Example of structural/residential damage in Altenahr (town).

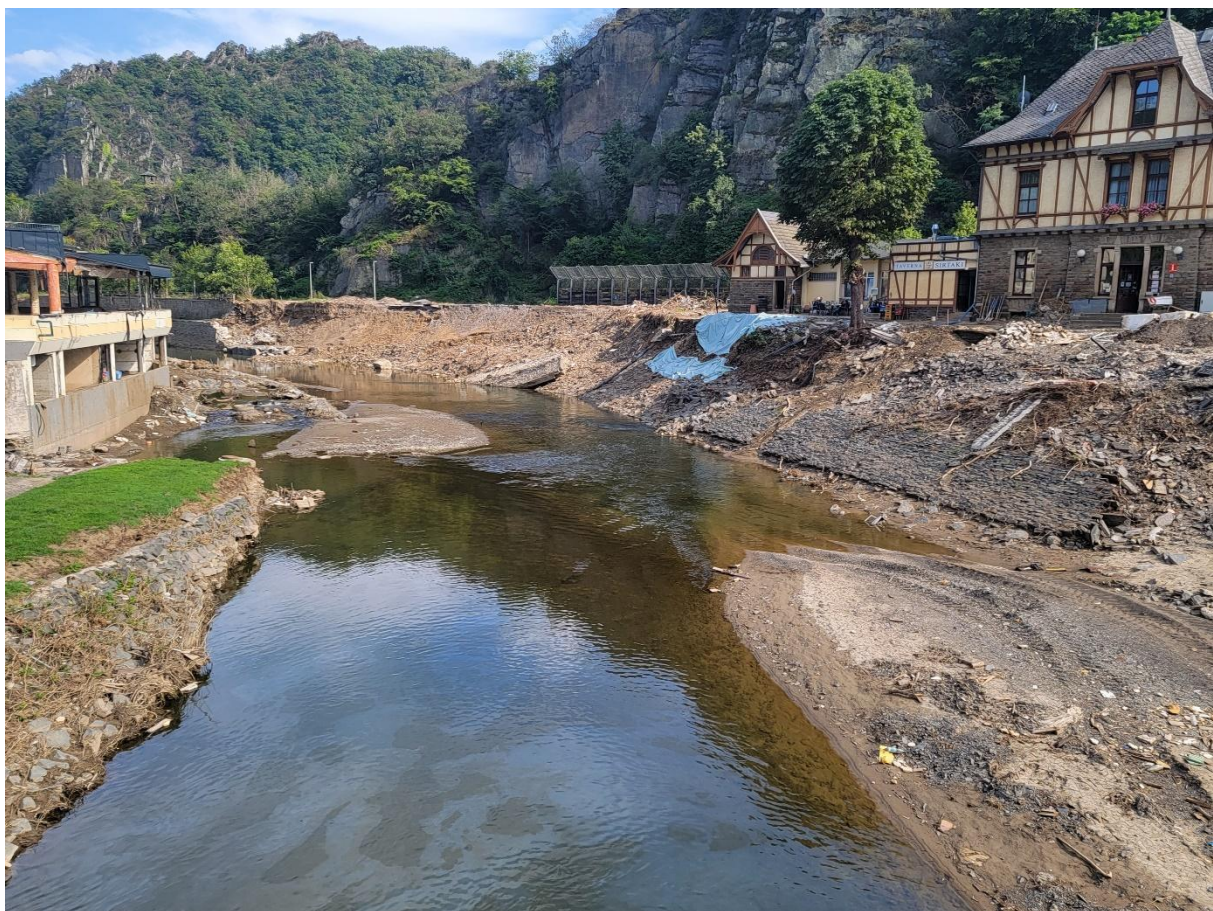
Figure 5 shows the Ahr river at the Altenahr train station, a transportation key point for the Ahr Valley tourism. The station (building to the right in Figure 5) was situated between a river meander (outer bend) and steep hill slopes (consisting primarily of rock cuts) as shown in Figure 5. Substantial riverbank erosion, damage and washout of an earth retaining wall can be seen in this photograph. Likely due to the unfavorable location of the station, slope armoring and stabilization was not effective in preventing extensive damage to the riverbanks immediately adjacent to the train station.

**Figure 5.** Soil erosion and retaining wall failure at the Altenahr train station.

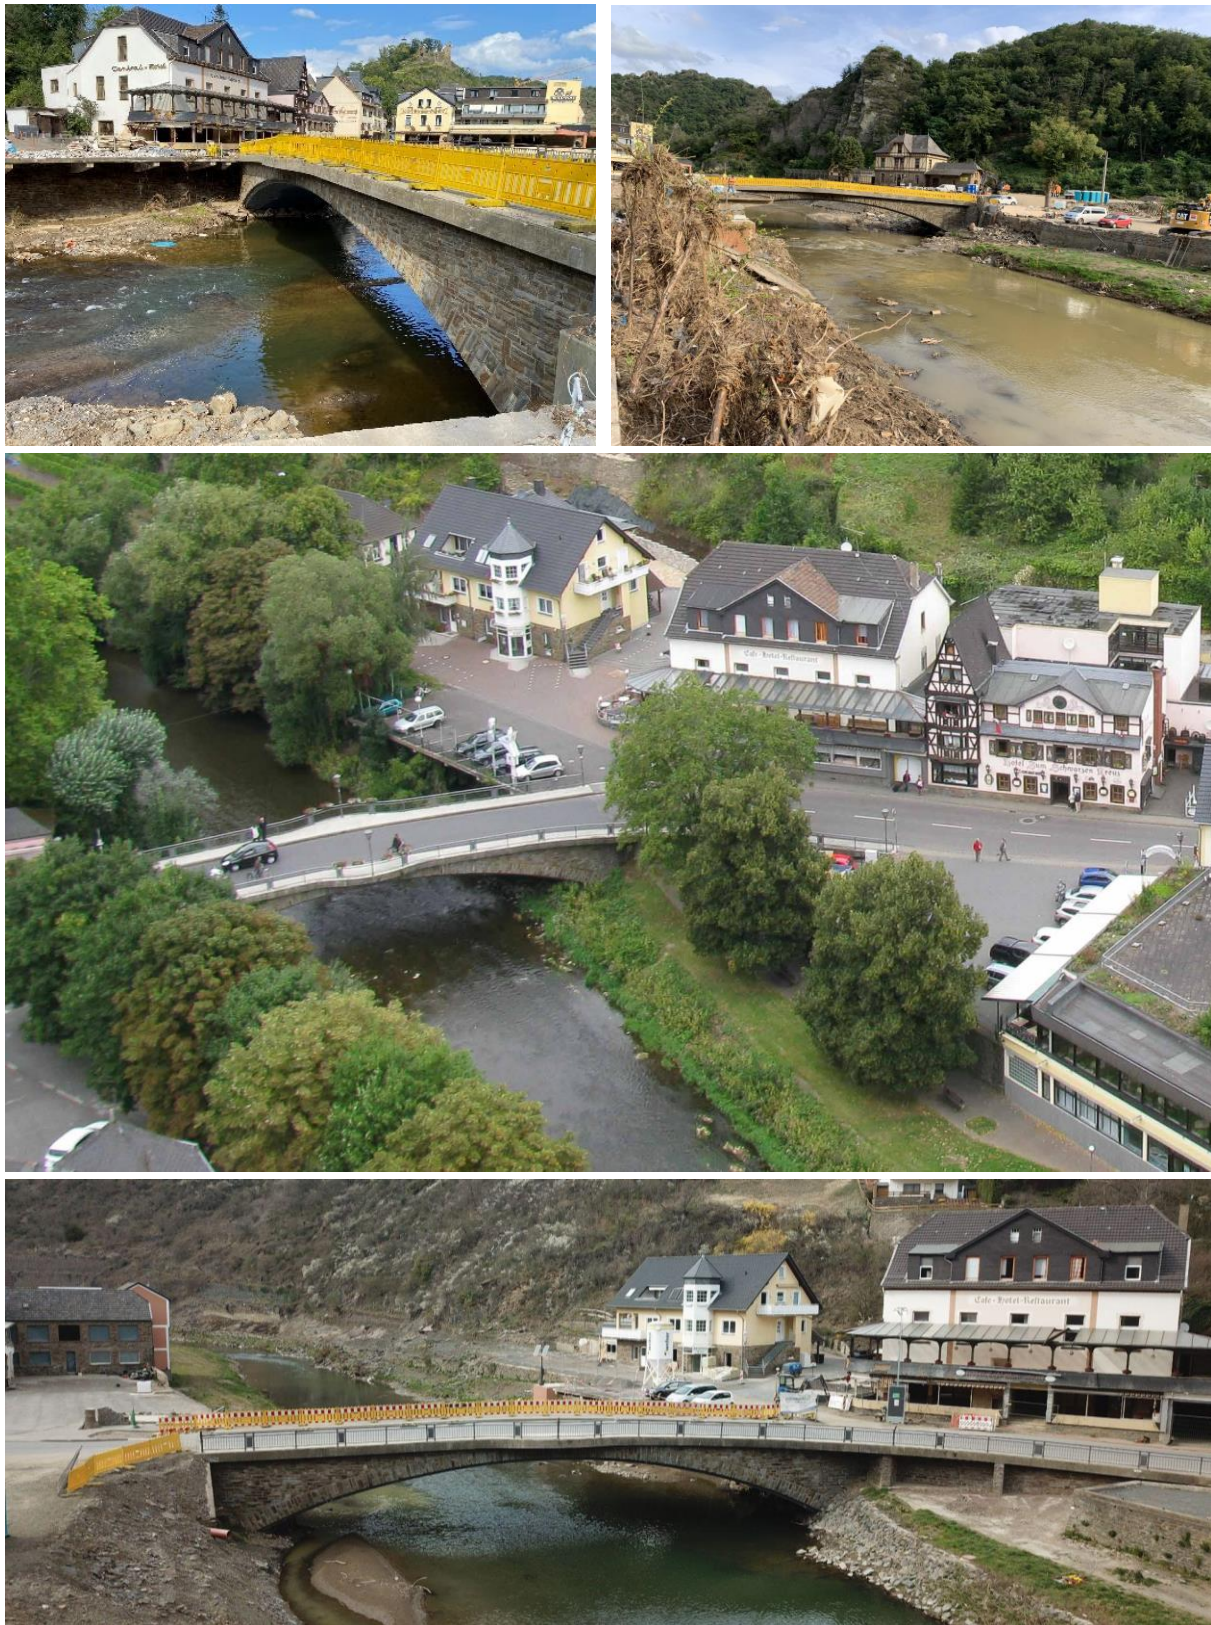
Out of the 17 bridges in the Altenahr district, only one bridge remained intact. The Altenahr road bridge, located in the town center (labelled in Figure 3 and photographed in Figure 6) remained structurally functional, allowing for post-flood traffic to resume normally upon clean-up and debris removal. This performance can be attributed in part to the favorable boundary conditions at the bridge ends. As shown in Figure 6, the bridge is connected with/to a continuous earth retaining wall (Fig. 6 top right) or has a wingwall, which prevented floodwaters from reaching behind the bridge abutment area and washing out backfill materials (as observed in many other locations). The other bridge end (shown in Figure 6 top left, center and bottom) was connected with the adjacent road through an integrated retaining wall with deck (Fig. 6 middle/bottom). Figure 6 shows the bridge at the time of the reconnaissance visit (top), the pre-flood condition (center), as well as eight months after the flood event during a second visit of the reconnaissance team (bottom, March 2022).

**Figure 6.** Photographs of the only structurally intact bridge in Altenahr following the flood, Top: Photos of abutment regions of the bridge in Aug 2021, Middle: Pre-flood aerial photograph, Photo Credit: Heinz Grates (<https://www.aw-wiki.de/w/index.php?curid=36263>), Bottom: Aerial photo taken by the GEER team in March 2022, showing the bridge after clean-up work.

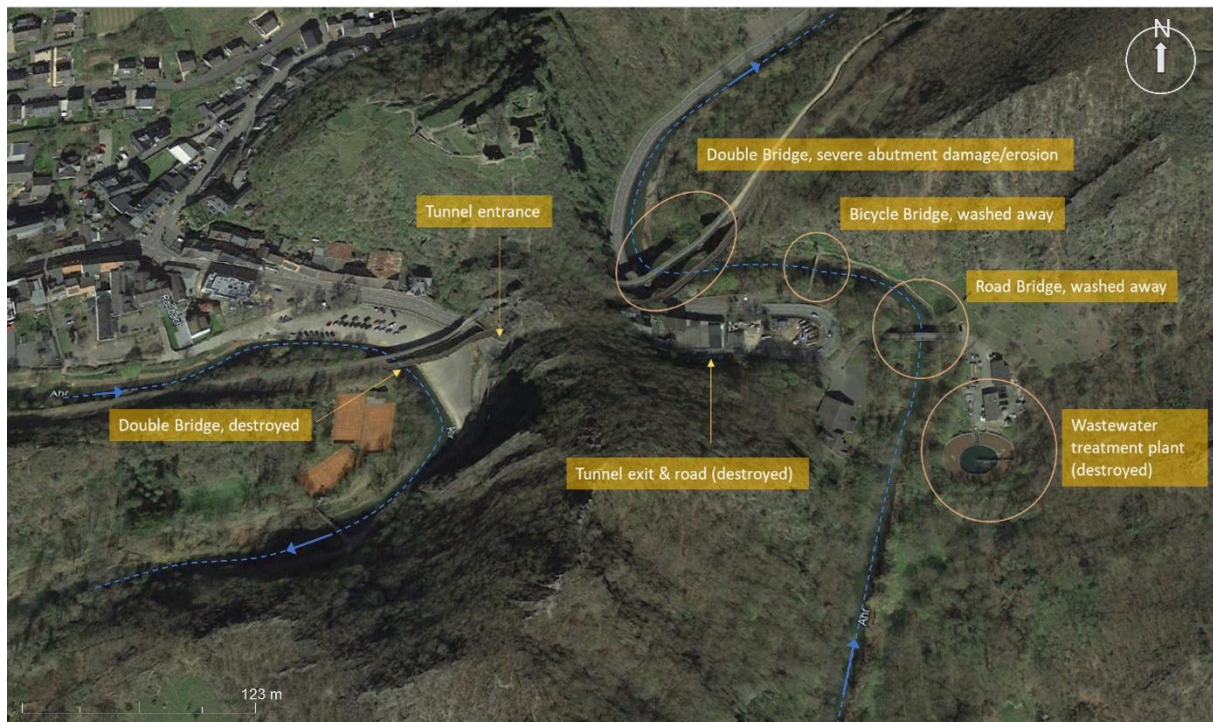
The tunnel exit site in Altenahr has been one of the most featured damage locations of the Ahr valley in Germany. Figure 7 shows an aerial map obtained from Google Earth and various infrastructure facilities near the affected site. This location is of particular interest for documenting how soil relocation near the tunnel and intersection with the Ahr river relate to local hydraulics, geology, and abundant infrastructure. The location features multiple key infrastructure items forced to be tightly grouped due to the restrictive, steep valley, and the river. The presence of this infrastructure, in particular the tunnel, led to a significant change in local hydraulics.

The *Ahr* river makes a bend around the tunnel (which is located south of the photo, but not visible in Figure 7). Aside from the tunnel entrance and exit areas, Figure 7 also describes the infrastructure around the tunnel and its performance during the flood. Flood waters flowed through the tunnel from the tunnel entrance on the west side, nearly filling the opening cross-section. The relatively small cross-sectional opening of the tunnel caused a high-velocity water efflux that exited on the east. The double bridge (rail/bicycle) on the west side of the tunnel was also destroyed during the flood.

**Figure 7.** Google Earth Aerial View of the tunnel entrance/exit site in Altenahr prior to the flood (3/2020).

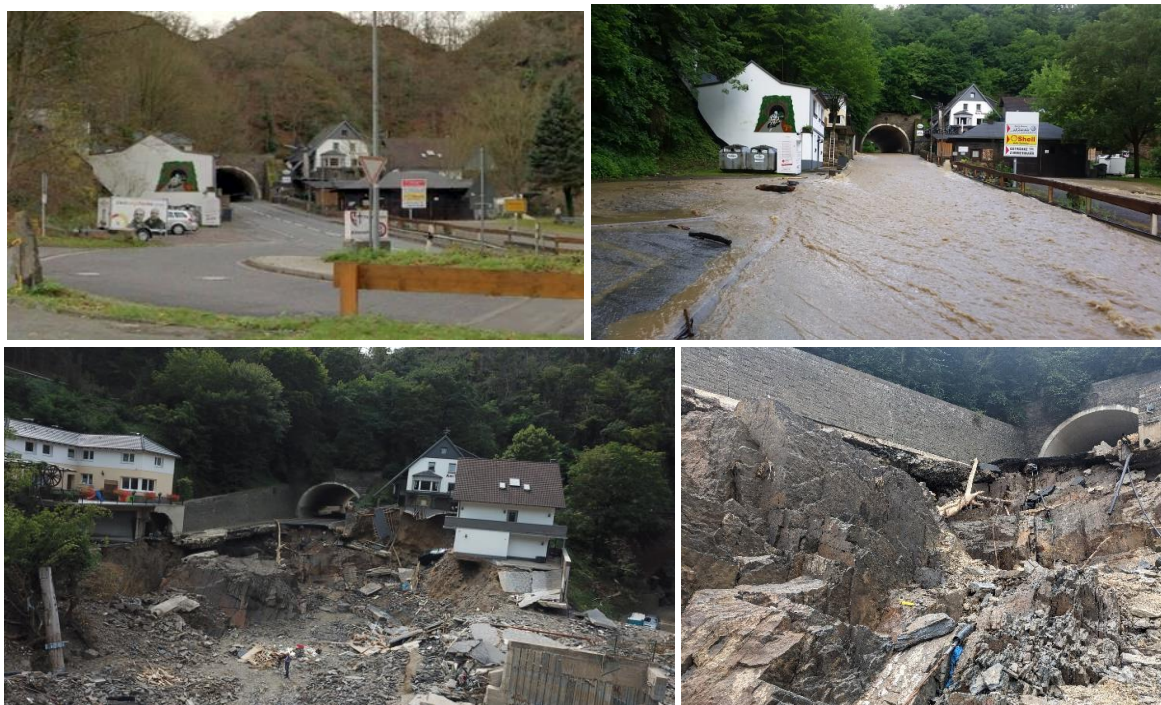
Figure 8 (top) shows a Google Street View of the tunnel exit in May 2021 prior to the 2021 flood event, followed by a reference photograph of the tunnel exit during the 100-year return flood in 2016 (Fig. 8 (top, right)). Figure 8 (bottom) shows the tunnel exit and surrounding area on August 13, 2021, approximately four weeks after the flood. The tunnel street (Tunnelstrasse) was completely destroyed by the water efflux rushing out of the tunnel exit and exposed underlying bedrock to depths of 9 m. Figure 8 (bottom) also shows the jointing orientations in the underlying rock, damage to the adjacent residential buildings, and the large volume of material that was eroded downstream of the tunnel exit. The eroded crater-like feature outside the tunnel exit had approximate dimensions of 9 m in depth and 50 m in width. A similar feature was documented during the 1910 flood at the east side of the tunnel (Gaertner, 2022).

**Figure 8.** Top left: Google Earth/Maps Street View of the Altenahr tunnel from May 2021; top right: photo during the June 2016 flood event (Source: [https://www.altenahr.de/index.php?id=26&publish\[id\]=9709&publish\[mode\]=overview&no\\_cache=1#18](https://www.altenahr.de/index.php?id=26&publish[id]=9709&publish[mode]=overview&no_cache=1#18)); bottom: photos by the reconnaissance team after the 2021 flood, August 2021 (50.5165261, 6.9975355)

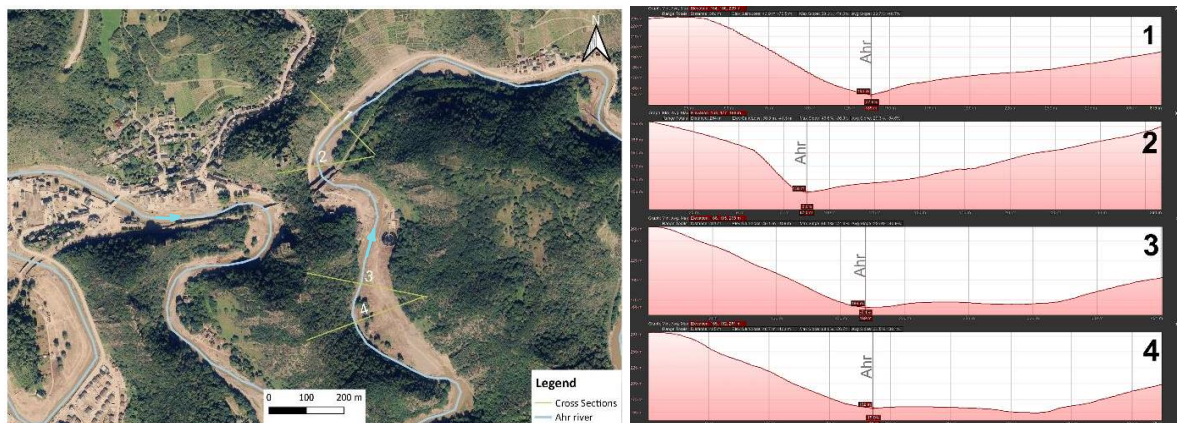
**Figure 10.** Left: Plan view of tunnel exits and location of cross-sections; Right: Elevation profiles in near vicinity of the Altenahr tunnel exit

Near the tunnel exit, a double bridge connected railway tracks and a road across the Ahr river. Figure 9 shows the severe damage to both bridges, but also the extent of sediment relocation and streambed destruction at this location. The image also illustrates a key geological and topographic characteristic of the Ahr valley: its steep slopes and limited width of the river valley. This topography has been highlighted as a key issue that led to the severity of the flood in the Ahr valley. Figure 10 shows an elevation profile at the location of the double bridge and surrounding area. The bridge is situated near profile #2 in Figure 10 (right). The maximum slope of the adjacent hillside was approximated as 76.9% (cross-section 2). Figure 10 also illustrates the extent and width of soil erosion and sediment redeposition along the Ahr river in the vicinity of Altenahr (Fig 10, left).

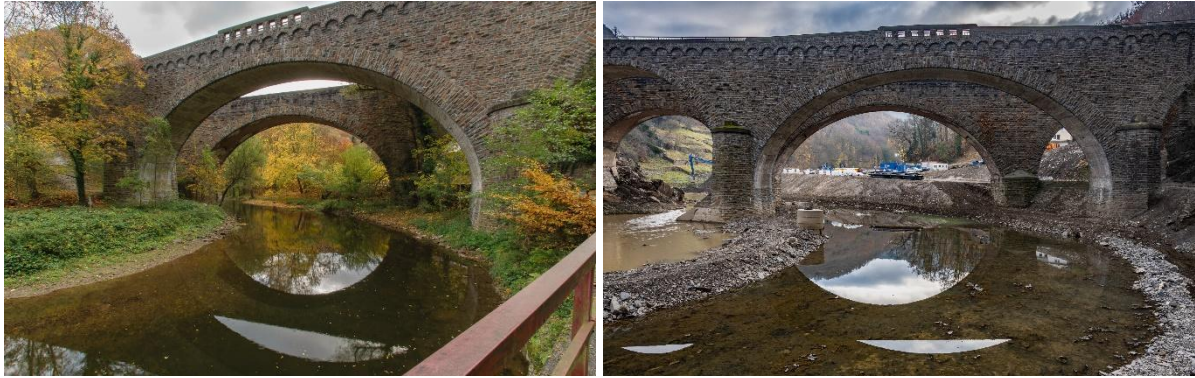
The bridge has a total height of 18 m, and a length of 100 m. The bridge arches have a clear cross-section of flow of nearly 33 m in width and 15 m in height. The bridge piers have a thickness of 5.3 m and an enlarged sloped reinforced mantel at the bottom of the piers. The bridge was placed on shallow reinforced concrete footings. No structural damage was observed at any of the intermediate bridge supports. A comparison of before-after imagery (Figures 9, 11) suggests the pre-flood channel of the Ahr river through the middle arch of the bridge (Figure 11, left), while the immediate post-flood route of the river occurred primarily through the left arch of the bridge as shown in Figure 9. This left side of the bridge was the most severely affected, with substantial erosion and damage to the abutment region (Figures 9 and 12, left). Following restoration and clean-up work in the area, the river was guided back into its pre-flood channel (Figure 11, right).

**Figure 11.** Before and photos of double bridge at tunnel exit taken in upstream direction, photo credit: Heinz Grates, Source and access at <https://www.aw-wiki.de/w/index.php?curid=67031>; Left: Pre-flood, Right: Post Flood and post-river rerouting back into its original riverbed

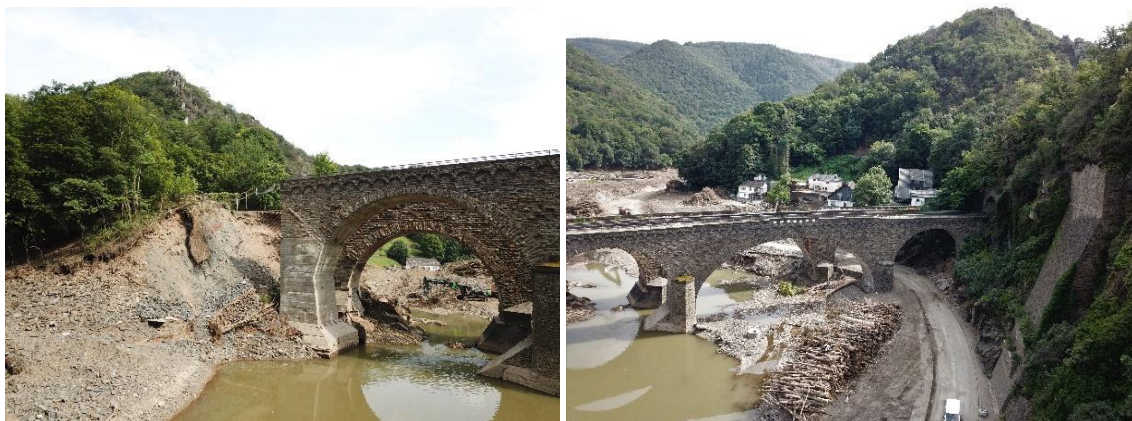
Figure 12 shows close-up photos of the abutment region around the double bridge. The extent and elevation of the washed-out abutment area provides an estimate of the water elevation (~18 m above its original water level) within this narrow stretch of the valley. Remnants of the damaged train tracks span between the bridge and the adjacent hillside. The bridge abutment area in Figure 8 (left) consists of an un-engineered connection between the bridge arch and adjacent natural hillside, likely backfilled with excavation spoils at the time of construction. The lack of wingwalls and armoring likely contributed to the extensive erosion in the vicinity of the abutment. However, the large cross-sectional flow area of the bridge arches and additional flow area created by the abutment erosion likely mitigated structural damage to the bridge structure itself.

**Figure 12:** Photo of the abutment region of the double bridge, August 13<sup>th</sup>, 2021. Left: Washed out abutment area, Right: bridge abutment area intact and connected to adjacent rock slope

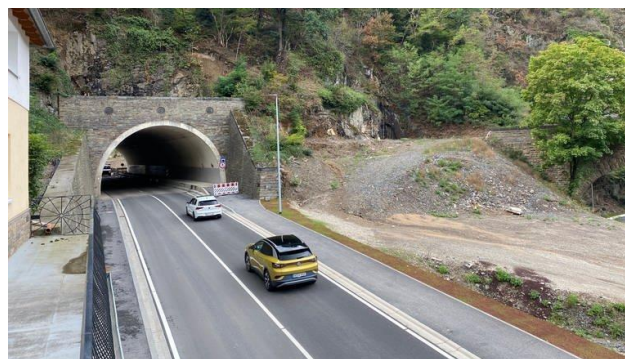
**Figure 13.** Tunnel street at opening in September 2022

In September, 2022 the tunnel exit was reopened following road construction of nearly 2.43 Million Euros. Four adjacent residential structures were removed (Gaertner, 2022). According to city officials, the extent of future flooding is expected to be less due to increased asphalted surfaces near the tunnel exit and due to lack of easily-eroded cobblestone sidewalks.

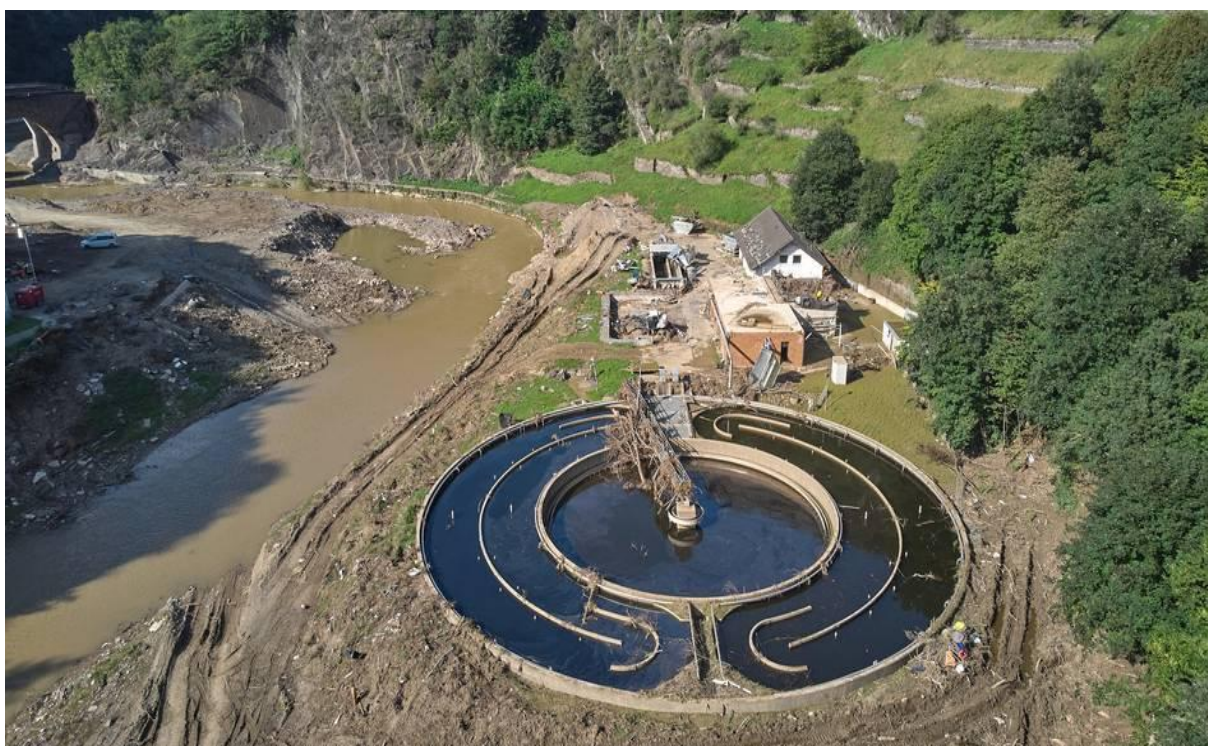
In the background of Figure 9, a water treatment plant is visible which was also affected by the flood event. The water treatment plant (shown in Figure 14) was irreparably damaged (General Anzeiger, 2022), and wastewater was directly discharged untreated into the Ahr River according to authorities in Mainz, the capital of Rhineland-Palatinate (RP). This incident was not isolated and the Altenahr treatment plant was one of several plants (including its canalization) that could not be repaired. Approximately 30 Million Euros were allocated for the reconstruction of sewers and wastewater treatment plants in the Altenahr district. However, this allocation is only a fraction of the more than 183 Million Euros needed to repair the major wastewater facilities within the Ahr valley and remediate wastewater-based environmental damage to the region (General Anzeiger, 2022). The wastewater treatment plant experienced flood water influx from both upstream and downstream directions due to (1) water flushing through the narrow stretches of the Ahr bend (upstream), and (2) water being backed up as efflux from the tunnel hits the steep slopes across the tunnel exit. The adjacent structure of the wastewater facility was also destroyed. Current estimates by government officials suggest that  $\frac{1}{3}$  of the canalization in the Ahr valley is damaged, destroyed, or entirely washed away. The restoration of the entire sewer system is expected to take 10 years. Small mobile wastewater treatment plants are currently being erected to prevent continued discharge of untreated water into the Ahr (SWR.de, 2021).

**Figure 14.** Wastewater treatment plant Altenahr following the 2021 flood, Source: DPA/Thomas Frey

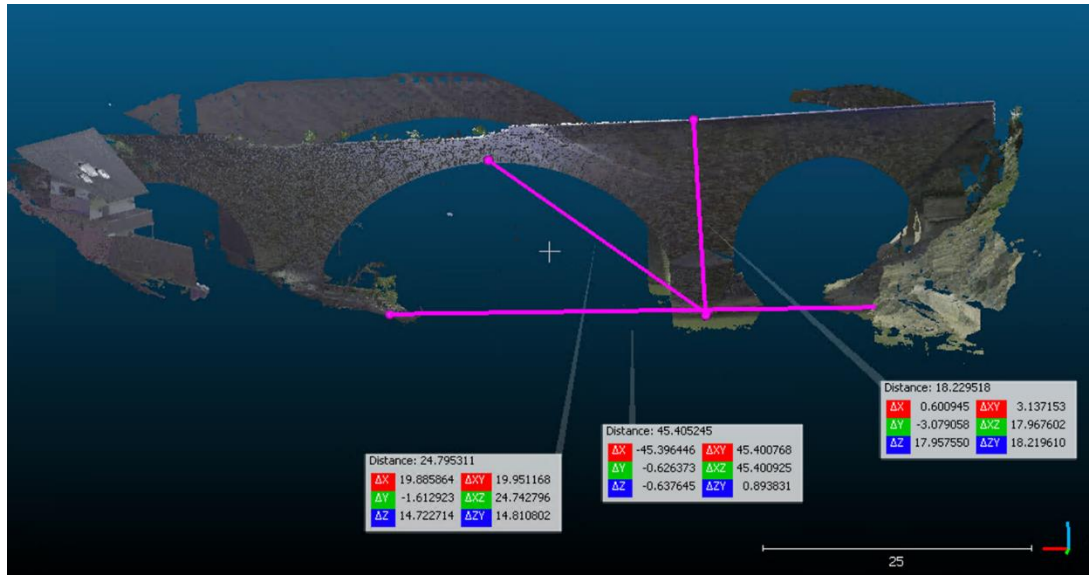
Figure 15 depicts an excerpt of initially collected 3D point cloud data of the double bridge using terrestrial LiDAR. Data processing from this location (as well as most others) is still ongoing. The generation of the point cloud model from terrestrial LiDAR allows for geometric measurements of features of interest. As shown in Figure 15, estimates of the total bridge height, clearance height, and cross-sectional distance of the river were found to be 17.96m, 14.72m, and 45.50m respectively. Similar measurements are possible in point clouds generated from UAV imagery, albeit with less accuracy. Aside from measurements depicted in Figure 15, possible future geometric measurements include volume of soil lost due to scour and erosion, angle of pier tilt, deck deflection, and the dimensions of resulting cracks in decks or piers. These data provide meaningful information for numerically modelling water-structure-soil interaction at the bridge location.

**Figure 15.** 3D point cloud excerpt derived from terrestrial LiDAR at the Altenahr double bridge. From left to right, measurements of the bridge clearance height ( $\Delta Z = 14.72\text{m}$ ), river cross sectional distance ( $\Delta X = 45.50\text{m}$ ), and total bridge height ( $\Delta Z = 17.96\text{m}$ ) were measured using the LiDAR derived point cloud.

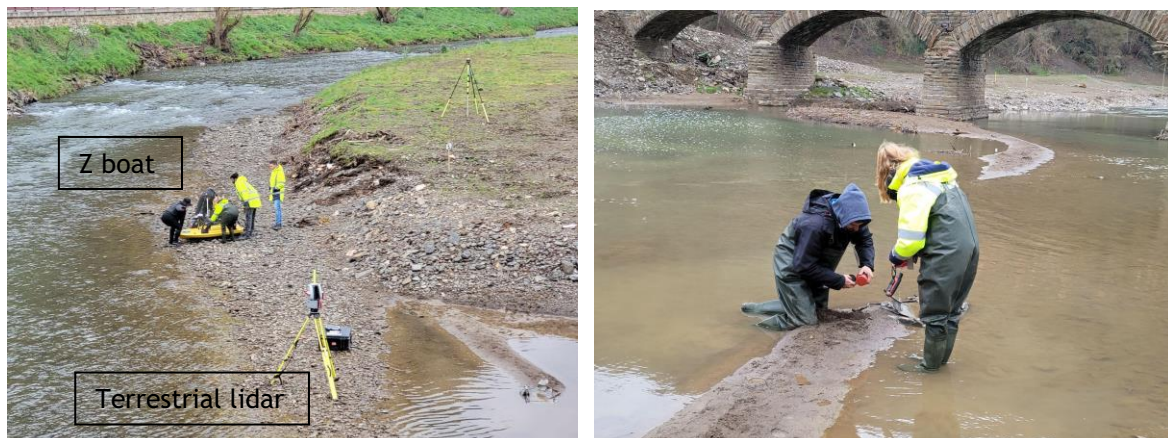
At five selected locations in the Ahr Valley, including in Altenahr, in-water measurements including bathymetry and riverbed sediment classification were performed using different geo-acoustic surveying tools (single beam sonar, side scan sonar, low-frequency chirp sonar), physical testing of riverbed sediments using a portable free fall penetrometer, and sediment sampling. Figure 16 (left) shows the deployment of a remotely operated vehicle equipped with a single beam sonar for bathymetric measurements, as well as the terrestrial lidar system used. Figure 16 right shows sediment sampling of flood deposits. Both images represent a severely damaged double bridge site just upstream of entering the town of Altenahr center. While this data is still in processing, it will provide seamless data sets connecting subaerial topography and subaquatic bathymetry to enable a full picture of sediment relocation during the flood event. Also, scour depths around bridge piers and abutments were determined. Most significant sediment deposition sites were easily identified by surficial fine-grained soft sediments, while erosion hotspots represented significant bathymetric features, or bedrock, cobbly and gravelly surfaces stripped from any more mobile sediments. The combination of subaerial to subaquatic elevation mapping and sediment characterization represents a unique data set for water-structure-soil interaction modelling and investigation of the detailed processes that resulted in the severe damages.

**Figure 16.** Left) Deployment of Z-boat for bathymetric measurements in the Ahr river in just upstream of the town entrance of Altenahr. Right) Sediment sampling in the same location.
