3<sup>rd</sup> International Conference on Natural Hazards & Infrastructure

## Initial geo-structural performance observations of critical infrastructure components during the 2021 Western European Floods

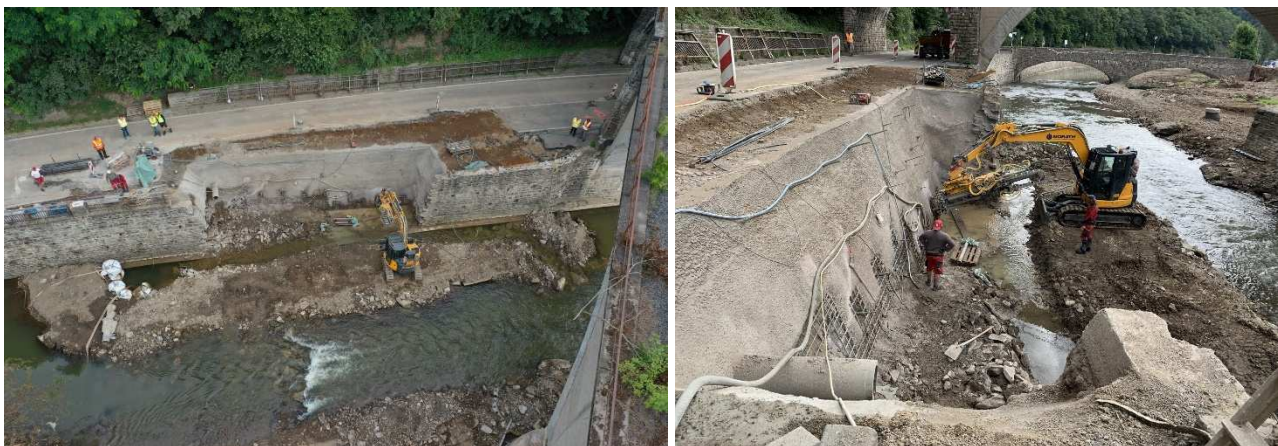
*Figure 3. Ongoing repairs of localized embankment failure along highway L73*

Key connection roads between towns were also destroyed or damaged to the level that required immediate repair to reintroduce or maintain safe access to towns and areas. Figure 3 shows ongoing repairs of localized embankment failure along highway L73 near the town of Schuld (in the Ahr valley). The local embankment failure was unique in that it included soil nailing, which is rare in the region. Failure likely occurred as a result of increased active earth pressure due to backfill saturation and insufficiently long soil nails (which were roughly 2m in depth). Repair work was underway at the time of the team's visit and involved 10 m long soil nails and the top row of pins will be driven into bedrock (personal communication with onsite contractors).

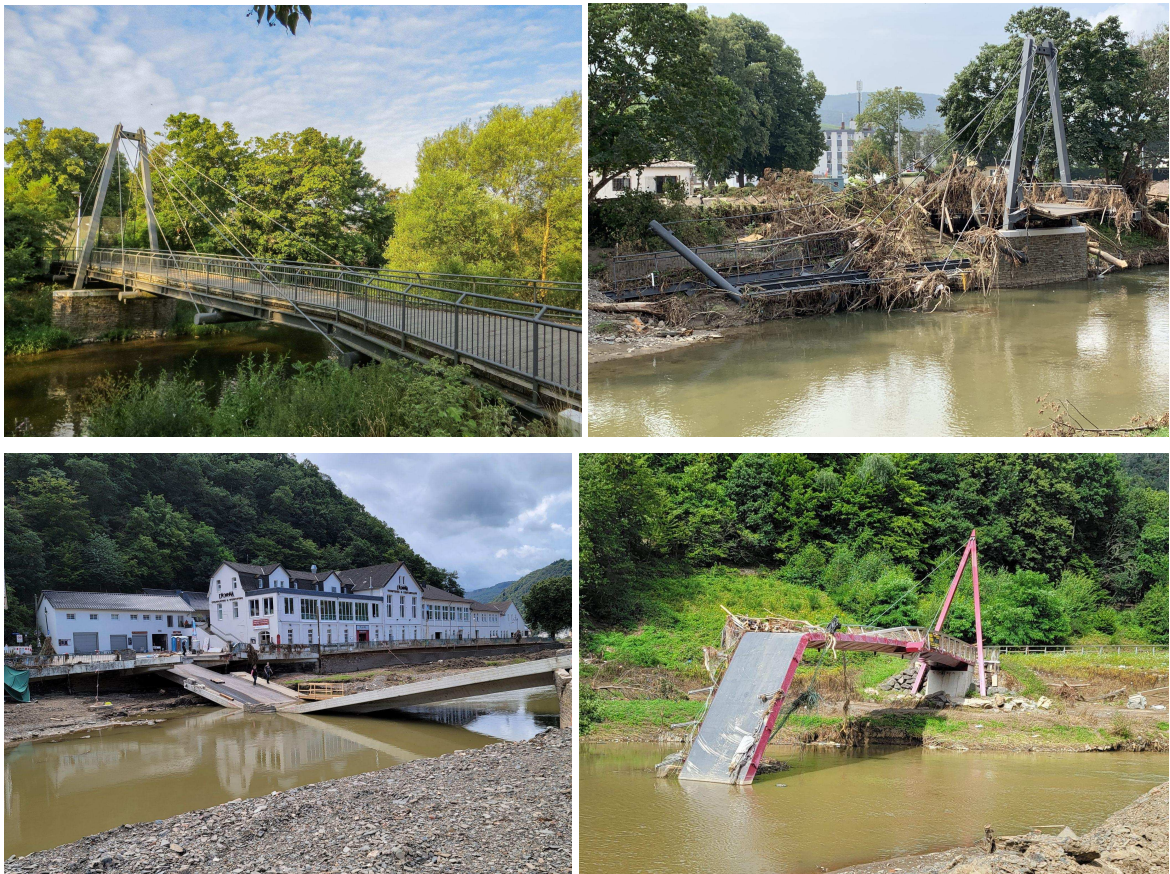
Newer bridges also suffered substantial damage, as shown in Figure 5: a road bridge in Bad Neuenahr-Ahrweiler before and after the flood event (Fig. 5 top row, (note the large amount of entangled debris)), an unrepairable road bridge in Dernau, and a destroyed bicycle bridge in Reimerzhoven. Both cable span bridges followed an identical damage pattern, where one abutment is still standing while the bridge deck has been lifted up at its opposite support and subsequently rotated (and failed) in downstream direction. The bridge deck of the two-span reinforced concrete bridge in Dernau (Figure 5 bottom, left) collapsed due to failure of the middle pier foundation, which was destroyed/removed by the flood.

**Figure 5:** Otterbruecker, Bad Neuenahr Ahrweiler: before the flood (top left) Source: (<https://www.aw-wiki.de/w/index.php?curid=49168>), and at the time of the visit (top right); Road bridge failure in Dernau (bottom, left), and bicycle bridge damage in Reizenhoven, near Altenahr (bottom, right).

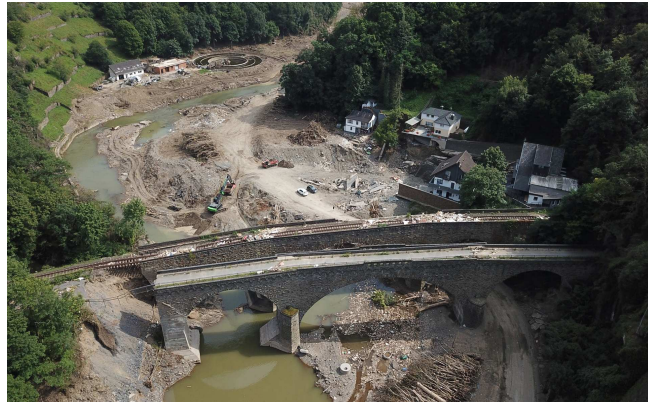
**Figure 7.** Aerial image of the Altenahr tunnel exit and double bridge, August 13<sup>th</sup>, 2021
