## SEISMIC RESPONSE OF NONSTRUCTURAL COLD-FORMED STEEL FRAMED INTERIOR WALL SUBASSEMBLIES WITH EXPANSION JOINTS

**Abstract:** Cold-formed steel nonstructural wall subassemblies, including a variety of interior partition walls, both typical and two-hour rated shaft walls, were constructed within a 10-story mass timber building and tested at the NHERI@UC San Diego outdoor shake table. Since the primary cause of damage to cold-formed steel walls is differential story drift, the walls were detailed with two types of horizontal slip tracks to accommodate up to 2.5% of interstory drift at each level. Three types of corner expansion joints were also installed to address movement conflicts at intersecting walls. The test building was subjected to 88 earthquake motions, ranging in hazard from 43-year return period to  $MCE_R$  shaking intensities. Throughout the motions, most of the wall assemblies observed slip relative to the attached floor. Given the special detailing, the walls were isolated from the interstory drift, which reduced the drift-induced damage to the walls and door openings and shows the potential to eliminate drywall repair after large seismic events. This paper presents

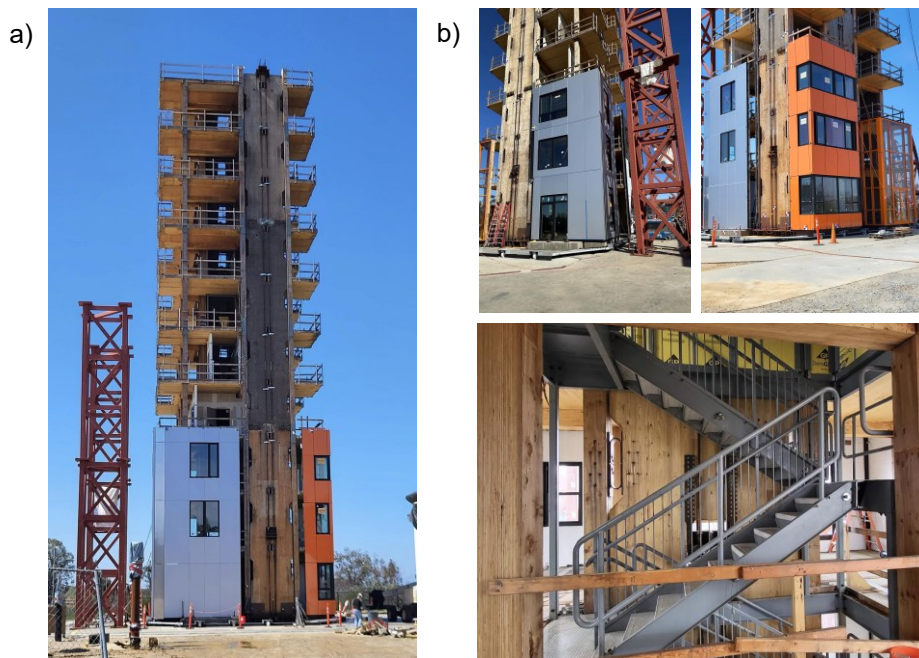
Figure 2. Test building: (a) 10-story mass timber building; (b) nonstructural systems

The test building, a full-scale 10-story mass timber building, was built on the NHERI@UC San Diego outdoor shake table (Fig. 2a). This 10-story test building incorporated resilient post-tensioned mass timber rocking wall lateral systems (cross-laminated timber (CLT) and mass plywood panel (MPP) with U-shaped flexural plates (UFPs)). In addition, gravity connection details - pinned connections at veneer-laminated timber (VLT) beams and columns - were designed to remain damage-free during a series of shaking. The total height of the test building was 34.3 m, with each story being 3.3 m, except story 1, which was 3.9 m. The floor plan of the building was roughly 10 m x 10.5 m. The test building also included other nonstructural systems such as exterior façade subassemblies (CFS-framed with an aluminum composite exterior finish and curtain walls on stories 1-3) and a full-scale stair tower with access on all floor levels (Fig. 2b).

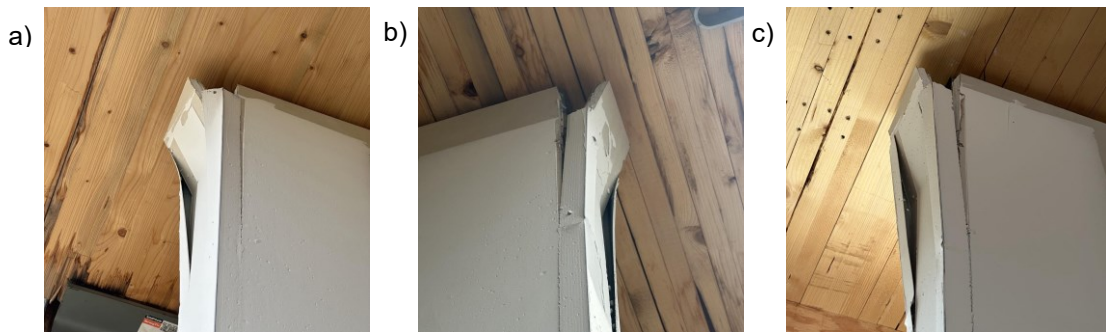
Figure 8. End of wall panel damage: (a) W6, (b) W5, (c) W16

The end gypsum cover panels of the walls with the double slip track detail were damaged during the test, as shown in Fig. 8. This damage was only observed in the double slip detail due to the in-plane movement. The top of the end wall gypsum cover impeded the top track movement after the wall slipped, as shown in Fig. 9. However, this damage is easy to repair, or can be prevented by trimming the end of the wall gypsum lower than the upper track (by 63.5 mm), and any exposed ends would likely be hidden in the ceiling plenum.

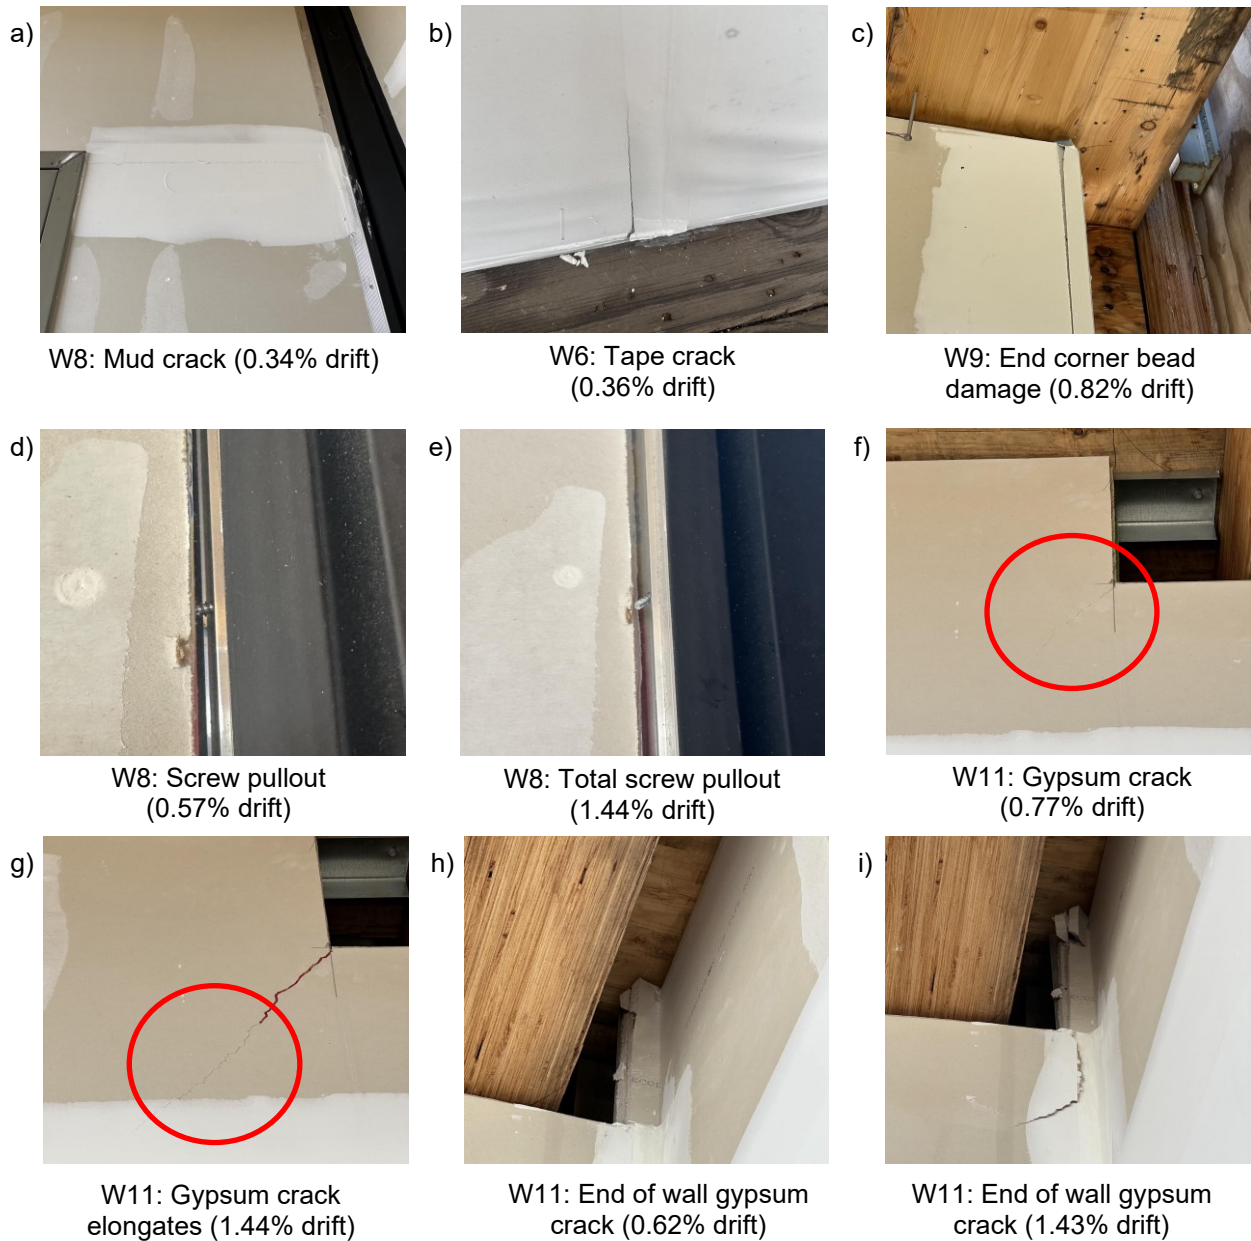
Figure 14. Observed damage to partition walls and expansion joint on Story 4 at various stages of testing.

The primary observed damage to the interior partition walls is summarized in Fig. 14 to 16. On story 4, Figures 14a and 14b show that the joint tape started to crack in some walls at story drifts of approximately 0.34%. At W9, the end of the wall corner bead was damaged due to insufficient space between the wall and the upper-level floor (Fig. 14c). At W8, due to difficulty of installing the supplied hardware in the studs, the expansion joint hardware screws reflected incipient pull out and ultimately completely pulled out of the aluminum liners that house the gaskets at drifts of 0.57% and 1.44% respectively (Fig. 14d and 14e). The correct screws for the substrate should be installed every 457.2 mm o.c for future construction to avoid this type of failure. Figures 14f to 14i show that the end of the wall at W11 cracked as it was not separated from the incompatible movement from the adjacent wall. On story 5, several examples of damage at the wall-stair column intersections that lacked official expansion joints are shown in Fig. 15. On story 6, Figure 16 shows that the expansion joint covers at W15 and W16 on story 6 were bent and popped out due to the bidirectional movement putting torque demand on the joint cover. The movement that led to this phenomenon is illustrated in Fig. 17.
