Reconnaissance of Two Liquefaction Sites Using Small Unmanned Aerial Vehicles and Structure from Motion Computer Vision Following the April 1, 2014 Chile Earthquake

Abstract: Small unmanned aerial vehicles (sUAVs) were used to reconnoiter, image, and model the effects of soil liquefaction at two separate sites following the M8.2 and M7.6 earthquakes near Iquique, Chile, on April 1 and 2, 2014, respectively. Geotechnical investigators performed conventional observations/measurements at the two sites using traditional reconnaissance methods, and virtual observations/measurements using sUAV-based remote sensing and structure from motion (SfM) computer vision. Two types of sUAV platform/sensor combinations were evaluated for this study. Comparisons between the traditional and sUAV-based reconnaissance methods were performed and observations are discussed. The sUAV-based point cloud models of the sites were between 770 and 2,600 points per square meter depending on the camera that was used, with average model dimensional error ranging from ± 1.0 to $\pm 3.5\%$. Lateral spread displacement measurements from the UAV-based three-dimensional models were generally within 9 cm of the lateral

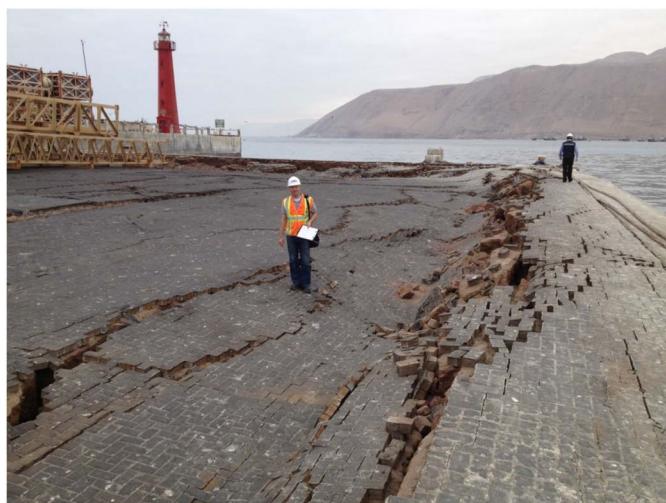
Fig. 2. Liquefaction and lateral spread damage near the head of the Molo Pier in Iquique, Chile (reprinted from Rollins et al. 2014, with permission)

Significant evidence of liquefaction was observed and documented across much of the Molo Pier (Rollins et al. 2014). Fig. 2 presents a photograph of the damaged pier. Cracks caused by lateral spread displacement were measured by researchers, resulting in estimated lateral ground deformations ranging from approximately 0.5 to 2.0 m. Measured post-liquefaction settlements behind the quay wall ranged from 0.8 to 1.1 m. The majority of these deformations occurred along the east quay wall of the pier. Observations also were made that lateral spread displacements appeared to continue slowly, increasing over a period of weeks following the earthquake.

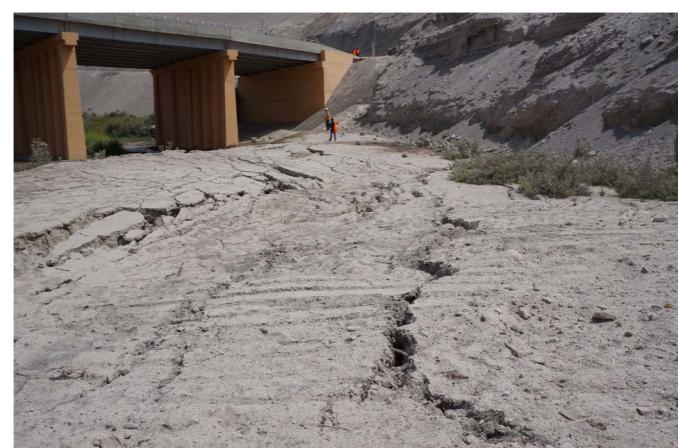
Fig. 3. Liquefaction and lateral spread displacement at the Tana Bridge on Interstate-5 in Chile (image by K. Franke)

Geotechnical investigators found significant evidence of soil liquefaction and lateral spread displacement in the vicinity of the Tana Bridge following the April 1 and 2 earthquakes. Fig. 3 presents a photograph of the bridge and apparent liquefaction/lateral spread displacement evidence. Several sand boils were documented adjacent to the northern-most bent, and post-liquefaction settlements ranging from less than 15 cm to over 50 cm were observed

at the bent. Lateral spread displacements were observed on both sides of the bridge on the north and south sides of the stream. However, displacements and cracking on the east side of the bridge were much more visible because of the lack of surficial vegetation. Very large displacements and vertical slumping failures were documented on the north side of the stream, and horizontal displacements were very difficult to measure because of the extent and the severe level of distress in the ground. Vertical offsets of the slumps were measured at approximately 1.5 m, and the measurement of cumulative crack widths (i.e., the summation of the crack widths along a line that runs perpendicular to the cracks) on the south side of the stream suggested lateral spread displacements ranging from 0.8 to 2.8 m.

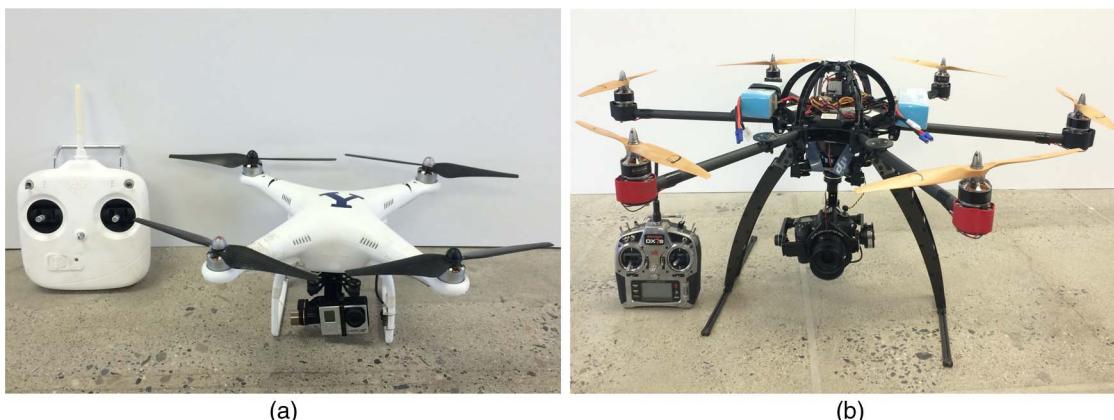
Fig. 4. sUAV platforms used in the post-liquefaction reconnaissance study including: (a) DJI Technologies Phantom II quadrotor with GOPRO Hero 3+ HD video recorder; (b) Aeronavics Limited Skyjib Super-6 hexrotor with Nikon D7100 DSLR camera with 35 mm AF-S Nikkor prime lens

quadrotor sUAV, manufactured by DJI Technologies (Shenzhen, China). This platform has a typical 15–25-min flight duration, and a recommended payload of 0.5–1.0 kg. The platform incorporates a 2-axis auto-stabilizing gyro for the mounted sensor. An additional technical feature that was incorporated in the reconnaissance effort was first person view (FPV) technology, which allowed the sUAV operator to remotely view a low-resolution image from the mounted optical sensor in real time. A photograph of the quadrotor sUAV that was used in the reconnaissance of the liquefaction sites is presented in Fig. 4(a).

A photograph of the Skyjib Super-6 sUAV platform and the D7100 sensor that were used in this study is presented in Fig. 4(b).

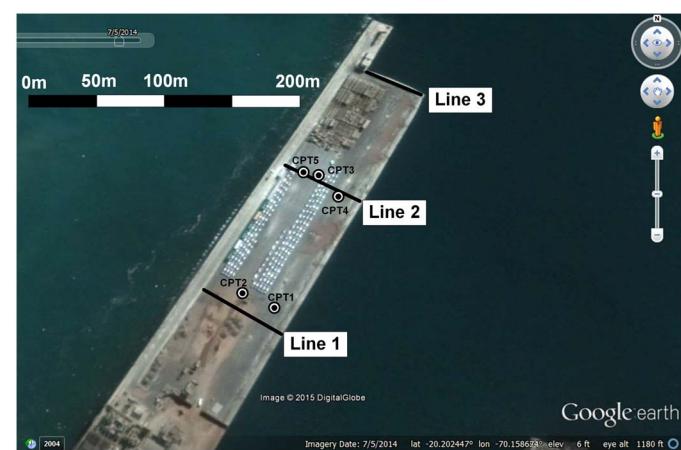
Fig. 5. Plan view layout of the geotechnical site reconnaissance activities at the Molo Pier (image © 2015 DigitalGlobe; adapted from Rollins et al. 2014)

Rollins et al. (2014) describe in detail the field reconnaissance activities that occurred during June 2014 at the Molo Pier. A total of five cone penetration tests (CPT) were performed adjacent to two lines that ran transverse across the pier. Manual crack measurements were made along these two lines using a surveyor's tape, and cumulative lateral spread displacements were computed. A third line of crack measurements was performed at the head of the pier. A plan view layout of the field activities performed at the Molo Pier is presented in Fig. 5 (after Rollins et al. 2014).

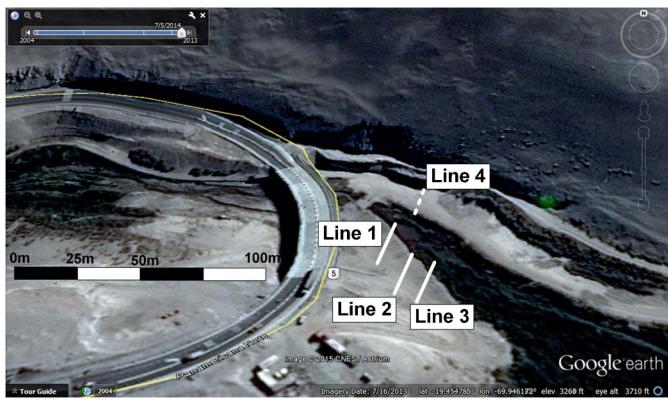
Fig. 6. Plan view layout of the geotechnical site reconnaissance activities at the Tana Bridge (Image © 2015 CNES/Astrium)

Researchers performed initial observations and preliminary measurements of liquefaction effects at the Tana Bridge within one week following the April 1 and 2 earthquakes (Rollins et al. 2014). The locations of sand boils, liquefaction-induced settlements, abutment wall damage, and lateral spread displacements were documented and a few preliminary measurements were made with a surveyor's tape. Some of these researchers returned to the Tana Bridge site again in June 2014 with sUAV equipment to assess the state of the liquefaction evidence and to perform additional, more accurate measurements of surficial liquefaction evidence. These engineers observed that the liquefaction evidence remained largely in the same condition as they had observed immediately after the earthquake, likely because of the site's remote location and very arid climate. Lateral spread displacement crack widths were measured along three lines on the east side of the bridge and south of the stream, as shown in Fig. 6. A fourth line of crack measurements also was attempted within the slump zone on the north side of the stream (shown as a dashed Line 4 in Fig. 6), but the significant ground disturbance, crumbling, and shear failures in the soil made any attempt to objectively measure horizontal crack widths and vertical deformations along this line unfeasible.

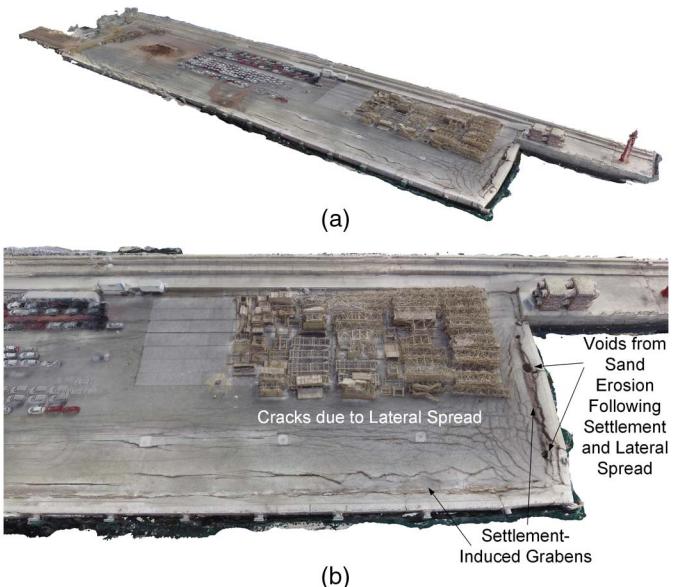
Fig. 7. sUAV-based computer vision 3D point clouds of (a) the entire Molo Pier; (b) a close-up of the heavily damaged head of the pier

Images of the resulting dense point cloud models for the Molo Pier and the Tana Bridge are presented in Figs. 7 and 8, respectively. The total number of points in the dense point clouds was

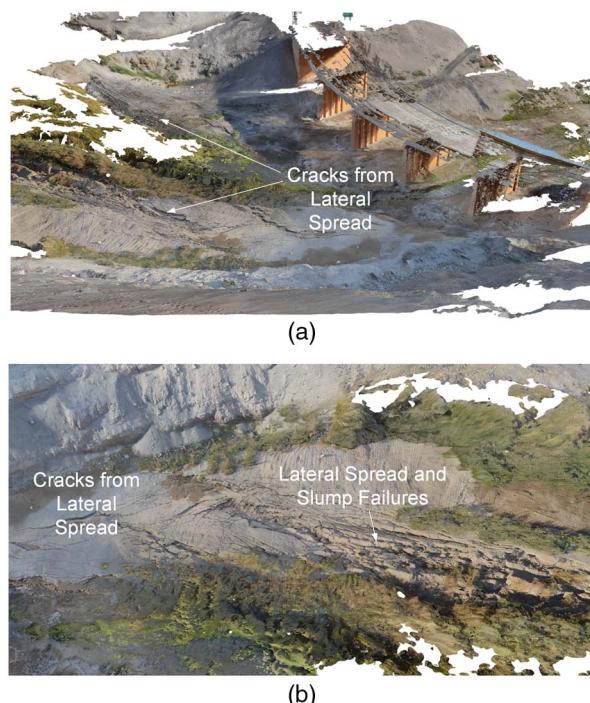
Fig. 8. sUAV-based computer vision 3D point clouds of (a) the Tana Bridge site (looking to the south); (b) a close-up of the lateral spread and slump zone on the north side of the stream (looking to the north)

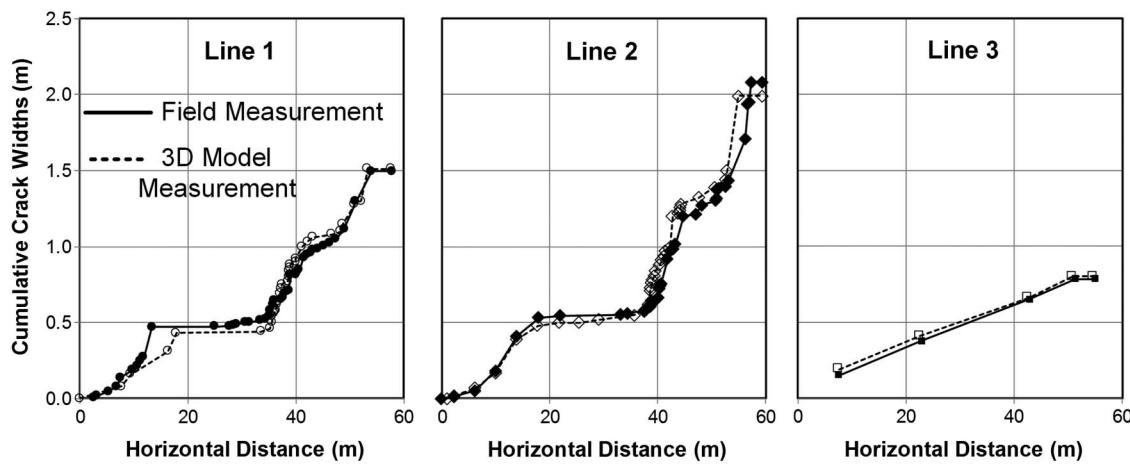
Fig. 9. Crack width comparisons between actual field measurements and virtual measurements from the UAV-based 3D point cloud model of the Molo Pier

measured in the meshed models using *Memento Beta* at each location in which corresponding crack width measurements were performed in the field. As previously stated, only one of the three lines of crack width measurements (Line 2) could be measured in the Tana Bridge model because of the sparseness of the point cloud at the other two line locations. The resulting comparisons between the virtual (i.e., UAV model) and actual (i.e., measured) cumulative crack widths at the Molo Pier and the Tana Bridge sites are presented in Figs. 9 and 10, respectively.

Fig. 9 shows the cumulative crack width comparisons. The measurements taken from the Molo Pier meshed model captured the overall displacement pattern measured in the field and generally were within 0.3 m of the actual field measurements at any location. Additionally, the total cumulative crack width measurements taken from the meshed model were within 0.09 m of the actual field measurements at all three lines. As expected, the disparity between the model crack width measurements and the actual field measurements was even smaller at the Tana Bridge site (shown in Fig. 10), at which the higher-quality D7100 DSLR camera was used with the sUAV. The measurements taken from the Tana Bridge meshed model generally were within 0.1 m of the actual field measurements at any location, and the total cumulative crack width measurement

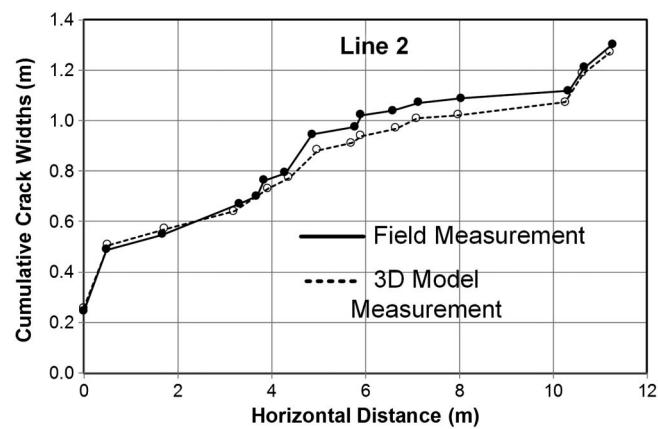
Fig. 10. Crack width comparisons between actual field measurements and virtual measurements from the UAV-based 3D point cloud model of the Tana Bridge

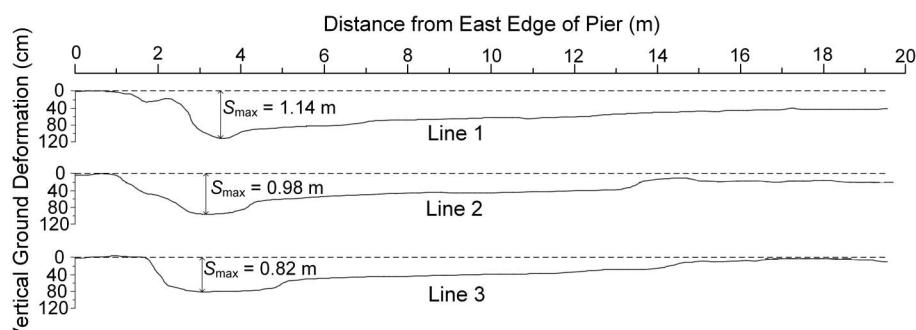
Fig. 11. UAV-based vertical deformation profiles along Lines 1, 2, and 3 at the Molo Pier

Fig. 11 presents ground surface profiles developed from the 3D point cloud across the liquefaction-induced graben along the eastern side of the Molo Pier for Lines 1, 2, and 3. Also drawn on these figures is the assumed horizontal ground surface from

before the earthquake (shown as a dashed line). From each of these profiles, the maximum measured vertical deformations along the lines are 1.14, 0.98, and 0.82 m for Lines 1, 2, and 3, respectively. These values compared well with the observed vertical deformation range of 0.8 to 1.1 m reported by geotechnical extreme events reconnaissance (GEER) investigators (Rollins et al. 2014). However, deviations from the assumed of a horizontal pre-earthquake ground surface could induce some errors in measured vertical deformations.

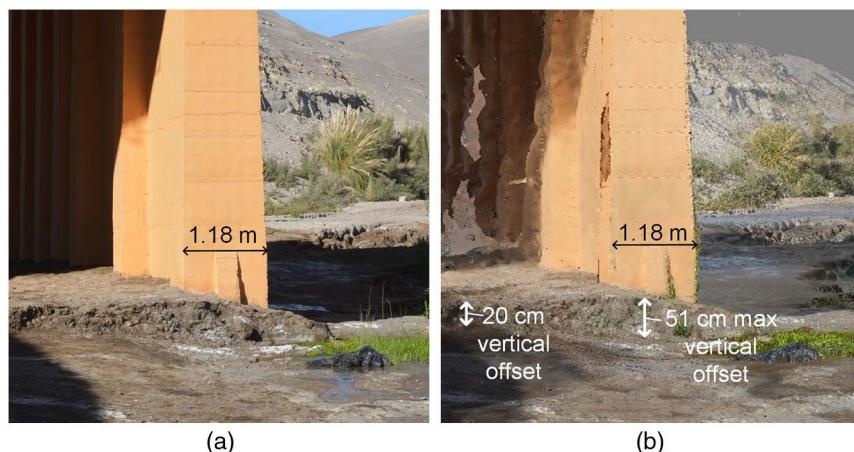
Fig. 12. Post-liquefaction ground settlement at the western side of the northern bent of the Tana Bridge: (a) digital photograph of the settlement taken from the UAV-based DSLR camera; (b) 3D meshed simulation of the bent shown in Part (a) with settlement measurements

Three-dimensional point cloud and meshed models of the Tana Bridge also are useful for evaluating vertical ground deformations at the bridge site. For example, Rollins et al. (2014) reported that a number of liquefaction surface features and evidence of liquefaction-induced settlement were visible adjacent to the northern pier of the bridge. An approximate vertical offset of 15 cm because of the liquefaction-induced settlement was reported. This liquefaction-induced vertical offset was still visible two months after the initial GEER team reconnoitered the site, and is shown in Fig. 12(a), which is a digital photograph captured by the sUAV-mounted DSLR camera. Using the 3D-meshed SfM model of the site presented in Fig. 12(b), vertical offsets were measured carefully along the liquefaction-induced settlement feature at the bridge bent. Model measurements showed that the vertical offsets increased linearly from 0 cm of settlement midway between the bent and the northern abutment to 51 cm of maximum settlement adjacent to the bent. Therefore, the average vertical offset was approximately 25 cm, which is greater than the reported offset of 15 cm

by Rollins et al. (2014). A possible explanation for this discrepancy might be that additional ground settlement occurred between the time of the initial GEER reconnaissance in April 2014 and the sUAV reconnaissance in June 2014. It is also possible that the initial GEER researchers simply measured the vertical offsets in a different location that produced the 15 cm settlement estimate. Regardless, Fig. 12 demonstrates the potential usefulness of a 3D point cloud and/or meshed model in validating initial displacement estimates obtained by field reconnaissance investigators.
