Catastrophic flood disturbance and a community's response to plant resilience in the heart of the Texas Hill Country

Kimberly M. Meitzen ^{a,*}, John N. Phillips ^a, Thaïs Perkins ^b, Aspen Manning ^a, Jason P. Julian ^a

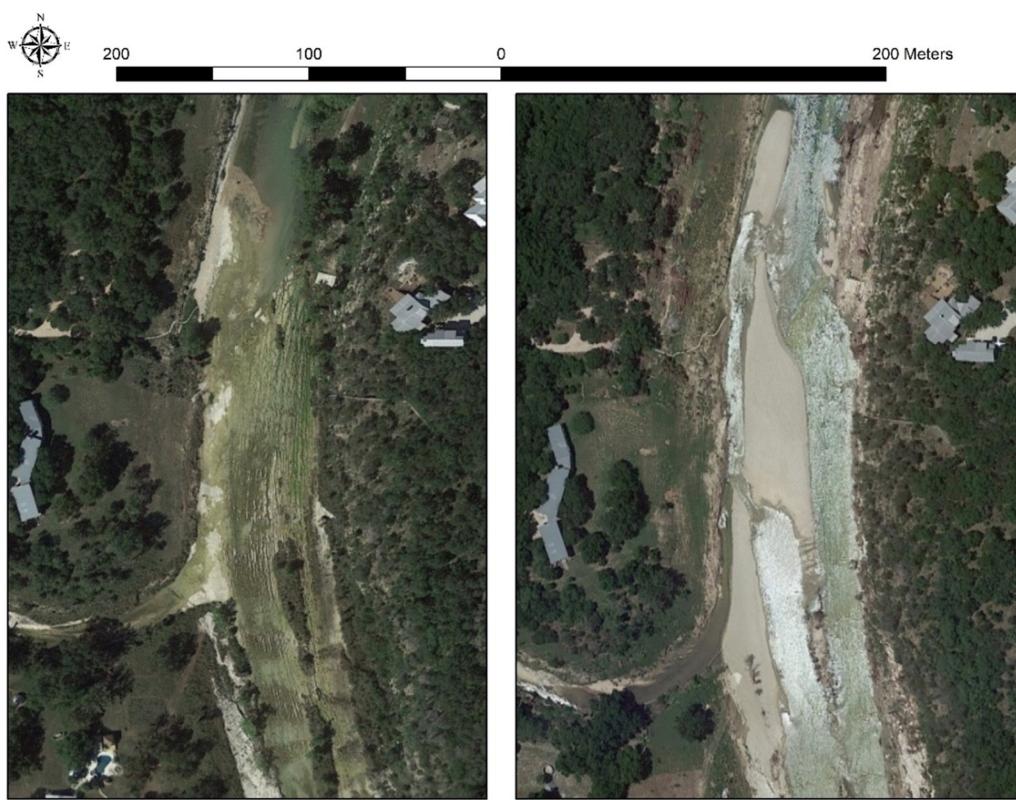
Fig. 6. Sediment deposits at the confluence of Lone Man Creek and the main channel. The image to the left is pre-flood and the right is post-flood.

Zones of major riparian and geomorphic disturbance (i.e., floodplain stripping) were observed at most tributary confluences (Fig. 6), with the greatest extent at the mainstem confluences of Lone Man, Cypress, and Halifax creeks. Similar patterns of floodplain stripping were seen at all three confluences, despite them being located along various reaches of the upper, middle, and lower sections of the study area respectively. The mechanisms that caused these patterns of disturbance at confluences are not entirely clear but is likely from interacting effects between complex hydraulic forces and channel biogeomorphology in terms of channel geometry (mainstem and tributary), the angle of confluence, local gradient, and vegetation type/structure (Guillén-Ludeña et al., 2016; Julian et al., 2016).

Of the tributary confluences, Lone Man Creek was of particular interest because it is dammed immediately upstream before it flows into the Blanco River. Dams typically limit sediment supplies (Graf, 2006; Julian et al., 2016); yet at this confluence, three large new sediment bar deposits were observed (Fig. 6). Because the first of these occurs upstream of the confluence, their presence is likely attributed to main stem
