Heat Mapping Drones: An Autonomous Computer Vision-based Procedure for Building Envelope Inspection using Unmanned Aerial Systems (UAS)

Comprehensive and accurate energy audits are essential to maximize energy savings and improvements in buildings realized from the design and implementation of deep retrofits for building envelopes. This paper presents a methodology for employing drones to conduct rapid building envelope performance diagnostics and perform aerial mapping of energy flows. The presented framework is tested on the Syracuse University campus to showcase: 1) visually identifying areas of thermal anomalies using an Unmanned Aerial System (UAS) equipped with thermal cameras; 2) detailed inspection applied to areas of high interest to quantify envelope heat-flow using computer vision techniques. The overall precision and recall rates of 76% and 74% were achieved, respectively. A discussion of the findings suggests refining procedure accuracy, as a step towards automated envelope inspection.

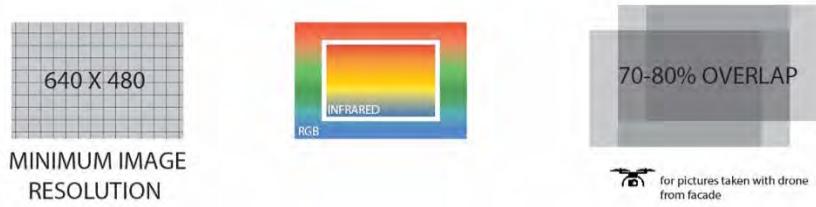
Figure 2 - In-flight imaging procedure for possible dual cameras, demonstrating target % overlap for auditing purposes.

In order to identify flight path parameters, the literature was reviewed for inspection distances for structural performance and building examination (Figure 1) and the investigation concluded that envelope inspection distances vary according to equipment and building conditions. A general distance of approximately 13m away from a building is proposed, at changing bay heights of 2-3m, with images gathered approximately every 2m along the flight path. The goal is to ensure approximately 70-80% overlap between photos captured for the purposes of using 3D photogrammetry to construct CAD models (Figure 2).

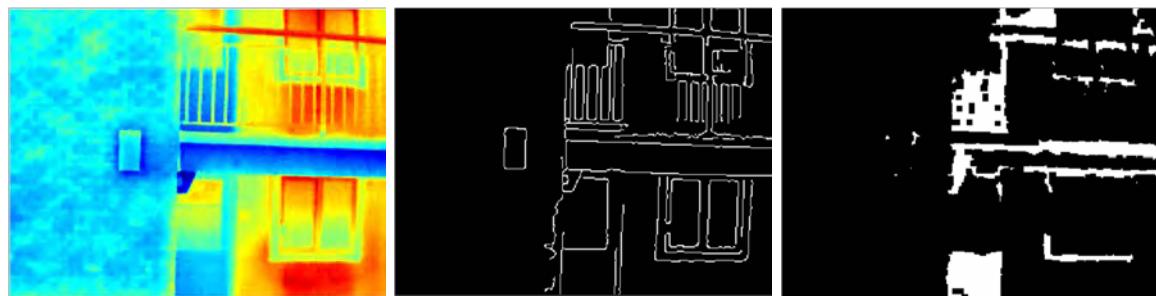
a) Successful infiltration detection.

b) Successful thermal bridge detection.

c) False positive detection of infiltration and missing envelope deterioration.

Figure 9 - Experimental results from different sides of the inspected buildings. In each triplet, the left images are the IR scenes, the middle are the edge detection, and the right are the segmented leakage regions.

The model is expected to perform well on precision and recall measures for a detection task. A higher precision score means that most of the detections are actual leakages, while a higher recall score means that most of the actual leakages are detected. The importance of these measures can differ based on the needs of the application. In this scenario while some false positives can be tolerated, i.e., relatively lower precision, the recall rate was expected to be as high as possible, since the aim is to not miss any of the actual thermal leakages. The method resulted in precision and recall rates of 76% and 74%, respectively. In order to increase the recall rate, the techniques for elimination of false positives could be less restrictive, by tuning some parameters such as decreasing the threshold in Canny edge detection or modifying the representativeness factors in threshold selection stage. Although this will decrease the precision rate, the number of missed leakages will decrease too. In addition to low-level tuning of the algorithm, a comprehensive and systematic audit procedure will also increase the recall rate by inspecting a location from multiple viewpoints and capturing overlapping thermal pictures. Figure 9 and 10 highlight a series of sample heat leakage images and their corresponding detection results.
