Article

Corrosion Behavior Evaluation of Coated Steel Using Fiber Bragg Grating Sensors

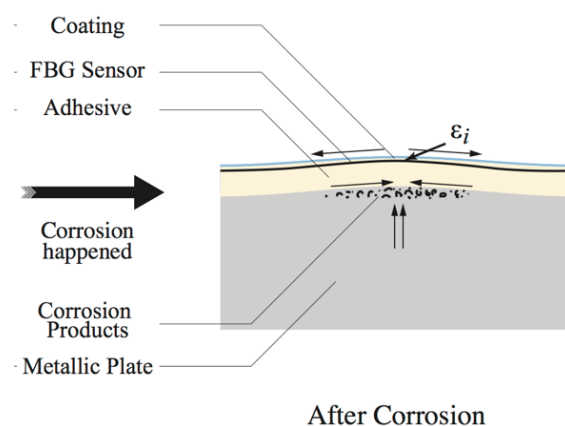
Figure 1. Cross-section of embedded FBG sensors based corrosion monitoring system.

where CR is the corrosion rate, ρ is the density of the coating, $k_1 = \frac{ly}{2EI}$ and $k_2 = \frac{l^3}{48EI}$, which relate only to the moment of inertia of the cross section with sensors (I), the span of beam (l), half of the height of cross-section (y), and the modulus of the coating (E). k_3 is the linear scaling factor between volume of corrosion products and induced center displacement, and k_4 is the expansion factor between the volumes of corrosion products and the iron, $\Delta \lambda$ is the Bragg wavelength change measured with the embedded FBG sensor, and γ is the sensitivity of the sensor toward corrosion rate of metals which can be calibrated with known corrosion rate of one certain material. With laboratory accelerated corrosion tests, the parameters above in Equation (5) can be calibrated. The calibrated model can then be applied to various coated steel components for further corrosion assessment.

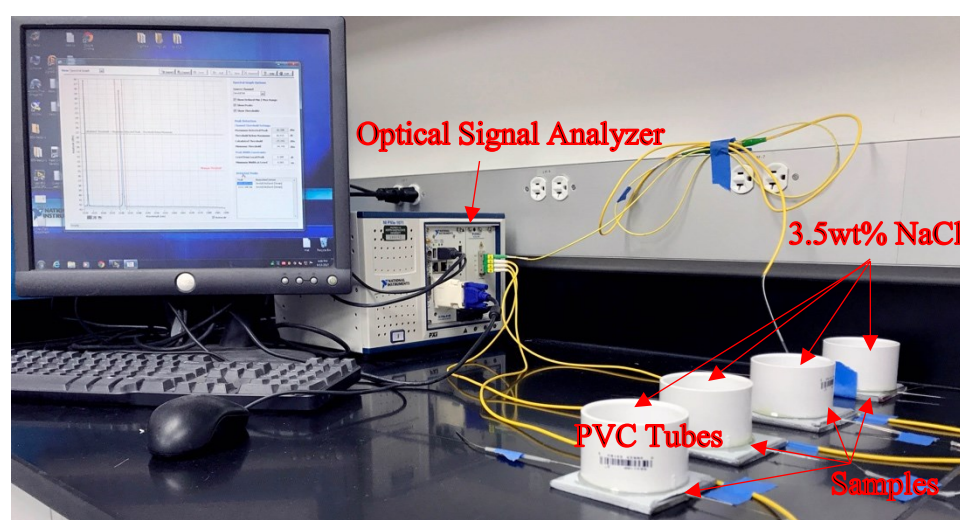
Figure 2. Accelerated corrosion test set-up.

For accelerated corrosion tests with embedded FBG sensors, Figure 2 shows the test setup. To create a corrosive environment for accelerated corrosion, a PVC pipe with a diameter of 2 inch was fixed on top of the embedded sensors by Loctite heavy duty epoxy adhesive and filled with 3.5wt% sodium chloride (NaCl) solution. The NaCl solutions were kept at room temperature ($22\pm3^{\circ}\text{C}$) during the entire testing period. In addition to the test samples with embeeded sensors, an additional temperature compensation sample was made for both polymeric coating and wire arc sprayed Al-Zn coating to monitor the Bragg wavelength changes with tempeature variances. The Bragg wavelength changes from all the FBG sensors had been recorded using an optical signal analyzer (National Instruments PXIe-4844 Optical Sensor Interrogator integrated with PXIe-1071 Controller and PXIe-8133 Chassis) continuously during the testing period with a sampling frequency of 10Hz. Visual inspections for all the samples were also scheduled at 12:00 p.m. daily to inspect the existence of corrosion on surface of the samples.

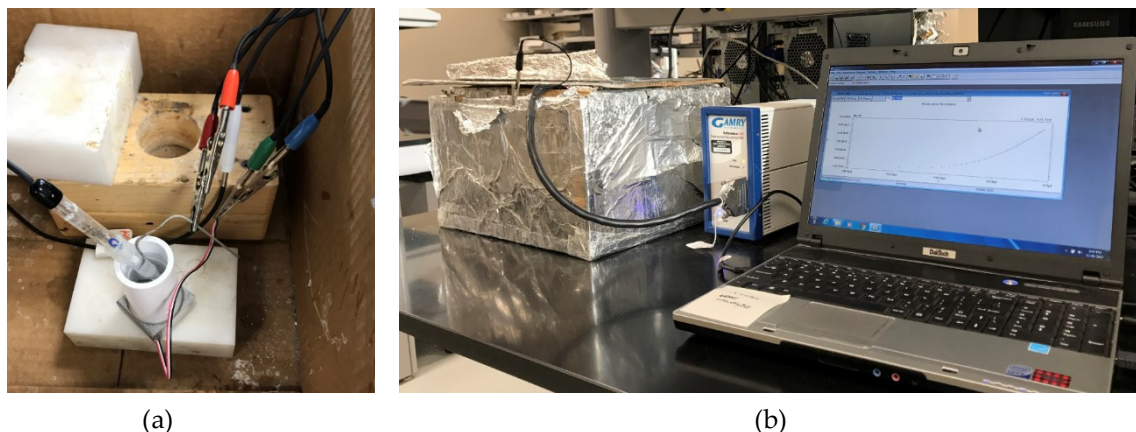
Figure 4. Electrochemical corrosion test set-up (a) and test layout (b).

For the electrochemical corrosion test on bare steel and wire arc sprayed Al-Zn coating, Tafel test was performed to obtain the reference corrosion rate, which is one of the most commonly used approaches for corrosion resistance evaluation of material for short term corrosion behavior [50]. In this study, a Gamry Reference 600 Potentiostat/Galvanostat/ZRA was used to conduct the Tafel tests. Figures 4(a, b) show the Tafel test setup. In order to conduct electrochemical corrosion test on the test sample, a PVC pipe was also attached to the sample and filled with 3.5wt% NaCl solution to create free electron. After using epoxy to glue PVC pipe to the surface of the coated sample, a conductive wire connected to the bottom of the sample for connecting testing instrument as shown in Figure 4(a). A scan rate was set to be 0.1 mV/s for the Tafel test.

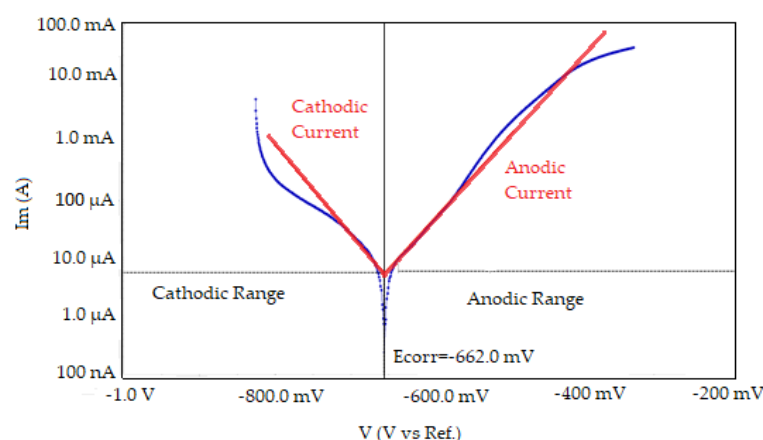
Figure 5. Tafel Plot from bare steel sample (Sample B)

Since the corrosion is an electrochemical reaction, the corrosion rate could be described by its reaction rate, or the electron transferring rate, i.e. the current between anode side and cathode side. In a typical Tafel test, the testing instrument generates a range of potential between the anode and cathode, by attached counter electrode and working electrode, to excite the oxidation reaction on anode side and the reduction reaction on cathode side. At the same time, the instrument also records the current for each potential generated during this process. As a result, two current vs. potential curves, one for the anode side and the other for cathode side, can be plotted in one graph, named as Tafel plot. Figure 5 shows the measured Tafel plot from bare steel sample (Sample B).

Based on Figure 5, the test sample dimensions, and the material property, for bare A36 steel, the parameters in Equations (6, 7) can be estimated as shown in Table 2. The calculated corrosion rate for bare steel is 39.263 $\mu\text{m}/\text{year}$ from the Tafel test.

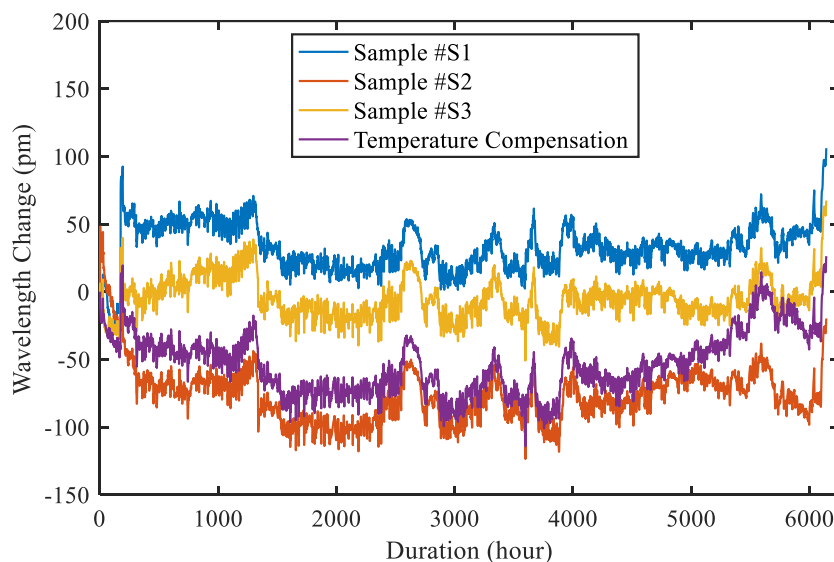
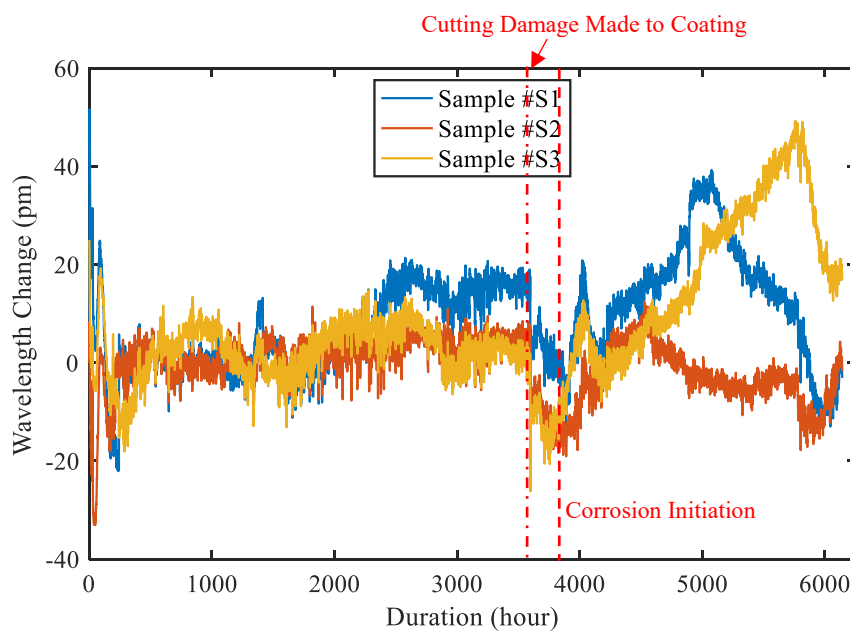
Figure 6. Bragg wavelength of embedded FBG sensors with soft coating vs time (a) before temperature compensation and (b) after temperature compensation

corrosion experiment run for 6480 hours (270 days) in total. The center wavelength change collected from FBG sensors were shown in Figure 6(a) before temperature compensation and (b) after temperature compensation. If the epoxy coating was not damaged, it can isolate the substrate from corrosive environment outside very well. Thus, corrosion cannot get initiated without the damage of epoxy coating. It was observed that after the first 144 hours (6 days) short-term effects for coatings and sensors to be settled down, started from the 144 to 3598 hours (6 to 150 days), the center wavelength of embedded FBG sensors of samples did not change, except for Sample #S1, which increased about 20 pico-meters. However, in practical, epoxy coating was vulnerable to external physical interferences such as impact force, abrasion, and metal cutting. To simulate the corrosion on epoxy coated steel, after 3598 hours (150 days) as shown in Figure 6(b), a manual cutting damage of around 2.5 mm in length was intentionally made to the epoxy coating parallel to sensor location. Selected visual inspection results of the epoxy coated steel samples were shown in Figure 7 for 0 hours (Day 0), 1440 hours (Day 60), 3624 hours (Day 151, which was right after the fabricated cutting damage), and 6480 hours (Day 270, which was the end of the lab testing).

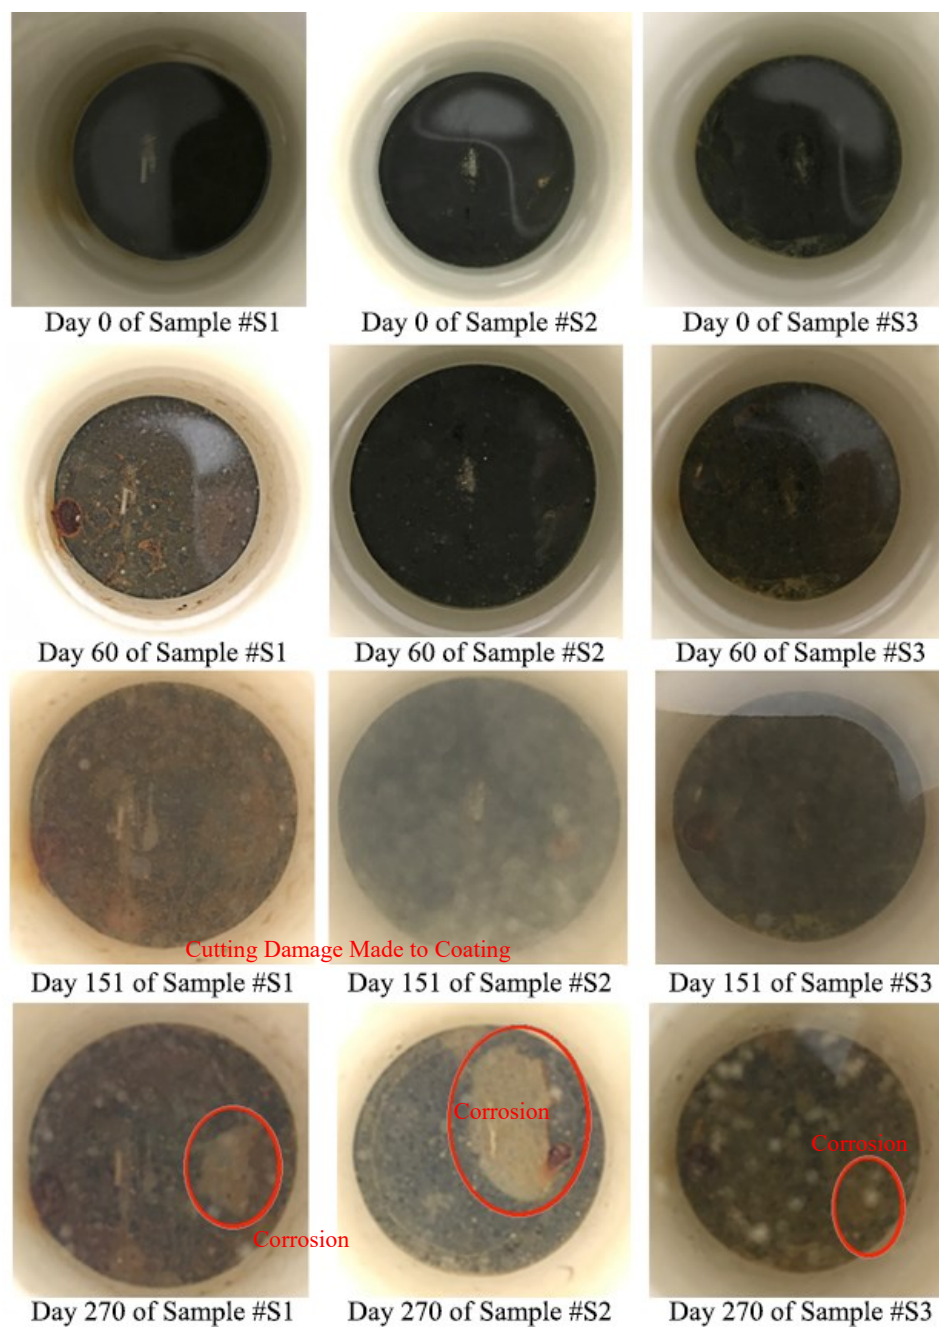
Figure 7. Visual Inspection of Sample #S1, #S2, and #S3.

It was observed from visual inspection in Figure 7 that Sample #S1 had corrosion initiation before the cutting damage was made. This contributed to the 20 pico-meter increase in FBG sensor's Bragg wavelength change of Sample #S1 started from about 1270 hours (53 days), as shown in Figure 8. This may be induced by the fact that the PVC pipe was attached using a different type of epoxy before the epoxy coating was fully cured, causing the coating delaminated from the substrate.

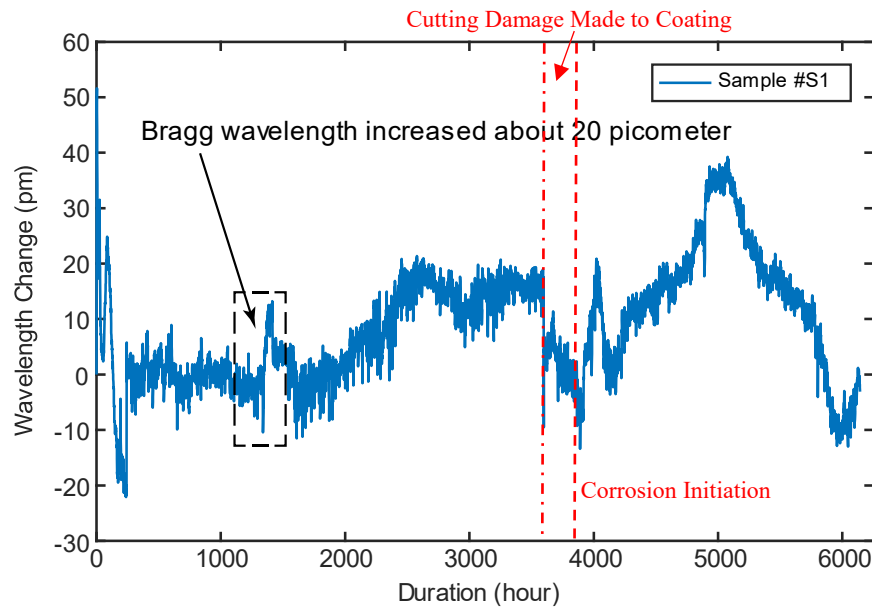
Figure 8. Bragg wavelength change of Sample #S1.

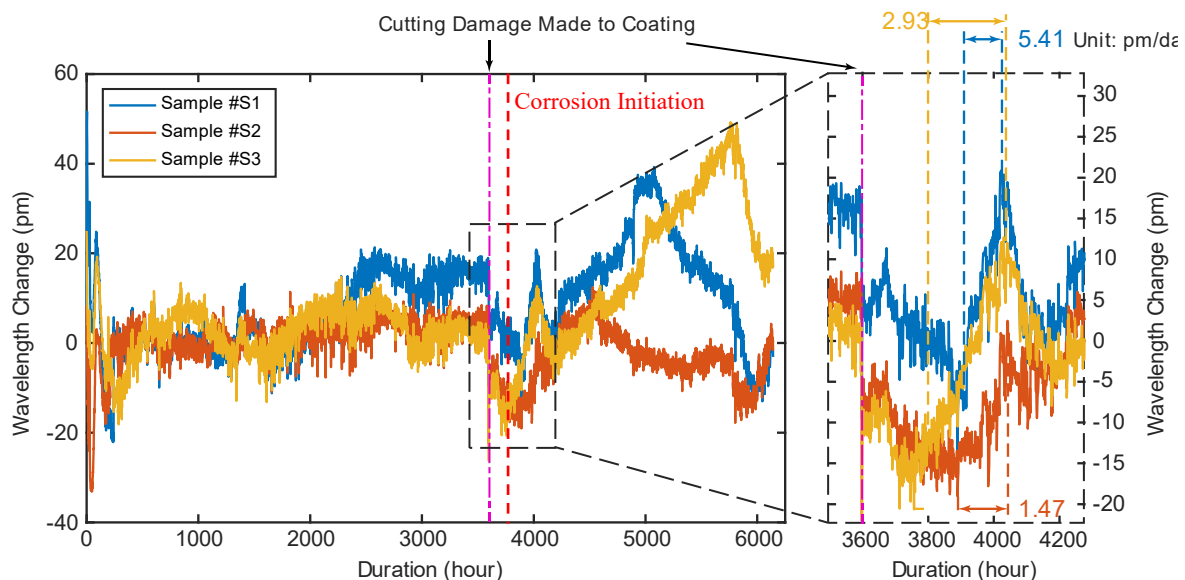
Figure 9. Bragg wavelength of embedded FBG sensors with polymeric coating with partial enlargement.

By taking a closer look at the Bragg wavelength change curve of the three sensors together as seen in Figure 9, it was found that when the cutting damages were intentionally made to the epoxy coatings, the Bragg wavelength drop dramatically, indicating damage initialization. After the initial Bragg wavelength drop, it was followed by a rapid increase similar to corrosion initiation pattern. This rapid increase suggested that once the epoxy coating had been damaged, the bare steel had exposed to the corrosive 3.5wt% NaCl solution, and corrosion started to occur on the substrate.

In Figure 9, it was observed that the Bragg wavelength increases were followed by drops, and each of these drops suggested an internal crack or delamination of the epoxy coating. From the visual inspection result of 6480 hours (day 270), it can be clearly identified that large portion of epoxy coating had delaminated from the substrate, and the samples were severely corroded. Also, the

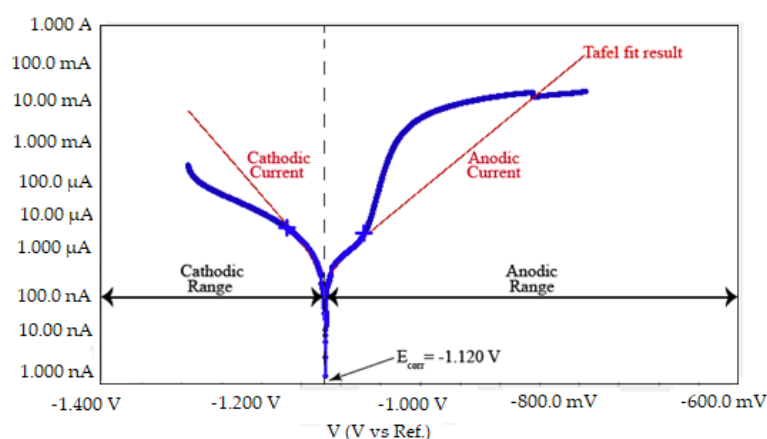
Figure 10. Tafel plot measurement result of wire arc sprayed Al-Zn coated sample.

Steel plate coated with wire arc sprayed Al-Zn coating, Sample A#4 was firstly tested using Tafel test for corrosion rate estimation. The measured Tafel plot of wire arc sprayed Al-Zn coated sample (Sample A#4) was shown in Figure 10. The corrosion rate of the tested sample was calculated using Equations (6, 7), and Table 4 listed the parameters estimated from the Tafel test. The corrosion rate of the wire arc sprayed Al-Zn coating was measured as 2.184 $\mu\text{m}/\text{year}$ using the electrochemical method.

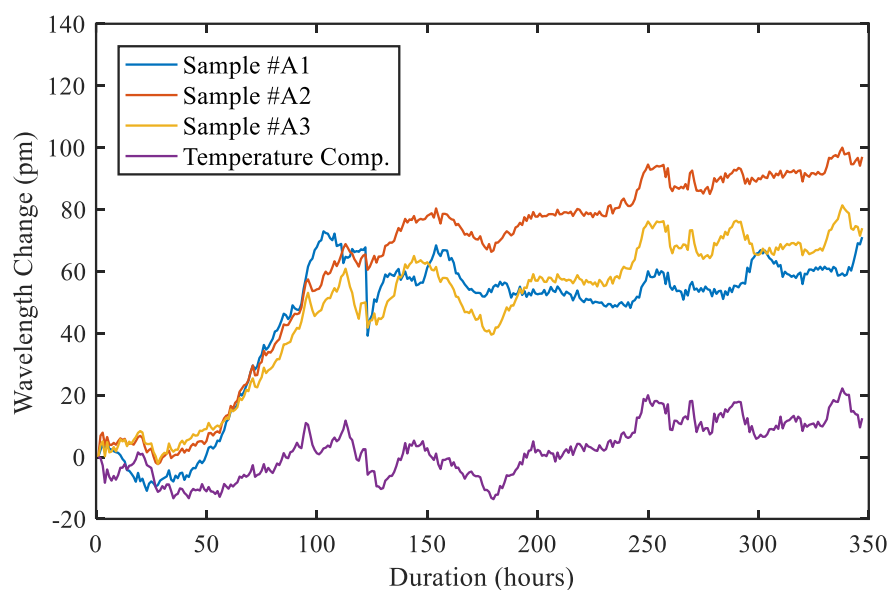
Figure 11. Bragg wavelength of embedded FBG sensors with wire arc sprayed Al-Zn coating vs time (a) before temperature compensation and (b) after temperature compensation.

Steel plates coated with wire arc sprayed Al-Zn coating were also assessed using the embedded FBG sensors through laboratory accelerated corrosion tests as indicated in Table 1. Figure 11(a) shows the data collected from embedded FBG sensing system together with the data collected from the

temperature compensation sensor during the two-week period, and Figure 11(b) shows the data after temperature compensation.

Based on Figure 11, the corrosion rate of Sample #A1, #A2, and #A3 could be calculated using the linear increase part of the Bragg wavelength change graph following Equation (5), as shown in Figure 14. In Figure 14, it was observed that there were multiple spikes on curve of Sample #A1 at range from 95 hours to 200 hours (4 days to 8 days), indicating the coating structure had been severely corroded. From Figure 14 and the previous study [48], it can be seen that the corrosion progress of the wire-arc Al-Zn coating can be divided into three different phases: Phase 0 (P0 in Figure 14) is the corrosion initialization phase when corrosion products start to fill the pores between adhesive and FBG sensor; Phase 1 (P1 in Figure 14) is the high corrosion rate phase, at which the slope of wavelength change curve in Phase 1 reflects the production rate of corrosion products; and Phase 2 (P2 in Figure 14) is the stabilized corrosion progress, when oxygen further diffuses through the corrosion products and strain caused by corrosion products slowly evanesce, and the remaining sensor reading on wavelength change curve is primarily remnant stress. Thus, all the experiments stopped after the coating corrosion stayed in Phase 2 for 168 hours (7 days). From the visual inspection pictures shown in Figure 12 and 13, it was also confirmed that at bottom left corner of the sample, severe corrosion had occurred in the coating, and started from 120 hours (Day 5), the coating delaminated from the substrate. This also caused a higher corrosion rate for Sample #A1, comparing with Sample #A2 and #A3. Possible reason of higher corrosion rate of Sample #A1 might be a higher porosity of coating, or unevenly applied coating. The final corrosion rate of the tested three samples are listed in the Table 5. The average corrosion rate of the wire arc Al-Zn coating is $2.182 \mu\text{m}/\text{year}$ measured from the embedded FBG sensors. The calculation results suggested that the developed FBG sensing system could serve as an effective way of real-time onsite corrosion monitoring.

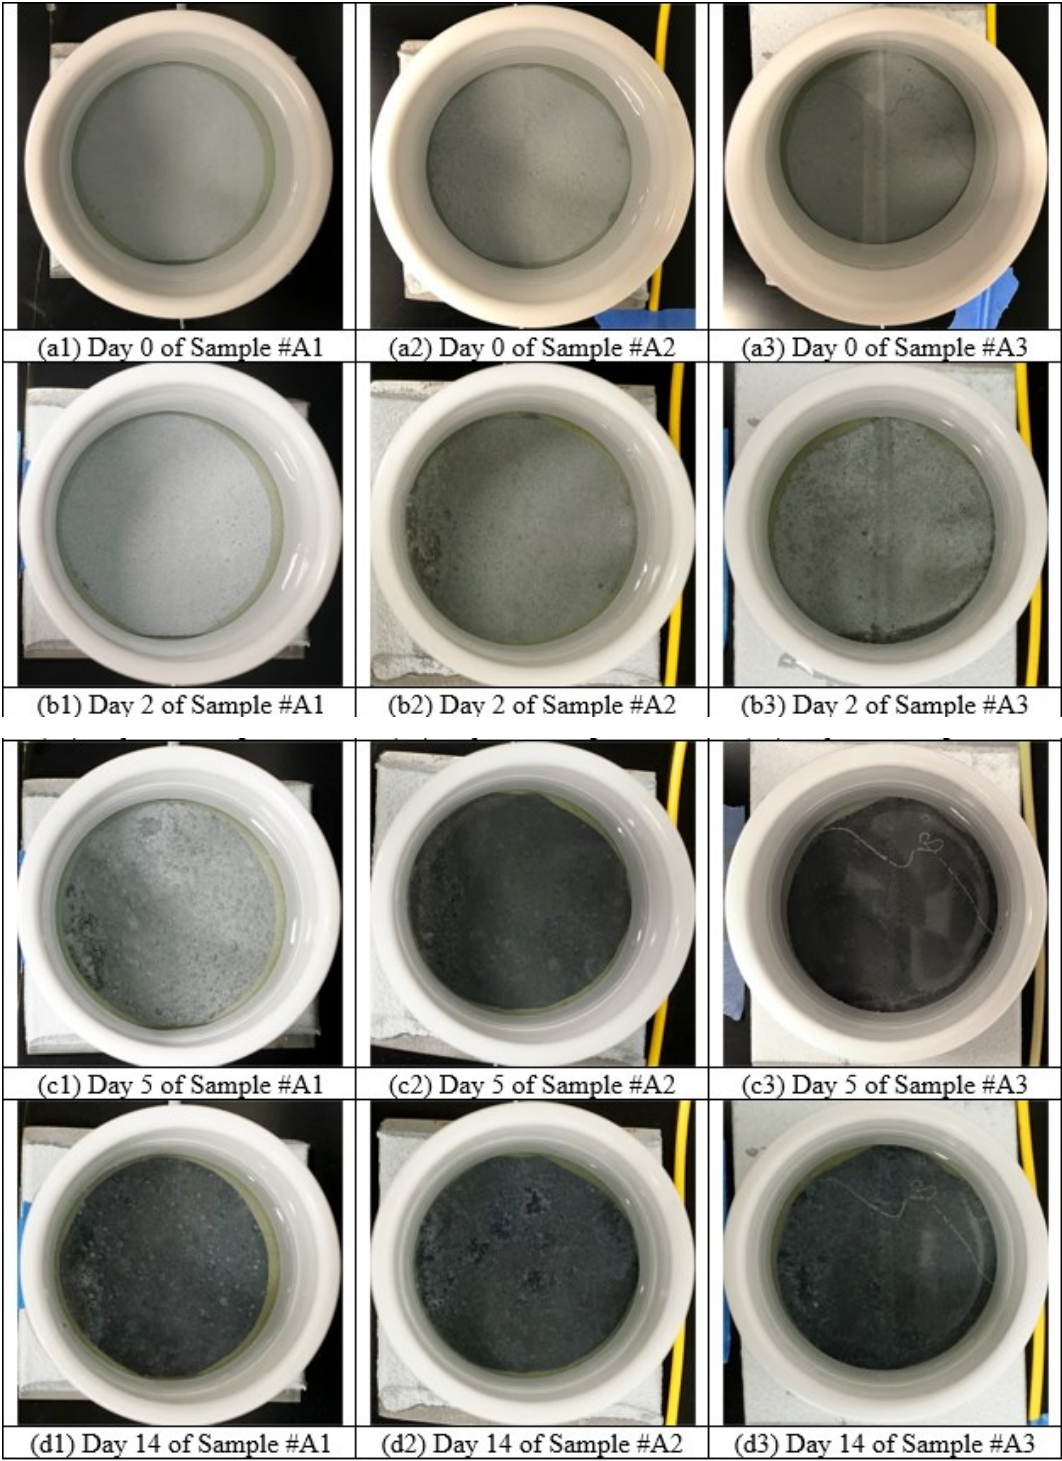
Figure 12. Visual inspection results for Sample #A1, #A2, and #A3.

Figure 12 shows selected visual inspection results and Figure 13 compares the SEM images on the cross-section of the wire arc sprayed Al-Zn coating before and after accelerated corrosion tests. From Figures 12 (b1~b3) for Samples A#1~3, it can be clearly seen that after 48 hours (Day 2), corrosion started to occur on the wire arc sprayed Al-Zn coating. Figures 12 (c1~d3) indicates that after 120 hours (Day 5) till 336 hours (Day 14), the corrosion was very intensive and visible micro cracks started to form and penetrate through the coatings. The comparison of coating cross-section before and after corrosion in Figure 13 also illustrates that corrosion produced porous corrosion product on the surface of the coating after corrosion occurred.

A close look at the changes of curves in Bragg wavelength of FBG sensors as shown in Figure 14 compared with visual inspection results in Figure 12, reveals that several inner coating cracks could be distinguished by the embedded sensor from 96 hours (Day 4) as shown in Figure 15. After each crack, the Bragg wavelength of the FBG sensor firstly dropped for a short period, then increased rapidly, indicating an increase in corrosion rate, until a new crack was formed and then a new corrosion cycle started. Table 6 showed the corrosion rate of Sample #A1 before each coating crack. Table 6 showed that the corrosion rate was drastically increased after formation of cracks in the coating from $5.588 \mu\text{m}/\text{year}$ to $11.938 \mu\text{m}/\text{year}$. Compared with the initial corrosion rate in Table 5, the fact that Table 6 showed a higher corrosion rate could be a combined corrosion progressing from the coating and its substrate after the occurrence of micro cracks.

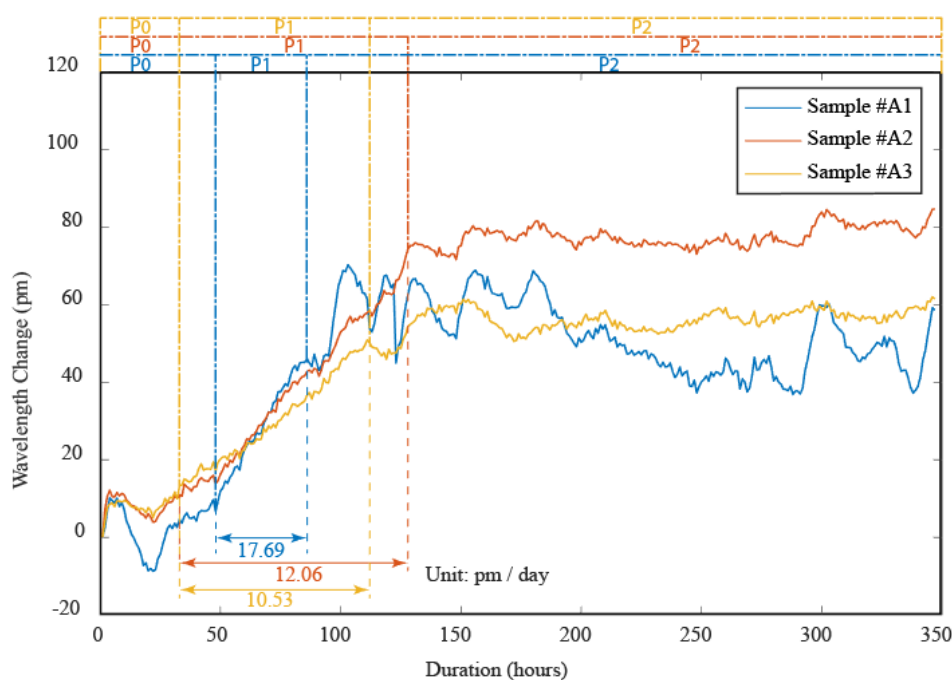
Figure 14. Bragg wavelength of embedded FBG sensors with wire arc sprayed Al-Zn coating with linear increase part marked.

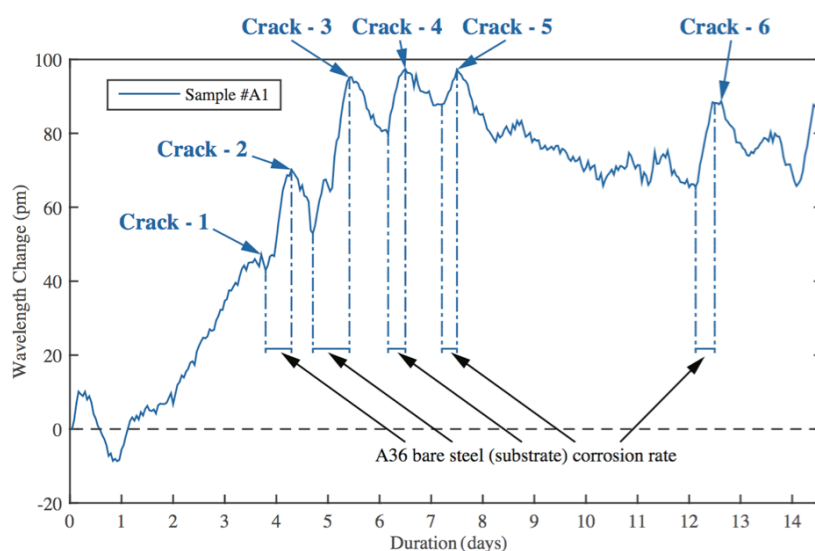
Figure 15. Change of wavelength curves in FBG sensor due to existence of the cracks.
