# Experimental study of performance of engineered bamboo beams exposed to three-sided standard fire

**Abstract:** This paper presents a pilot experimental study aimed at evaluating the performance of engineered bamboo beams exposed to and following exposure to three-sided standard fire conditions. Nine tests were carried out including two constant applied load fire tests and seven flexural tests of engineered bamboo beams following exposure to fire. Test parameters include load ratio in fire tests, fire exposure duration, beam geometry and engineered bamboo type. Two engineered bamboo products: laminated bamboo and bamboo scrimber, commonly used in construction were considered. In all cases, regardless of fire exposure, the failure mode was flexural failure associated with tensile fracture of the extreme tension fibre. The stiffness and ultimate loads of engineered bamboo beams were observed to decrease with increased fire time and the strain distribution at the mid-span cross-section remained linear after exposure to the standard fire. The fire resistance of laminated bamboo beams decreased with increased applied load. Charring depth was measured for all beams after tests and equ

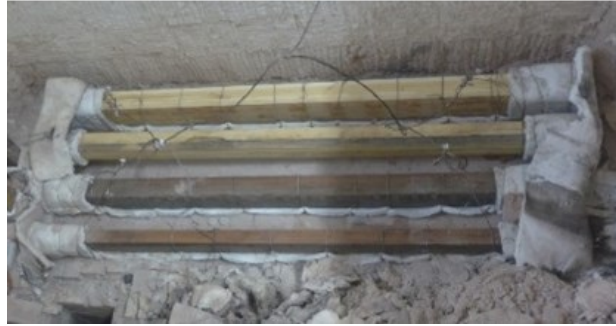
a) specimens in furnace before fire exposure

Figure 2 Test specimens.

Two laminated bamboo and three bamboo scrimber specimens (LGBA and SGBA specimens) were exposed to the initial 10 or 25 minutes of an ISO 834 standard fire [17]. These beams were placed in the furnace (rather than being simply supported) and mineral wool was used to protect the supporting surface and beam ends (Figure 2a). Following fire exposure for the prescribed time (Table 2), the furnace was allowed to cool for about 5 to 7 mins and the beams were moved out the furnace and cooled with water before being tested in flexure in the same manner as the control specimens in order to determine post-fire residual capacity. The top, compression face of the beam was that protected during the fire exposure. Figure 2b shows the beams following fire exposure.

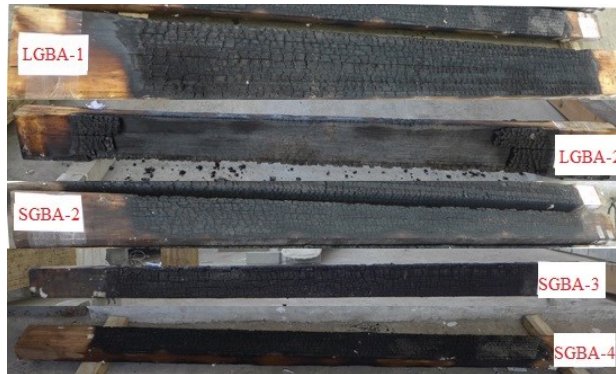
b) specimens following fire conditioning

Following 3 to 5 minutes of fire exposure, smoke was observed and increased with time. Photographs of the fire-exposed specimens in Figure 2b show alligator fissures on the exposed beam surfaces and some lamellas of bamboo peeling off the exposed beam soffit.

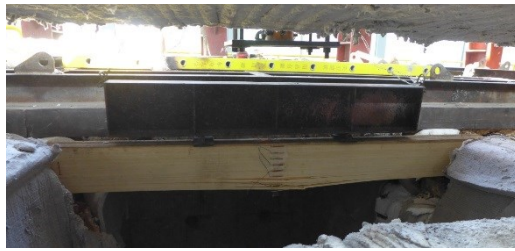
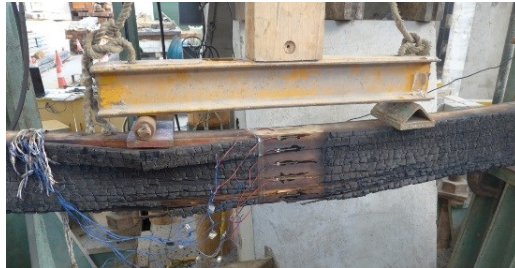
(a) LGB

(b) LGBA-1

(c) LGBA-2

Figure 5 Failure modes of laminated bamboo specimens.

Control specimen LGB began to crack at an applied load of 120 kN; this corresponds to the onset of non-linear load-deflection behaviour of the beam (Figure 4a). Crack sounds increased with the increasing load, and at 190 kN, the beam fractured suddenly at the bottom fibre (Figure 5a). For specimen LGBA-1, exposed to fire for 10 minutes, cracking was initially heard at 39 kN. At an applied load of 56 kN, the bottom bamboo lamina fell off and the load-deflection behaviour became distinctly non-linear (Figure 4a). The beam failed at 100.3 kN. Diagonal cracks formed below the left loading points and the bottom fibre fractured at the mid-span as seen in Figure 5b. Specimen LGBA-2, exposed for 25 minutes, exhibited initial cracking at an applied load of 19.1 kN, and at 43.3 kN failed due to the tensile fracture of the lowermost lamina as shown in Figure 5b.

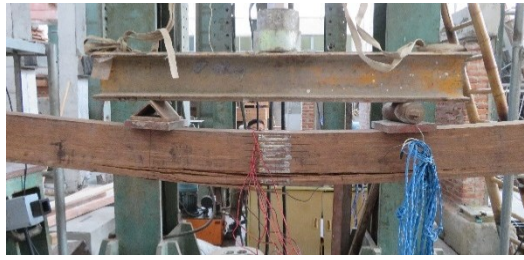
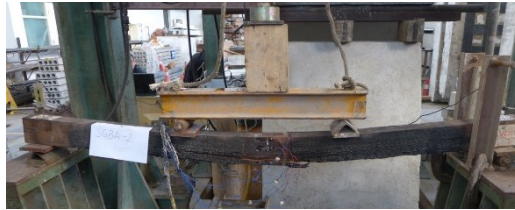
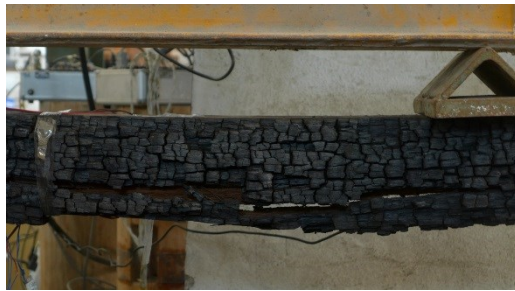
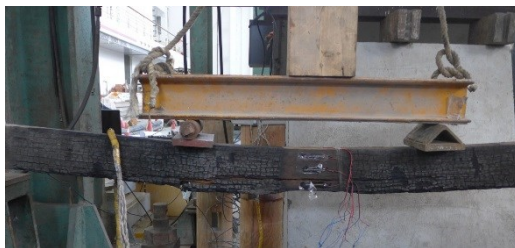
(a) SGB

(b) SGBA-1

(c) SGBA-2

(d) SGBA-3

Figure 6 Failure modes of bamboo scrimber specimens.

Control specimen SGB began to crack at an applied load of 47 kN, indicating the onset of non-linear load-deflection behaviour of the beam (Figure 4b); cracking increased with increasing load. At 52 kN, a crack was observed at the beam soffit at mid-span. The beam failed suddenly at an applied load of 68.1 kN; longitudinal cracks extended to both two loading points (Figure 6a). For specimen SGBA-1, exposed to fire for 10 minutes, cracking was first heard at 38 kN; non-linear load-deflection behaviour began and the beam failed due to tensile fracture of the bottom fibres at 45.5 kN (Figure 6b). Specimen SGBA-2, exposed for 25 minutes, began to crack at an applied load of 14.5 kN, and exhibited a tensile fracture of the bottom fibres at 16.4 kN (Figure 6c). Specimen SGBA-3, having a width of only 70 mm and exposed to fire for 10 minutes began to crack at 14.2 kN. Cracks developed at the bottom of the beam and the beam failed at 22.5 kN (Figure 6d).

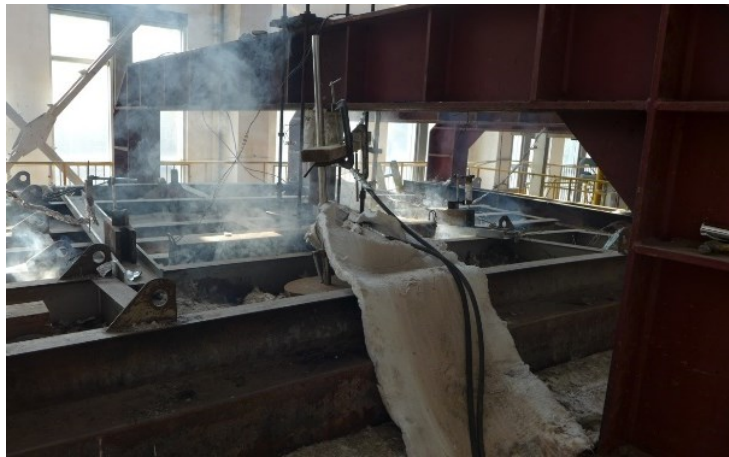
a) during fire tests

b) after fire tests (top:LGB-3; bottom: LGB-4)

Figure 9 Fire resistance tests

About 4 minutes after the fire began, smoke was observed (Figure 9a) and increased with time. In each test, the mid-span deflection, shown in Figure 8, increased gradually with the time, and increased suddenly as the specimens approached failure. Once load carrying capacity was lost, the furnace temperature was cooled and specimens removed and cooled further with water. As shown in Figure 9b, longitudinal and transverse

alligator fissures were observed on the side surfaces of the beams and the bottom lamellas of bamboo peeled off due to the charring. More bamboo lamellas were observed to have peeled off near the mid-span.

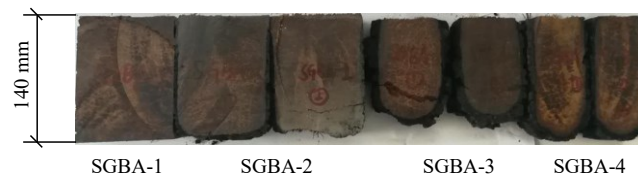
(a) laminated bamboo

(b) bamboo scrimber

Figure 13 Residual cross-sections of specimens.

To investigate the extent of charring, the residual geometry of the fire-exposed beams was measured from 50 mm-thick pieces cut from the beam at loading points after the charring layer was removed (see Figure 13). The residual cross-section of specimens LGBA-1 and LGBA-2 was slightly different than specimens LGB-3 and LGB-4. This may be mostly attributed to the fact that the top surface of specimens LGB-3 and LGB-4 were located slightly higher than the bottom surface of the furnace lids in order to prevent the flame getting out of the furnace. This caused the top area to not be directly exposed to fire. Specimens LGBA-1 and LGBA-2 were laid inside the furnace with the top surface covered with insulation and side surfaces were fully exposed. For laminated bamboo beams, the top and bottom surfaces were exposed to fire with the tangential direction in perpendicular to grain, while the other sides were exposed to fire with the radial direction perpendicular to grain. Knowing the original section geometry, the extent of charring was calculated. As seen in Figure 13, the bottom corners which were subjected to heat transfer from two directions, exhibited greater section loss due to charring leading to a rounding effect. Accurate measurements of the charred sections

were made by exporting the images into drafting software and measuring the geometric properties of the residual sections. To simplify the calculation of the moment capacity, the residual cross-section was equated to an equivalent rectangular cross-section having the same elastic section modulus (second moment of area divided by the depth of the centroid of the cross-section) as the irregular charred beam section. The equivalent charring rate, given in Table 3, was calculated based on the equivalent rectangular section (discounting the rounding effects at the corners) and is therefore marginally greater than the average rate based on actual geometry away from corners. In Table 3, the equivalent fire duration time used to calculate the charring rate was taken as 5 minutes plus the time of the furnace fire based on the principle of equal area below the measured and ISO 834 standard fire curves considering the combustion of the beams themselves after the furnace fire was stopped. The laminated bamboo beams had a higher charring rate than the bamboo scrimber. This may be attributed to the greater density of the bamboo scrimber (Table 1). The relatively high charring rate of LGB-4 was caused by the peeling off of the lamellas from the bottom of the beam. The measured average charring rate was slightly larger than that the calculated average charring rate for specimens exposed to a heat flux of  $50 \text{ kW/m}^2$  for 30–60 min. from cone calorimeter tests [13]. The difference was because in the cone calorimeter tests specimens were exposed to fire only on one face while those reported here are exposed on three sides, and relative short fire exposure time in this study. The charring rate of bamboo scrimber was close to the observations in the study by Xiang [21]. No apparent effect was observed of the load during the heating process on the charring rate, although
