# Identification and Characterization of Particulate Contaminants Found at a Data Center Using Airside Economization

*Contamination due to the use of airside economizer has become a major issue that cost companies revenue. This issue will continue to rise as server components become smaller, densely packed, and as companies move into more polluted environments. Contaminants with small particles less than 10  $\mu\text{m}$  are not noticeable; yet, these particles are most likely to get to areas where they can cause damage. Dust from different sources and suspended in air settles on surfaces of electrical components. The dust mainly contains two components: salts and metallic particles. The salts may be neutral or corrosive and the nature of the salt depends on the deliquescent humidity. For metallic particles, surveys are performed in various data centers in order to determine the limits in terms of weight per unit area and particle size distribution. It is necessary to first identify those contaminants that directly affect the information technology (IT) equipment in the data center. In this research, a real-world data center utilizing airside economization in an ANSI/ISA classif

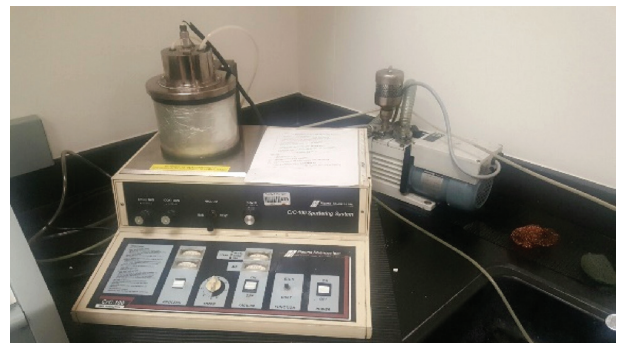
Fig. 6 CrC 100 sputtering system used for coating the nonconductive samples with silver

**3.1.1 Sample Preparation.** Contaminants from the server shown in Fig. 3 were collected. Since the contaminants were expected to be nonconductive, they were placed on a carbon tape and coated with silver using the CrC 100 sputtering system shown in Fig. 6. Figure 7 shows the sample holder with the silver-coated sample.

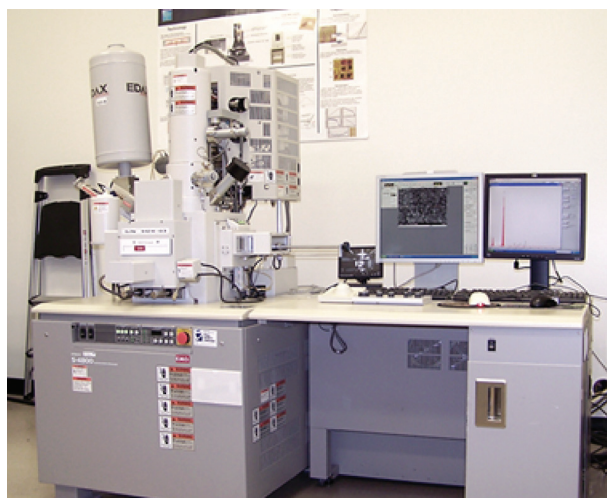
Fig. 5 Hitachi S-4800 II FE SEM with cold field emission source

There are two types of signal electrons used for SEM imaging that result from elastic and inelastic scattering of electrons due to the interaction of probe electrons and sample. The elastically scattered electrons produce backscattering electrons (BSEs), while the inelastic scattering produces secondary electrons (SEs). In this study, both SEs and BSEs were used to obtain high-resolution images. Two SEMs were used for this test: Hitachi S-3000N variable pressure SEM with a thermionic source (W gun) (Fig. 4) and Hitachi S-4800 II field emission (FE) SEM with cold field emission source (Fig. 5).

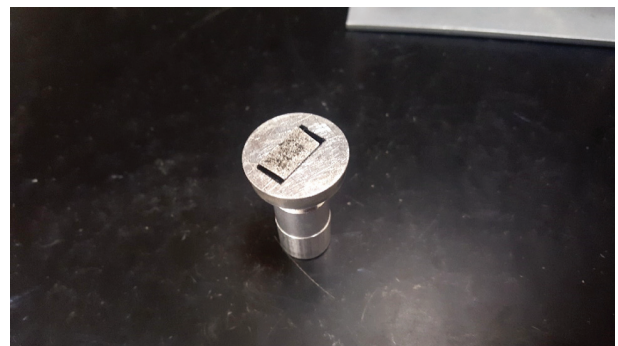
Fig. 7 Sample holder with the silver-coated sample

magnifications. The same sample shown in Fig. 7 was used for measurements using Hitachi S-4800 II FE SEM as well.

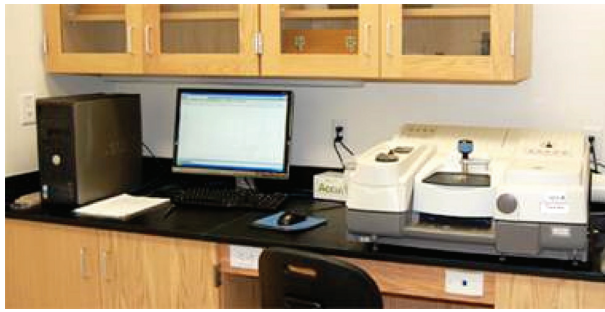
**Fig. 8 Thermo Nicolet 6700 FTIR spectrometer**

Thermo Nicolet 6700 FTIR spectrometer along with the smart iTR accessory shown in Fig. 8 was used to study the powder samples collected from the server locations shown in Fig. 3. For both the transmission and absorption measurements, the following parameters were selected:

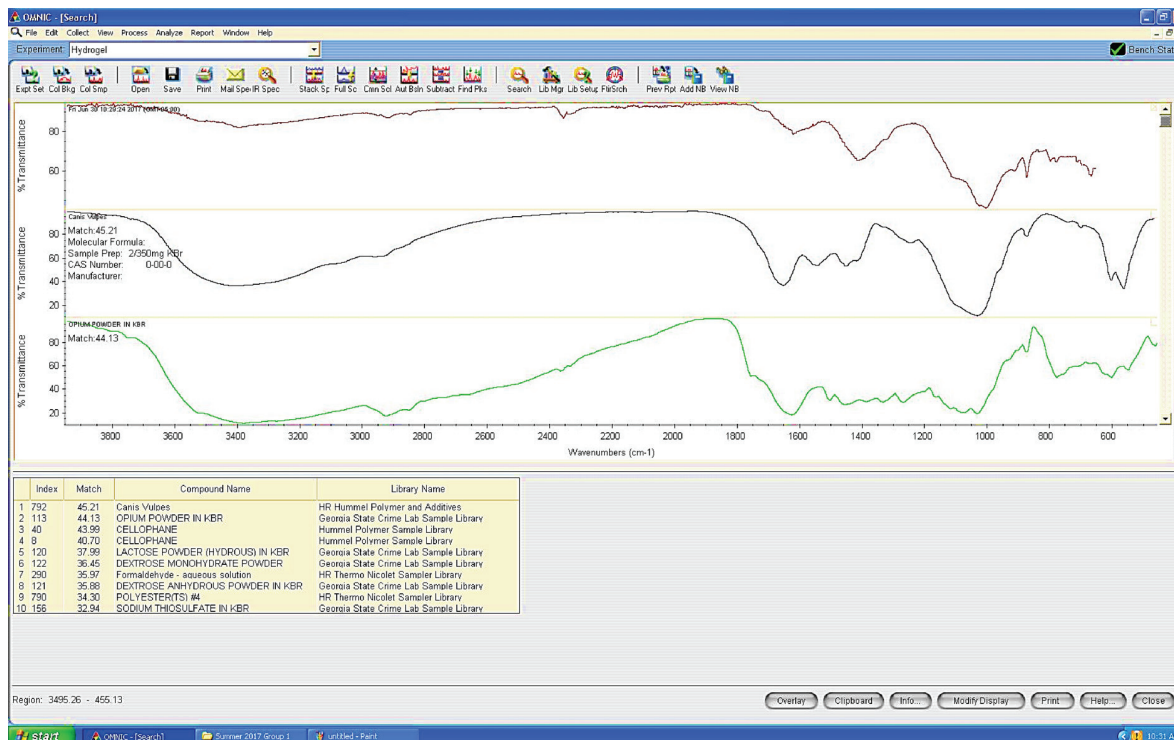
**Fig. 14 (a) Absorbance data collected using FTIR, (b) transmission data collected using FTIR, and (c) result obtained after performing the search in the FTIR database**

**4.3.1 Results.** Figures 14(a) and 14(b) show the absorbance and transmission data collected using the FTIR, respectively. Figure 14(c) show the results obtained after performing the search in the FTIR database. The result shows low percent match with different compounds. Identifying the details of these compounds will be part of future work.

**4.3.2 Data Analysis.** Fourier transform infrared spectroscopy was performed to analyze the molecular structure and compounds of found particulates. Based on the results obtained, it can be concluded that the contaminant sample contained different compounds. Unfortunately, these compounds could not be identified from the FTIR search database. Therefore, online tools that provided chemical group classification as a function of the wavenumber were used to identify the possible chemical groups that are present in the contaminant sample. The sources available from *Michigan State University* and *Chemistry LibreTexts* were used to determine Table 2, respectively [14,15].
