The Effect of Postweld Heat Treatment on Hydrogen-Assisted Cracking of F22/625 Overlays

Hydrogen-assisted cracking at the interface of F22/Alloy 625 weld overlays is found to be a strong function of PWHT using the delayed hydrogen cracking test

T. DAI AND J. C. LIPPOLD

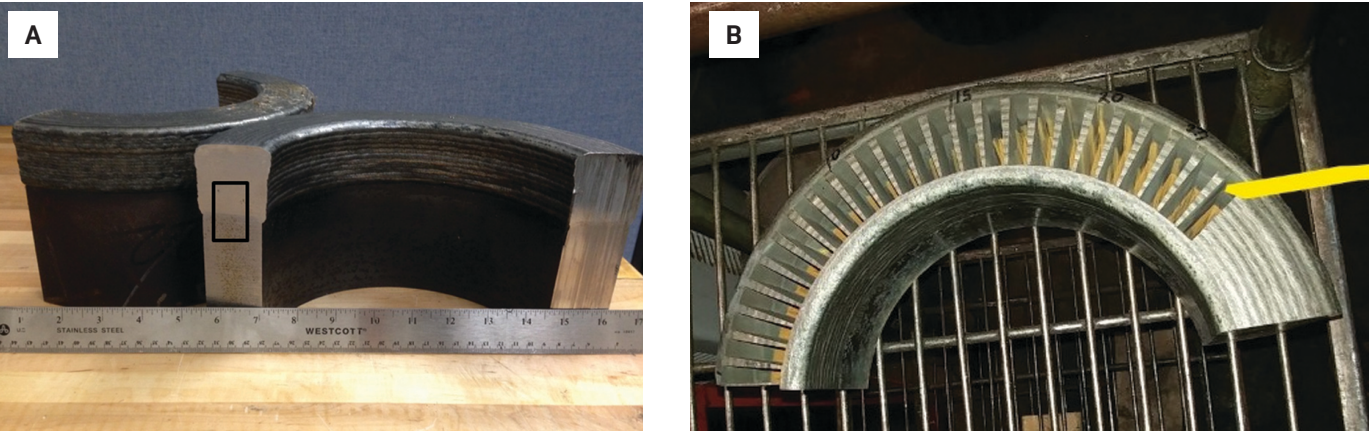
Fig. 1 — A — F22/625 dissimilar metal weld coupon; B — coupon after EDM machining of DHCT samples.

Samples were cut from the F22/625 overlay coupon with electron discharge machining (EDM) (Fig. 1B), and machined to the DHCT geometry shown in Fig. 2. The delayed hydrogen cracking test samples were conducted under constant load in conjunction with a hydrogen-charging system. There is no standardized sample geometry for the DHCT, so a reduced gauge-section sample was used with the weld interface perpendicular to the loading direction and in the middle of the gauge section. The width of the sample was 0.6 in., which encompassed approximately four weld bead widths from the original overlay.

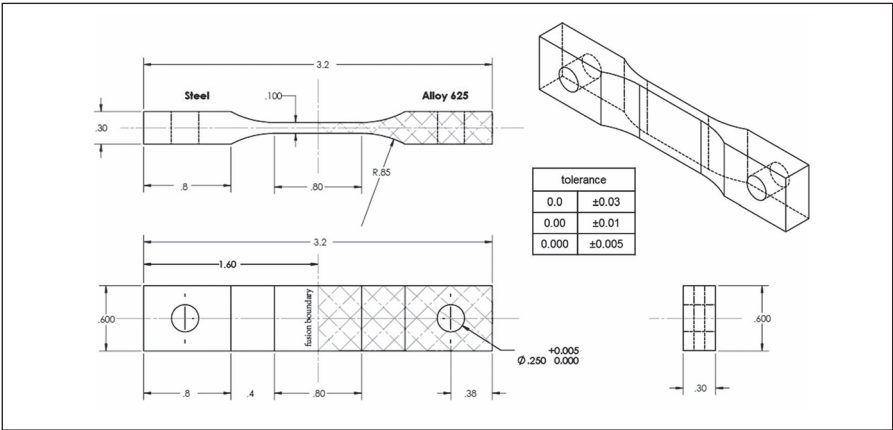
Fig. 2 — Sample geometry for the DHCT with units in inches.

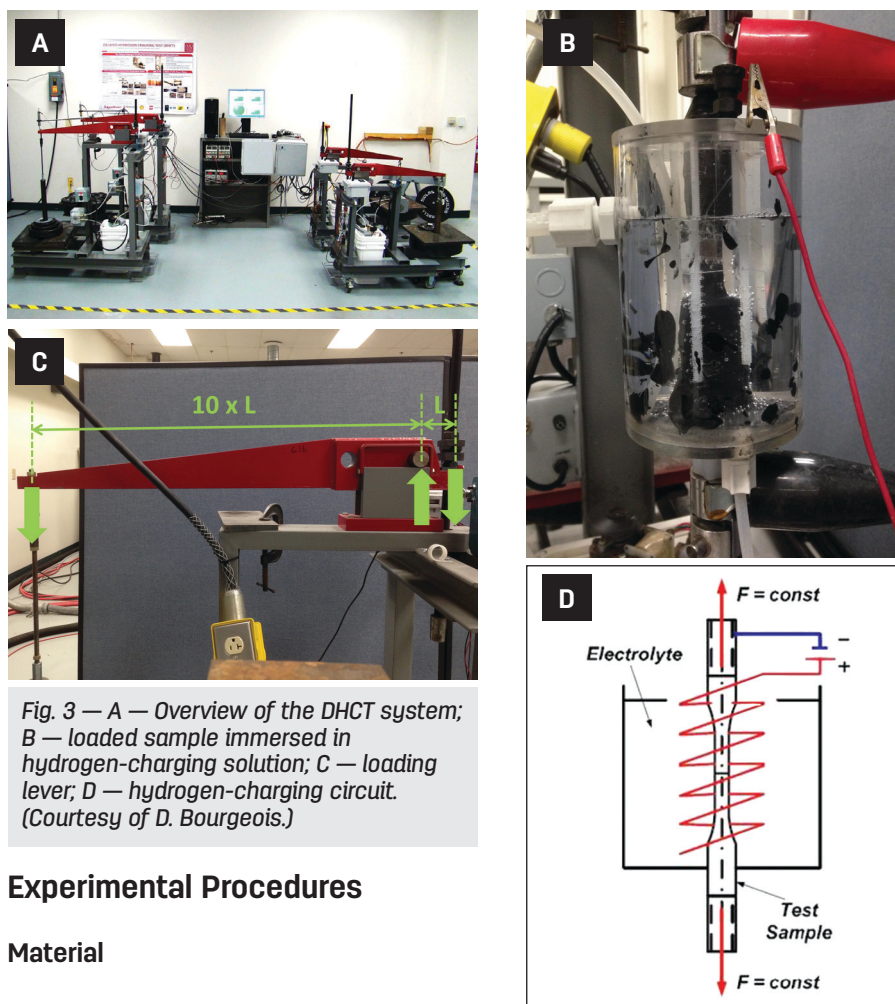
Fig. 3 — A — Overview of the DHCT system; B — loaded sample immersed in hydrogen-charging solution; C — loading lever; D — hydrogen-charging circuit. (Courtesy of D. Bourgeois.)

The delayed hydrogen cracking test (DHCT) is essentially a constant-load lever system (Fig. 3A and C) used to apply constant tensile stress on the loaded sample. A reservoir was used for the hydrogen-charging solution, which was circulated through a transparent plastic container where the sample was submerged and the charging current was applied (Fig. 3B). The charging solution was sulfuric acid (H_2SO_4) with $pH = 1.29 \pm 0.02$ (10 L distilled water + 27.5 mL H_2SO_4 , or 0.05145 mol/L) maintained at a temperature of $22 \pm 2^\circ C$. Five grams of sodium thiosulfate ($Na_2S_2O_3$) was added to the solution as the hydrogen recombination poison. Each test started 24 h after making the fresh charging solution. Additional details of the DHCT procedure can be found elsewhere (Ref. 15).

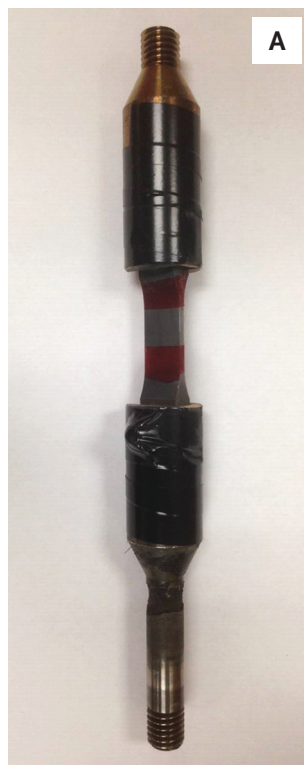
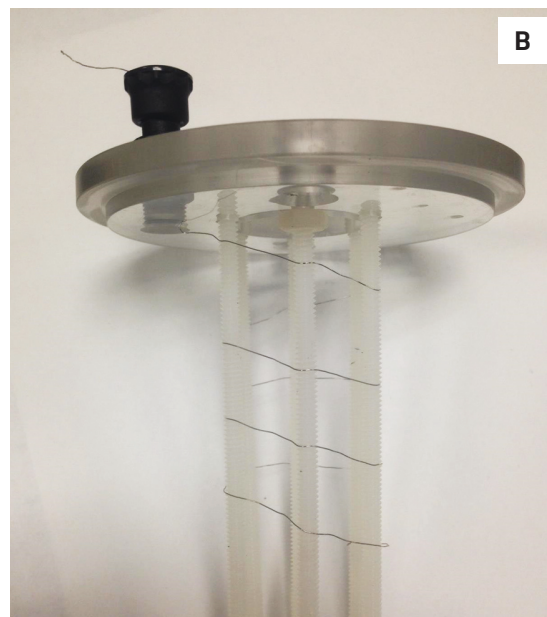
Fig. 4 — A — Sample installed in holders on two ends with masking to only expose the 0.5-in. gauge section; B — the lid of the transparent sample container with platinum wire as the anode.

0.125 in. of Alloy 625 and 0.375 in. of the F22 steel — Fig. 4A. This exposed region contained the weld metal, transition zone, and the entire F22 HAZ. Corrosion of the steel by sulfuric acid

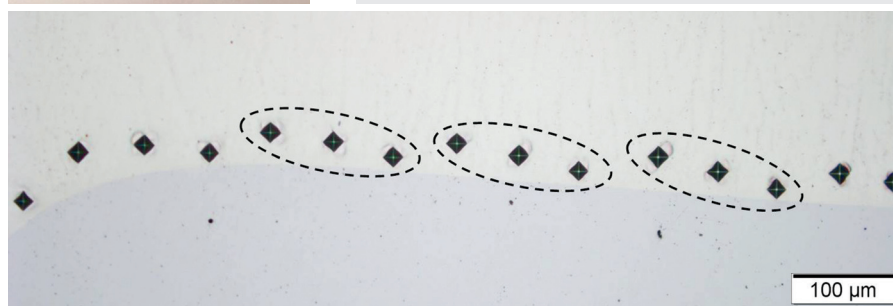
Fig. 5 — Microhardness indentations along the fusion boundary for obtaining the hardness in the PGZ.

Two sections removed from each sample gauge section were tempered together with their parent sample for the DHCT. A section containing the fusion boundary was cut and mounted in Bakelite to make a sample for hardness mapping and testing. The detail of the hardness testing procedure can be found elsewhere (Ref. 5). Indentations (100 g load) were made adjacent to the fusion boundary to obtain the average and maximum hardness in the PGZ. Every three indents were a set, as circled in Fig. 5. Three indents were needed due to the variation of distance be-

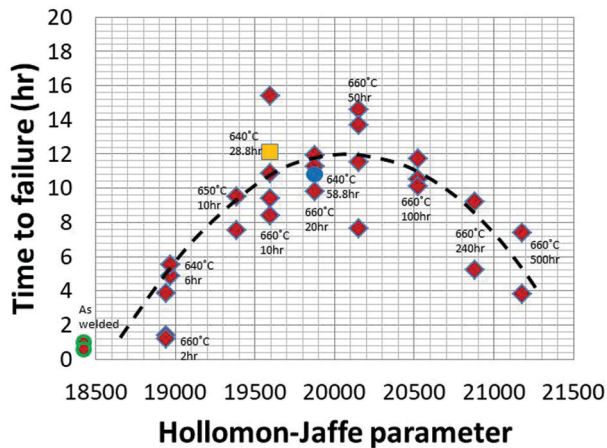
Fig. 6 — Summary of the DHCT results and the trend line of TTF with respect to the HJP.

The DHCT failure data in terms of time-to-failure (TTF) for the as-welded and different PWHT conditions are listed in Table 5. The TTF is plotted as a function of the HJP in Fig. 6. Generally, as the HJP increases, the TTF of the samples increases and then decreases after achieving a maxi-

Although the general trend of the TTF with the HJP (Fig. 6) is quite clear and consistent with tempering effects on microstructure, the TTF exhibited some scatter, especially for PWHT 660°C/50 h, 660°C/240 h, and 660°C/500 h. There are several reasons for this. First, the PGZ microstructure of the F22/625 sample periodically varied along the fusion boundary, especially the width of the PGZ and the presence of a “swirl structure” (Refs. 5–7). When considering duplicate samples with the same PWHT condition, one sample may have a susceptible feature such as a swirl on the edge, and another may not. The sample with the susceptible microstructure on the edge had a shorter TTF because it took less time for the hydrogen to diffuse into the susceptible microstructure.

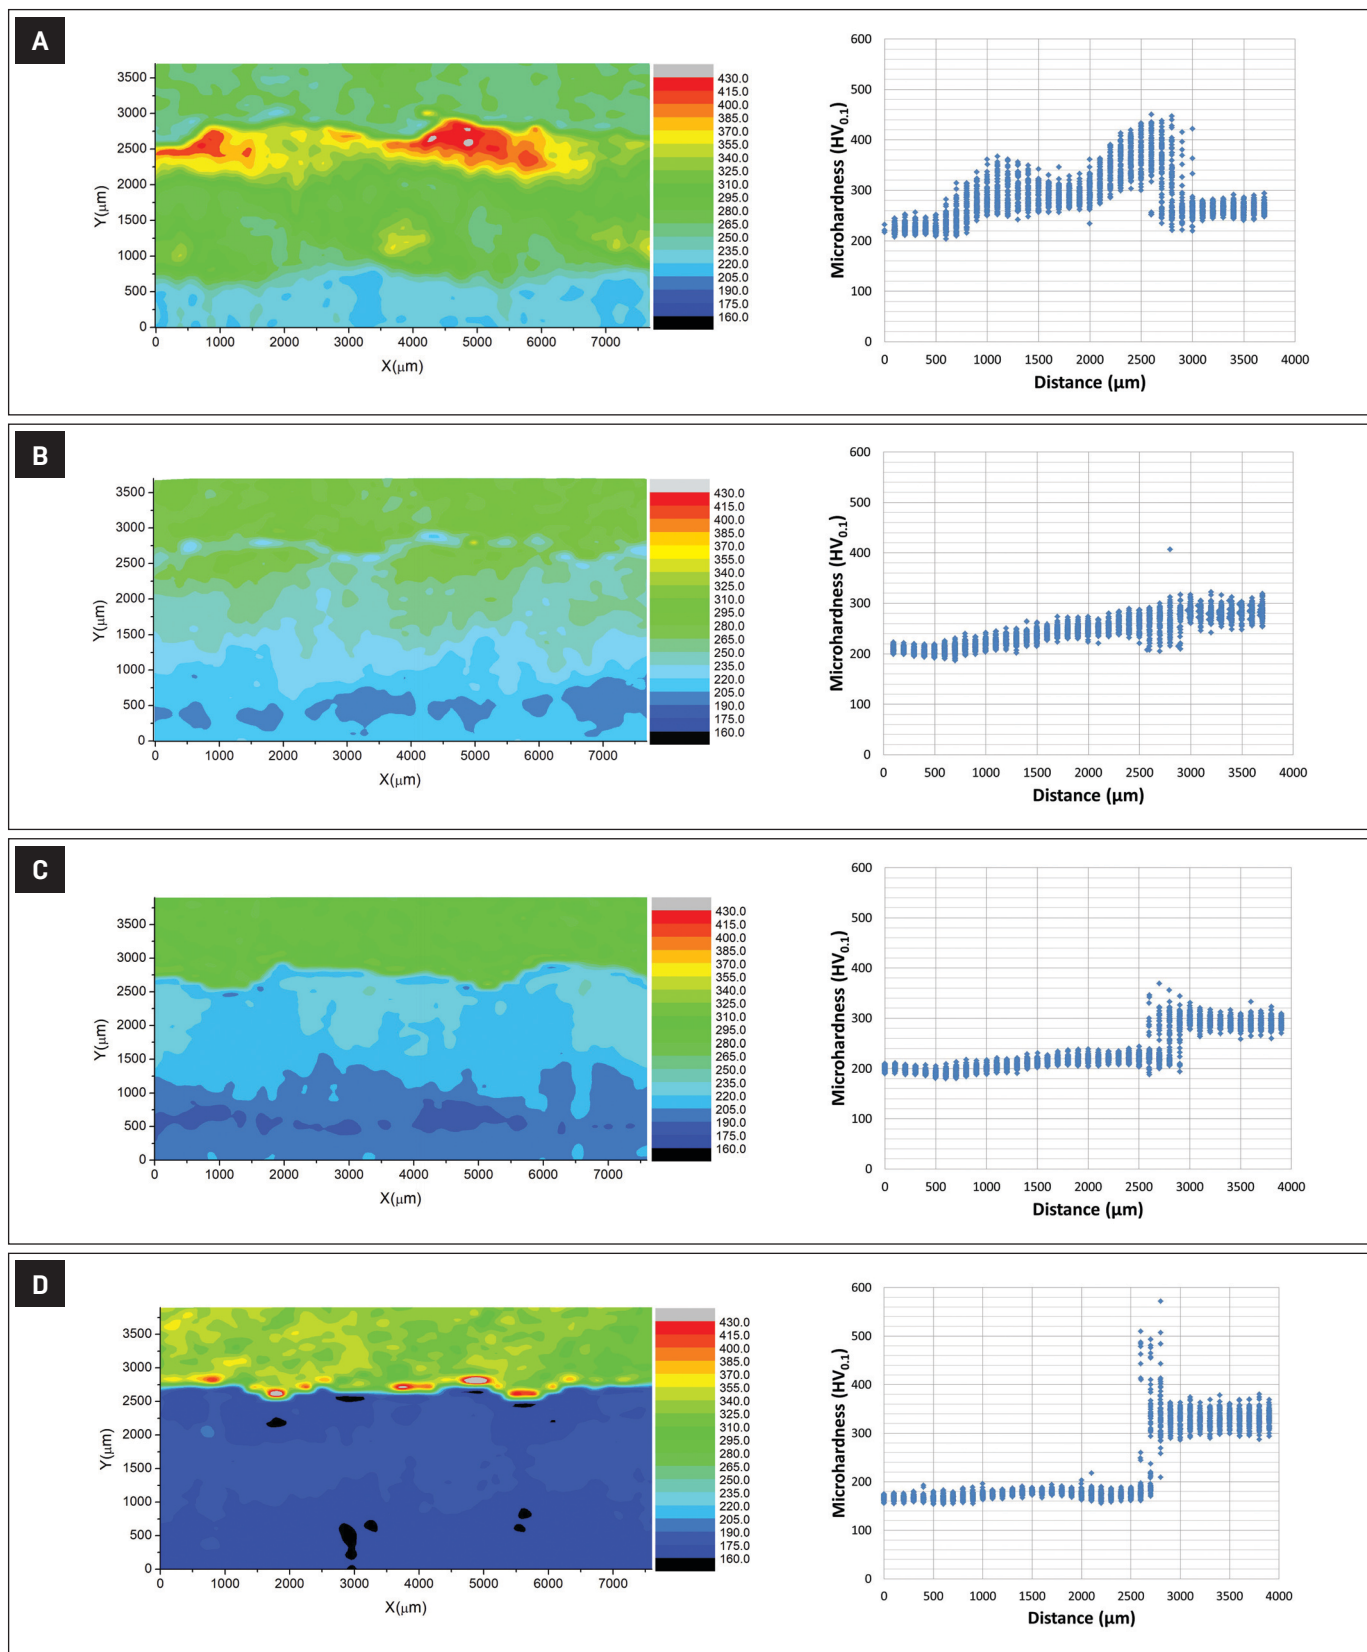
Fig. 7 — Hardness maps and hardness distributions of PWHT samples (Ref. 5): A — As-welded; B — 640°C/6 h; C — 660°C/20 h; D — 660°C/500 h.

the as-welded and 11 PWHT conditions were evaluated using hardness mapping. Figure 7 shows the hardness maps and hardness distributions of the as-welded condition and selected samples at three PWHTs. Hardness maps for additional PWHT conditions and the fusion boundary microstructure have been published previously (Ref. 5). The hardness distribution plots associated with these maps can show the quantitative variation of hardness in the CGHAZ, PGZ, and WM. As the HJP increases, the CGHAZ hardness decreases due to tempering of the martensite, and WM hardness increases due to precipitation. Also, with increased tempering time and temperature, hardness peaks appear in the PGZ due to carbon diffusion and buildup — Fig. 7B to D.

The CGHAZ of the as-welded sample was not homogeneous due to the tempering effect of the multibead overlay where adjacent passes provided some tempering effect. In the as-welded condition, the CGHAZ hardness of up to 450 HV_{0.1} was observed (in the hardness scale bars of Fig. 7, gray color scale is > 430 HV_{0.1} and the black color scale is < 160 HV_{0.1}). The PWHT at 640°C/6 h decreased the average CGHAZ hardness to 270 HV_{0.1}, while PWHT at 660°C/20 h reduced the average CGHAZ hardness to 220 HV_{0.1}. In both cases, there was no strong hardness peak observed in the PGZ. Hardness values up to 500 HV_{0.1} were present at the fusion boundary after PWHT at 660°C/500 h.

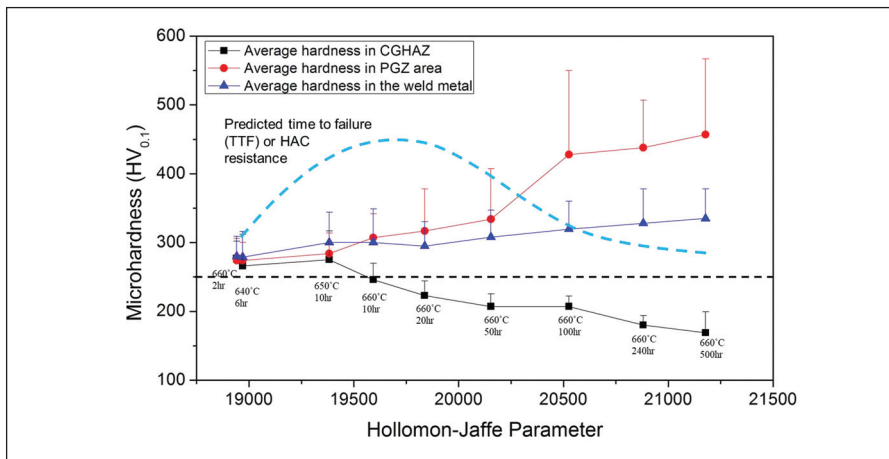
Fig. 8 — Summary of hardness response in the CGHAZ, WM, and PGZ areas as a function of the HJP, as well as the predicted TTF trend with the HJP according to hardness variation.

the precipitates did not form until PWHT at 660°C/50 h. There were only tiny precipitates on the fusion boundary surface. This can partially explain why the TTF (HAC resistance) of sample 660°C/50 h was better than samples at severer PWHT. Interestingly, the area of “orange” fracture surface increased and then decreased, corresponding to the predicted trend of TTF shown in Fig. 8.

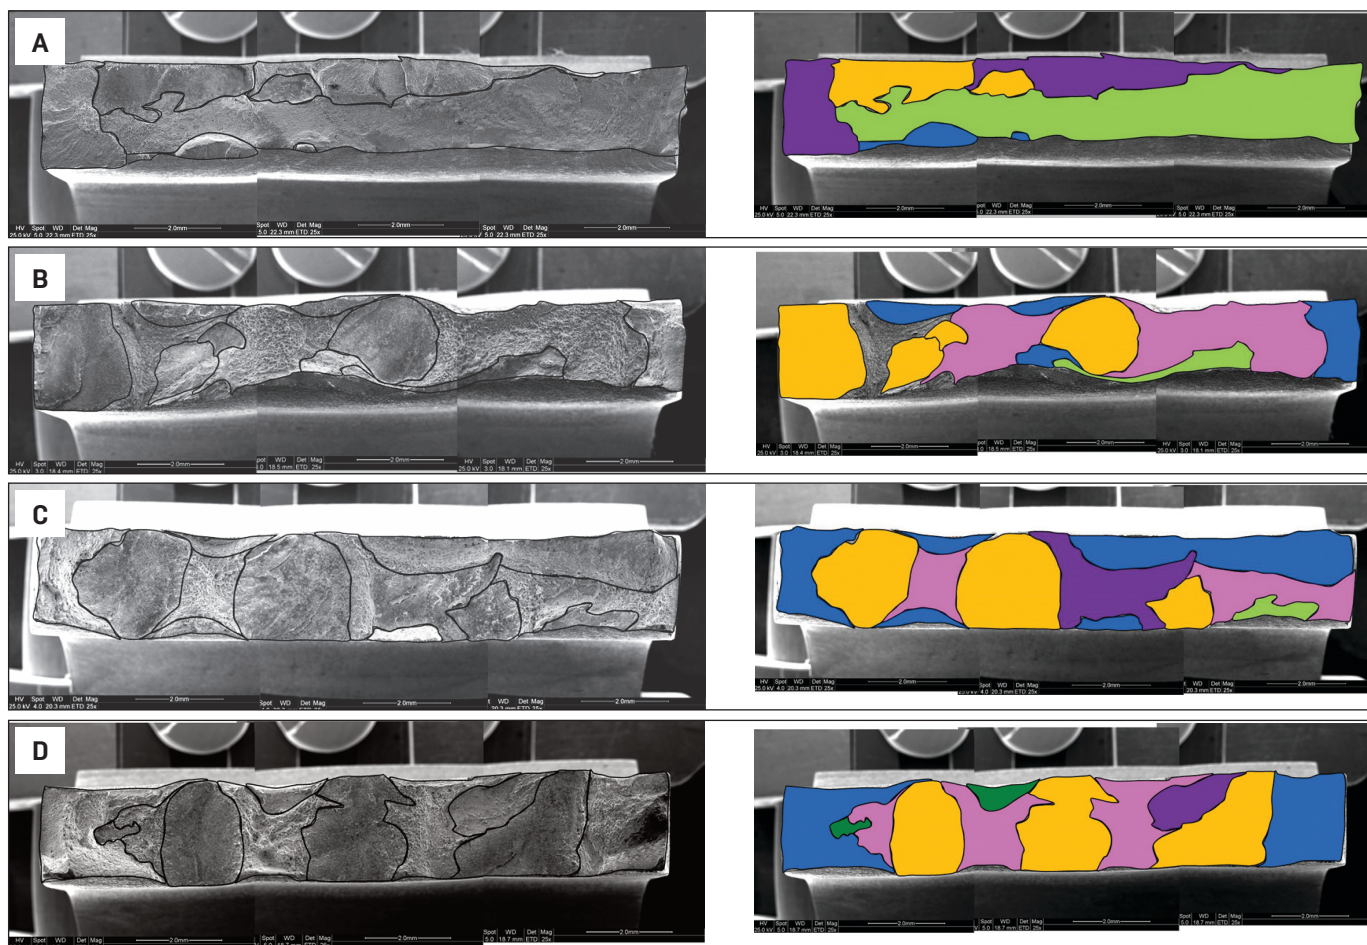
Fig. 9 — The fracture surface of different samples on the Ni-alloy 625 side and the different typical morphologies are represented by different colors: A — As-welded; B — 640°C/6 h; C — 660°C/10 h; D — 660°C/20; Light green = microvoid coalescence in weld metal by overload; purple = quasi-cleavage in the CGHAZ; orange = fusion boundary fracture; pink = microvoid coalescence in the base metal; dark green = quasi-cleavage, cleavage, or terrace fracture in the PGZ; blue = overload fracture in the base metal.

Eight samples were selected to show the morphology of the fracture surface. Only the fracture surface on the Alloy 625 side of the sample was shown because the corresponding fracture surface on the F22 steel side is a “mirror-image.” The black lines on the macroscopic fracture surfaces shown in Fig. 9 separate regions with different fracture

In the as-welded condition, the “light green” fracture morphology covered most of the total fracture surface (> 50%) because the as-welded weld metal had a lower hardness/strength than the CGHAZ or even the base metal. As the HJP increased, the area of “light green” fracture decreased. The increasing HJP promoted precipitation hardening in the Alloy 625 weld metal, which reduced, or eliminated, overload failure in the weld metal.

“Orange” region along the fusion boundary. The morphology represented by orange was observed in all the samples — Fig. 9A to H. These fracture surfaces represent the fusion boundary surface. Two types of grain boundaries can be observed on the fracture surfaces. One type is the Alloy 625 austenitic grain boundary, as indicated by yellow arrows in Fig. 12A. The second type of grain boundary is represented by the residual base metal attached to the fusion boundary surface, as indicated by the white arrows in Fig. 12A. The EDX analysis also showed that the residual metal on

In Fig. 9A to H, the blue area increased with the HJP. As the PWHT increases, the CGHAZ became increasingly softer. The softened base metal and HAZ became the weakest zone at a high HJP and led to overload failure after the crack propagated along the fusion

The “purple” and “dark green” regions are HAC initiation sites. For the as-welded sample (Fig. 9A), the HAC initiated in the CGHAZ with a high hardness and a martensitic microstructure. As the HJP increased, the HAC initiation location moved from the CGHAZ to the fusion boundary, as summarized in Table 5. The maximum HJP from Dodge’s work (Ref. 6) was 20,306 (650°C/100 h). In

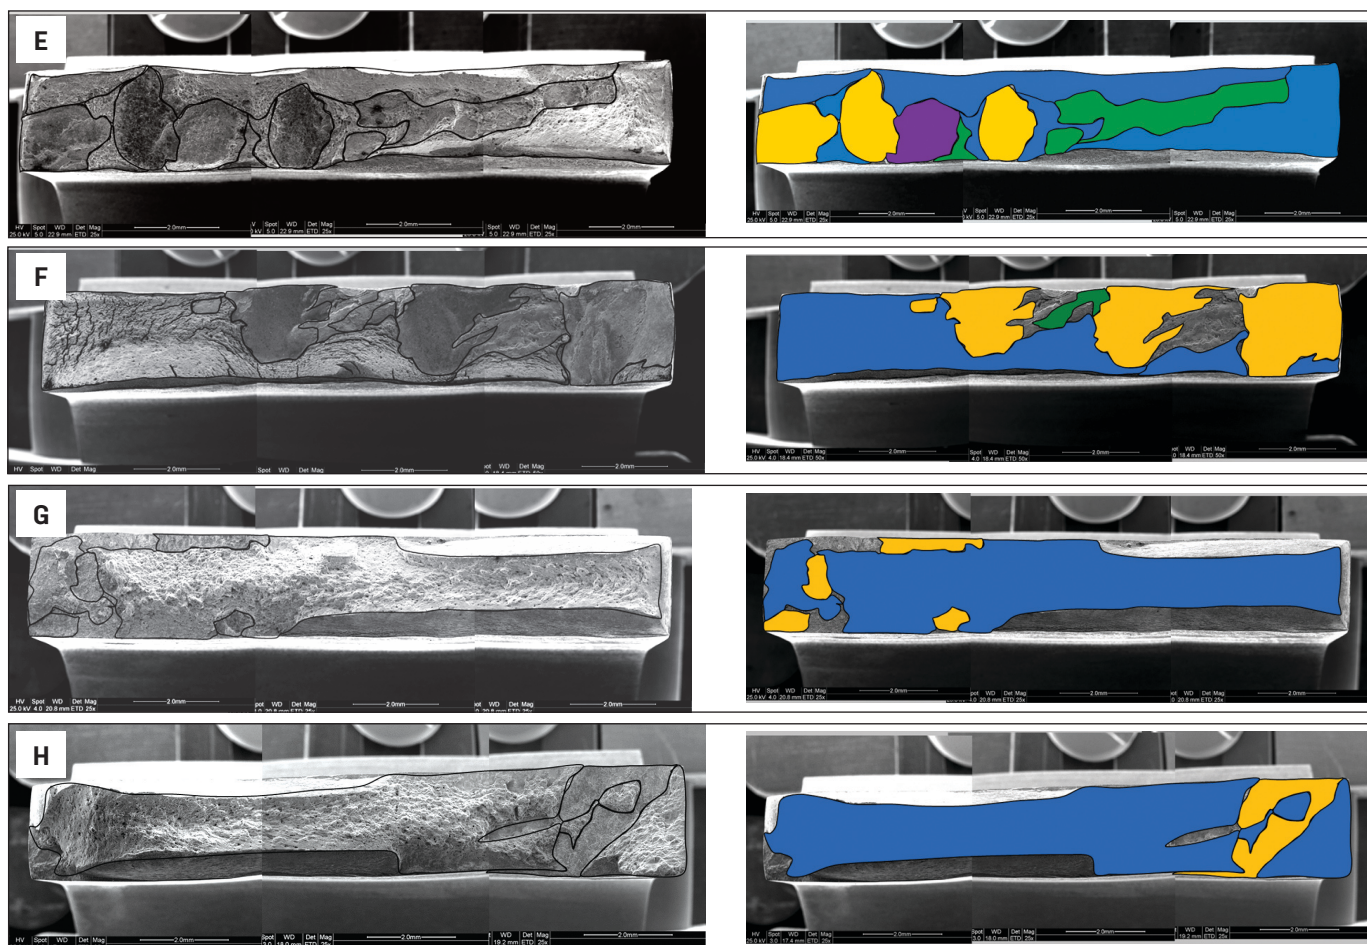
Fig. 9 (continued) — The fracture surface of different samples on the Ni-alloy 625 side and the different typical morphologies are represented by different colors: E — 660°C/50 h; F — 660°C/100 h; G — 660°C/240 h; H — 660°C/500 h. Light green = microvoid coalescence in weld metal by overload; purple = quasi-cleavage in the CGHAZ; orange = fusion boundary fracture; pink = microvoid coalescence in the base metal; dark green = quasi-cleavage, cleavage, or terrace fracture in the PGZ; blue = overload fracture in the base metal.

The cleavage and quasi-cleavage (“dark green”) fracture morphology (Fig. 9D and E) in the inner area of the whole fracture surface is surrounded by a “blue” fracture area on the sample

For the 660°C/20 h condition, there was a similar fracture initiation area (dark green area in Fig. 9D), and its TTF was also high. This then defined the optimum HJP range of 19,800 to 20,200. Although the PWHT times (20 and 50

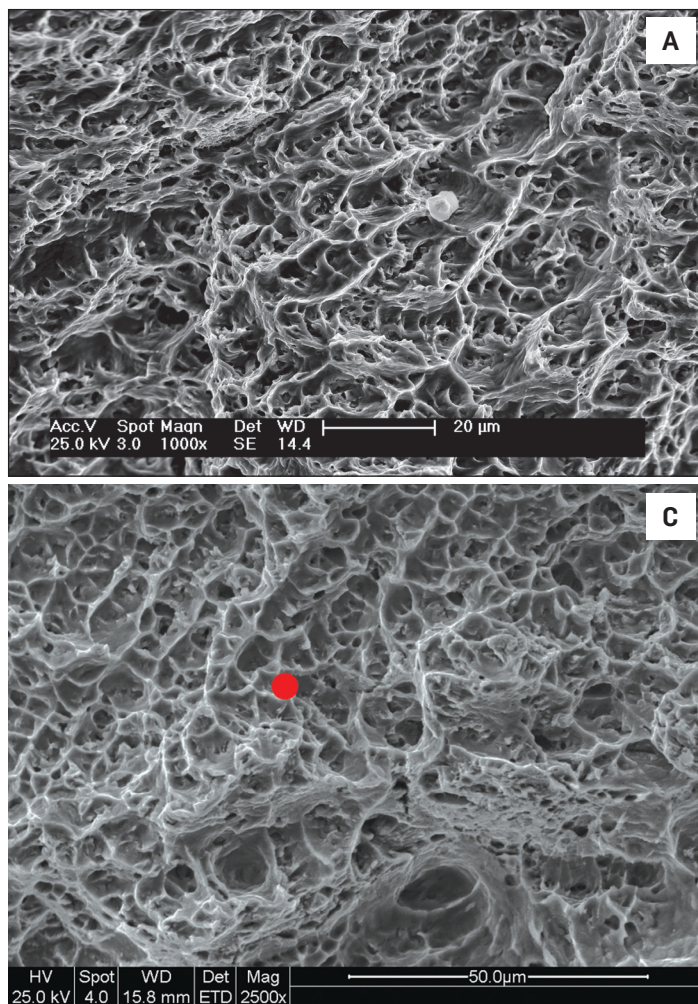
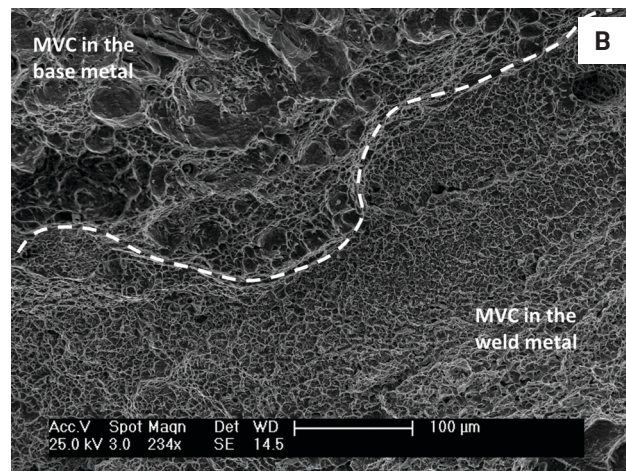
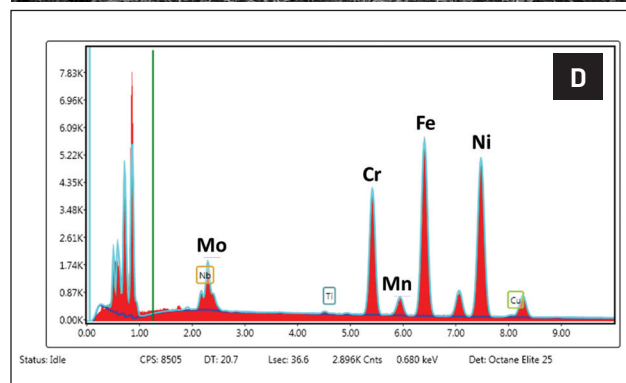
Fig. 10 — Morphology of the “light green” fracture regions:
 A — As-welded sample from Fig. 9A; B — sample 640°C/6 h from Fig. 9B; C — sample 660°C/10 h from Fig. 9C; D — EDX analysis spectrum of the red spot in Fig. 10C.

“Light green” region microvoid coalescence in the weld metal. This morphology is represented by a light green color — Fig. 9A to C. Figure 10 shows this morphology at a higher magnification of the as-welded sample — samples 640°C/6 h and 660°C/10 h. The morphology was classic ductile, microvoid coalescence (MVC). All these represented fracture through the weld metal as indicated by the high Ni content. This fracture surface was formed due to overload at the later stage of the cracking, rather than at the initiation stage of the cracking. Hydrogen did not assist the fracture propagation through the austenitic nickel-based

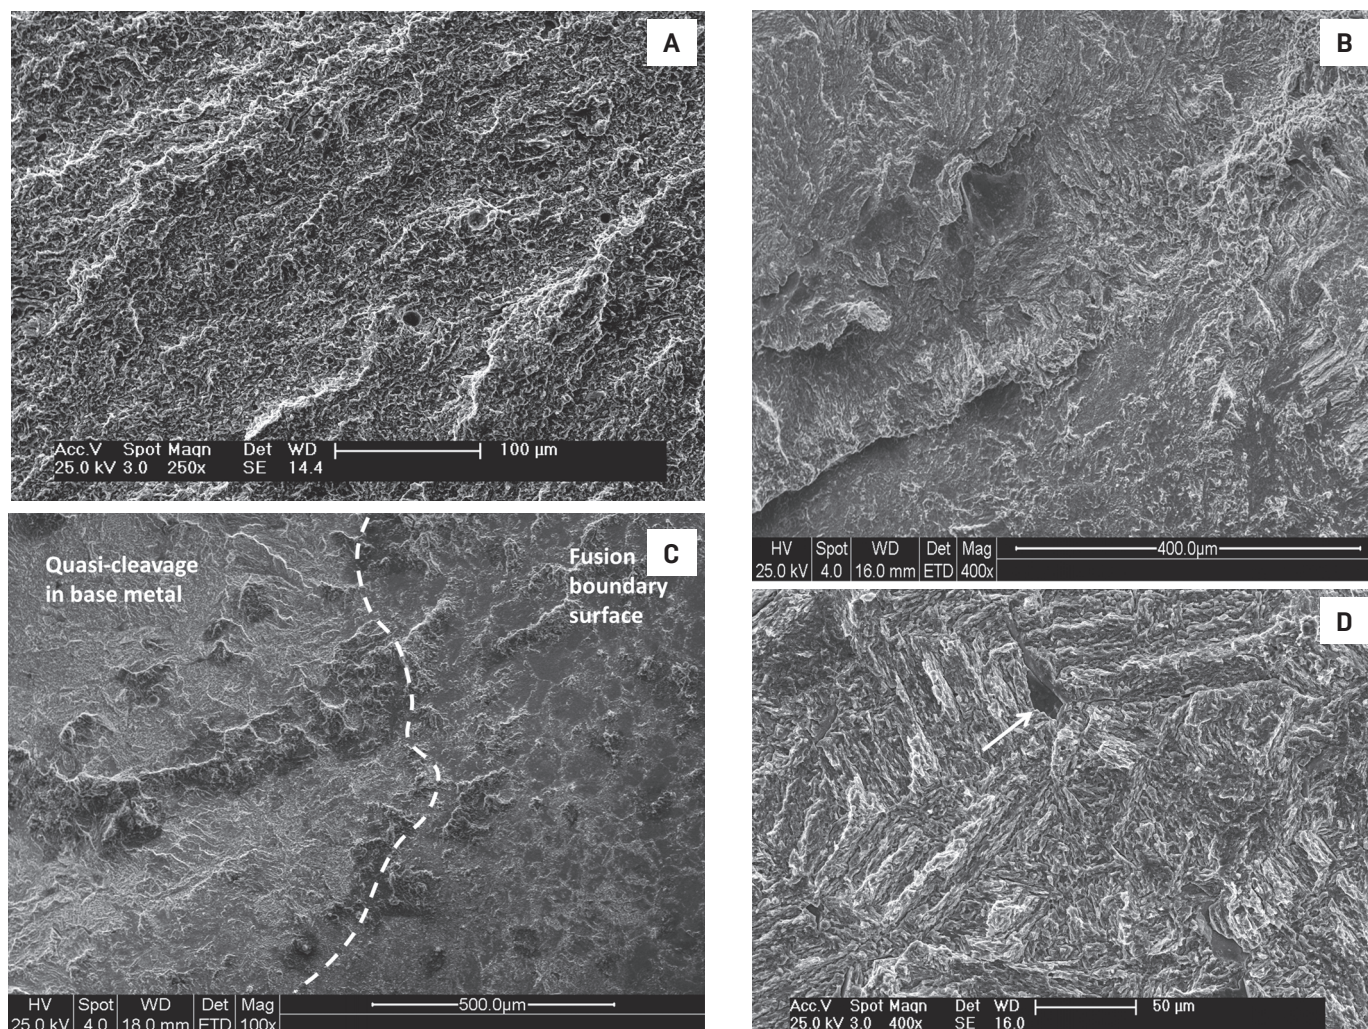
Fig. 11 — Morphology of the “purple” fracture in different PWHT conditions: A — As-welded sample from Fig. 9A; B — sample 660°C/10 h from Fig. 9A; C — sample 660°C/20 h from Fig. 9D; D — sample 660°C/50 h from Fig. 9E.

Figure 11D shows a lath structure, suggesting a martensitic structure. These fracture paths propagated through the base metal and may have transitioned gradually to the fusion boundary surface — Fig. 11C. The EDX analysis showed that the morphologies of Fig. 11A and B exhibit Fe levels of 95 wt-%, and that the surface in Fig. 11D shows 77 wt-% Fe. It is possible that the layer of steel martensite was so thin that the EDX also detected the chemical composition of the Alloy 625 under the martensite layer. In fact, the region marked by an arrow is the fusion boundary surface — Fig. 11D.

the largest since HAC occurred preferentially in the as-welded CGHAZ containing hard martensite. The “purple” area decreased with the increasing HJP (Fig. 11A–D) due to tempering of the CGHAZ.

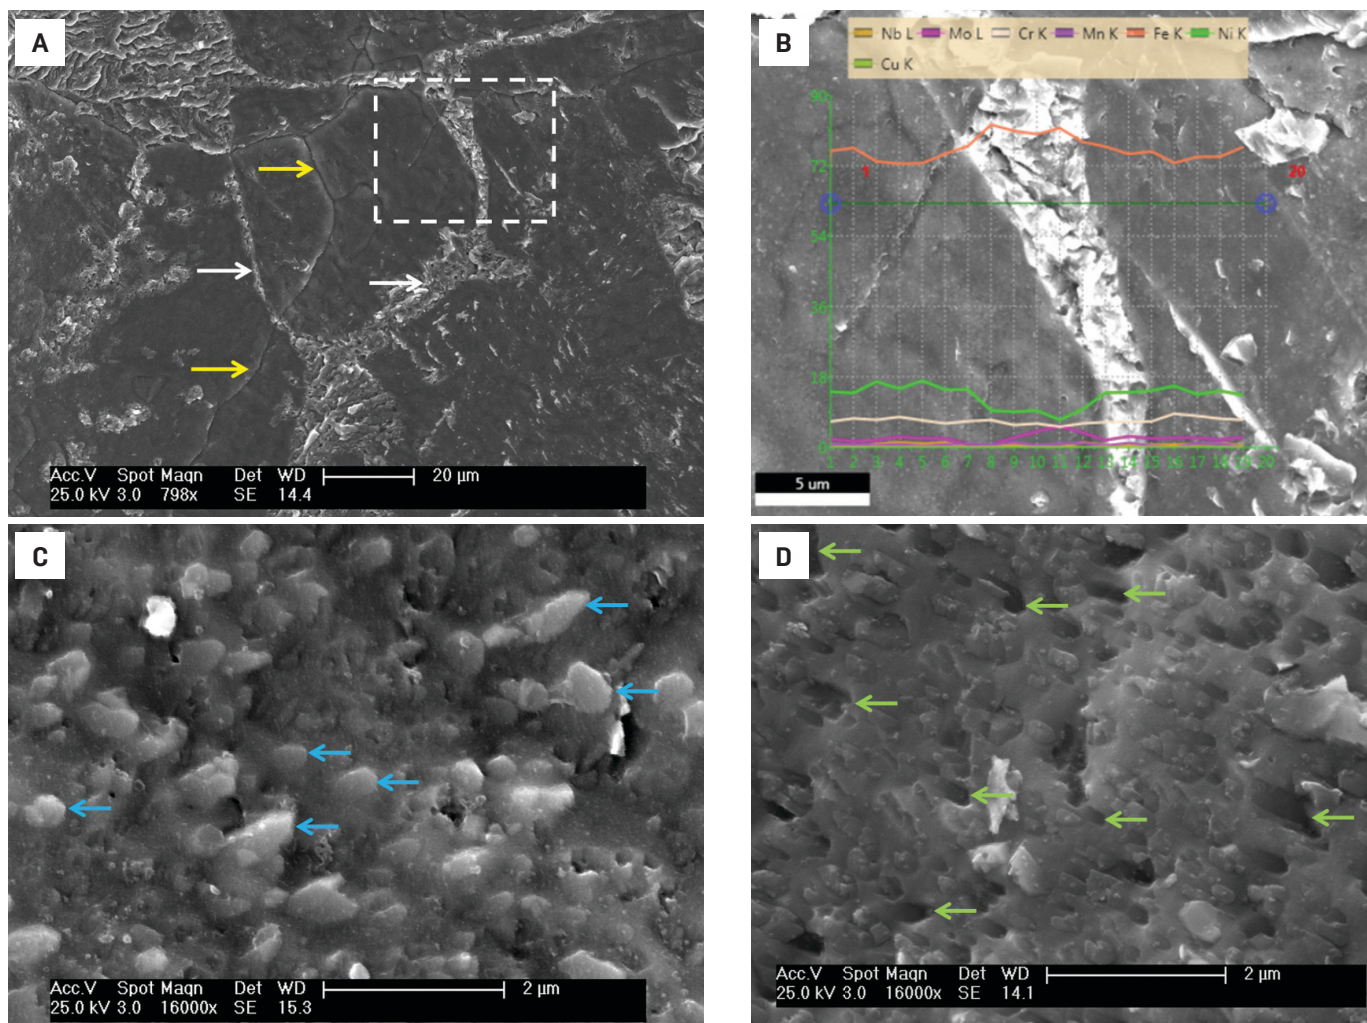
Fig. 12 — Typical morphology of the “orange” fracture in the selected PWHT conditions: A — Sample 660°C/10 h from Fig. 9C. White arrows show the CGHAZ grain boundaries, and yellow arrows show the PGZ boundaries; B — EDX line scan across the residual metal in the framed area in Fig. 12A; C — precipitates indicated by the blue arrows on the fracture surface of the Alloy 625 side of sample 660°C/240 h; D — “holes” indicated by the green arrows on the fracture surface of the base metal side of sample 660°C/240 h.

These precipitates were plate-like in shape (Fig. 12C), with approximate dimensions of 0.1 to 0.5 μm . Precipitates of this size were seen in fracture samples from the following heat treatments: 660°C/50 h, 660°C/100 h, 660°C/240 h, and 660°C/500 h. As the HJP increased, the amount of the precipitates increased.

In this work, larger HJPs were also studied: 20,526 (660°C/100 h), 20,881 (660°C/240 h), and 21,178 (660°C/500 h). Precipitates were found at the fusion boundary in the three PWHT conditions, as indicated by the white arrows in Fig. 12C. The precipitates promoted the HAC and probably made the fusion boundary (“orange” region) become more susceptible to HAC than the PGZ. Thus, the fusion boundary became the HAC initiation location again.

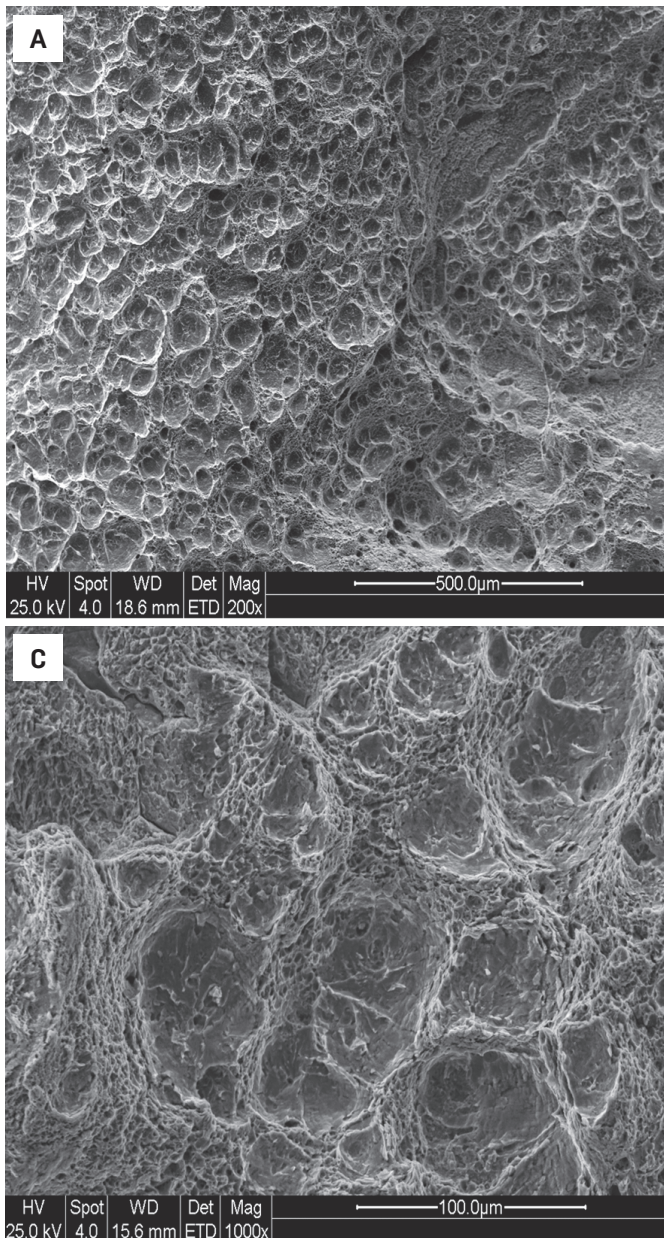
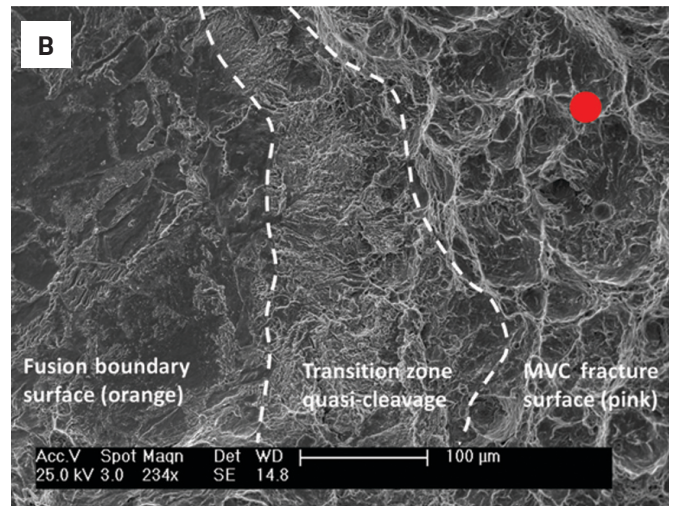
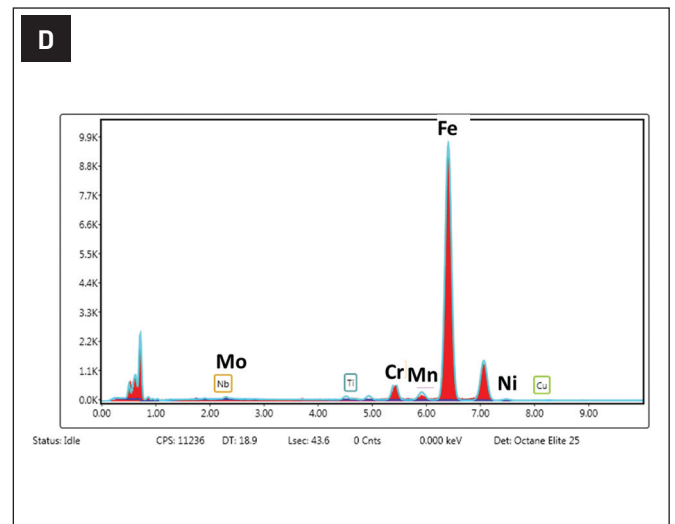
Fig. 13 — Typical morphology of the “pink” fracture in the selected PWHT conditions: A — Sample 640°C/6 h from Fig. 9B; B — transition from “orange” fracture to “pink” fracture on sample 640°C/6 h from Fig. 9B; C — sample 660°C/10 h from Fig. 9C; D — EDX analysis spectrum of the red spot in Fig. 13B.

phology represented by pink regions is shown in Fig. 9B to D. Figure 13 shows a closer view of the fracture surfaces of samples 640°C/6 h and 660°C/10 h. This was typical ductile, microvoid coalescence similar to the light green fracture surface in Fig. 10, but it did not occur in the weld metal. The EDX analysis showed the Fe composition in this region was above 90 wt-%, and Fig. 13B shows the MVC fracture was above the fusion boundary surface, considering the fracture was on the half sample of the Alloy 625 overlay. Thus, the “pink” fracture went through the base metal, probably assisted by hydrogen. The MVC is a common HAC morphology in steel according to Beachem’s theory (Refs. 18 and 21).

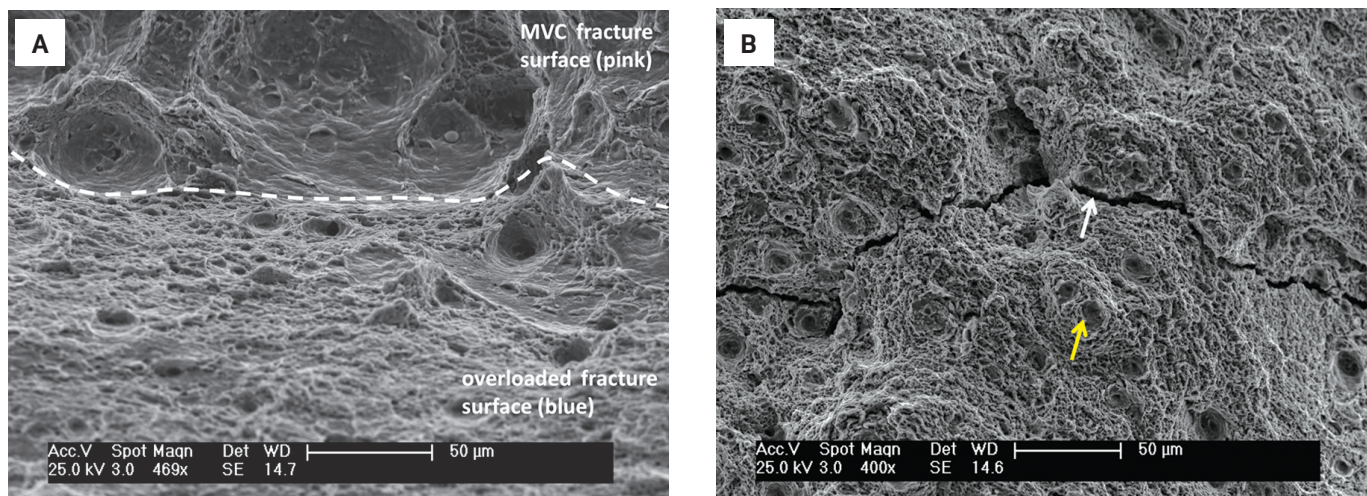
Fig. 14 — Typical morphology of the “blue” fracture regions in the selected PWHT conditions: A — Sample 640°C/6 h from Fig. 9B shows the contrast between the “pink” and “blue” fractures; B — sample 660°C/50 h from Fig. 9E. The white arrow shows a secondary crack in the CGHAZ. The yellow arrow shows a large dimple due to precipitates.

“Blue” region overload in the base metal. The morphology represented by blue regions appeared in all the samples — Fig. 9A to H. Only two typical samples were shown in Fig. 14 because the morphologies of the “blue” fracture surface of all the samples were similar.

The EDX analysis showed that the iron content was around 95 wt-%. The morphology in the “blue” fracture was ductile rupture and occurred through the base metal due to overloading. Its morphology and formation mechanism were different from the MVC fracture shown in Fig. 13. Figure 14A shows both types of fracture morphologies and clearly indicates the contrast between coarse MVC fracture and the overload region of the fracture surface. The large depth of field in Fig. 14A shows the overloaded fracture surface was much more above the MVC fracture surface. As shown in Fig. 14B, there was a mixture of coarse and fine dimples (yellow arrow) and secondary cracks (white arrow) on the overload fracture surface.

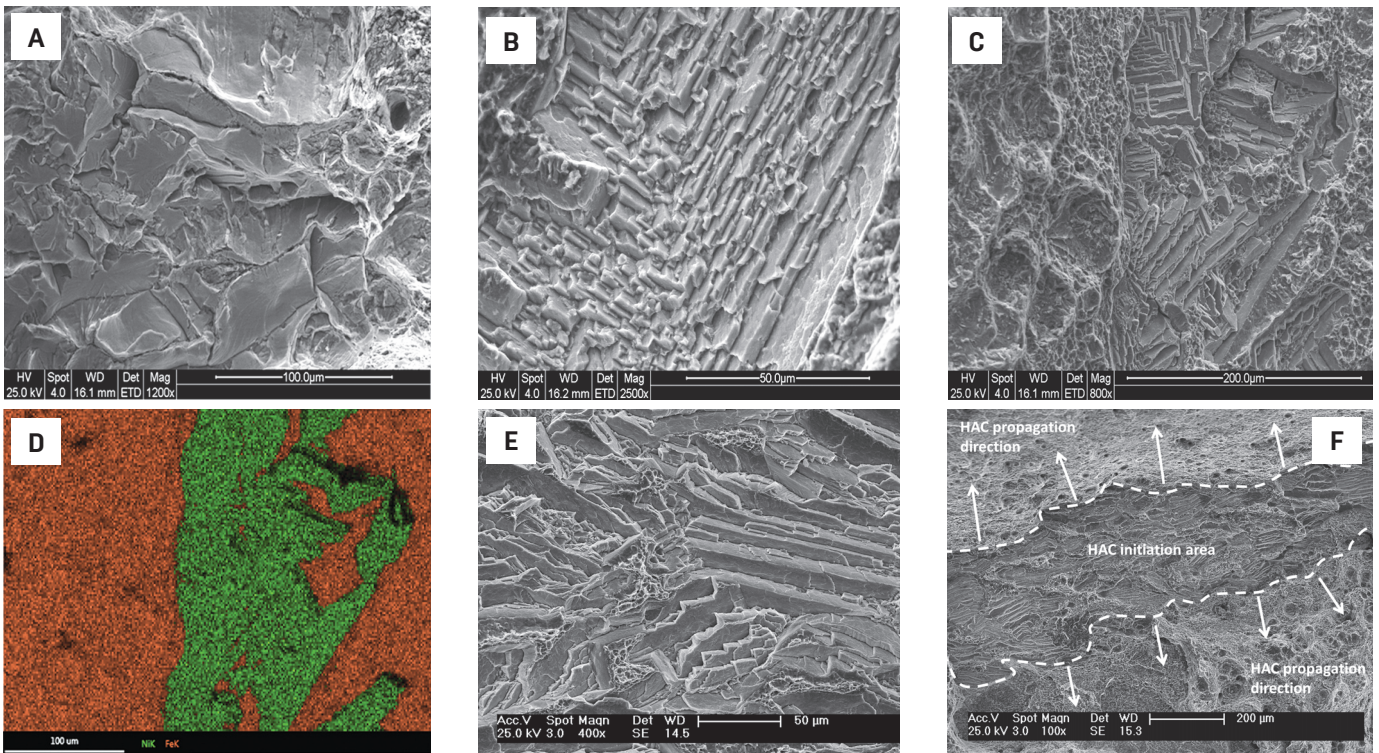
Fig. 15 — Typical morphology of the “dark green” fracture in the selected PWHT conditions: A — Cleavage and quasi-cleavage fracture surface of sample 660°C/20 h from Fig. 9D; B — terrace fracture surface of sample 660°C/20 h from Fig. 9D; C — terrace fracture surface surrounded by a more ductile fracture surface of sample 660°C/20 h from Fig. 9D; D — the EDX map of Fig. 15C; E — terrace fracture surface of sample 660°C/50 h from Fig. 9E; F — HAC initiation area surrounded by HAC propagation area, with propagation directions shown.

“Dark green” region quasi-cleavage in the PGZ. The morphology represented by the dark green regions appears in Fig. 9D to F. Figure 15 shows higher magnification fractographs of the samples at 660°C/20 h, 660°C/50 h, and 660°C/100 h, respectively. The “dark green” fracture shows various morphologies: cleavage (Fig. 15A), quasi-cleavage (Fig. 15A), and/or terrace structures (Fig. 15B, C, and E), which are all typical HAC

It is likely that the “dark green” regions were the initiation sites of the HAC. For samples 660°C/20 h, 660°C/50 h, and especially 660°C/50 h, the “dark green” fracture was in the inner area of the entire fracture. When the HAC initiated in the “dark green” area, the cracking propagated into the over-tempered base metal in all directions and produced the ductile, overloaded fracture (blue) around the HAC initiation area — Fig. 15F.

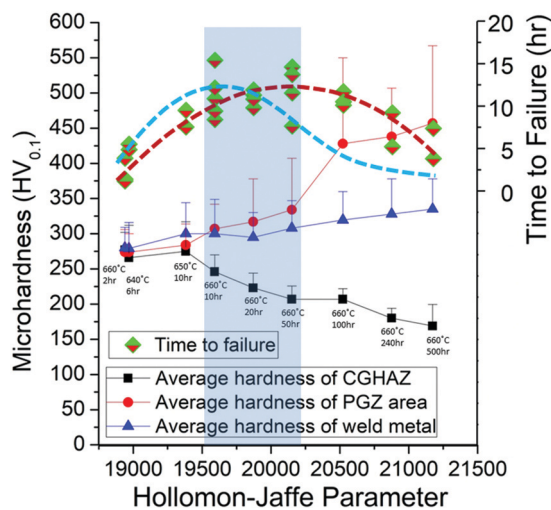
Fig. 16 — Comparison of the TTF trend (blue dashed curve) inferred from hardness results and the TTF trend from the DHCT results (red dashed curve).

The hardness of three regions and the TTF was plotted together in Fig. 16. Based on these results, it appears that a tempering “sweet spot” exists in an HJP

range from 19,800 to 20,200. For example, PWHT at 660°C/20 h resulted in a CGHAZ hardness below 250 VHN as well as a PGZ and weld metal hardness of ~300 VHN. Multiple DHCT tests of samples subjected to this heat treatment resulted in near-maximum values of TTF, indicating good resistance to HAC. At lower values of HJP, TTF dropped off due to high hardness in the CGHAZ. While at higher values (> 20,200 HJP), TTF decreased due to embrittlement of the PGZ or fusion boundary by carbon buildup and carbides precipitation, which will be further discussed in the next section.
