Protecting natural landforms and habitats by nourishing an eroding estuarine beach

Abstract

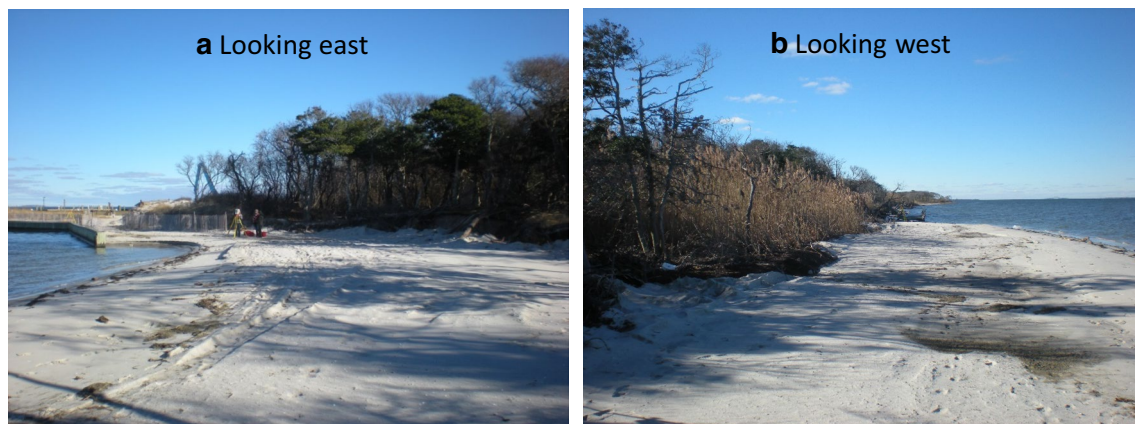
Fig. 2 West of Sailors Haven Marina December 16, 2015, just after placement of the fill

US Army Corps of Engineers data indicate that 1099 m^3 of fill was dredged from the navigation channel between 18 November and 4 December 2015, with 90% designated to go on the west side of the marina and 10% on the east side. The fill placed on the west side was initially shaped to create a backshore about 15-m-wide fronting the upland near the bulkhead (Fig. 2a) and ranged from about 0.75 to 0.95 m

above NAVD88, with an average elevation of about 0.65 m. The highest fill elevations were roughly the height of the washover ridge over the marsh (Fig. 2b) and represent the elevation of natural storm-wave uprush. The fill extended west from a sheltered location within the western extension of the bulkhead to near Transect 70 (Fig. 1b). In contrast, the fill placed in 2011 was 1.2–1.4-m above NAVD88, essentially creating an unvegetated upland at a height similar to the previously eroding bluff and higher than the washover ridge over the adjacent marsh. The 2011 fill was too high to be overtopped by waves, resulting in a prominent scarp in the foreshore that had not achieved an equilibrium slope as late as 5 months after fill placement (Nordstrom et al. 2016).

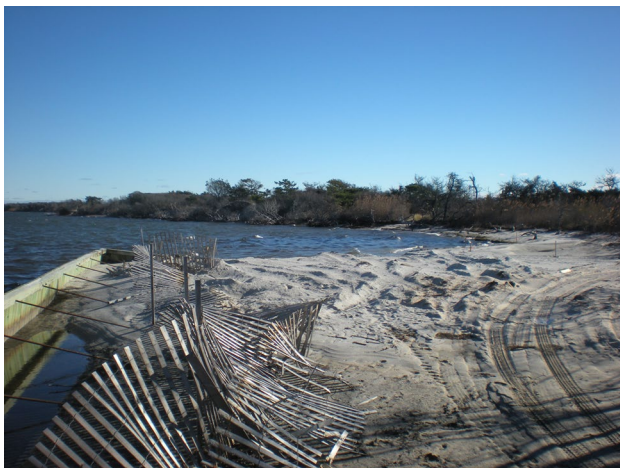
Fig. 3 East of Sailors Haven Marina December 16, 2015, just after placement of the fill

The small volume of fill placed on the east side of the marina in 2015 was designed to fill the erosional reentrant landward of the eastern extension of the bulkhead (Figs. 1c, 3) and provide a diagnostic for the way fill would move in a larger operation. The bayshore near the bulkhead (Upland A) is a remnant of a washover deposit delivered from the ocean side. This deposit is vegetated by grasses and low shrubs, with *P. Australis* marsh landward of Transect 0 (Fig. 1c). The shore to the east (Upland B) is a relic dune that formed when an inlet existed here.

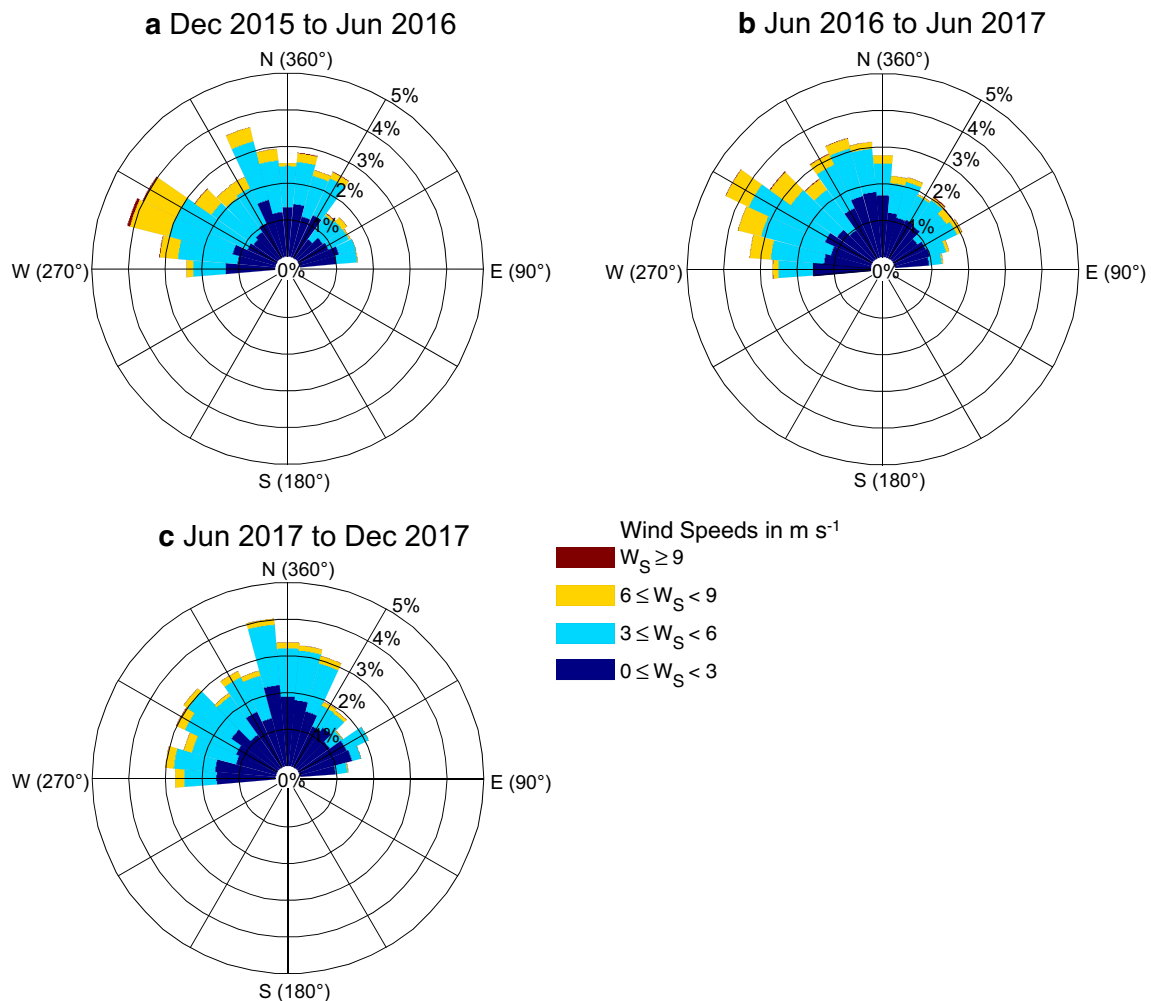
Fig. 4 Wind roses for data from the Islip MacArthur Airport, separated by elapsed times between topographic profiles. The shoreline trend at the site is nearly east–west (azimuth 86–266). Offshore winds do not contribute to generation of large bay waves and are omitted from the diagrams

Winds from the northwest quadrant were dominant during the study period (Fig. 4). Winds from the northeast occurred less frequently, but the strongest speeds ($> 9 \text{ m s}^{-1}$) occurred nearly as frequently. The 6 months between the topographic profiles taken in June and December 2017 included less of the winter storm season and the winds were less strong and more frequently shore-normal (Fig. 4c).

The lower rate of beach loss on the east side of the marina than on the west side implies that the net direction of longshore transport in the absence of the marina would be from east to west in this portion of Fire Island. Easterly transport on the east side of the bulkheads at Sailors Haven and Fire Island Pines indicate that those bulkheads partially counteract westerly transport during easterly winds, at least close to the structures. Wave and water level data gathered on the west side of the Sailors Haven bulkhead (Jackson et al. 2017) indicate that wave interactions with the structure induced westerly transport during westerly winds. Westerly transport also occurred during the present study despite the dominance of westerly winds (Fig. 4). The flow counter to

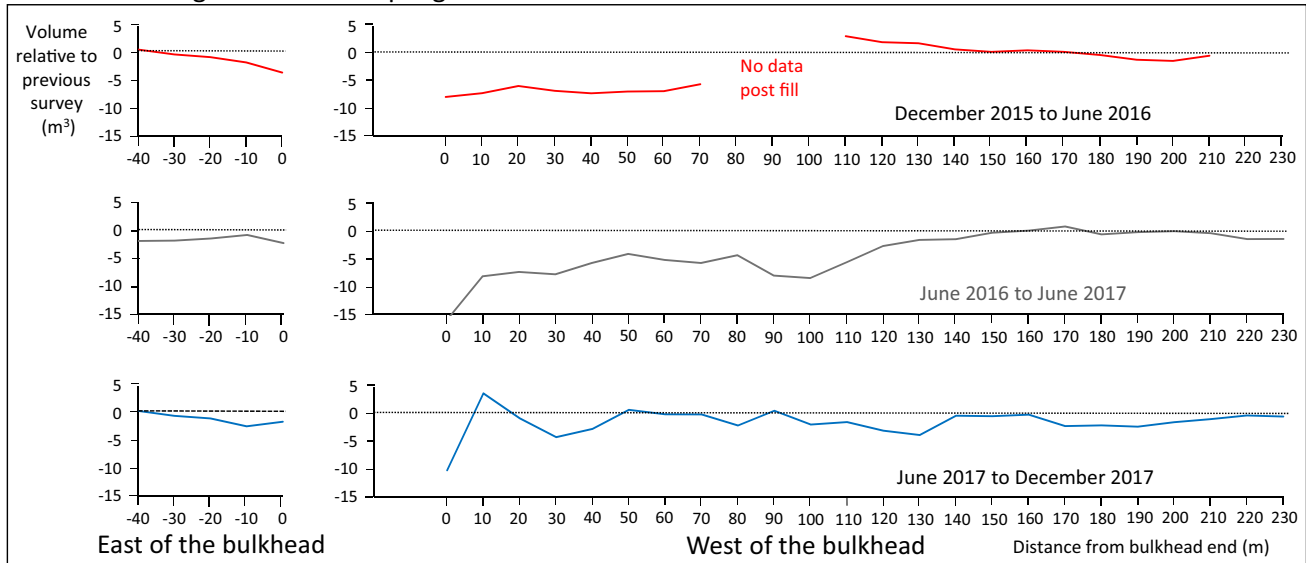
Fig. 5 Alongshore differences in sediment volume change. The dotted line at zero volume in Panel **a** represents the condition of each transect at the end of the previous survey. The dotted line in Panel **b** represents the condition just after the fill was emplaced

Sediment losses from the fill area west of the bulkhead (Fig. 5a, right side) were persistent in the first 18 months after emplacement. The movement of fill sediment toward the west in the first 6 months appears to have contributed to a gain in volume as far alongshore as Transect 140. Transects west of 140 were relatively stable until the final 6-month interval, when transects downdrift of Transect 160 revealed slight erosion. The relative stability west of Transect 140 may be at least partially attributed to the fill, because the

The amount of sediment loss at all of the transects within the 70-m-long segment, where fill was placed west of the marina was similar alongshore in the first 6 months, varying between 5.54 and 7.87 m³ m⁻¹. Greater longshore variability in erosion or accretion within the placement area occurred through time. Less sediment was removed from this 70-m-long segment between June 2017 and December 2017, after the bulk of the fill moved west and the bluff and marsh were subject to direct attack by waves and swash. The reduction in removal rate could be attributed to the lower wave energy at this time, revealed in the lower wind speeds (Fig. 4). Local differences in the height of the bluff, which provides sediment to the beach, and in bluff and marsh vegetation, which dampens wave energy and traps sediment (Fig. 6) could also have contributed to less erosion in the former fill area during the last 6 months. The local differences in shoreline characteristics may account for the greater longshore variability revealed in the cumulative volume changes at the end of the 24-month period (Fig. 5b).

Volume changes east of the marina (Fig. 5, left side) reveal persistent loss near the bulkhead but at a rate far less than west of the marina. Cumulative losses east of the marina over the 24 months (Fig. 5b) were no greater than 7.1 m³ m⁻¹ (at Transect 0). Cumulative volume changes reveal a progression similar to those occurring west of the marina, where loss in or near the bulkhead and placement area is accompanied by greater stability downdrift. In this

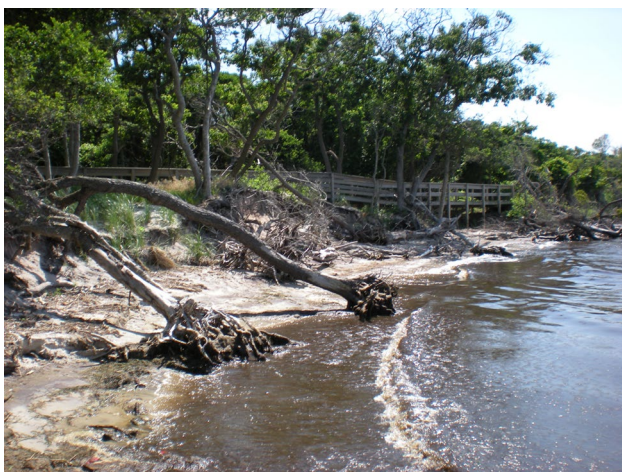
Fig. 6 Looking west from Transect 0 (west side) June 2017, showing pronounced longshore differences in shoreline conditions when coastal formations are exposed to wave erosion without a fronting beach fill

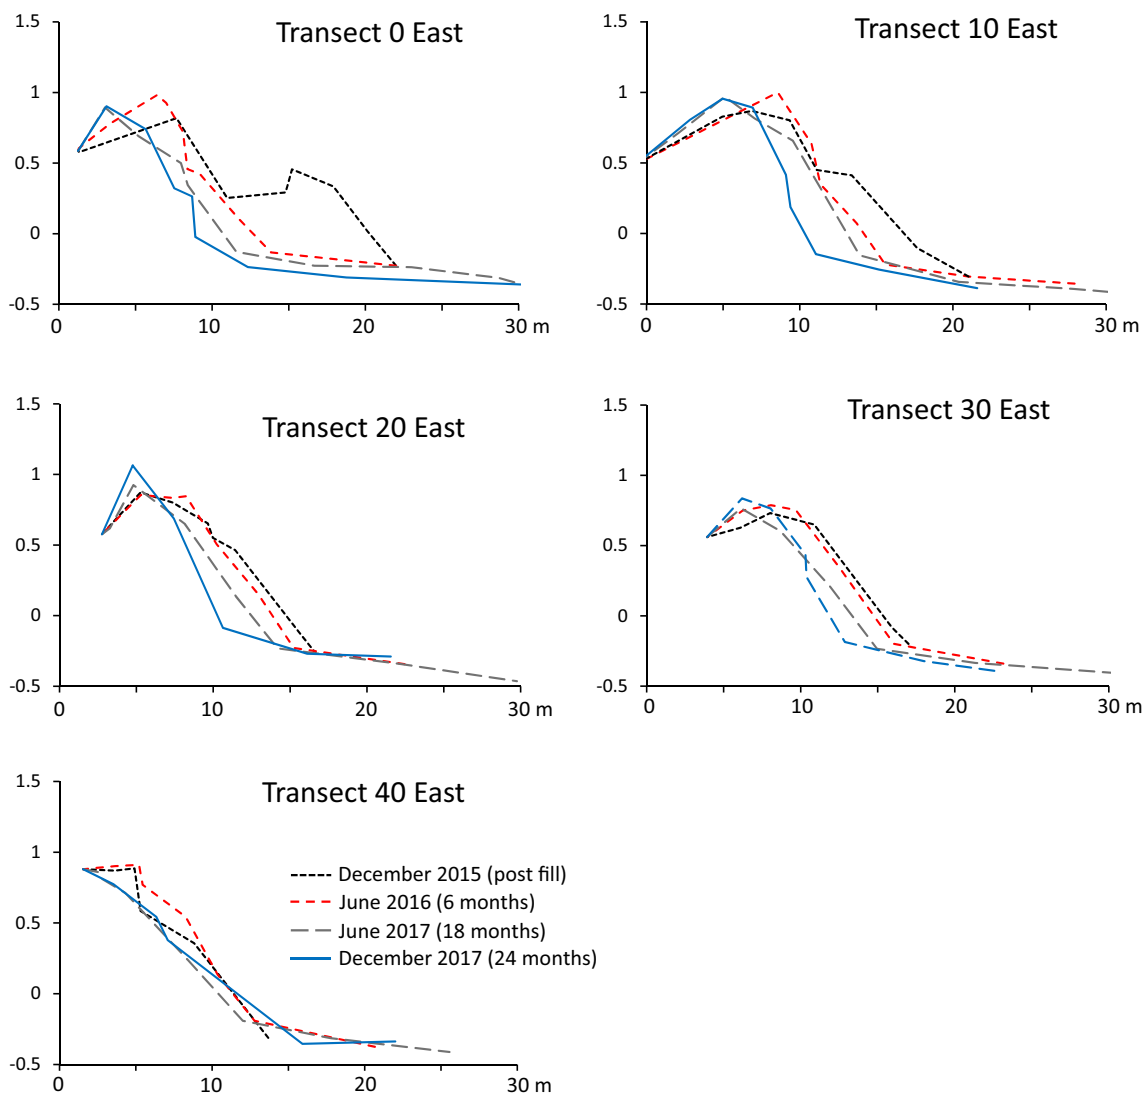
Fig. 8 Beach profiles monitored east of the marina 16 December 2015, 27, 28 June 2016, and 28 June 2017

East of the marina (Fig. 8), the greatest amount of initial foreshore retreat was within the fill area (Transect 0). Foreshore retreat in the 24 months after the fill was placed decreased alongshore east of the bulkhead, likely because of delivery of sediment from the fill area (at and west of Transect 0) by longshore transport. Profile 40, underwent net gain in the first 6 months, but erosion of the upland occurred by 24 months after fill placement. The foreshores of all other sites east of the marina revealed progressive erosion in the 24 months following the fill, although the crest of the washover deposits did not change in the last 6 months.

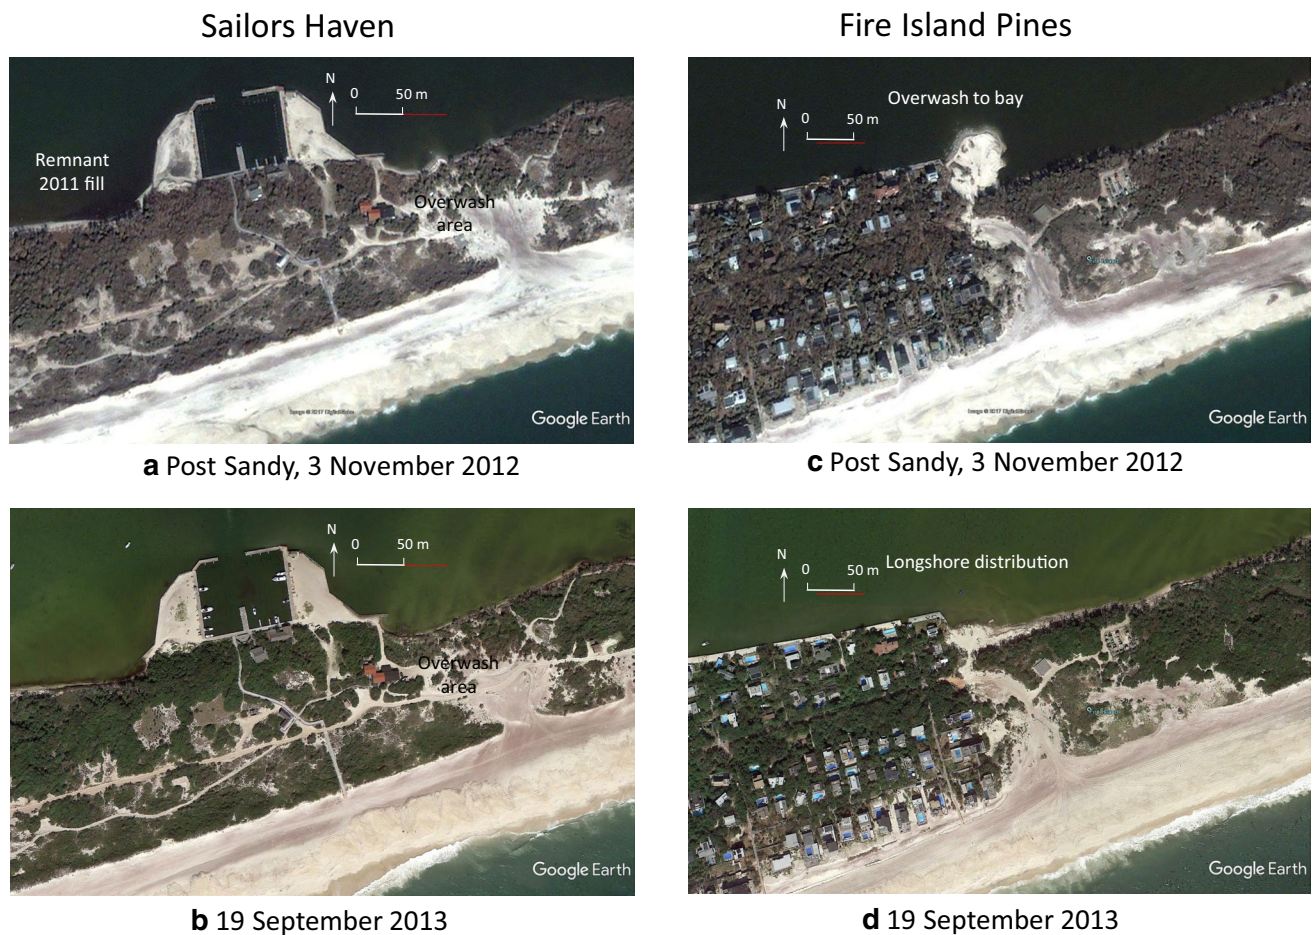
Fig. 9 Overwash areas created during Hurricane Sandy east of Sailors Haven (**a** and **b**) and Fire Island Pines (**c** and **d**)

numerous places along Fire Island. Sediment was deposited directly into the bay in four locations—through a 60-m-wide gap at Fire Island Pines (Fig. 9c), through a 60-m-wide gap just west of Smith County Park (Fig. 1a) and through gaps of 883 and 558 m just east of the access bridge to Smith County Park. Sediment deposited bayward of the 883-m breach evolved into salt marsh. The 558-m breach included a temporary inlet, and a sandy barrier formed over the marsh that evolved on the inlet flood tide delta, creating a beach up to 94-m bayward of the pre-inlet bay shoreline. A higher washover deposit near the inlet evolved into a new upland extending up to 30 m farther into the bay than the previous shoreline. A new inlet that remains open was created just west of Smith County Park (Fig. 1a). A new marsh is likely to evolve on the flood tide delta of this inlet.

The only overwash through the dune near Sailors Haven during the storm (Fig. 9a) deposited sediment to a distance of 80-m landward of the seaward face of the dune. The deposit covered 4560 m² of the upland surface, and its shape did not change by September 2013 (Fig. 9b). Island width east of the bulkhead at Fire Island Pines (Fig. 9c) was narrower, and overwash extended 60 m farther into the bay than the former shoreline. The deposit in the bay was 2820 m². This deposit moved onshore and alongshore by September 2013, creating a 10–12-m-wide beach to a distance of 120 m east of the bulkhead (Fig. 9d). This beach was gone by May 2016.

Sediment delivery from inlet formation, storm-wave overwash and dune migration has not been prevented (Fig. 9), but it has been greatly restricted by beach nourishment, dune building and dune stabilization projects on the ocean shore. Bulkheads constructed on the bayside within the developed communities on the island have also reduced sediment inputs to the beach. Erosion is pervasive all along the bay shore in the central portion of the island, not just adjacent to bulkheads (Nordstrom et al. 2009). This problem of sediment starvation on estuarine shores is common on developed barrier islands, where cross-shore sediment transfers are prevented (Jarrett 1983). Creating artificial fans by placing fill sediment on the bayside but not on the marsh would be a creative way to mimic incipient natural landforms. The extent of overwash on the east side of the marina during Hurricane Sandy indicates that overwash could reach the bay in a storm of greater magnitude or duration. The marina would likely occupy part of the footprint of a large overwash fan, and the bulkhead at the marina would interfere with natural westerly transport of the bulk of the sand residing in a fan east of the marina. Accordingly, placement of sand west of the marina appears to be warranted in any project to create an overwash fan near the marina. A sand bypass operation would have no value now, because there is so little sand moving from the east, but that condition would change dramatically if an artificial overwash fan is created east of the marina, where overwash is now favored (Fig. 9).
