# Recent Advances in Geotechnical Post-earthquake Reconnaissance

Jonathan D. Bray<sup>1\*</sup>, James D. Frost<sup>2</sup>, Ellen M. Rathje<sup>3</sup> and Fernando E. Garcia<sup>4</sup>

This article was submitted to  
Earthquake Engineering,  
a section of the journal  
Frontiers in Built Environment

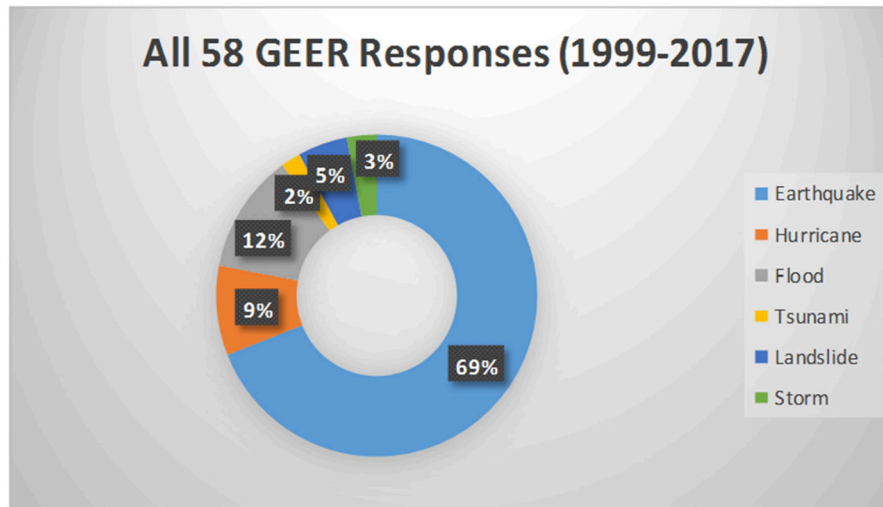
**FIGURE 1 |** Summary of GEER Event Responses (1999–2017).

Since 1999, GEER (initially informally and subsequently formally) has responded to 58 events worldwide with 69% of those being earthquake related. The distribution of responses by event type for this period is shown in **Figure 1**.

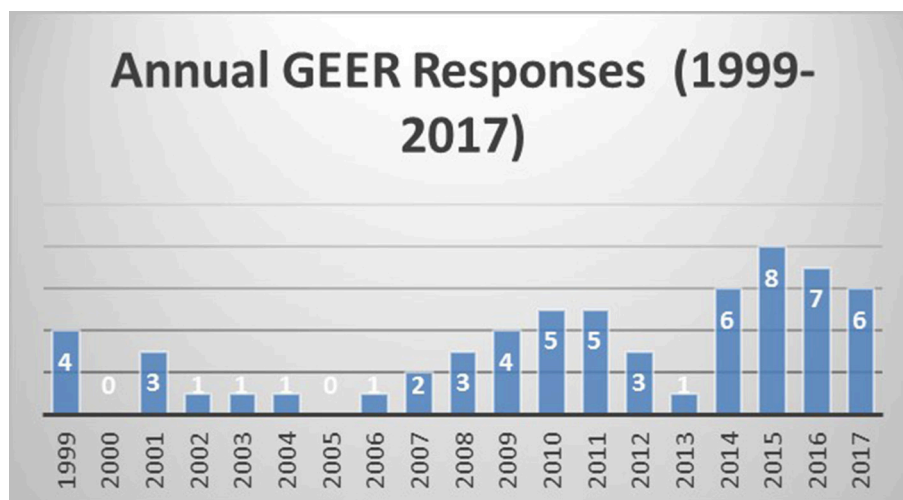
**FIGURE 3 |** Number of GEER Responses by Year (1999–2017).

As noted previously, GEER has responded to 58 events worldwide since 1999. The timeline distribution of these responses is shown in **Figure 3**. While the average annual response rate since 1999 is about three, the response rate in the past 4 years has been about 7 and is reflective of both the broadening of the GEER mandate and the increasing number of unprecedented extreme events that have occurred.

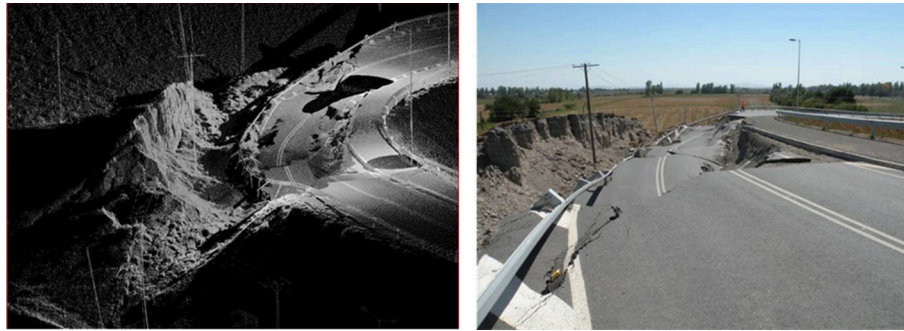
**FIGURE 4 |** Ground-based LIDAR and optical images of a failed overpass embankment on Ruta 5 as a result of the 2010 Chile Earthquake (LIDAR survey by Kayen presented in Bray and Frost, 2010).

Light Imaging Detection and Ranging (LIDAR) has more recently been used successfully to document damage to earth structures and ground failure after several extreme events. For example, aerial photography and ground-based LIDAR were used to document the Shiroya (White Rock) landslide, a large landslide produced by the shaking in the 2004 Niigata-ken Chuetsu, Japan earthquake, which adversely impacted a major road and adjacent bridge (Rathje et al., 2006). Another example is the detailed depiction of a failed highway overpass embankment in Chile, which is shown in **Figure 4**. The LIDAR image is, in reality, a detailed 3D digital surface photograph wherein each pixel is identified with its x, y, and z location. Efforts to utilize LIDAR to capture pre-event urban conditions (e.g., Borfecchia et al., 2010; Rovithis et al., 2017) will enhance the ability for post-event scans to capture ground movements.

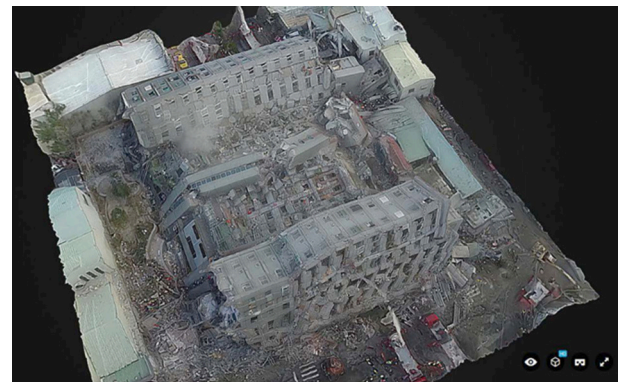
**FIGURE 5** | SfM model of the collapsed Weiguan Jinlong Complex developed using UAV photogrammetry (23.0052°N 120.261°E; Sun et al., 2016a).

Quantitative imagery was obtained by the GEER team using LIDAR to create 3D, interactive fly-through models that allow viewers to virtually enter and exit structures and quantify damage (Sun et al., 2016b). Aerial imagery via a quadcopter UAV also provided photogrammetry datasets with which to create 3D point cloud models using SfM. The point cloud data did not require control points on the ground; instead, the UAV photos for this reconnaissance were geo-tagged so that the relative locations of the viewpoints of each image could be used directly to create high-resolution, 3D models such as that shown in Figure 5.

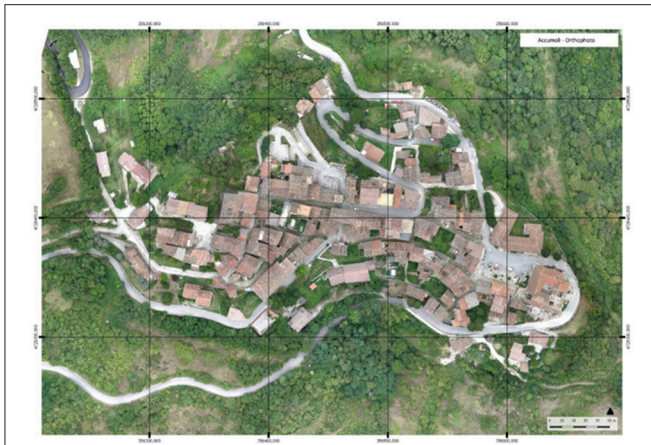
**FIGURE 6** | Orthophoto of the town of Accumoli developed with images obtained via fixed-wing UAV (42.96467°N, 13.24760°E; Zimmaro and Stewart, 2016).

The reconnaissance team utilized a variety of UAVs equipped with high-resolution cameras to obtain photogrammetric imagery with which to develop 3D models of damage sites using SfM. Three types of UAVs were used to obtain imagery from the Central Italy earthquakes: a fixed-wing UAV, a quadcopter UAV, and a helicopter UAV, the specifications of each of which are available in Zimmaro and Stewart (2016). While the quadcopter and helicopter UAVs needed to be manually controlled, the fixed-wing UAV was programmed to follow a specific flight path using selected waypoints. The automated capabilities of the fixed-wing UAV allowed the GEER team to produce an orthophoto of entire towns such as Accumoli shown in **Figure 6**.

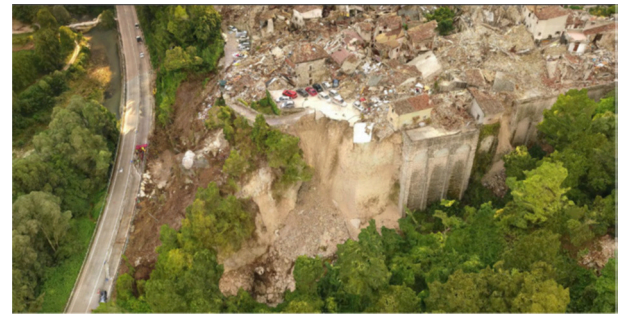
**FIGURE 7** | 3D SfM model of a slope failure in Pescara del Tronto possibly caused by a retaining wall collapse (N42.75109°E13.27208 °; SfM by Franke et al. presented in Zimmaro and Stewart, 2016).

SfM proved to be especially useful in obtaining 3D imagery for significant landslide events occurring in rugged or steep terrain, in heavily vegetated areas, or in other areas with limited site access. For example, **Figure 7** shows a 3D image of a slope failure in Pescara del Tronto resulting from retaining wall failure. The SfM imagery and point cloud data can be used to perform further quantitative analyses post-reconnaissance, and this data can be further verified for accuracy by combining them with other geomatics technologies such as LIDAR.

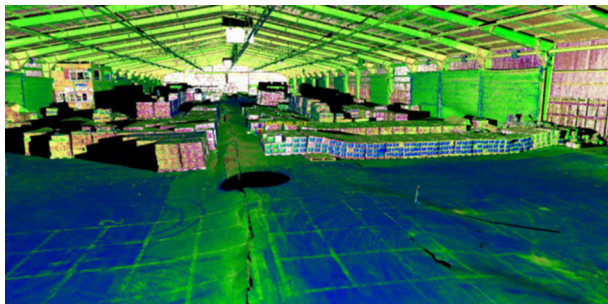
**FIGURE 9** | LIDAR scan obtained inside Building S37 in CentrePort of Wellington showing cracking and settlement of the pavement around the buried precast concrete seawall (up to 550 mm of differential settlement occurred) (LIDAR survey by Olsen presented in Cubrinovski and Bray, 2017).

GNS-UC-GEER team members made effective use of LIDAR scanning to document earthquake effects both inside and outside structures at key locations of interest. **Figure 9** shows a LIDAR scan from within Building S37 at CentrePort in Wellington showing an example of the cracking and settlement induced by liquefaction. The floor slab of this building was not pile-supported and settled up to 550 mm relative to adjacent pile-supported structures.

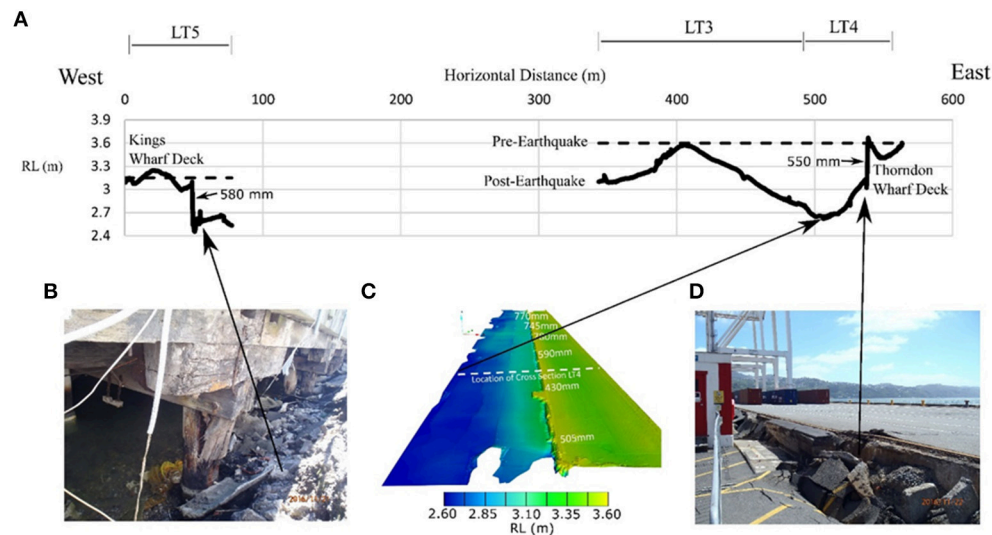
**FIGURE 10 |** LIDAR scans of wharves at CentrePort Wellington showing deformation from the 2016 Kaikoura earthquake [LIDAR survey data from M. Olsen in Cubrinovski and Bray (2017)]: (A) East-west pre- and post-earthquake ground surface profiles from LIDAR surveys of Kings Wharf bulkhead and Thorndon Reclamation and wharf with representative images of: (B) timber pile damage at Kings Wharf (S41.280900° E174.784375°), (C) Thorndon Reclamation and wharf LIDAR digital elevation model, and (D) 550 mm ground settlement adjacent to pile-supported Thorndon Wharf (S41.277743° E174.789236°).

**Figure 10A** shows measurements of liquefaction-induced settlement across CentrePort along the cross-section line shown in **Figure 10C**. The deck of King's Wharf, supported on driven timber piles as shown in **Figure 10B**, underwent lateral displacement due to lateral spreading in the fill behind it, which tilted and split the supporting timber piles. **Figure 10D** shows the manifestation on the Thorndon Wharf deck of

differential settlement between the ground and a buried precast concrete seawall. The LIDAR scans provided point cloud data with which to measure small displacements on the order of centimeters due to liquefaction and lateral spreading, and they supplement SfM models gained via UAV photogrammetry.

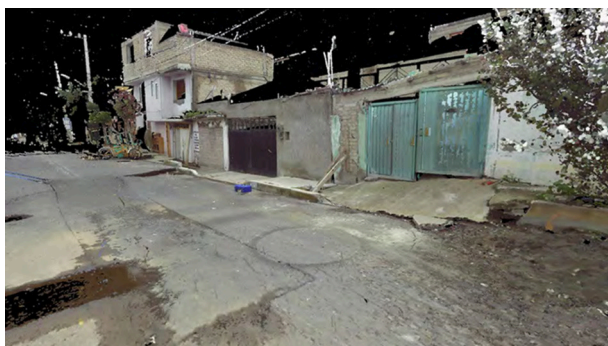
**FIGURE 11 |** LIDAR model showing ground failure in Colonia del Mar (N19.2851°, W99.0579°; Mayoral et al., 2018).

The GEER-UNAM team deployed LIDAR stations and UAVs to survey the extent of damages and performed seismic surveys using tools such as MASW. They used ground-based LIDAR to model the interior and exterior of damaged structures and facilities. In the southern section of Colonia Del Mar, where extensive ground settlement was observed, GEER main team members utilized LIDAR to map ground cracking and ground failure patterns as shown in **Figure 11**. In Morelos, they used LIDAR to map the damage to the Rio Yauatepec Bridge near the towns of Estacas and Yauatepec. A 40 m wide landslide occurred adjacent to this bridge, damaging the roadway approach to the bridge and its southwest wing wall. The team gathered UAV

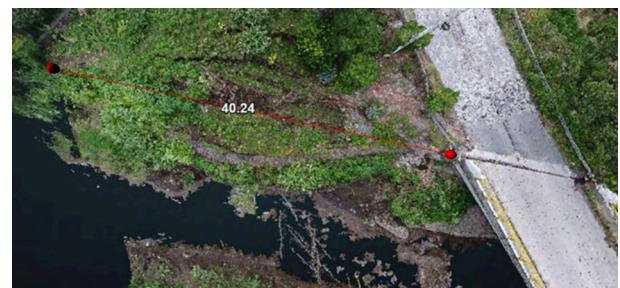
**FIGURE 12 |** 3D model of a landslide adjacent to the Rio Yautepec Bridge created using SfM from UAV images (N18.7306°, W99.1194°; Mayoral et al., 2018).

imagery of this bridge and stitched the imagery together using SfM technology to create a 3D model of the damaged bridge as shown in **Figure 12**. The figure shows the landslide-related damage to the bridge as well as the 40 m width of the landslide and tension cracks forming up the slope behind the slide. In total, the GEER main team and advance team conducted UAV surveys at 23 different locations and LIDAR surveys at 5 locations, garnering over 260 GB of image data that allow researchers to continue to analyze damages even after the conclusion of field reconnaissance (Mayoral et al., 2018).
