# Earthquake geotechnical engineering reconnaissance methods and advances

**ABSTRACT:** Earthquake geotechnical engineering is an experience-driven discipline. Field observations are particularly important, because it is difficult to replicate in the laboratory the characteristics and response of in situ soil deposits. Much of the data generated by a major earthquake is perishable, so it is critical that it is collected soon after an event occurs. Detailed mapping and surveying of damaged and undamaged areas provides the data for the well-documented case histories that drive the development of many of the earthquake geotechnical engineering design procedures. New technologies are being employed to capture earthquake-induced ground deformation, including Light Detection and Ranging, Structure-from-Motion, and Unmanned Aerial Vehicles. Post-earthquake reconnaissance has moved beyond taking photographs and field notes to taking advantage of technologies that can capture ground and structure deformations more completely and accurately. Moreover, electronic data enables effective sharing and archiving of the measurements. Unanticipated observations from major events often catalyze new

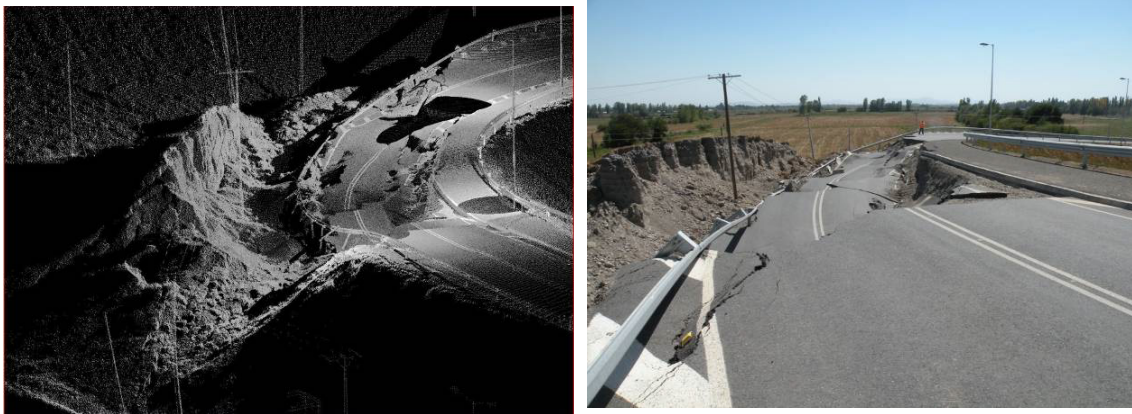
Figure 2. Ground-based LIDAR and optical images of a failed overpass embankment on Ruta 5 from the 2010 Chile Earthquake (LIDAR survey by Kayen presented in Bray and Frost 2010).

LIDAR has been used in GEER responses to document damage to earth structures and ground failure after several extreme events. For example, aerial photography and ground-based LIDAR were used to document the Shiroya landslide, a large landslide produced by the shaking in the 2004 Niigata-ken Chuetsu, Japan earthquake, which adversely impacted a major road and adjacent bridge (Rathje et al. 2006). Another example is the detailed depiction of a failed highway overpass embankment in Chile, which is shown in Figure 2. The LIDAR image is a detailed 3-D digital surface photograph wherein each pixel is identified with its x, y, and z location. Efforts to utilize LIDAR to capture pre-event urban conditions (e.g., Rovithis et al. 2017) will enhance the ability for post-event scans to capture ground movements.

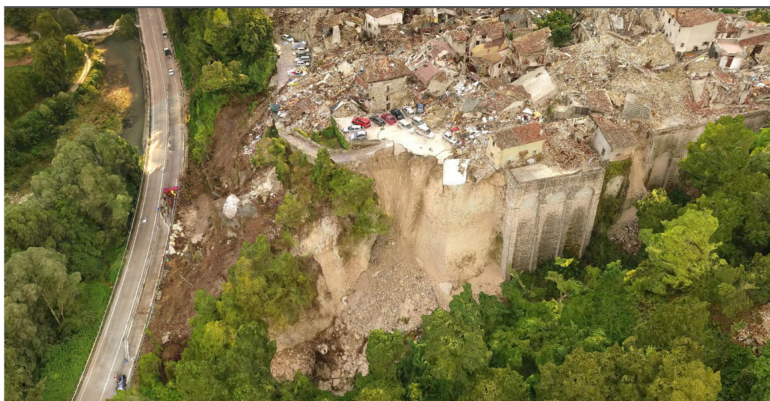
Figure 4. 3D SfM model of a slope failure in Pescara del Tronto possibly caused by a retaining wall collapse ( $42.75109^{\circ}$  N  $13.27208^{\circ}$  E; SfM by Franke et al. presented in Zimmaro and Stewart 2016).

SfM proved to be especially useful in obtaining 3D imagery for significant landslide events occurring in rugged or steep terrain, in heavily vegetated areas, or in other areas with limited site access. For example, Figure 4 shows a 3D image of a slope failure in Pescara del Tronto resulting from retaining wall failure. The SfM imagery and point cloud data can be used to perform further quantitative analyses post-reconnaissance, and this data can be further verified for accuracy by combining them with other geomatics technologies such as LIDAR.

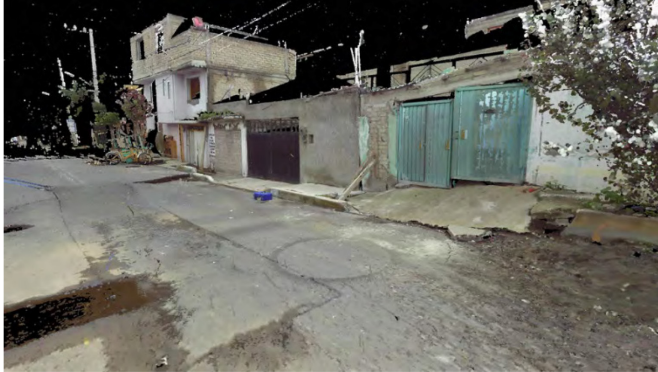
Figure 8. LIDAR model showing ground failure in Colonia del Mar (N19.2851°, W99.0579°; Mayoral et al. 2018).

The GEER-UNAM team deployed LIDAR stations and UAVs to survey the extent of damages and performed seismic surveys using tools such as MASW. They used ground-based LIDAR to model the interior and exterior of damaged structures and facilities. In the southern section of Colonia Del Mar, where extensive ground settlement was observed, GEER main team members utilized LIDAR to map ground cracking and ground failure patterns as shown in Figure 8. In Morelos, they used LIDAR to map the damage to the Rio Yautepec Bridge near the towns of Estacas and Yautepec. A 40-m wide landslide occurred adjacent to this bridge, damaging the roadway approach to the bridge and its southwest wing wall. The team gathered UAV imagery of this bridge and stitched the imagery together using SfM technology to create a 3D model of the damaged bridge as shown in Figure 9. The figure shows the landslide-related damage to the bridge as well as the 40 m width of the landslide and tension cracks forming up the slope behind the slide. In total, the GEER main team and advance team conducted UAV surveys at 23 different locations and LIDAR surveys at 5 locations, garnering over 260 GB of image data that allow researchers to continue to analyze damage even after the conclusion of field reconnaissance (Mayoral et al. 2018).

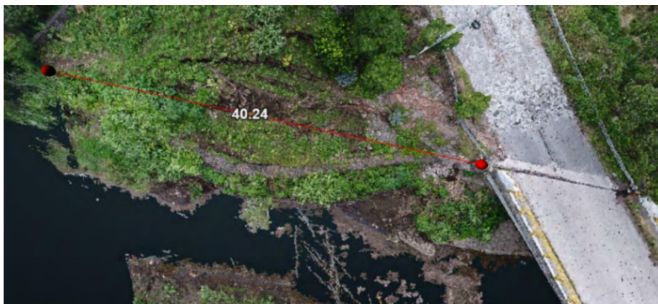
Figure 9. 3D model of a landslide adjacent to the Rio Yautepec Bridge created using SfM from UAV images (N18.7306°, W99.1194°; Mayoral et al. 2018).
