Exploring the Utility of Small Unmanned Aerial System (sUAS) Products in Remote Visual Stream Ecological Assessment

sUAS for Stream Ecological Assessment

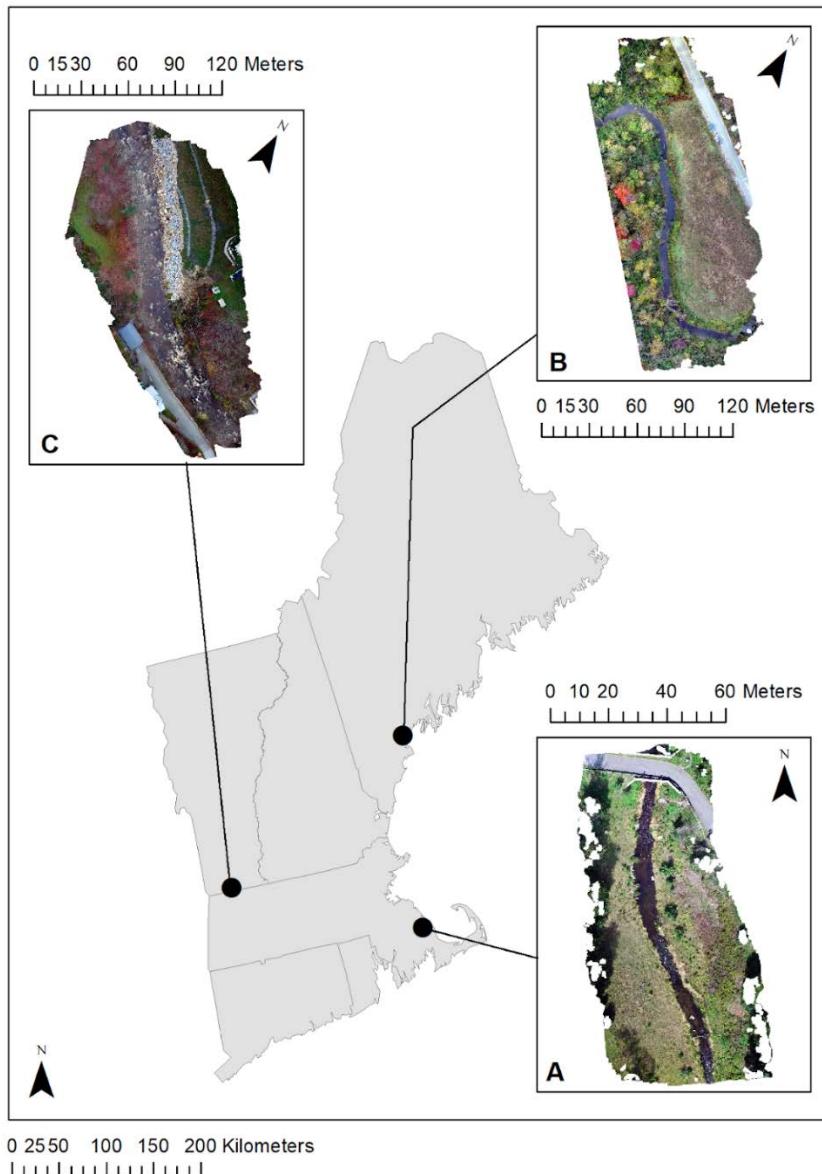
Figure 1: The three sites selected from the stream reaches visited by the USACE during their SVAP2 tour. (A) Town Brook in Plymouth, MA. (B) East Branch Piscataqua River in Falmouth,

ME. (C) West Branch Deerfield River in Readsboro, VT. The MA site lies in the Atlantic Coastal Pine Barrens EPA ecoregion. This reach is the site of the Off-Billington Street Dam removal project. It has clear, shallow water, an early successional floodplain, and contains engineered habitat features. The ME site lies in the Northeastern Highlands EPA ecoregion. This reach is a muddy, entrenched former agricultural site with slow moving, turbid water. One bank consists of forest while the other is adjacent to a field with a shrub line that contained many invasive plant species. The VT site also lies in the Northeastern Highlands EPA ecoregion. Unlike the site in Maine, this reach features a large bank stabilization project and the reach itself is set in a ravine. The topography combined with the clearer, rushing water and coarser cobble/boulder-dominated substrate differentiates this site. The orthomosaics shown were produced from the sUAS imagery. New England shapefile created by MassGIS.

Three of the streams assessed by the USACE were revisited for sUAS imagery collection (Fig. 1). These sites were chosen for their diversity in site characteristics (e.g. turbidity of water, channel condition, restoration project types). The sensor on the sUAS was a consumer-grade RGB camera and terrain beneath tree canopy could not be seen. Therefore, USACE sites with minimal canopy cover were selected for this study. The first reach is located on Town Brook in Plymouth, MA ([3D model](#), [orthomosaic](#)). The second reach is located on East Branch Piscataqua River in Falmouth, ME ([3D model](#), [orthomosaic](#)). The third reach is located on West Branch Deerfield River in Readsboro, VT ([3D model](#), [orthomosaic](#)).

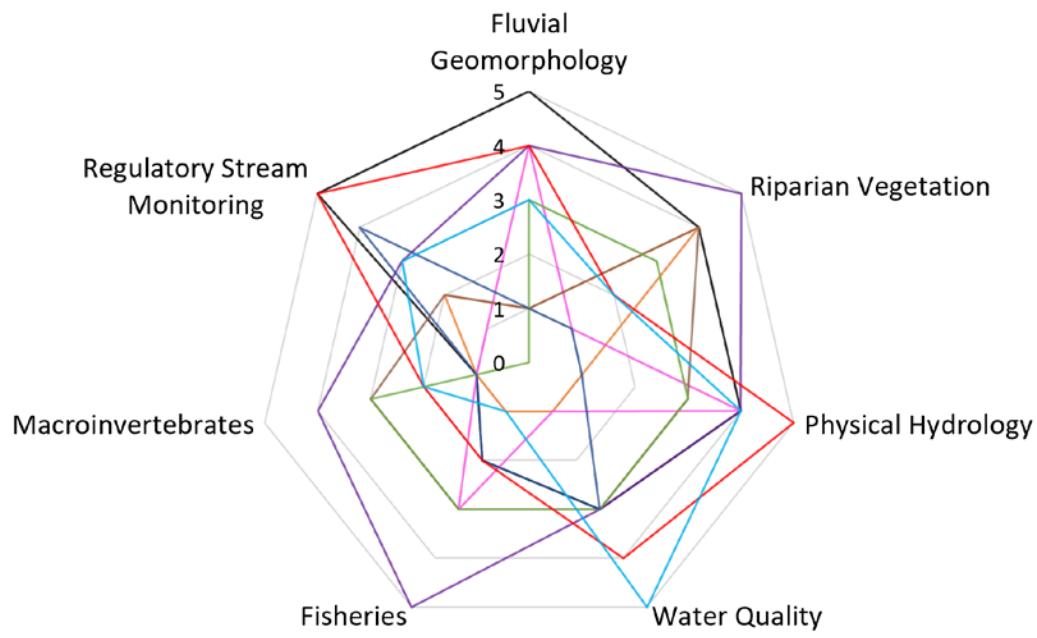
Figure 3: Visualization of the self-assessed areas of expertise from the nine survey participants who reported scores, with each color representing one participant. A score of zero indicates no expertise, while a score of 5 indicates a high level of expertise.

Nine participants reported their self-assessed expertise on a scale of 0 to 5, with a score of 5 representing a high level of expertise. In general, there is a relative gap in macroinvertebrates and fisheries expertise in the participant pool (Fig. 3). Participants reported additional areas of expertise, including GIS and LiDAR, dam removal, stream crossing assessment, and creating ecological assessment protocols. Out of the ten participants, four had experience with the SVAP2 prior to completing the survey. Out of the ten participants, six reported experience with other visual assessment protocols. One participant had no experience with visual assessments.

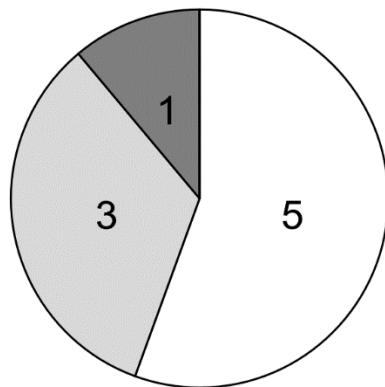
Figure 4: Categorized results for the survey question “Do you think having imagery and models such as these is useful for regulatory stream monitoring purposes? How about in the context of general restoration efforts?”

The narrative survey responses were key in determining the sUAS product utility according to the stream experts. When asked “Do you think having imagery and models such as these is useful for regulatory stream monitoring purposes? How about in the context of general restoration efforts?”, most survey participants reported that the imagery and models would be useful for regulatory stream monitoring purposes and restoration efforts (Fig. 4). Out of the nine respondents, five participants agreed that the products would be useful (“Useful”). One participant wrote: “I found the [sUAS] products to be very useful to assess condition. I would think these tools could be used to assess stream condition and monitor changes over time in different study reaches.” Three of these nine participants acknowledged the usefulness of the products for these applications, but mentioned limitations (“Useful, but...”). One participant acknowledged difficulty seeing the streambed in some products. Another responded that regulatory monitoring is often based on water quality, so in-field quantitative measurements would be more effective in these cases. The third participant stated that sUAS would certainly have value for regulatory monitoring purposes, but “because of the nature of what regulatory agencies are, [sUAS] use by the agencies themselves for regulation will not be occurring for the foreseeable future.” One participant responded with “maybe” for this question, and their reasoning related to the SVAP2 metrics rather than the utility of the sUAS products. Based on

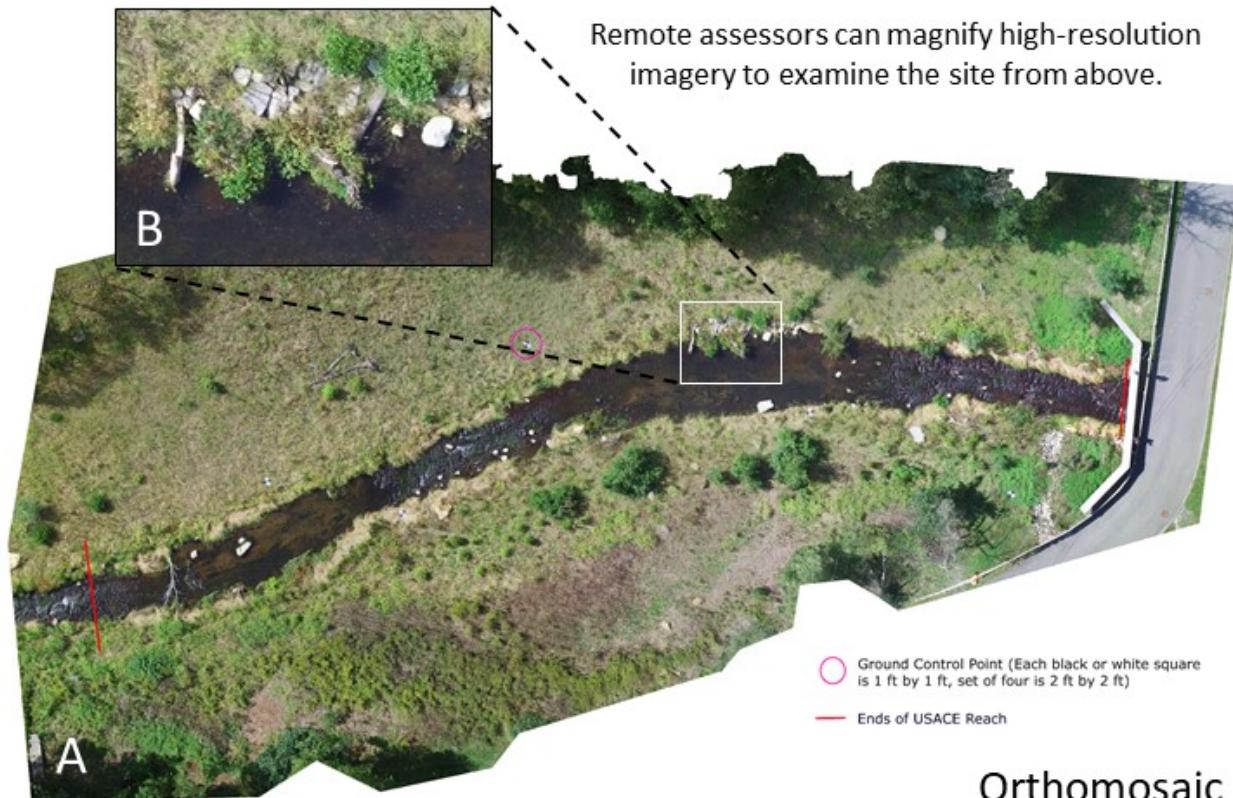
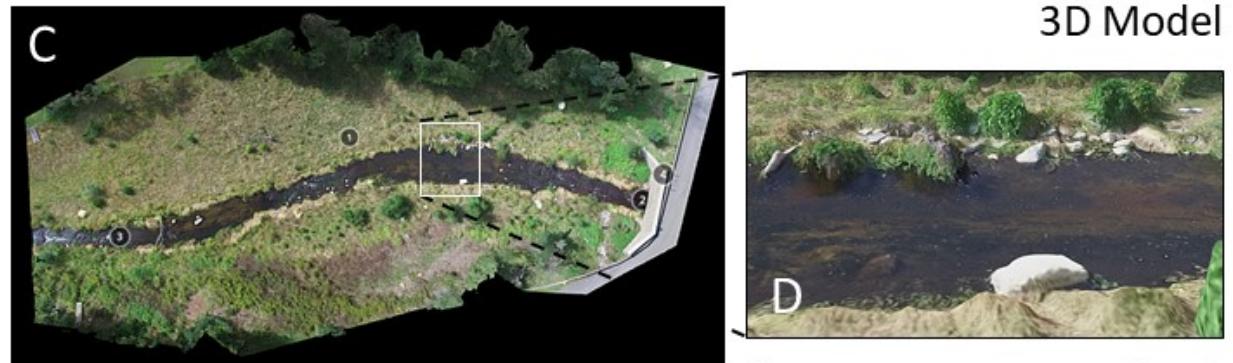
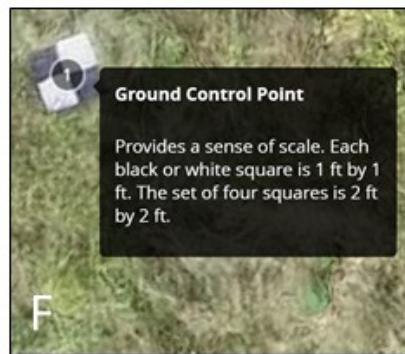
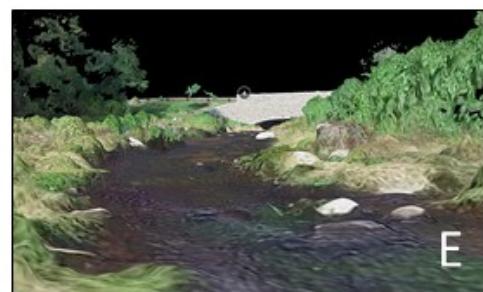
Remote assessors can click on numbered annotations to learn about the model.

Remote assessors can magnify and rotate detailed models to examine the site from many perspectives.

Figure 5: Illustration of the differences between the sUAS orthomosaics and 3D models using the MA site as an example. Image A is the annotated orthomosaic provided to the remote assessors. Image B shows a magnified version of some habitat features on the bank using the same orthomosaic. Image C shows the same aerial perspective the orthomosaic provides but using the 3D model. Image D shows a magnified oblique perspective of the 3D model highlighting the same habitat features in image B. Image E shows a perspective on the 3D model as if you were standing in the stream. Image F illustrates the numbered annotations on the 3D model that viewers can click on and scroll through to learn more about the model and site characteristics. Screenshots of the 3D model were taken from the model viewer on the Sketchfab website.

The orthomosaics were helpful for all feasible scoring elements, while the 3D models were reported to be especially useful for examining channel condition, entrenchment, bank features, and relative vegetation height (Fig. 5). Most of the participants cited the orthomosaics or 3D models as the most useful products for remote evaluation, and one participant preferred the video. The video gave participants the ability to observe water flow and gave a better sense of water clarity and depth. The usefulness of the 3D model was questioned by a couple participants, one who criticized that the models did not give enough sense of slope for it to matter, and another who did not use the 3D models much due to difficulty navigating them. On the other hand, another participant preferred using the 3D models because of the ability to navigate them

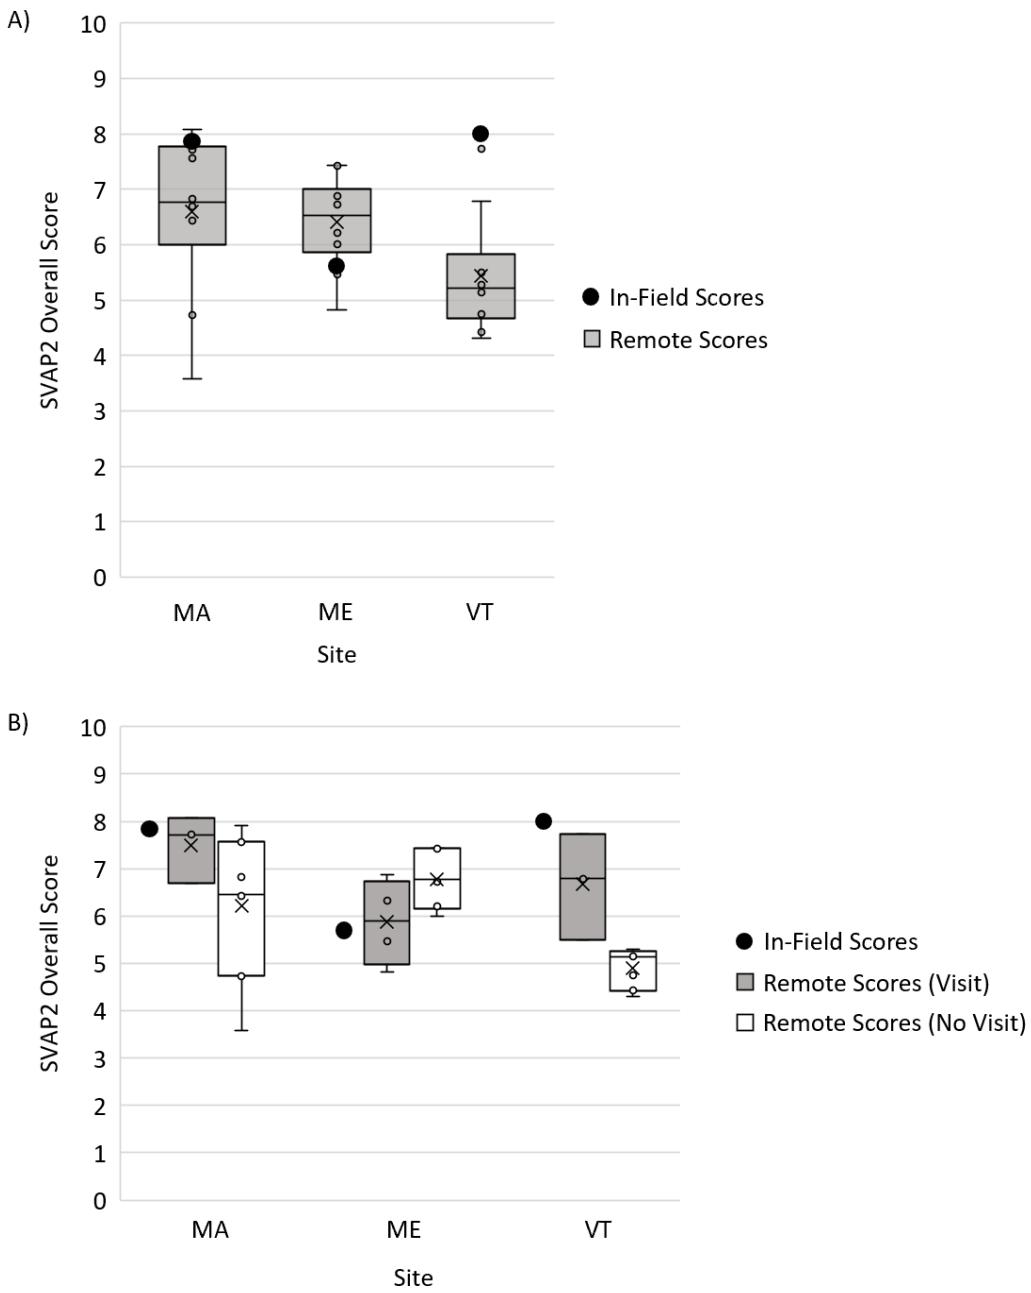
Figure 6: A comparison the remote overall SVAP2 scores provided by each survey participant to the score determined by the USACE team out in the field. “X” markers in box plots represent the

mean remote score for each site. A) illustrates a general comparison, B) divides the remote participants by those who had visited the sites in person prior to the survey and those who had not. Three out of the 10 participants had visited the MA site, four out of the 10 had visited the ME site, and three out of the 10 had visited the VT site.

It was insightful to see how the remote assessment scores reported by the participants (“remote scores”) compared to the scores from the assessment performed in the field (“in-field scores”). The remote and in-field scores were first compared according to their overall SVAP2 scores (Fig. 6a). This is the overall score assigned to a reach that reflects its general ecological condition, considering all the applicable SVAP2 scoring elements for a reach. One set of in-field scores for each reach was provided by the USACE that was agreed upon by the in-field team. The remote scores represent the overall scores calculated from each survey participants’ SVAP2 scores for each site. In general, the sites located in MA and ME had good agreement between the

in-field score and remote scores. The site in VT was evaluated to be in poorer ecological condition by the remote assessors than by the USACE team.

In general, if a participant had visited the site in person prior to conducting the remote assessment, their remote score was closer to the in-field score than those of participants who had not visited the site (Fig. 6b). The overall SVAP2 remote scores were significantly closer (smaller absolute difference) to the overall SVAP2 in-field scores if the survey participant had visited the site prior to completing the survey (Student's *t*-test, $\alpha = 0.05$, $p = 0.0036$). However, all the participants who had visited the sites before, except one for the ME site, were part of the USACE team that conducted the in-field assessments. None of the other reported nominal experience parameters showed significantly closer overall remote scores (smaller absolute differences) to the overall SVAP2 in-field scores, including prior experience with the SVAP2.

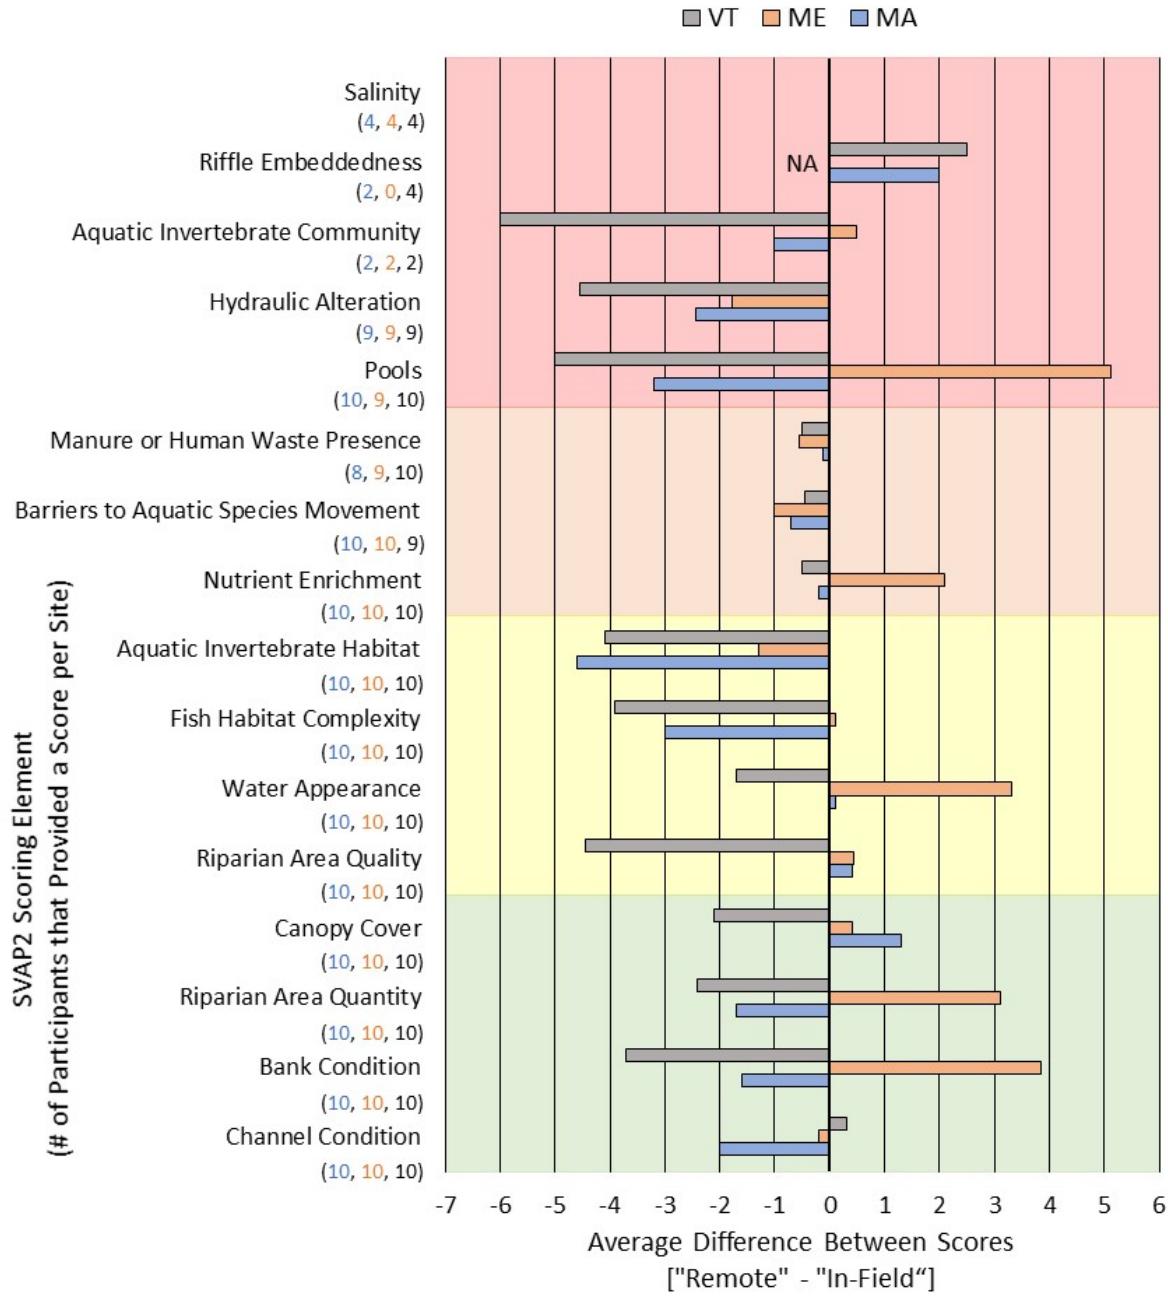
Figure 7: A comparison of the remote SVAP2 scores for each element across the sites against the in-field element scores. The average difference between the remote and in-field scores are shown (calculated as “remote element score” - “in-field element score” for each participant’s responses). Negative values indicate that the remote approach underestimated the ecological condition relative to the in-field approach while a positive value indicates that the remote approach overestimated ecological condition relative to the in-field approach. The elements are organized by their feasibility to be evaluated using the remote sUAS assessment approach: (red) infeasible and not recommended for remote assessment, (orange) some aspects of SVAP2 scoring criteria possible, (yellow) feasible but with some limitations due to quality of sUAS products, (green) feasible and straightforward for remote visual assessment. Riffle embeddedness was deemed not applicable (NA) by the USACE team in the field at the ME site.

Differences in site characteristics and sUAS product quality impacted the feasibility of remote assessment and contributed to the observed discrepancies between the remote and in-field scores. To determine specific characteristics, the differences in the remote and in-field scores were examined across the scoring elements that make up each site's overall SVAP2 score (Fig. 7). The elements were organized into four categories based on their feasibility to be evaluated using the remote approach: (red) infeasible and not recommended for remote assessment, (orange) some scoring metrics possible for remote assessment, (yellow) feasible for remote assessment but with limitations due to the quality of sUAS products, and (green) feasible and straightforward for remote assessment.

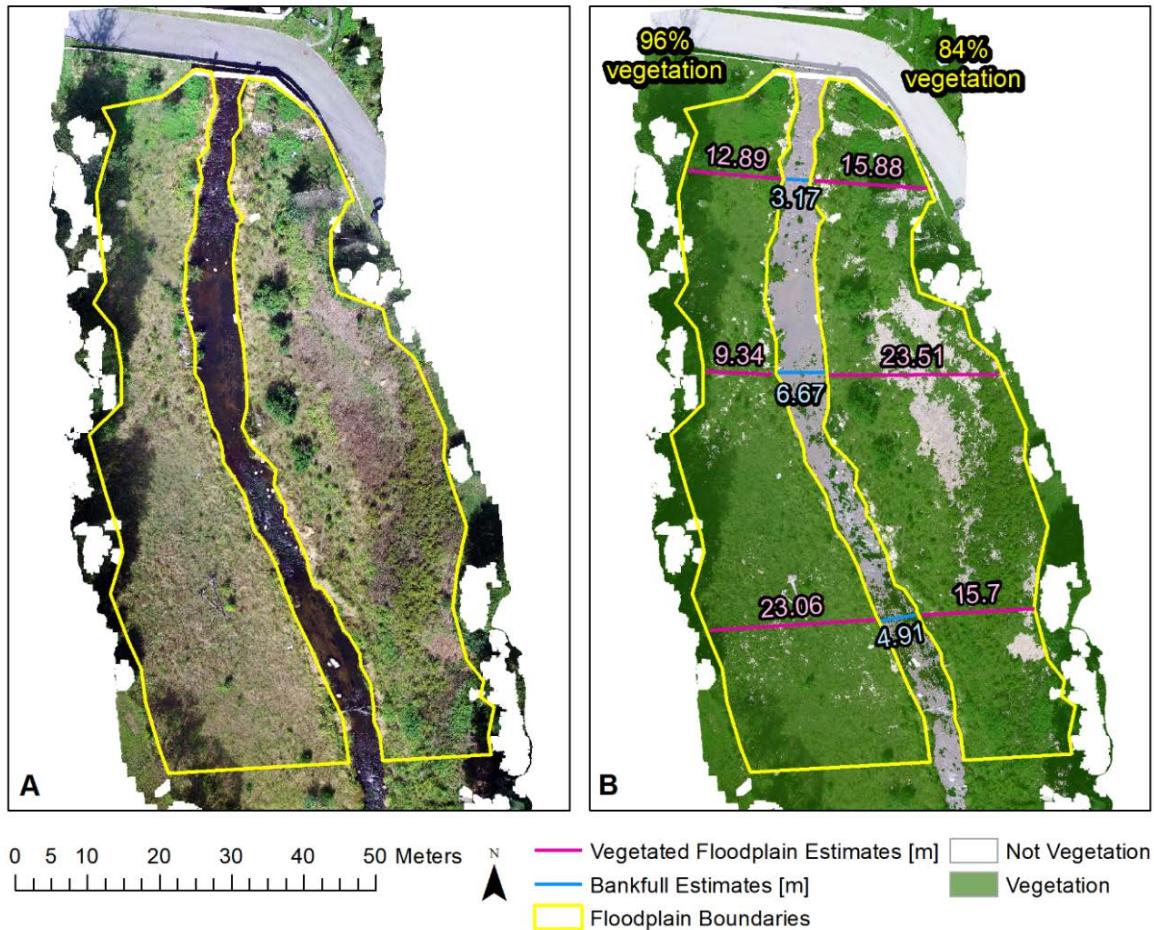
Figure 8: An example of how remote sensing and GIS can be used to calculate “true” ecological evaluation metrics analogous to the SVAP2 metrics. Specifically, this example depicts how this approach can calculate metrics related to the riparian area quantity element in the SVAP2. (A) MA site orthomosaic with assessment area. (B) MA site orthomosaic with partially transparent binary raster overlay showing the vegetation coverage throughout the site. A binary raster of vegetation cover was created in ArcGIS by using the raster calculator to first calculate the Green Leaf Index (GLI; Louhaichi et al. 2001), then again to select pixels with GLI values greater than

0.02 that represent vegetation. The zonal statistics tool in QGIS was used to calculate vegetation percent cover for each assessment area, with 96% vegetation cover calculated for the left bank and 84% vegetation cover calculated for the right bank. A bankfull width of 4.92 m was estimated by creating a set of three in-stream lines (towards the beginning, middle, and end of the reach), and averaging their length. Additional sets of three lines each were created perpendicular of the reach to estimate how far the vegetation continued into the floodplain. The lengths of these perpendicular lines were averaged for each bank (15.10 m left and 18.36 m right) and then divided by the bankfull width to estimate the extent of vegetation in the floodplain in terms of bankfull width. On average, the left bank had vegetation that extended 3.07 bankfull widths into the floodplain and the right bank had 3.73 bankfull widths.

To illustrate another, more technical solution for the inherent subjectivity in the SVAP2, we assessed the riparian area quantity scoring element for the MA site using a remote sensing approach in GIS (Fig. 8). These values derived in GIS are considered “true” vegetation cover values relative to the scores provided from both the in-field and remote visual assessment approaches. According to the SVAP2 criteria, with a vegetation cover of 96% on one bank and 84% on the other along with the vegetated bankfull width estimates, the reach’s score for riparian area quantity is 7.5 out of 10 (assumed score of nine for left bank, six for right due to vegetation gaps) using this GIS approach. The USACE gave this same reach a nine in the field for riparian area quantity, and the remote scores from the survey had a range of two to 10 with an average of 7.3. The in-field assessors overestimated the riparian area quantity relative to the GIS-derived score, while the remote assessors’ average score is close to the GIS-derived score, likely due to the aerial perspective provided by the sUAS products. This demonstrates how using sUAS products and multiple remote assessors can help produce a more objective evaluation when using visual metrics. However, given the range of the visually-derived scores, using a quantitative GIS analysis provides a more objective, accurate, and repeatable method.
