Bridge Case Study: What a Contractor Needs to Know on an FRP Reinforcement Project

Introduction: The Halls River Bridge

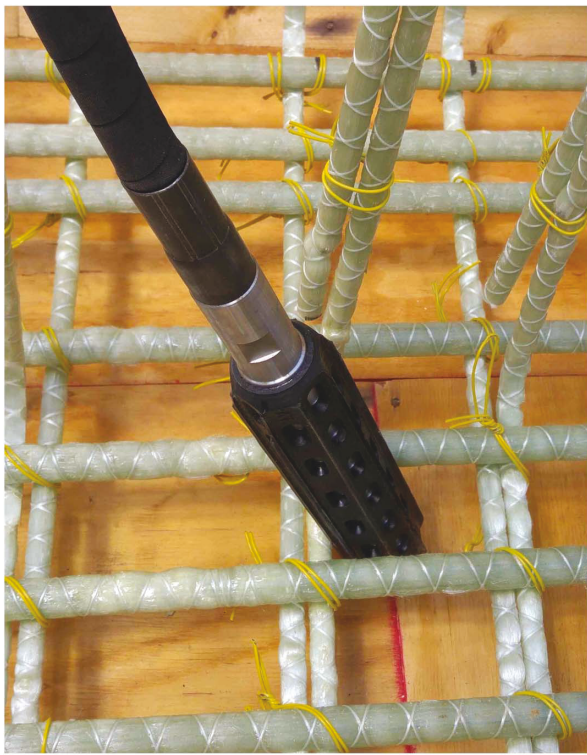
Fig. 3 shows the rubber-tipped vibrator used at HRB for any cast-in-place activity.

Fig. 3. Rubber-tipped vibrator. (Image by Thomas Cadenazzi.)

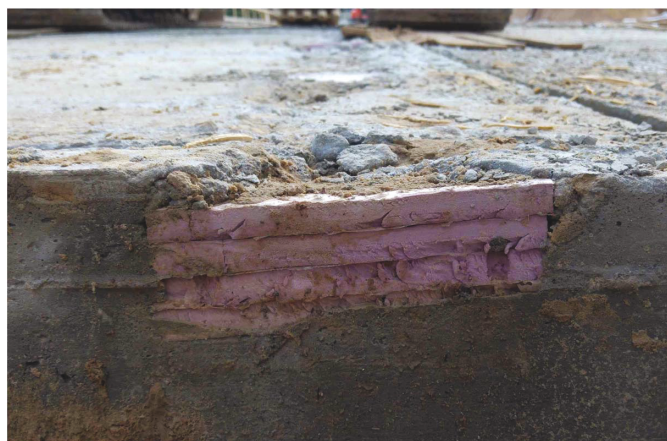
This process was intended to allow accurate embedment of the GFRP bar insert from the railings without damage to the deck reinforcement. Additionally, the process required transverse supporting rebars to ensure stability of the blockouts during construction. Fig. 4 shows the traffic railing reinforcement along with blockouts (coded as 5i and 5d in the figure) and additional bars, displayed as solid-filled elements.

Fig. 5. Shear key blockout. (Image by Thomas Cadenazzi.)

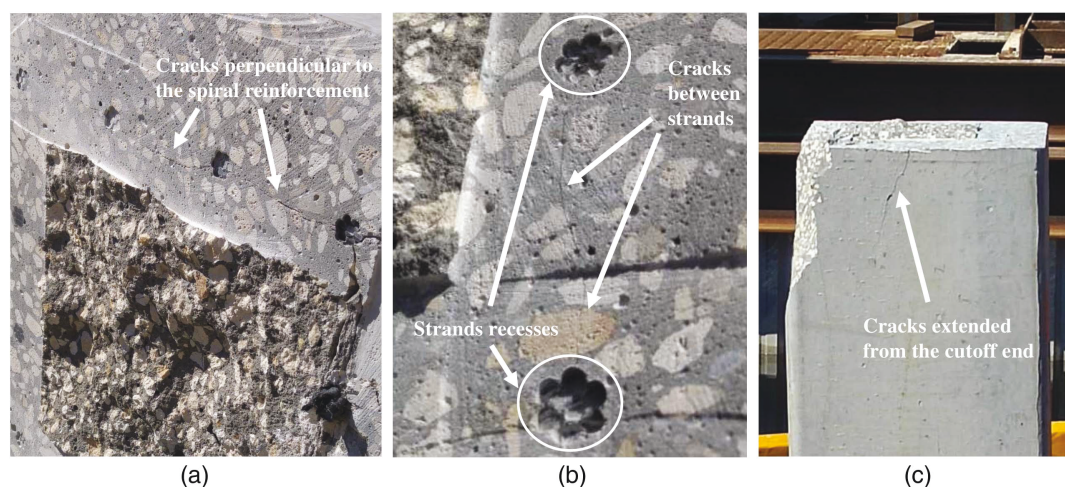
During pile cutoff activities, some cracking between the CFRP strands was observed on the faces of several piles. Cracks lay perpendicular to the spiral reinforcement [Fig. 7(a)] and between strands [Fig. 7(b)]. In some cases, longitudinal cracks extended from the cutoff end of the pile as well [Fig. 7(c)].

Cracks were caused by the transverse pressure exerted by the CFRP tendons. The majority of the strands on the cutoff face of the piles had slipped in the order of 9.53 mm (3/8 in.), as indicated in Fig. 7(b), resulting in the formation of cracks perpendicular to

the spiral reinforcement [Fig. 7(a)]. The maximum crack size measured in one of the piles was 0.28 mm (0.011 in.) with others equal to or lower than 0.18 mm (0.007 in.). Given that the length of most cracks was within 305 mm (12 in.), no remedial action was necessary as the cracks were encapsulated in the pile cap pour. Cracks that did extend beyond the cap were repaired per FDOT subarticle 400-21.5.2 (2016a) based on crack width.

Fig. 7. Pile cracks (a) perpendicular to the spiral reinforcement; (b) between strands; and (c) extended from the cutoff end of the pile. (Images by Thomas Cadenazzi.)

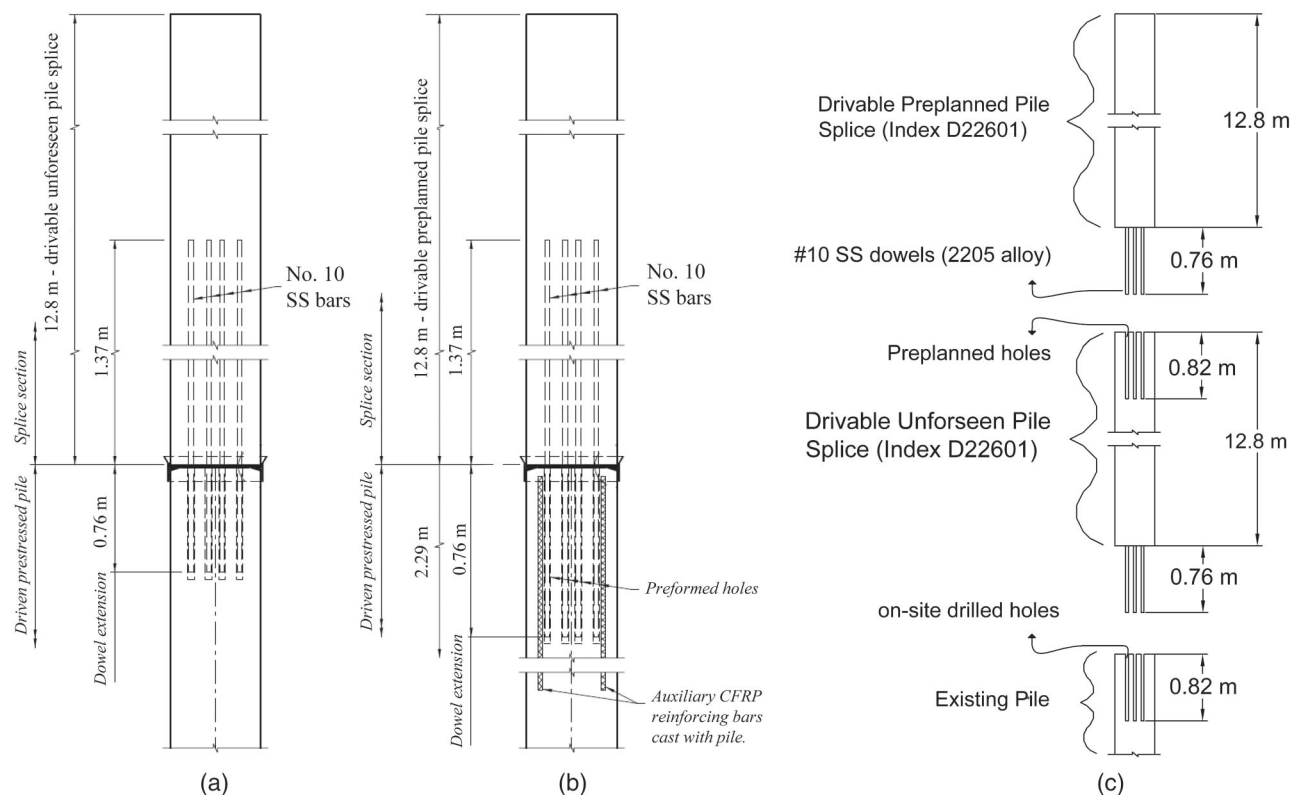
The total length of the splice was calculated as the difference between the length of the exploratory pile at capacity and the length of the original 20.1-m (66-ft) long PC pile. The pile splice length thus calculated was 25.6 m (84 ft). By means and methods of construction, such a splice was impractical to handle. Typical pile splices are approximately 6.4 m (21 ft) to 9.1 m (30 ft). Since the total splice length was longer than the installed pile, it would be difficult and also quite expensive to safely support a single 25.6-m (84-ft) splice next to active bridge traffic. Therefore, the pile splices needed to be divided into two segments of 12.8 m (42 ft) each.

Fortunately, each of the five installed piles needed one drivable unforeseen 12.8-m (42-ft) long pile splice, while an additional drivable preplanned pile splice was only required for Pile 3 in Bent 2 (close to the location of the exploratory H-pile). Figs. 9(a and b) (FDOT 2014a) show reinforcement detail of the drivable unforeseen pile splice and the drivable preplanned pile splice, respectively. Fig. 9(c) shows the lengths and splice sequence of the pile requiring two splices.

Fig. 9. (a) Drivable unforeseen PC pile splice detail; (b) drivable preplanned prestressed/precast pile splice detail (data from [FDOT 2014a](#)); and (c) pile splice installation sequence.

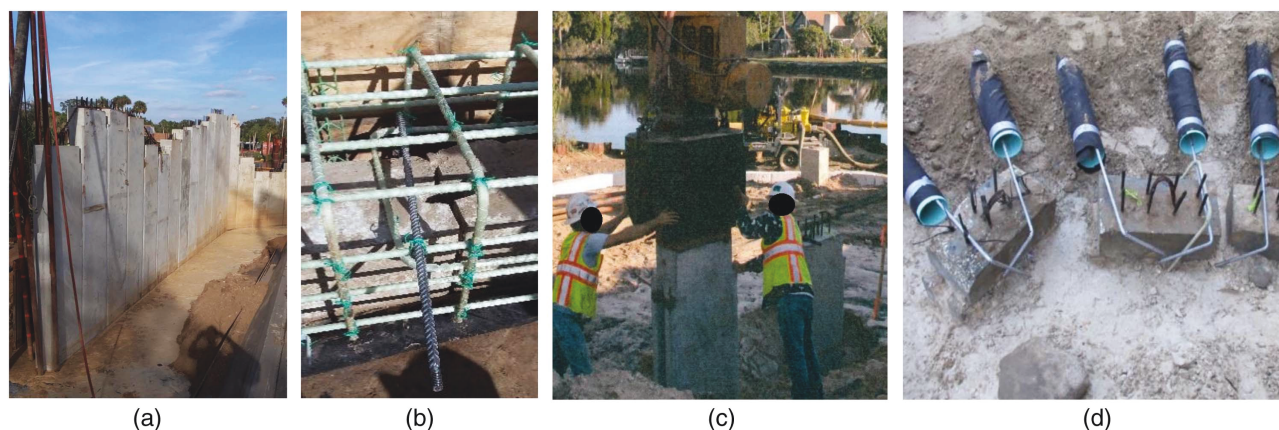
Fig. 13 shows the west end sheet pile wall design. For symmetry, the same design has been adopted on the east end. In doing so, the sheet pile structure was modified from a cantilevered [Fig. 14(a)] to an anchored design [Fig. 14(b)]. The new design reimplemented part of the sheet piles' cutoffs as deadman anchors, which are indicated in Fig. 13 and shown in Fig. 14(c).

The deadmen carry a substantial portion of the wall loading through threaded SS anchor rods [indicated in Fig. 13 and shown in Fig. 14(d)], installed within a 102-mm (4-in.) diameter PVC perforated pipe (for construction operation protection and drainage reasons). The connectors used were no. 5 SS rods ASTM A955, Grade 75, with length ranging from 8.2 m (27 ft) to 12.5 m (41 ft). The bar ends were threaded for coupling at one end and had a 25.4-m (10-in.) tail bend at 90° at the other. After installation and tightening, tie-backs and deadman anchors were backfilled with A-3 granular material as per AASHTO M-145 (AASHTO 2008).

Fig. 14. (a) Cantilevered sheet pile wall; (b) anchored sheet pile wall through SS rods; (c) deadman anchor installation; and (d) SS rods anchored to deadmen prior to casting of the deadmen cap. (Images by Thomas Cadenazzi.)
