# Evaluation of collapse resistance of reinforced masonry wall systems by shake-table tests

Department of Structural Engineering,  
University of California, San Diego, La  
Jolla, California, USA

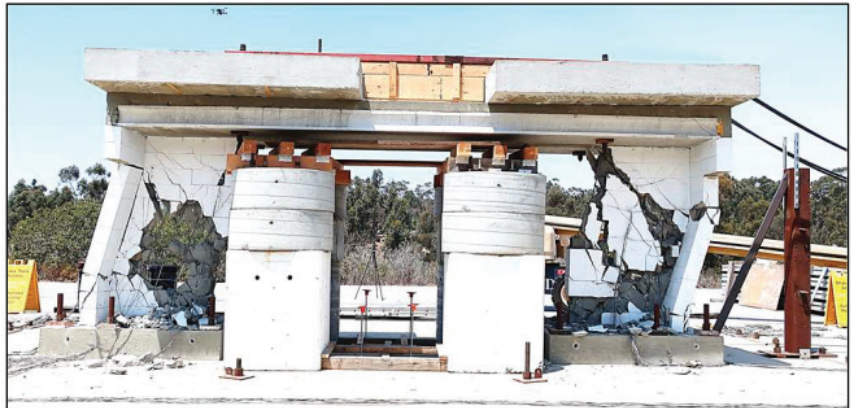
**FIGURE 9** Damage in Specimen 1 after MUL-133%: A, south view of Wall 1; B, north view of Wall 2

The last dynamic test on Specimen 1 was conducted with a 133%-level Mulholland motion. In this test, the walls developed severe shear cracks. The specimen exhibited significant lateral drifts as the period of the structure elongated into

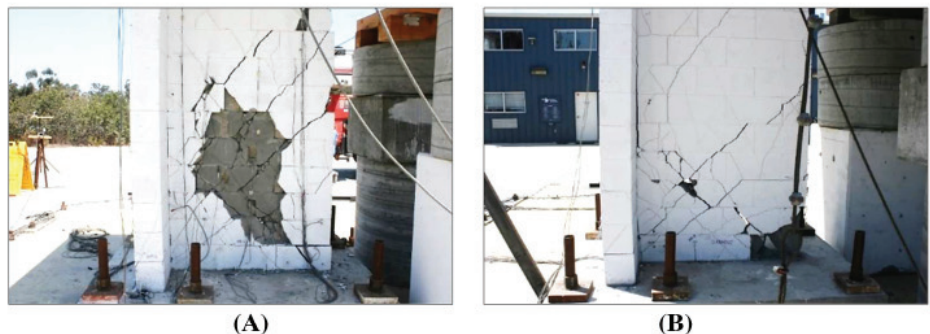
**FIGURE 10** Damage in Specimen 1 after the quasi-static pull test [Colour figure can be viewed at [wileyonlinelibrary.com](http://wileyonlinelibrary.com)]

After MUL-133%, to examine the maximum roof drift ratio that could be sustained by the structure before collapse, a quasi-static test was conducted by pulling the roof with steel cables. The quasi-static test was done instead of a dynamic test because of safety reasons. During the quasi-static test, the diagonal cracks in each wall continued to extend and open as the horizontal roof displacement increased. Severe crushing and spalling of the masonry were observed. As shown in Figure 8B, the lateral resistance of the wall system dropped to 44 kN (9.9 kips), which is 6% of the peak strength, when a roof drift ratio of 16.7% (42.4-cm roof horizontal displacement) was reached. Horizontal cracks were observed in the wall flanges, and a few diagonal cracks in the webs had extended into the flanges. As shown in Figure 10, at the roof drift ratio level of 16.7%, collapse was averted because the flanges were still able to carry the weight of the roof slab when the masonry in the wall webs had been severely crushed.
