## Observations and analysis of wind pressures on the floor underside of elevated buildings

Elevated buildings  
Wind engineering  
Hurricane Michael  
Wall of Wind

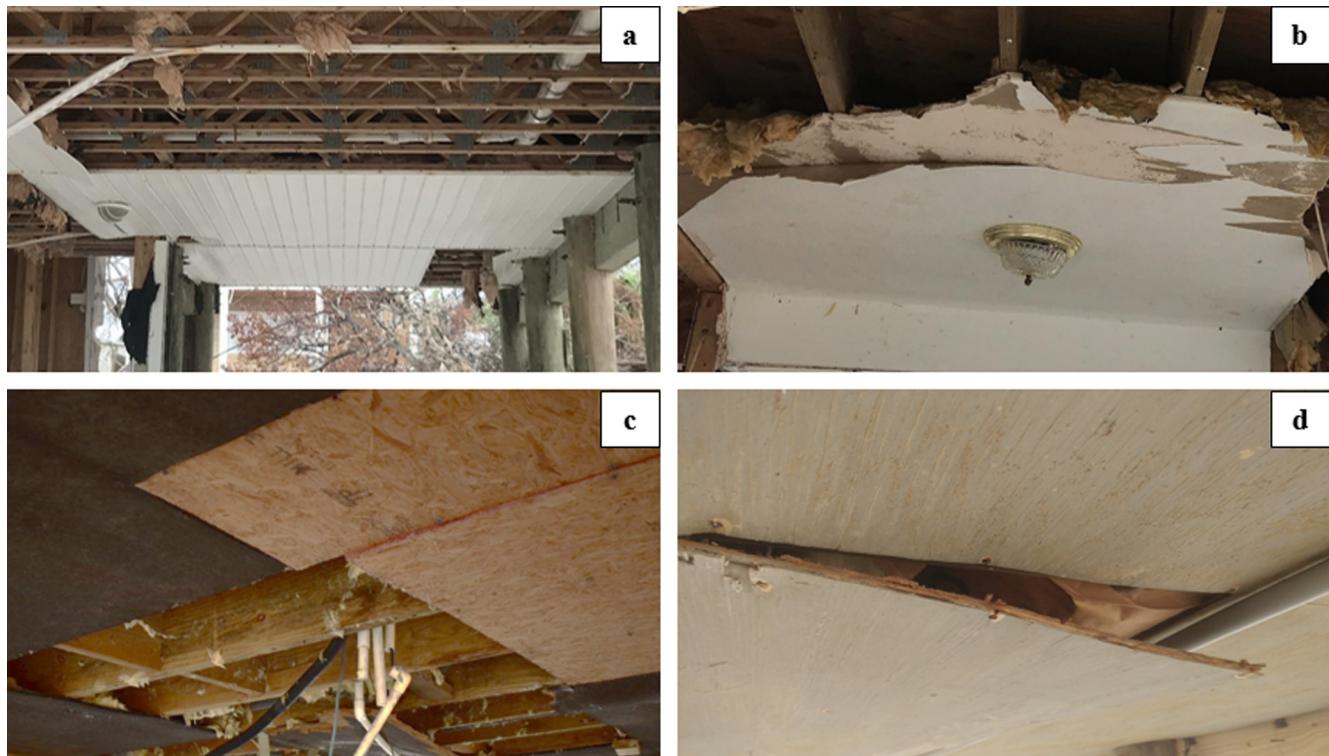
**Fig. 4.** Types of floor underside cladding and damage observed after Hurricane Michael; (a) vinyl with fastener failure, (b) hardboard with panel failure, and (c, d) wood structural panels with fastener failure. (Photo credits: (a, b) Elaina Sutley, University of Kansas, (c) Josh Hunt, University of Alabama, (d) Jae Kim, University of Kansas.)

buildings, it was unclear from the observation photos if cladding was present, or the sheathing panels on top of the floor joists were left exposed. These claddings generally consisted of either vinyl slats or panels, hardboard panels, or plywood or oriented strand board panels (see observed cladding examples in Fig. 4). Within the 50 cases with

cladding, survey photos show that at least 28 were visibly damaged, with a minimum of detachment of some cladding from the supporting members. Detachment of vinyl cladding and fracture of hardboard were the most common forms of damage, with limited damages seen in the wood structural paneling. In addition to aesthetic concerns, damages

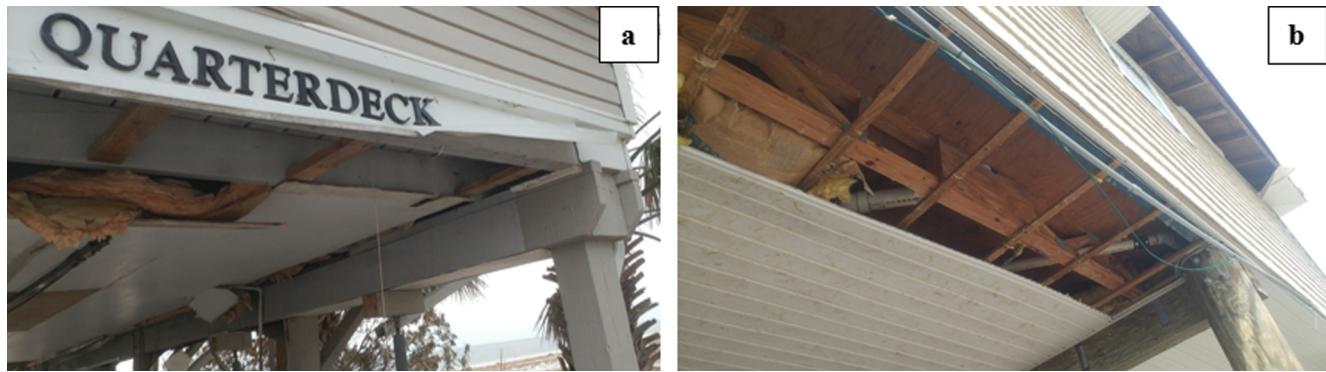
Fig. 5. Examples of edge and corner floor underside cladding damage. (Photo credit: Jae Kim, University of Kansas.)

claddings of elevated buildings were discerned, as demonstrated in Figs. 5 and 6: edge panel loss at the boundaries of the building floor, and widespread panel loss across the floor surface. These patterns are especially interesting due to the conclusions formed as a result of the experimental program conducted at the WOW. The potential for edge cladding loss is corroborated by the pressure coefficient patterns seen on the floor underside at higher elevations (Fig. 14), where there exists peak pressure coefficients comparable to those specified for gable roof

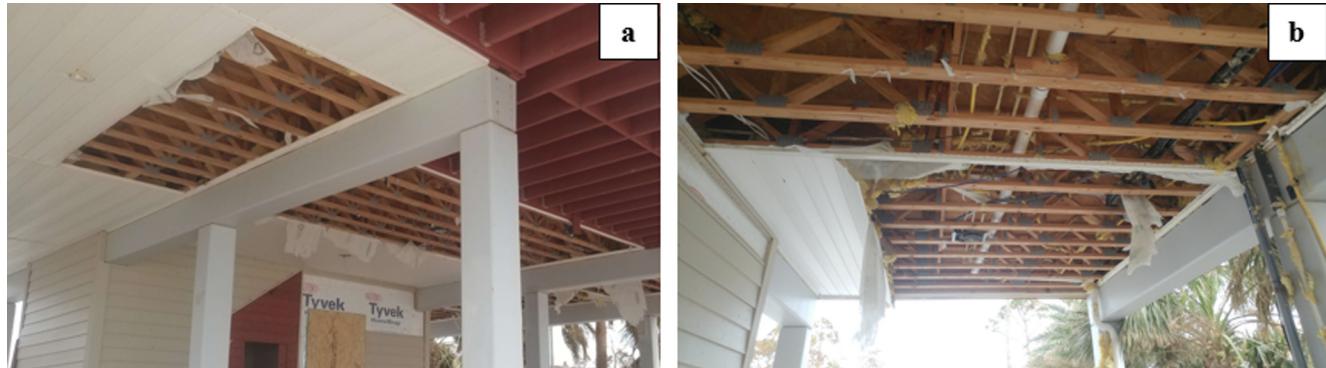
Fig. 6. Examples of large sections of cladding panel loss on the floor underside. (Photo credit: Jae Kim, University of Kansas.)

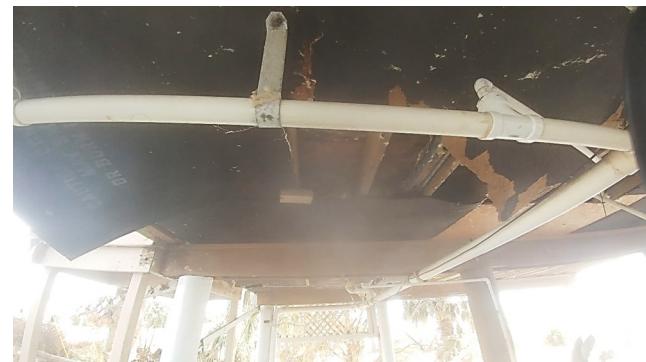
**Fig. 8.** Floor underside cladding damage on the southeastern edge of Building 225. (Photo credit: Josh Hunt, University of Alabama.)
