# Durability Assessment of 15- to 20-Year-Old GFRP Bars Extracted from Bridges in the US. II: GFRP Bar Assessment

**Abstract:** A multilaboratory investigation into the durability of glass fiber-reinforced polymer (GFRP) bars extracted from eleven 15- to 20-year-old bridges in the US will be performed. Part 1 (Benzcry et al., forthcoming) of this two-paper series describes the bridges and presents data on the condition of their concrete, and Part 2 focuses on the condition of the bars. Constituent content, maximum water absorption, as-received moisture content, glass transition temperature ( $T_g$ ), short bar shear (SBS) strength, and tensile strength will be evaluated. Scanning electron microscopy (SEM) and energy dispersive spectroscopy (EDS) will be performed. The fiber mass content of all bars was close to or greater than that specified in the current ASTM E1309 (ASTM 2011a) GFRP bar standard. SEM and EDS showed only slight signs of degradation, which was predominantly near the outer radius of the bars. The loss of SBS strength was slight to moderate in bars with control data for comparison. Tensile strength, which could only be evaluated in 1 bridge, showed a reduction of on

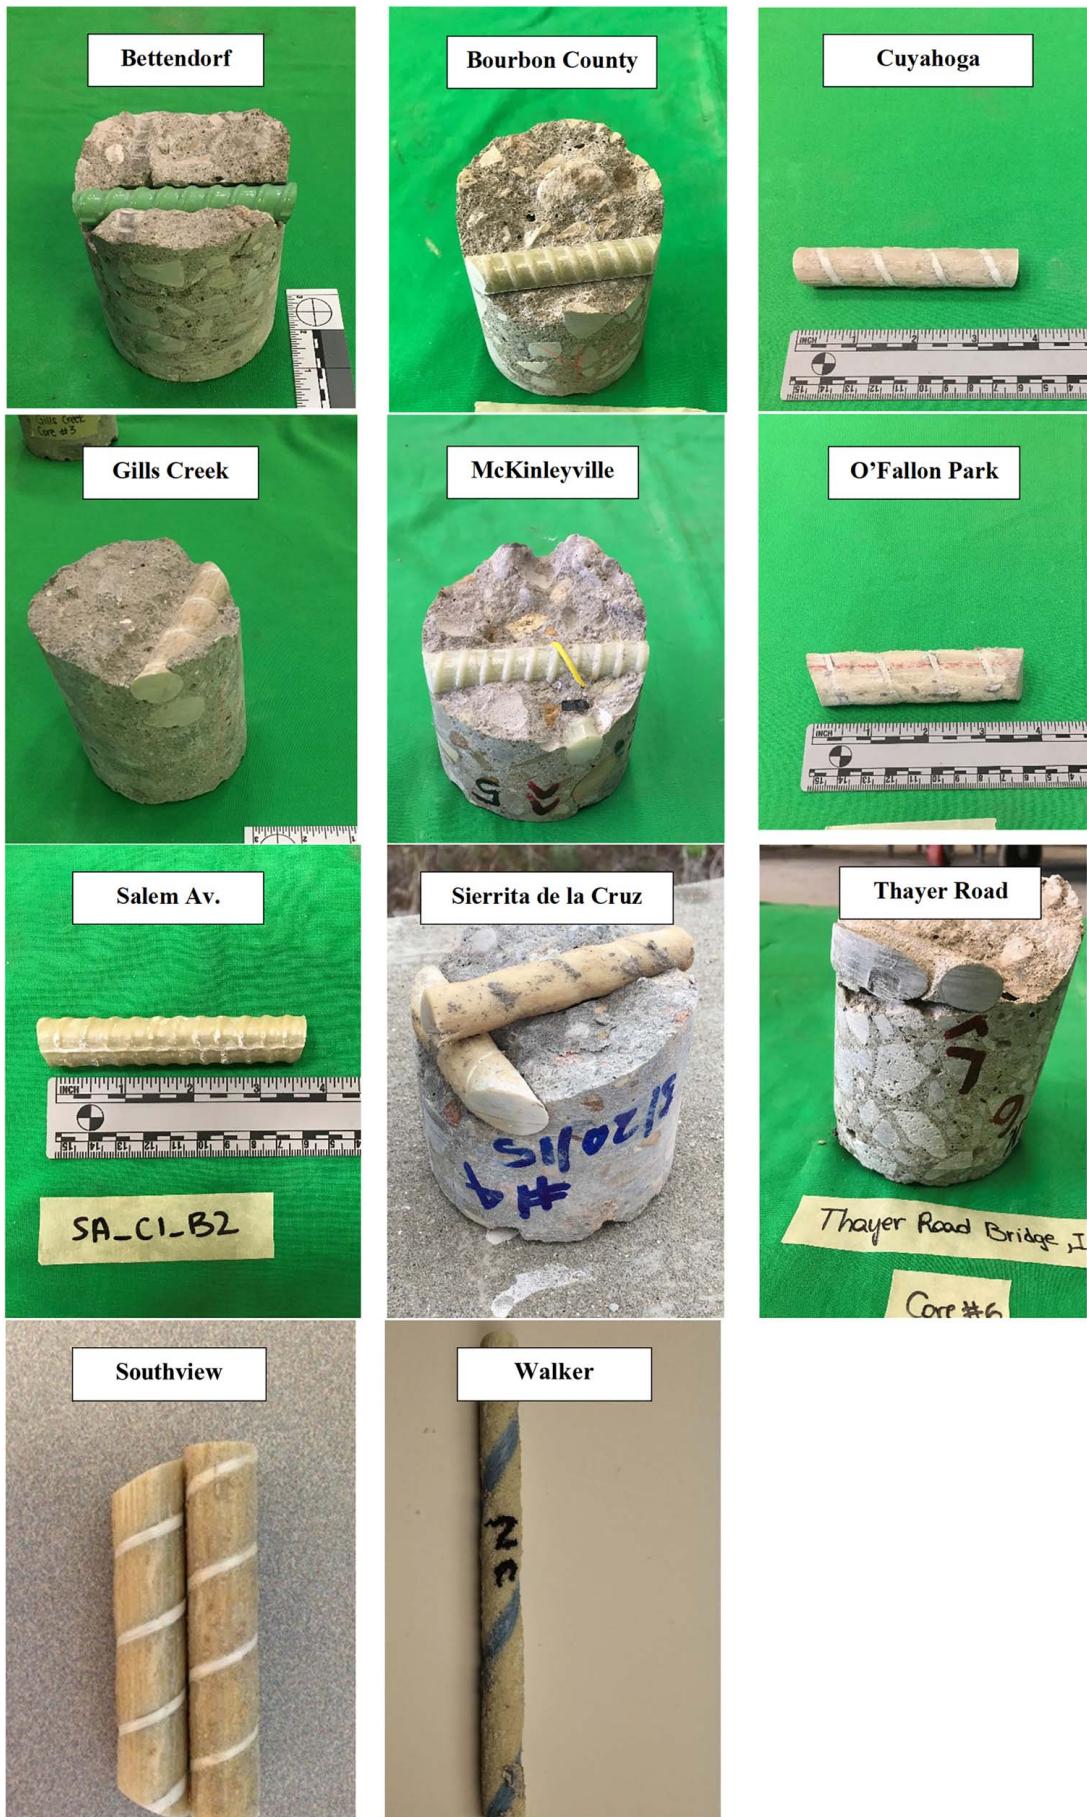
**Fig. 1.** Bars from the 11 bridges.

In the first part of this two-paper series (Benzcry et al., forthcoming), information on the bridges from which the bars were extracted, bar extraction methods, and the specimen labeling scheme are detailed. Fig. 1 shows photographs of the bars from all the bridges investigated in this research. The list of states in which the bridges are located is given in the first column of Table 1. Before testing, the bars were brushed and gently scraped to remove obvious contaminants, such as residual cementitious paste.

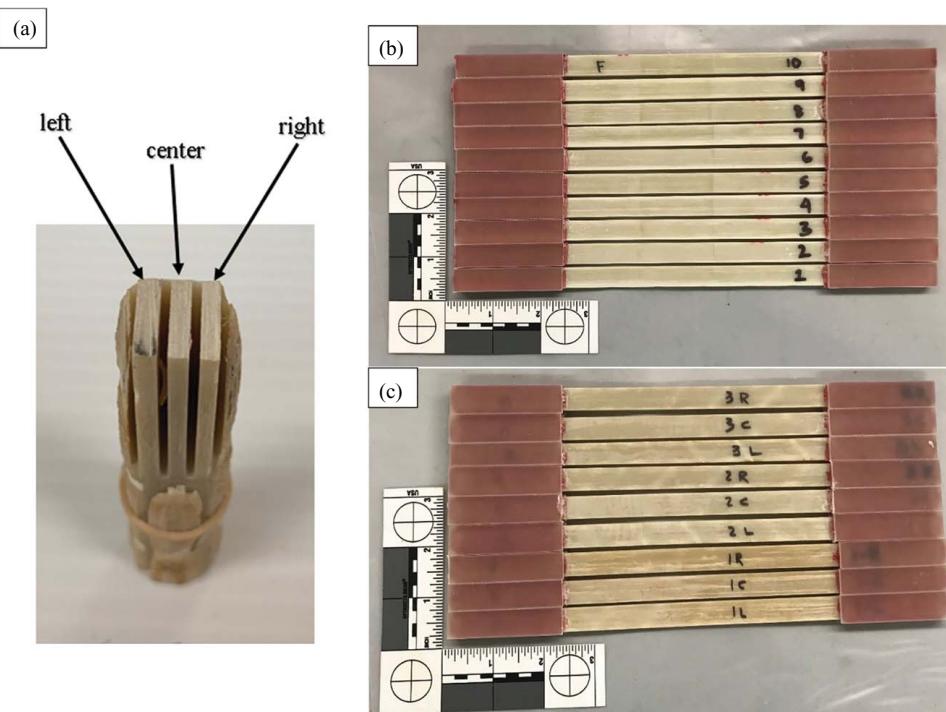
**Fig. 2.** Showing: (a) method to cut flat coupons for tensile testing; (b) current production tensile coupon; and (c) extracted tensile coupons.

Pristine current production bars similar in shape, size (16 mm diameter), and manufacturer to the bars extracted from the Sierrita de la Cruz Creek Bridge were obtained and tested as is (ASTM D7205, ASTM 2011b) and as flat coupons. The specific fiber and matrix

Photographs of the extracted and current production coupons with tabs are shown in Figs. 2(b and c). All coupons were tested using a 100 kN (22.5 kips) servo hydraulic load frame and a 50 mm (2.0 in.) extensometer to measure strain. The full-size bars were tested in an 890 kN (200 kips) Baldwin screw-driven universal test frame and a 100 mm (4.0 in.) extensometer was used to record strain. Both tests were performed at a rate of 2 mm/min (0.08 in./min.). Young's modulus of the coupons and bars was measured by the chord method between strains of 1,000 and 3,000  $\mu\epsilon$ .

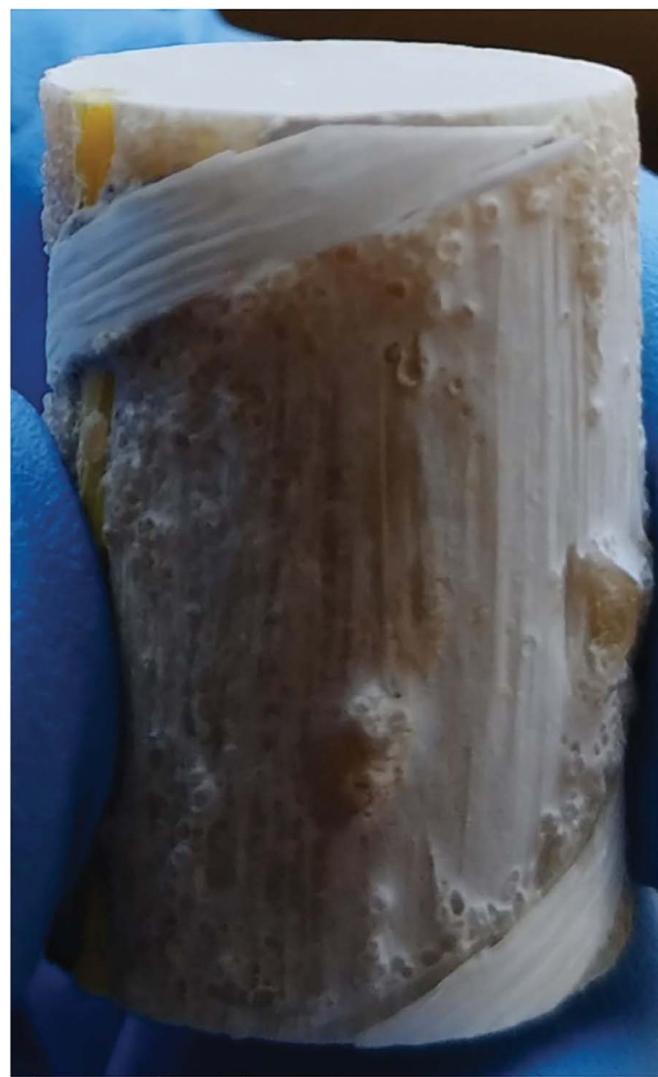
**Fig. 3.** Part of the helical wrap fell off one bar from the Cuyahoga Bridge during 50°C water absorption testing.

Water absorption at 50°C (122 F) was evaluated on bars from 8 of the 11 bridges. Several observations were noted that could affect the weight of the bar specimens. A loss in helical wrap was noted when the Cuyahoga Bridge (Southeastern lake, Erie Snowbelt, Ohio) specimens were soaked in water, as shown in Fig. 3. For continuity in the data, the weights of these large pieces of material were recorded along with the remainder of the specimens. Smaller particles on the surface of the bars, such as sand and residual cementitious material, were observed to fall off during conditioning, but the mass of these particles could not be tracked.

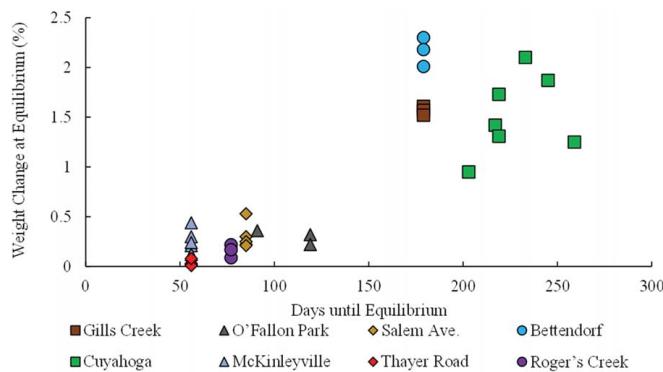
Fig. 4 shows the weight change at equilibrium versus time to reach equilibrium for each specimen. The current ASTM GFRP bar specification [ASTM D7957 (ASTM 2017a)] stipulates a qualification limit of 1% water absorption in pristine bars as an indication of bar durability. Bars from five of the eight bridges had equilibrium water absorption values of <1%, with the exceptions being those from Gills Creek Bridge (1.5%), Bettendorf Bridge (Bettendorf, Iowa) (2.1%), and Cuyahoga Bridge (Franklin County, Virginia) (1.5%). The times to equilibrium in the latter three bridges were considerably >150 days, and the others were approximately 80 days.

**Fig. 4.** Equilibrium weight change and time to reach equilibrium for bars immersed in 50°C water.

Table 2 gives the average weight change measured at 24 h and at equilibrium as well as the average time required to reach equilibrium for each bridge. It is emphasized that the water uptake measurements are relative to the existing water content of the bars following the superficial 48 h, 40°C (104°F) preconditioning regimen. For O'Fallon and Cuyahoga bars, the water content at the beginning of the uptake test (i.e., after preconditioning) was approximately 0.36%, according to dry-out tests performed at 80°C using ASTM D5229 (ASTM 2010). Therefore, the actual moisture content in the bars at equilibrium could be expected to be approximately 0.36% more than the values listed in Table 2. Some of the extracted bars could exceed the 1% absorption limit of ASTM D7957-2017 (ASTM 2017a); it is noted that the bars evaluated in this paper were manufactured before the existence of contemporary standards. In addition, as shown in the following section, the water content of the bars after 15–20 years of service was well below 1%.

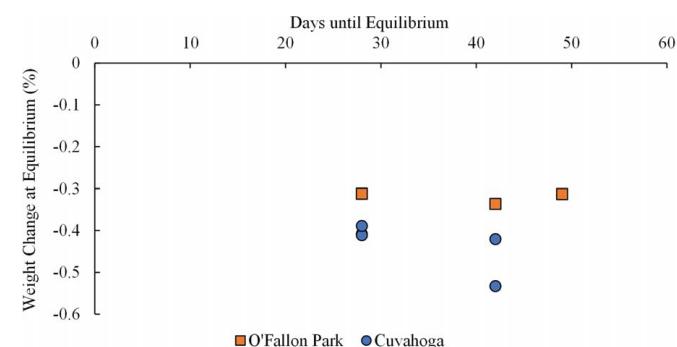
As-received (without preconditioning) moisture content was evaluated by drying out bars from two bridges, O'Fallon Park and Cuyahoga, at 80°C (176°F) (Table 3). Fig. 5 shows the weight change at equilibrium versus the time required for individual specimens to reach equilibrium. All of the specimens reached equilibrium after 49 days. Weight loss was observed to be nonmonotonic, potentially due to the variations in the humidity level in the laboratory. The O'Fallon Bridge bars had less as-received moisture (0.32% on average) than the Cuyahoga Bridge bars (0.44% on average). For reference, both of these values were significantly <1% equilibrium value allowed by ASTM D7957 for 50°C (176°F) water immersion, although the bars were not necessarily expected to be saturated to such a high degree by field conditioning.

**Fig. 5.** As-received moisture content of bars determined by drying at 80°C, along with time required to reach equilibrium.

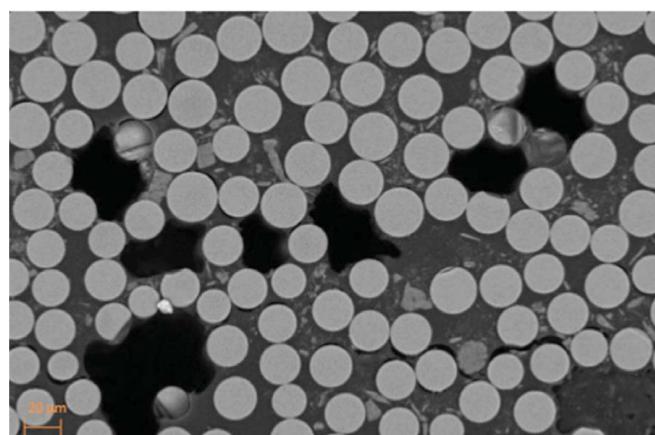
**Fig. 6.** SEM image of Gill's Creek Bridge.

SEM was performed on bars from all 11 bridges. In general, minimal evidence of environmental damage to the fibers, matrix, or fiber–matrix interface was seen. For example, in Gill's Creek Bridge, a few matrix and interfacial cracks were seen near voids that were located near the outer radius of the bar. Moreover, the number of fibers that showed signs of environmental degradation was approximately 192 out of 352,000 fibers (0.05%), estimated by counting fibers with and without signs of environmental damage in one quadrant and then multiplying by four. Fig. 6 shows an SEM image of a bar from Gill's Creek Bridge. In addition, the Cuyahoga Bridge bars displayed a small percentage of environmentally damaged fibers (Fig. 7). In these quantitative analyses of environmental damage in the fibers, damage attributed to specimen preparation, such as chipped or cracked fibers that had weak matrix support (e.g., located near a void), was omitted from consideration.

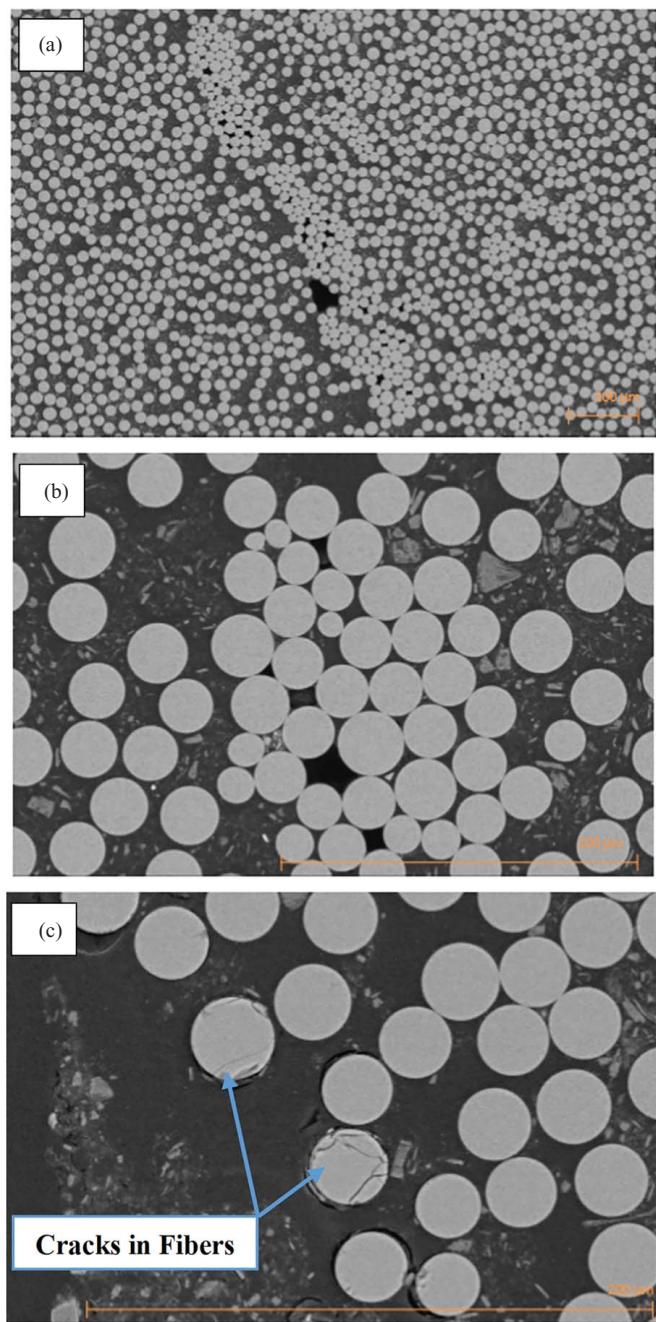
In the bars from Roger's Creek and McKinleyville Bridges, the incidence of environmentally damaged fibers, matrix, and interfaces was similar to or less than that seen in the Cuyahoga and

**Fig. 7.** SEM images of a bar from the Cuyahoga Bridge: (a)  $\times 100$  magnification; (b)  $\times 700$  magnification; and (c)  $\times 1,000$  magnification.

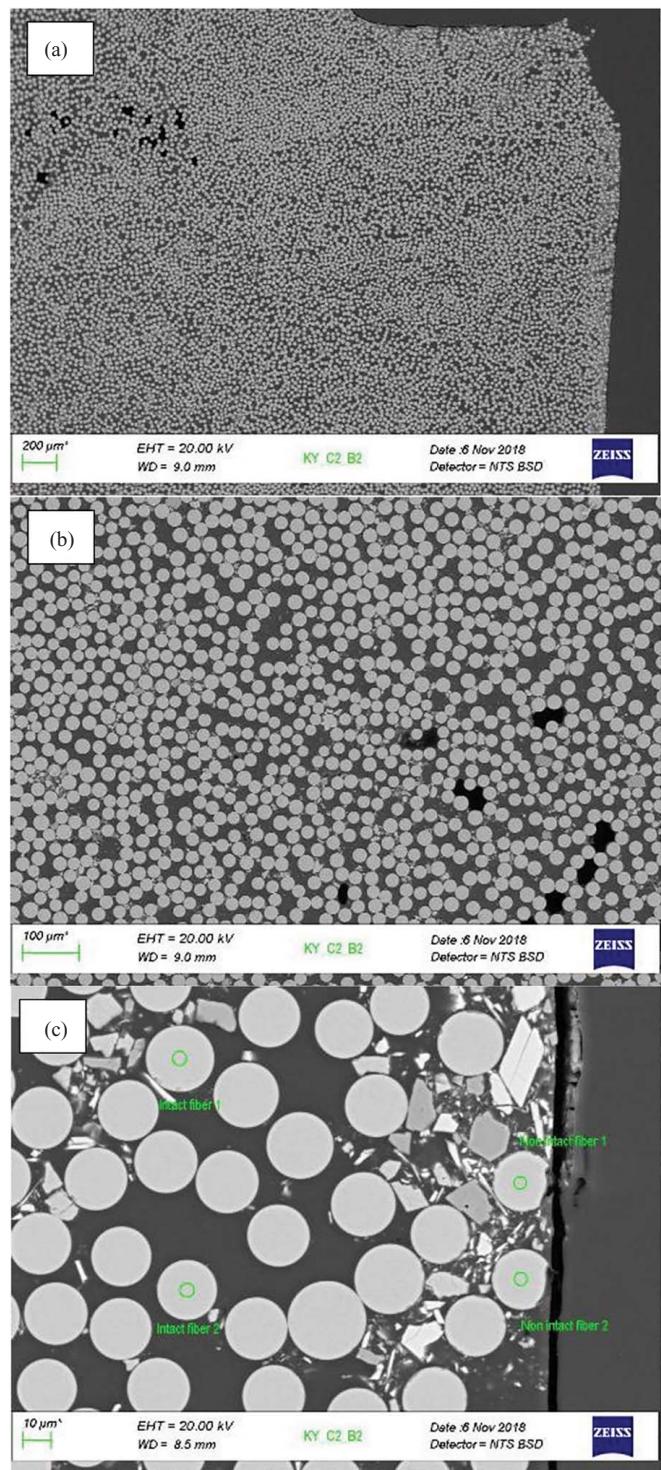
Gills Creek bars. Fig. 8 shows representative SEM images from Roger's Creek Bridge. Damage attributed to environmental effects was confined to regions near the outer radius of the bar.

**Fig. 8.** SEM images of a bar from the Roger's Creek Bridge: (a)  $\times 50$  magnification; (b)  $\times 100$  magnification; and (c)  $\times 800$  magnification.

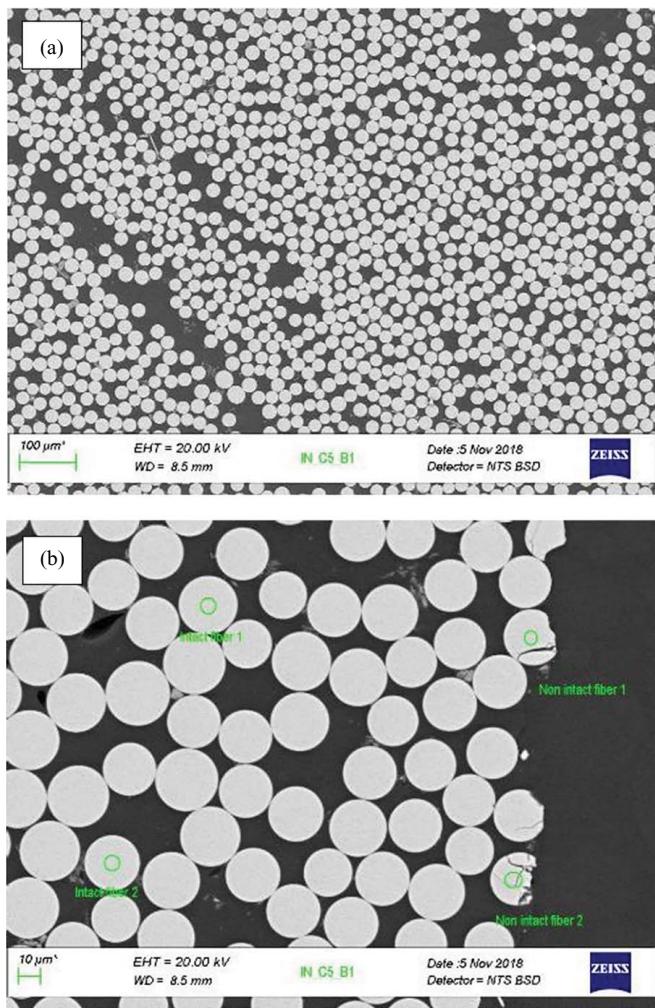
In the Thayer Road Bridge, fiber damage was found in some bars, but was believed to be caused by the particular manufacturing procedure used to make the bars. The interior region of the bar showed negligible fiber damage; numerous fibers at the outside radius appeared to be partially removed as if they were abraded during manufacture (Fig. 9).

**Fig. 9.** SEM images of a bar from the Thayer Road Bridge: (a)  $\times 100$  magnification; and (b)  $\times 800$  magnification.

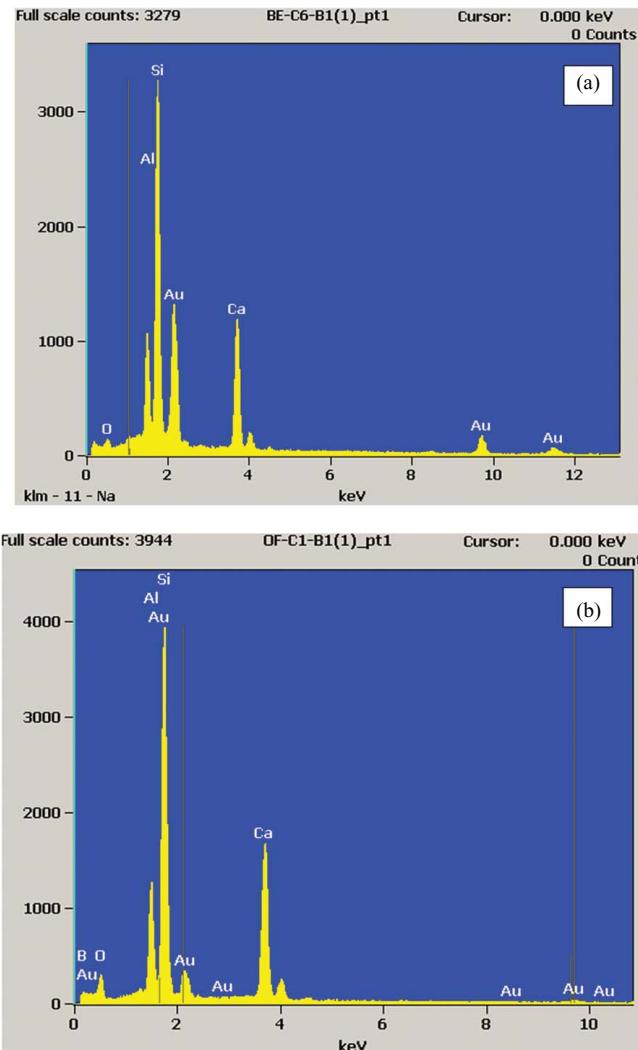
Representative EDS results for the Bettendorf and O'Fallon bars (Fig. 10) did not show evidence of environmental attack, which would be manifested as Na, K, and Ca present in the resin. However, for the Southview Bridge (Fig. 11), Na was found in the resin, but not in the fiber. Na in the resin indicated that the GFRP bar was under environmental attack, especially considering that the concrete tests showed a high pH and no signs of carbonation (Benzecry et al., forthcoming). In addition, the lack of Na in the fiber confirmed that the Na in the resin came from the environment rather than the fiber.

**Fig. 10.** EDS test results for bars from: (a) Bettendorf Bridge; and (b) O'Fallon Bridge.

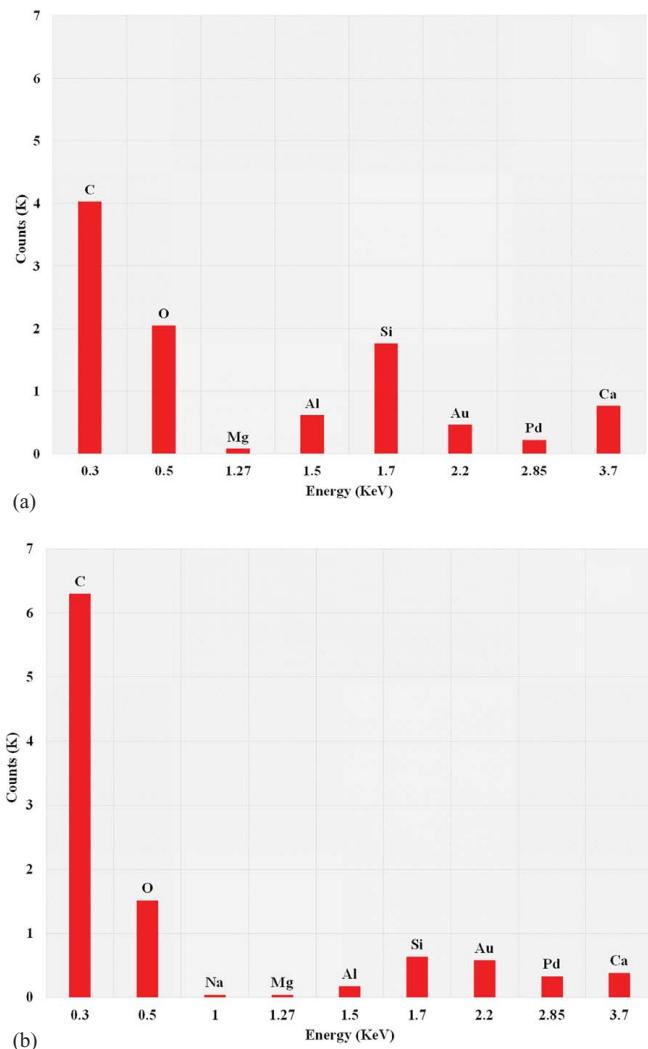
**Fig. 11.** EDS test results for a bar from Southview Bridge of: (a) fiber; and (b) resin.

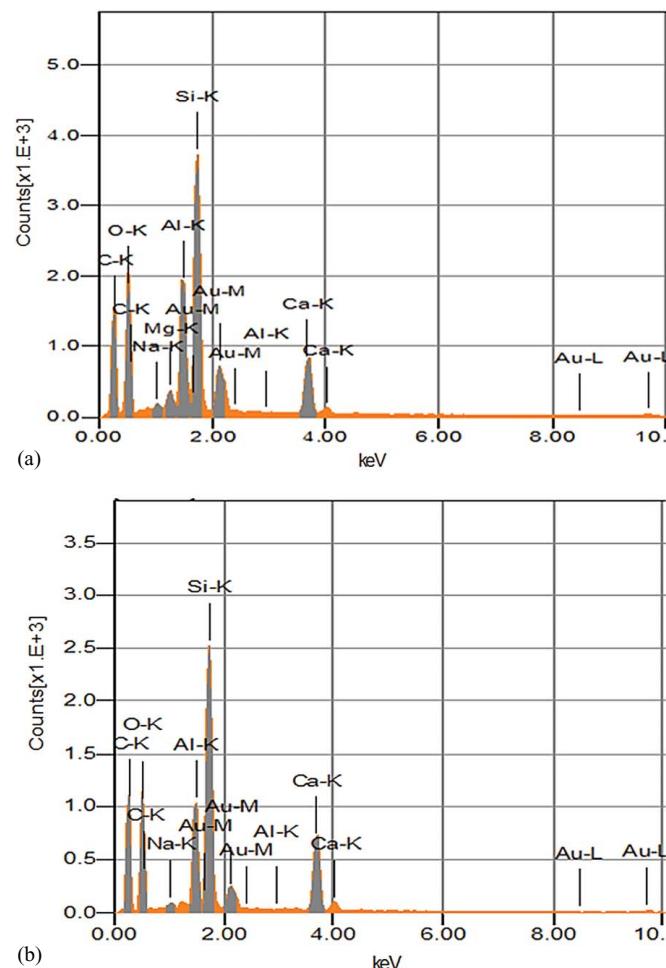
In the bar extracted from the Sierrita de la Cruz Creek Bridge, Na was found in the resin as well as the fiber [Fig. 12(a)]. In addition, EDS was carried out on pristine new generation bars that were similar to the bars extracted from the Sierrita de la Cruz Creek Bridge [Fig. 12(b)]. The Na emittances were similar in both tests, which provided no evidence of chemical attack (leaching, alkali hydrolysis, or both) of the fibers in the bars of the Sierrita de la Cruz Creek Bridge.

**Fig. 12.** EDS test results for bars from the Sierrita de la Cruz Creek Bridge: (a) extracted bars; and (b) pristine new generation bars.

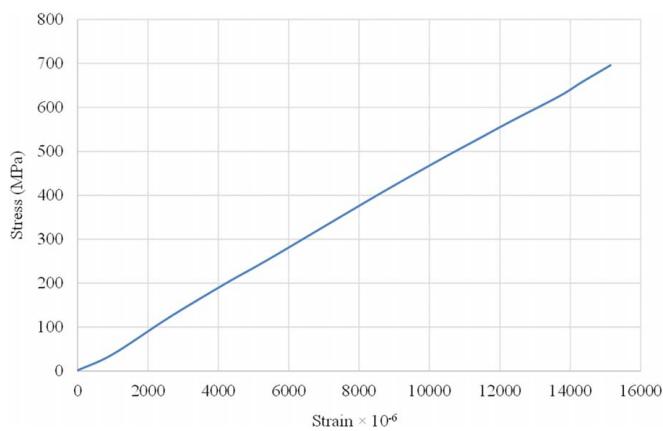
The tensile test results for flat coupons cut from Sierrita de la Cruz Creek Bridge 16 mm witness bars indicated an ultimate strength of 622 MPa (90.2 ksi) and an elastic modulus of 47.1 GPa (6,931 ksi), as given in Table 6. The stress-strain curves for the extracted coupons were approximately linear (Fig. 13), as commonly seen in a test of a typical full-size GFRP bar. Tables 7 and 8 list the strength and moduli of current production 16 mm bars tested as flat coupons and full bars, respectively. To calculate the correlation factor

**Fig. 13.** Tensile stress-strain curve of flat coupon 2C taken from a 16-mm bar extracted from the Sierrita de la Cruz Creek Bridge.
