Performance of Steel Grain Silos and Rural Communities to Windstorms

Lianne Brito¹ and Christine Wittich, Ph.D., A.M.ASCE²

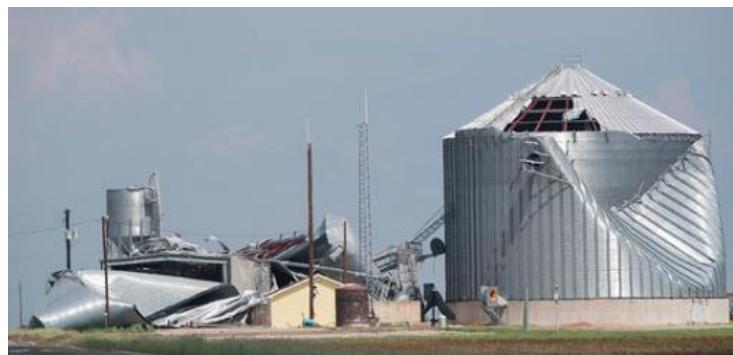
Figure 2. Three collapsed and severely damaged grain silos following Hurricane Harvey in Refugio, TX (photo courtesy of US Department of Agriculture: <https://www.flickr.com/photos/usdagov/36508165554>).

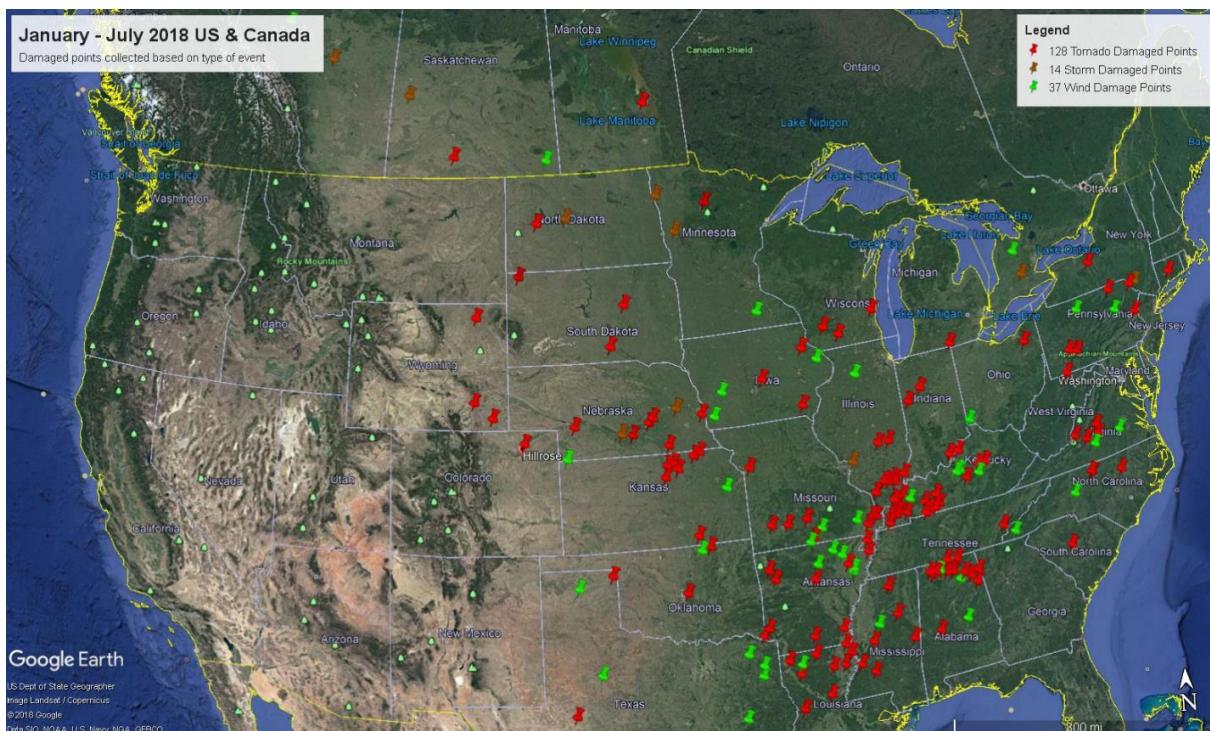
Figure 4. Rural resilience results based on type of damage

The results of the digital reconnaissance were first analyzed in terms of geographic distribution to understand if the vulnerability of rural communities is more prevalent in certain geographic regions. While instances of rural earthquake damage were noted elsewhere in the world (e.g. Peru, Mexico), no damage-inducing earthquakes were observed in the United States or Canada during the time period of the digital reconnaissance (January – July 2018). Therefore, the geographic distribution presented in Figure 4 includes only wind events, including tornadoes, thunderstorm, and straight-line wind, that resulted in documented rural damage. In this map, the

damage source is indicated by the color of the marker. As seen in this map, a total of 181 damage-inducing events were collected including 173 in the United States and 8 in Canada over the seven-month duration of the digital reconnaissance. In total 31 of 50 states in the US and 4 of 13 provinces in Canada had rural communities impacted by a wind event. While this represents greater than 60% of the states in the country, it is clear from the map representation that it is concentrated east of the Rocky Mountains with no damage data along the west coast of the country. However, it is noted that western rural communities are still vulnerable to hazards; and, a cursory review of news coverage beyond the seven-month duration presented indicate damage in these areas. In addition, it is noted that evidence of wind-induced rural damage occurs in many other areas of the world, with significant coverage and documentation of rural communities in Australia and New Zealand.

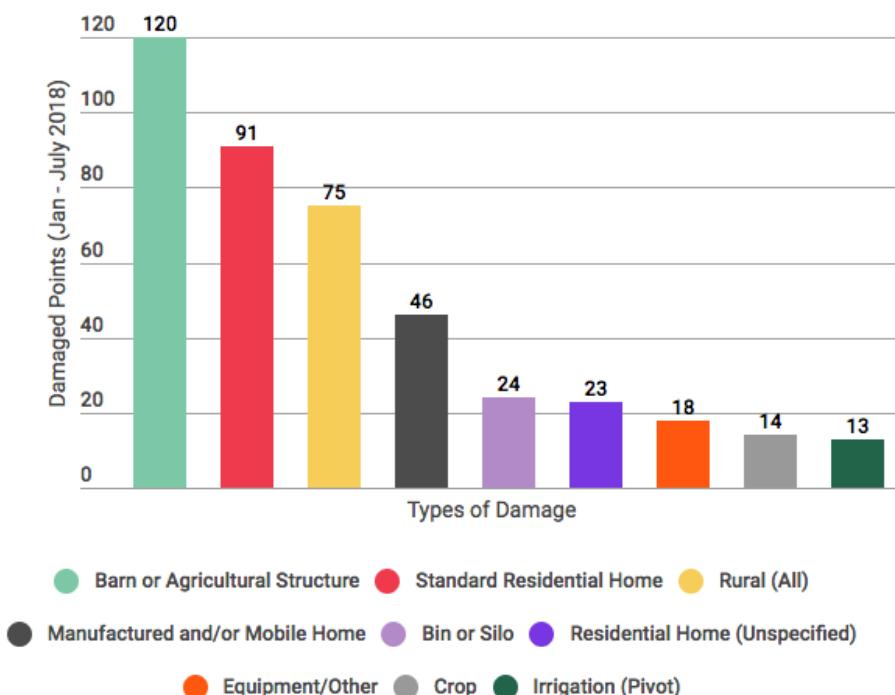
Figure 5. Rural resilience results based on structural system damaged

The digital reconnaissance was further analyzed by the type of damage observed, which is presented in bar chart form in Figure 5. The most prevalent type of damage documented was to residential housing, with a total of 160 events including 91 instances of damage to standard residential construction, 46 instances of damage to manufactured/mobile housing, and 23 instances of unspecified home damage. The most common damage documented for housing focused on the roof system, although detailed information regarding damage mechanisms is out of the scope of this digital reconnaissance. The second most common type of damage observed in the digital reconnaissance was to agricultural buildings including barns and storehouses, which accounted for 120 events and similarly included substantial documented roof damage but also included many instances of collapse. Following the documentation of building failures including both houses and agricultural structures, damage to grain silos, agricultural support equipment, crops, and irrigation systems accounted for 24, 18, 13, and 13 events, respectively. While the number of events that resulted damage to non-building structures were considerably

less than those resulting in building damage, this is not necessarily reflective of the structural vulnerability. Provided that the source for the type of damage was primarily news and media, the data collected likely contains significant bias towards housing or other large structures which impact a number of people. Despite the potential for bias, the digital reconnaissance highlights the remarkably high number of damage events that occurred over the relatively short duration of the study.

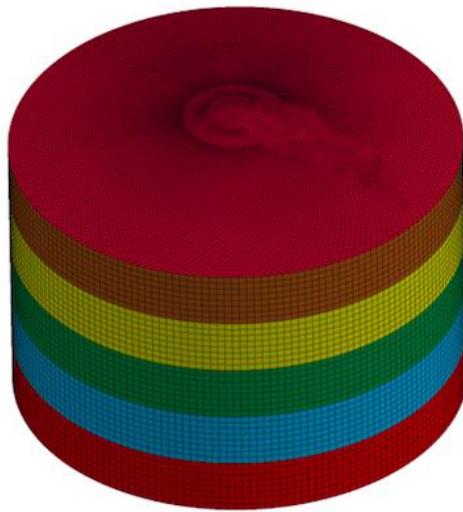
Figure 7. Mesh of silo with aspect ratio $H/D = 0.63$ and 29,880 shell elements

Table 1. Total number of elements for the finite element meshes of the tank models

H/D	Changed Height (D = 30.48 m)	Changed Diameter (H = 19.337 m)	High Pitch Roof	Flat Roof
0.24	25084	53462		
0.4	26812	67188		
0.63	29880	29937	31188	29456
1	33884	13878

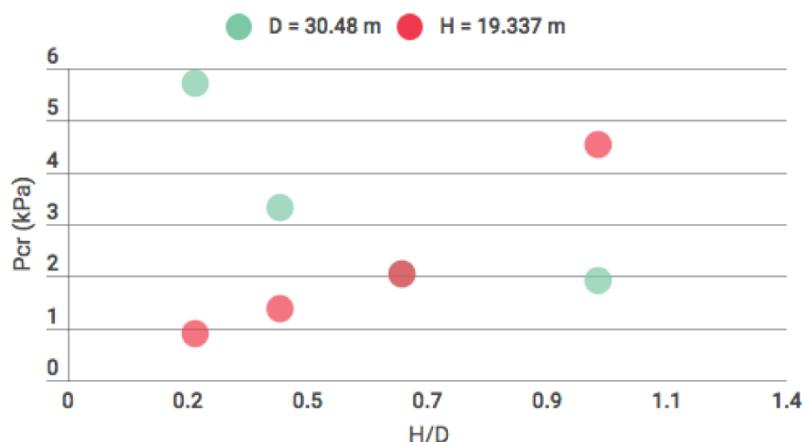
Figure 8. Aspect ratio and geometry of cylindrical shells

The results for the first variable tested, the aspect ratio and geometry of the steel storage silo, are presented in Figure 8. This scatter plot indicates the value of the critical buckling load, P_{cr} , as a function of the silo aspect ratio (defined in Figure 6). The dimension that was consistent throughout the parametric study is indicated by the color in the scatter plot, where green indicates a consistent diameter of 30.48 m and red indicates a consistent height of 19.337 m. It can be seen that the aspect ratio of a grain silo structure substantially influences the buckling load on the cylindrical wall with variations on the order of hundreds of percent. It is shown that as the height increases and the diameter stays constant, the buckling capacity decreases. As the

diameter increases and the height stays constant, the buckling capacity increases. Despite the significant variation in terms of the critical buckling load for the geometry, the buckling mode shape dominantly stayed the same with buckling primarily localized to the windward cylindrical wall – see Figure 9. In addition to the geometric variations, the wall thickness and roof slope were significant variables in the critical buckling load. Specifically, the critical pressure for the 95% wall thickness model was 1.81 kPa compared to 2.33 kPa for the 105% wall thickness model. This is a logical trend, yet it lends credence to further studies of the impact of rust and material loss as well as material imperfections. Similarly for the roof slope, variations in terms of the critical buckling load were observed, but were noticeably smaller than the variations observed due to geometry. Specifically, the critical pressure for the flat roof pitch was 1.24 kPa and for the higher roof pitch, 2.068 kPa.
