# DESIGN, FABRICATION, AND ASSEMBLY OF A TESSELLATED PRECAST CONCRETE SHEAR WALL

**Grace F. Crocker, EIT**, Clemson University, Clemson, SC  
**Brandon E. Ross, PhD, PE**, Clemson University, Clemson, SC  
**Michael Carlos Kleiss, PhD**, Clemson University, Clemson, SC  
**Pinar Okumus, PhD**, University at Buffalo, Buffalo, NY  
**Negar Elhami Khorasani, PhD**, University at Buffalo, Buffalo, NY  
**John Michael Romano, EIT**, Tindall Corporation, Spartanburg, SC

*This paper describes the fabrication and assembly of tessellated precast reinforced concrete shear walls. These walls are being constructed and tested as part of an NSF-funded research project designed to demonstrate the concept of Tessellated Structural-Architectural (TeSA) systems. The over-arching goal of this research is to explore tessellation patterns that can be implemented on a large scale, are architecturally appealing, and provide structural function. TeSA systems are comprised of individual tiles arranged in tessellations, or repeating geometric patterns. Tiles are topologically interlocking, which means that they transfer forces due to their interlocking geometry rather than through a bonding adhesive. The

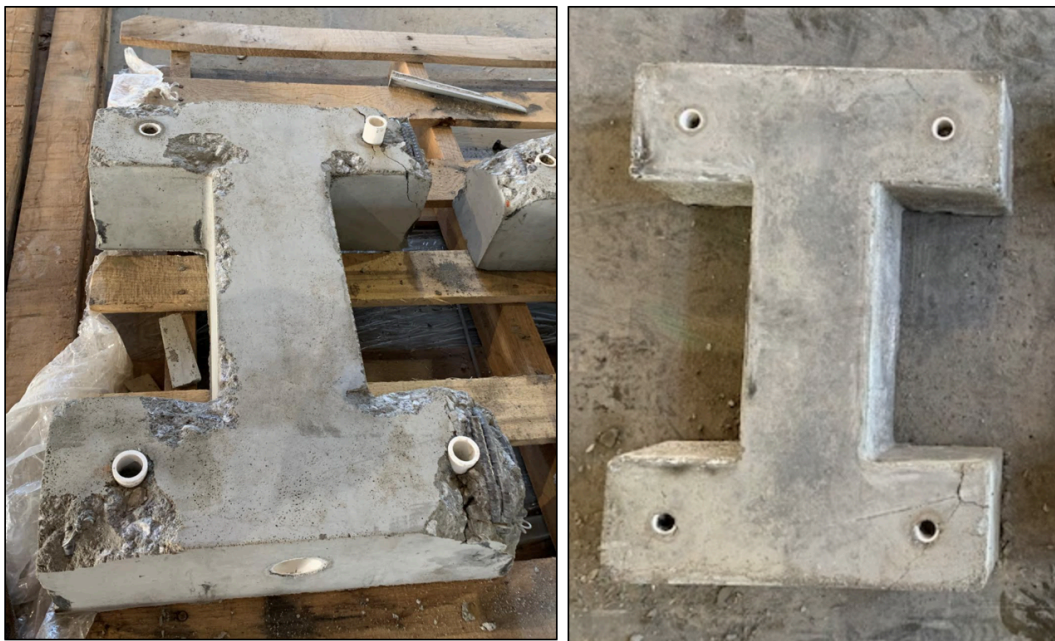
Figure 9: I-shaped tile before greasing forms and caulking joints (left); I-shaped tile after greasing forms and caulking joints (right).

8). Spalling was initially an obstacle, likely due to the small amount of cover at the corners of the tiles. However, caulking the joints of the forms and lightly greasing them helped to mitigate this problem (Figure 9). Greasing the forms caused the BIF face of each tile appear slightly darker than the TIF face. Additionally, TIF faces could not be finished due to the cage needed to hold the PVC pipes in place, so they appear rougher than the BIF faces. These aesthetic problems were deemed insignificant for the purposes of this research but may warrant more attention in future design.

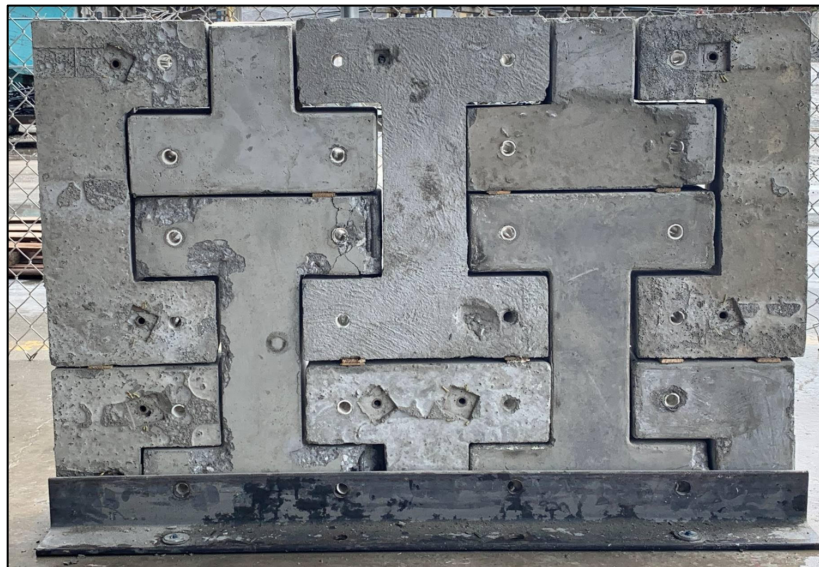
*Figure 10: Small mock-up constructed at precast facility.*

When approximately half of the tiles were cast, a small-scale mockup of the wall was constructed at the precast facility to ensure that tiles would fit together as planned (Figure 10). This stage of the process was crucial, as it provided some insight into the construction process and the problems that might be encountered. It was at this stage that keeping the tiles in plane was realized as a potential challenge. Plastic shims were used to maintain the intended void space between tiles, and several 2 foot long pipes with a diameter of 1 inch were inserted through the longitudinal PVC pipes to ensure that the holes would remain aligned. These practices were adopted throughout the construction process of the full wall specimen when it was stacked in the lab. Alignment “straps” were also used during construction of the mockup; these straps were small steel plates with two holes that could be bolted through the transverse PVC pipes to keep the tiles in plane. However, these straps were not efficient during construction of the full wall test specimen due to several factors, including the slight offset between holes of adjacent tiles and the required removal of the straps during the grouting process.

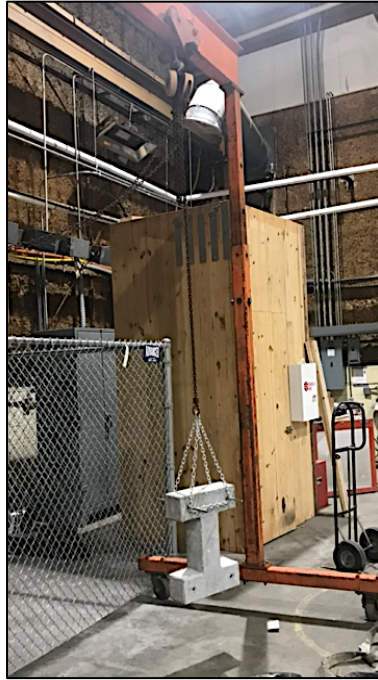
*Figure 11: Lifting strategy for tiles using chain hoist.*

Building on lessons learned from the mockup, construction of the full wall test specimen began. A 0.25 inch layer of grout was applied to the steel base before laying the first row of tiles. Because of the draft on the tile edges, the base layer of grout spread to be thicker on the BIF side and thinner on the TIF side of the tiles. Subsequent rows were lifted into place using a chain hoist (Figure 11). The chain hoist was selected due to the relatively small nature of the wall; however, it proved time consuming to lift each tile manually in this manner. Future assembly might be better executed with a crane or other mechanical lift, particularly for assembly of a larger system.

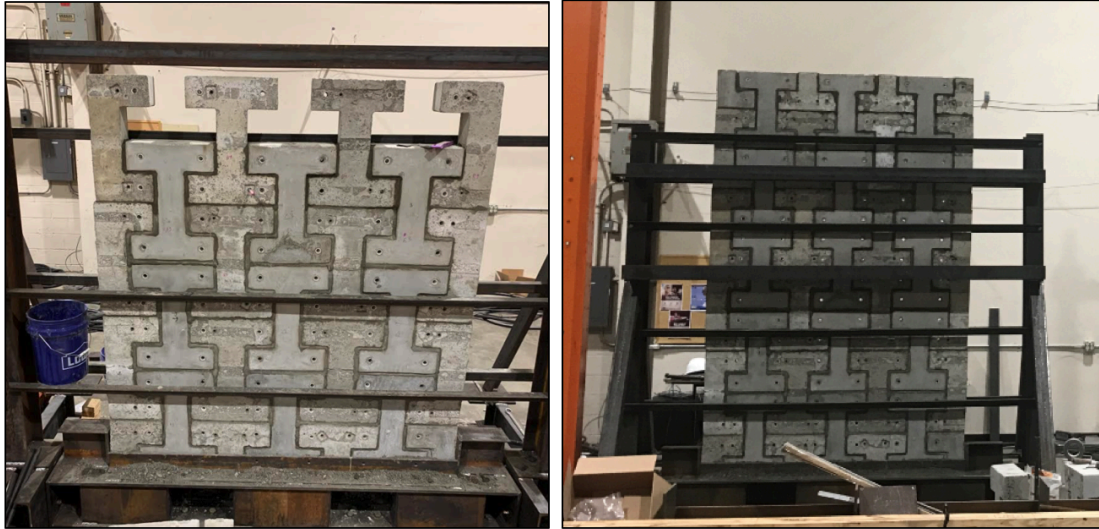
Figure 12: Each successive row could be slid into place by adding and removing angles during construction process (left); Fully stacked wall (right).

Shims of appropriate thickness were placed as needed just before installing each tile. Tiles were required to be slid into place after placing the first row, rather than being simply being stacked (Figure 12, left). Once the tile was roughly in place, a 1 inch diameter pipe steel pipe with a length of 24 inches was inserted through the longitudinal PVC pipe to ensure that it was aligned with the PVC pipe of the tile directly below it. The pipe had a flange on one end to prevent it from completely sliding into the vertical PVC pipes. With the 1 inch pipe and shims still in place, non-shrink grout was inserted in the gaps around the tile in a dry-pack consistency. The tile was monitored throughout this process to ensure that it remained level and in-plane. Removable horizontal angles were added and removed as needed to provide safety and stability throughout the process (Figure 12, left). Once grouted in place, the alignment pipe and shims were removed. This process was repeated row by row for the entire wall (Figure 12, right).

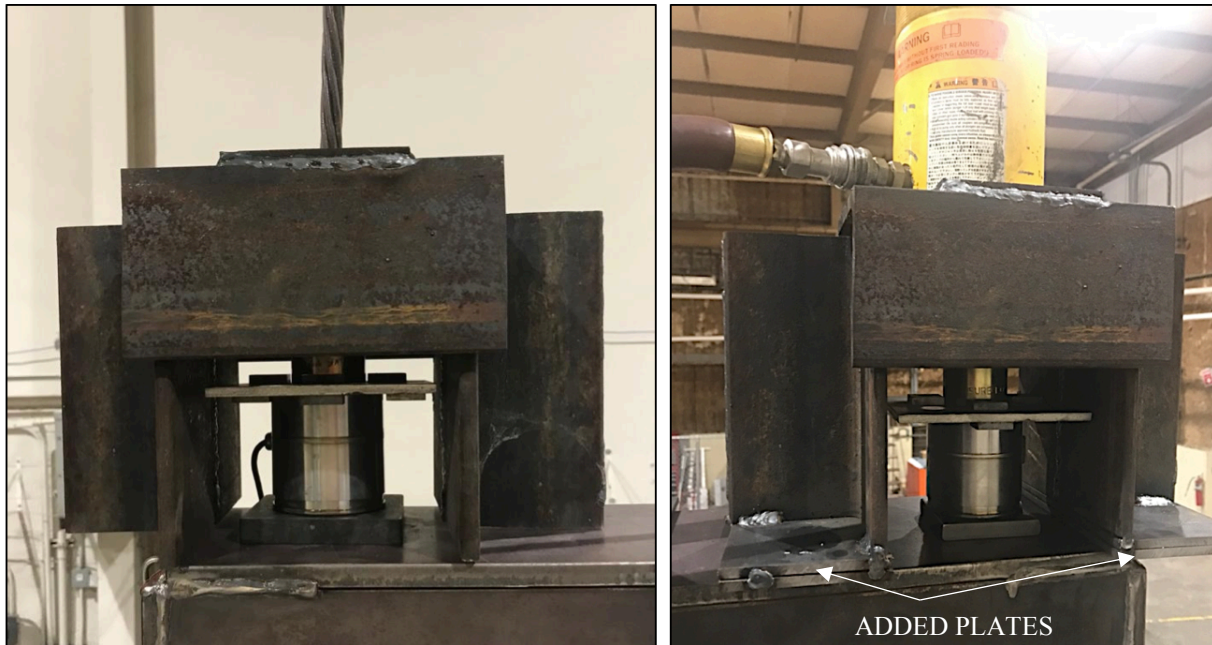
Figure 14: Steel saddle at edge before adding supporting plates to bottom (left); strand jacking setup with supporting plates added to saddle (right).

A problem encountered during this phase of construction, related to the difficulty of stressing the outermost strands due to their proximity to the edge of the wall. The dimensions for the steel saddle were selected to allow enough room for the strand chuck, as well as a hand, in the hollow interior. However, its size made it almost too large to sit on the edge of the steel cap for the outermost strands. A plate was added under each of the supporting angles with a small lip to provide additional bearing area during the stressing process (Figure 14, right).
