## Material characterization and structural response under earthquake loads of hakka rammed earth buildings

**Abstract:** Hakka Tulou are rammed earth buildings that have survived material aging, natural weathering and earthquakes for hundreds of years. Previous paper has reported our observations and findings from nondestructive evaluations in field with focus on the integrity of the rammed earth outer walls and inner timber structures as well as the thermal comfort of living in these buildings. This paper presents the structural response of Tulou buildings under earthquake loads using material data from field and employing finite element (FE) analysis program. The material characterization included scanning electron microscopy and compression strength/modulus of rammed earth samples and wall reinforcements, revealing their high strength and durability. The FE analyses were conducted on unreinforced Huanji Tulou as per the simplified lateral force analysis procedure defined by the Code ASCE-7 under three types of wall conditions: 1) unreinforced rammed earth outer wall only, 2) reinforced rammed earth outer wall without inner wooden structures, and 3) unreinforced rammed earth ou

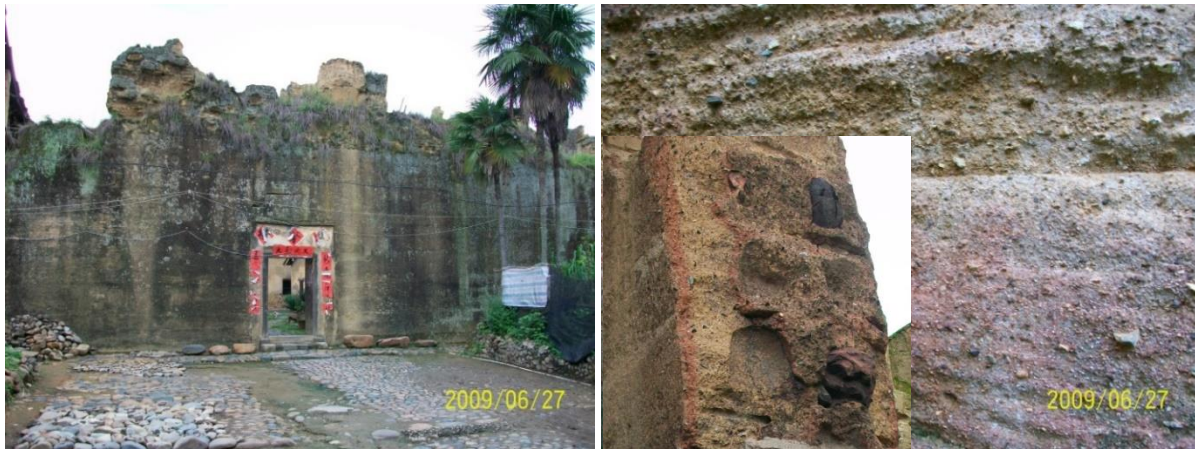
**Fig. 1.** Fuxing Tulou and its earth wall

door, illustrating how strong the wall is even after aging for 1200 years. Nondestructive evaluations (NDE) using infrared thermography, rebound hammer and ultrasonic testing were conducted on this building during field study and its earth wall samples were collected for laboratory testing.

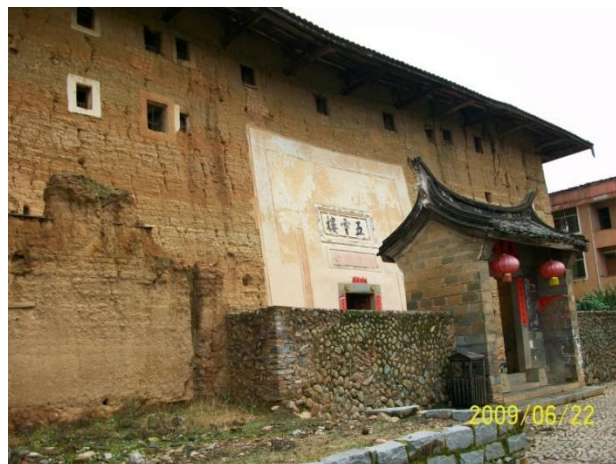
**Fig. 2.** Wuyun Square Tulou

Wuyun Tulou, located in Gaobei Village of Gaotou Town, is a square Tulou with four stories. Its front wall has some cracks and is buckling inward at the center section (Fig. 2). Several elders are living inside. Built around 1500 (Ming Dynasty), this is one of the oldest known rammed earth buildings in this village. The earth wall was found with wood chips as reinforcement. NDE testing was conducted on the earth walls during field study and the results were reported in [1]. Its earth wall samples were collected for laboratory evaluation and the data are presented in Section 3 of this paper.

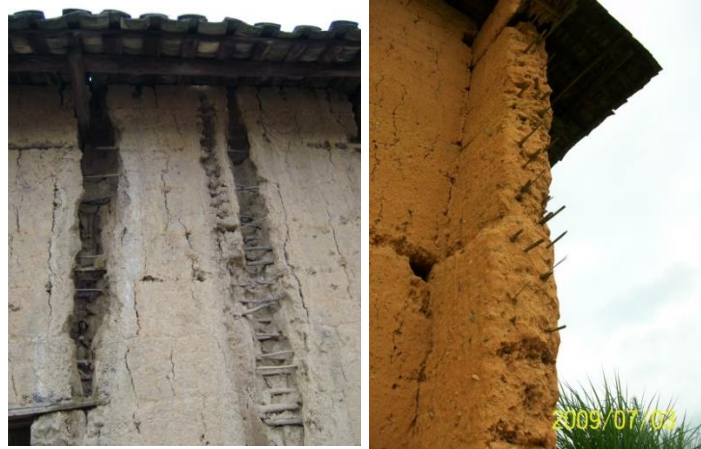
**Fig. 10.** Eroded earth wall exposing wooden sticks (left) and a wall section exposing bamboo strips as reinforcements (right)

To estimate the volume of reinforcements in a typical rammed earth wall (known as the fiber volume fraction for a fiber reinforced polymer composite), an easy-to-access cross section of rammed earth wall was identified with pultruding bamboo strips as wall ribs (Fig. 10, right). Dimensions of the exposed wall ribs, their spacing, and the wall thickness were field-measured and used to compute the volume of reinforcement for this particular wall. Based on the samples collected, the wooden sticks were typically round with about 4cm in diameter, which results in a fiber cross section of 12.56 cm<sup>2</sup> while bamboo strips were in near-rectangular shape with dimensions typically around 1.25cm x 2.5cm, which results in a fiber cross section area of 3.13 cm<sup>2</sup>. Assuming that the same spacing was used for both wood reinforcement and bamboo reinforcement as exhibited by the exposed wall ribs in Fig. 10 (right), then the volume fraction comes out to be 6.7% for wood reinforcement and 1.8% for bamboo reinforcement. Using the strength and stiffness data of constituent materials along with the above volume fraction Figs, the strength and modulus of elasticity for a reinforced rammed earth wall can be calculated using the Rule of Mixture. The average compression properties of rammed earth walls with and without reinforcements are listed in Table 3.
